FLYER TO THE SHIPPING INDUSTRY

RIVERDANCE

Listing incident followed by the grounding of a ro-ro cargo vessel at Cleveleys Beach

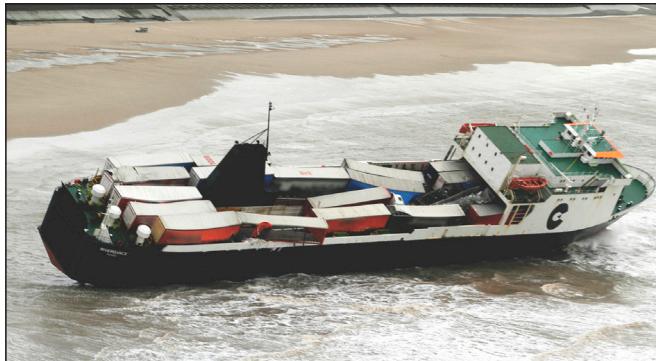
On 31 January 2008, the Bahamas registered ro-ro cargo vessel, *Riverdance*, grounded and became stranded on the Shell Flats, off Cleveleys Beach, Lancashire. The prevailing severe weather conditions prevented the vessel from being refloated, and subsequent attempts to salvage her failed. *Riverdance* was finally cut up in-situ. Fortunately, the crew were all safely recovered and there was no pollution.
