MARINE ACCIDENT INVESTIGATION BRANCH

FLYER TO THE SHIPPING INDUSTRY

Scot Isles collision with *Wadi Halfa*

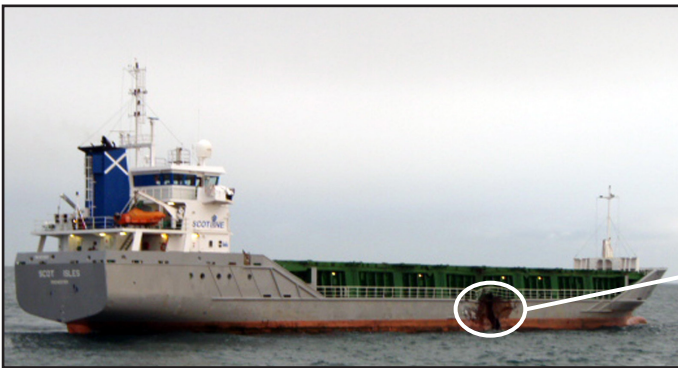
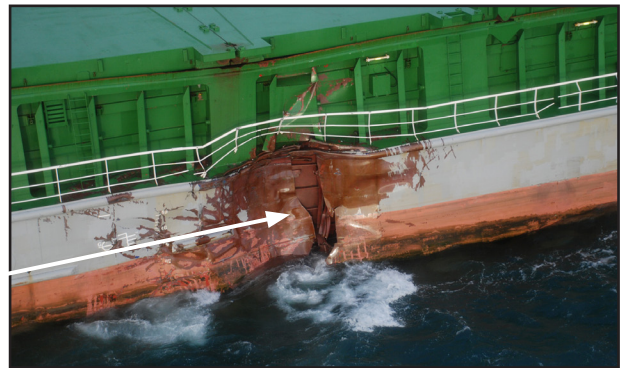
Damage to *Scot Isles*

Scot Isles was struck amidships and a fuel tank was breached, causing pollution, but the full extent of the damage was not discovered for some time due to ineffective post collision checks. The Coastal State subsequently directed the vessel to proceed to Dunkirk for a full damage survey and repairs, which kept the vessel out of service for several weeks.

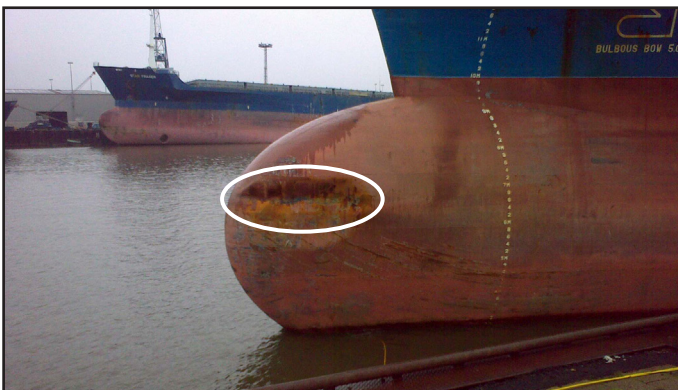
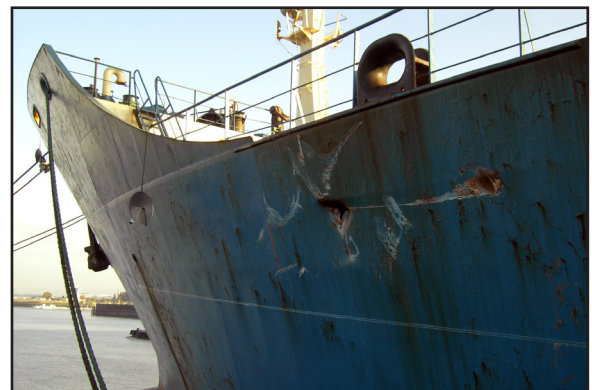
Damage to *Wadi Halfa*

Damage to *Wadi Halfa*, although less severe, took more than a week to repair on arrival at her next port in Germany.
