MARINE ACCIDENT INVESTIGATION BRANCH

## FLYER TO THE FISHING INDUSTRY Grounding of fishing vessel *Niamh Aine*

April 2009

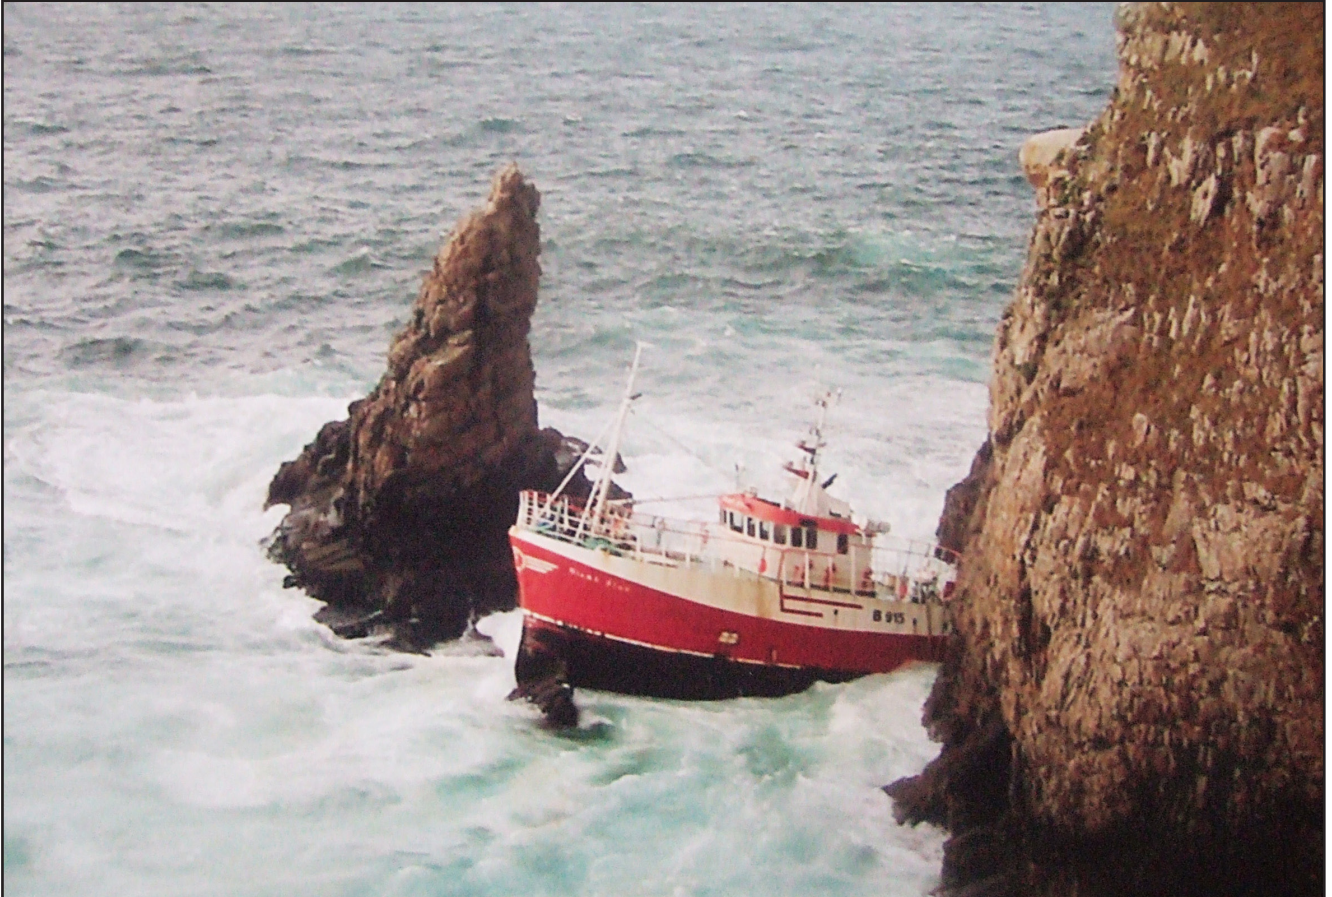
Photograph courtesy of the Irish Coast Guard

In the early hours of 22 March 2009, the shelter deck potter *Niamh Aine* ran aground as she returned to port to land her catch after a 6-day trip.

The skipper took over the bridge watch as the vessel approached her home port. It was a very dark night with a calm sea and no other vessels in the area. He sat in the wheelhouse chair, reset the bridge watch alarm, and then fell asleep.

The vessel was subsequently declared a constructive total loss.

- **Consider the appropriate manning levels required for each trip based on the hours the crew will have to work each day.**
- **Introduce measures to ensure that each crew member is properly rested in order to avoid accidents such as this.**
- **Ensure the bridge watch alarm is sited such that the watchkeeper is not able to cancel the alarm while seated in the wheelhouse chair.**
