# MAIB

MARINE ACCIDENT INVESTIGATION BRANCH

## FLYER TO THE SHIPPING INDUSTRY Hazardous Incident - *Norma* - 21 June 2008

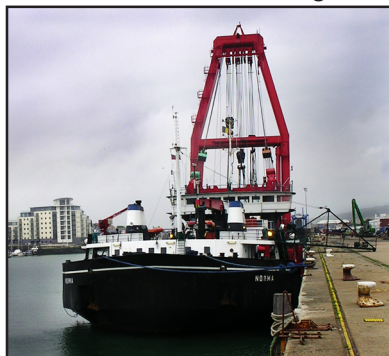
*Norma*

Figure 1 On 21 June 2008, *Norma*, a Belgium registered self-propelled crane barge (**Figure 1**) was assisting in a salvage operation to remove a wreck in the Dover Strait. By 1000, the vessel's anchors were holding her in position, and the master instructed the OOW to switch off the vessel's Voith Schneider propellers. At 1115, the master signed the diving contractor's 'permit to dive' request, on which he verified that the vessel's engines were stopped and isolated. In fact, the propellers were still rotating. The OOW had turned the steering control switch to 'off' which only disabled the control of the pitch of the propeller blades; he did not instruct the duty engineer to stop the electric motors.

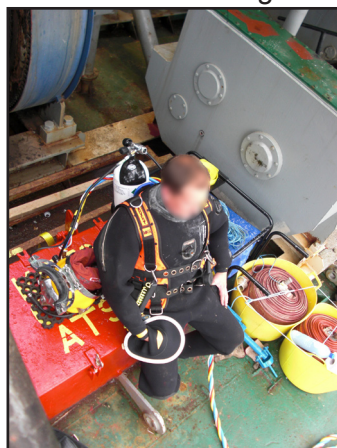
Figure 2

The diver (**Figure 2**) entered the water and, during his descent to a depth of about 20m, the umbilical containing his air supply and communication links was set towards the aft propeller by the tidal stream. The umbilical, along with a polypropylene rope the diver was carrying, then became entangled in the propeller and the diver was pulled rapidly towards its rotating blades. Although spinning, the diver managed to switch to the air supply provided by his 'bail-out' bottle.

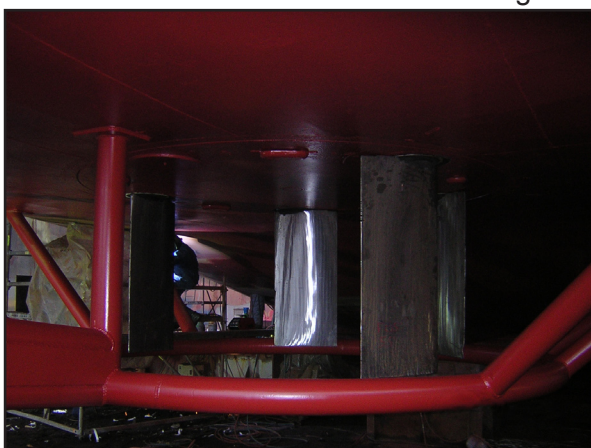
Figure 3

Voith Schneider propeller

The umbilical was also pulled from *Norma*'s aft deck and severed. The diving supervisor immediately contacted the bridge and the master quickly determined from the engine room that the propeller units were still running. The electric motors were stopped with the diver only about 3 metres away from the propeller (**Figure 3**). The diver then managed to free himself from the entangled mass of umbilical cord and rope and make his way to the surface, where he was safely recovered.

- **The operation of machinery which poses a risk to divers should be prevented by physical barriers such as the removal of fuses whenever possible.**
- **A master should authorise the commencement of diving operations only when he is satisfied that the required control measures have been taken and all key ship's personnel, such as the chief engineer, have been informed.**
