MARINE ACCIDENT INVESTIGATION BRANCH

## FLYER TO THE SHIPPING INDUSTRY

### *Pride of Canterbury*

#### Grounding of a passenger ferry on a chartered wreck while awaiting Dover port to reopen

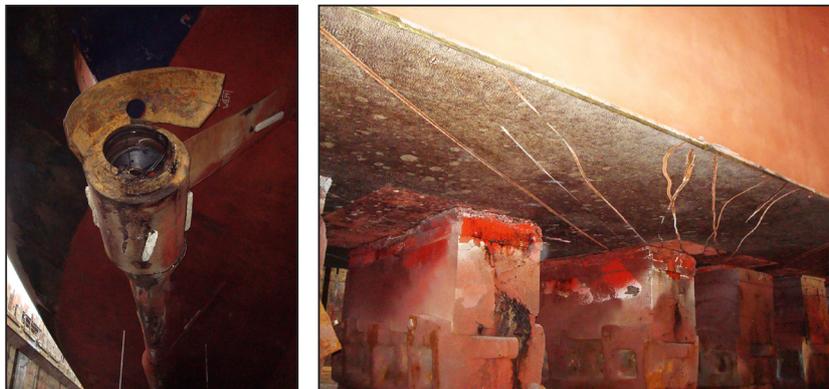
On the afternoon of 31 January 2008, while sheltering off the port of Dover in bad weather conditions, the passenger ferry *Pride of Canterbury*, with 275 passengers and 101 crew on board, grounded on a chartered wreck. She sustained major damage, including the total loss of her port controllable pitch propeller hub and a section of tail shaft.

Damage sustained by *Pride of Canterbury*
