MARINE ACCIDENT INVESTIGATION BRANCH

## FLYER TO THE FISHING INDUSTRY

### *KERLOCH:*

### GROUNDING AND FOUNDERING

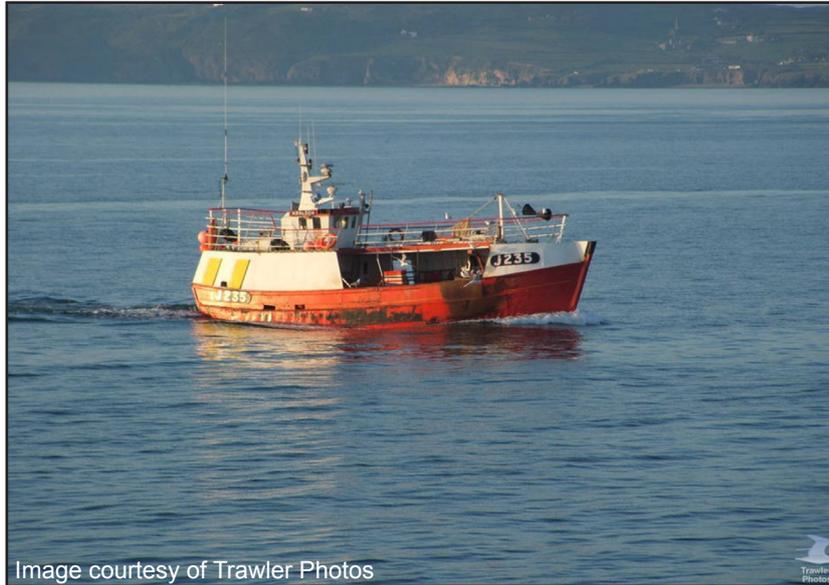
The Jersey-registered 15.45m crabber *Kerloch* (J235) was returning to port late on the afternoon of 20 February 2010, when she ran aground on Crow Rock, off the Pembrokeshire coast.
