MARINE ACCIDENT INVESTIGATION BRANCH

FLYER TO THE TOWING AND WORKBOAT INDUSTRY

LLANDDWYN ISLAND:

PARTING OF A HAWSER RESULTING IN A FATALITY

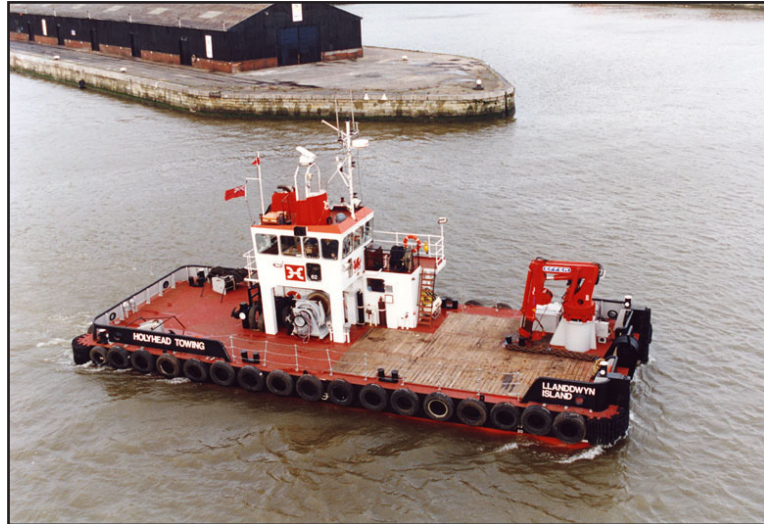
Llanddwyn Island

The 21.5m workboat, *Llanddwyn Island*, was assisting an 870t backhoe dredger into position, when the single hawser connecting the vessels suddenly parted under tension. As the hawser recoiled, it struck the deckhand who had entered the 'snap-back' zone. The deckhand died at the scene.

- **The deckhand was in the ‘snap-back’ zone when the hawser parted.** When a line is under tension or can tension without warning, it is dangerous to enter its ‘snap-back’ zone. Where it is impractical to mark ‘snap-back’ zones on decks, extra vigilance is required and anybody seeing another crewman approaching an area of potential recoil should not hesitate to warn the person concerned.

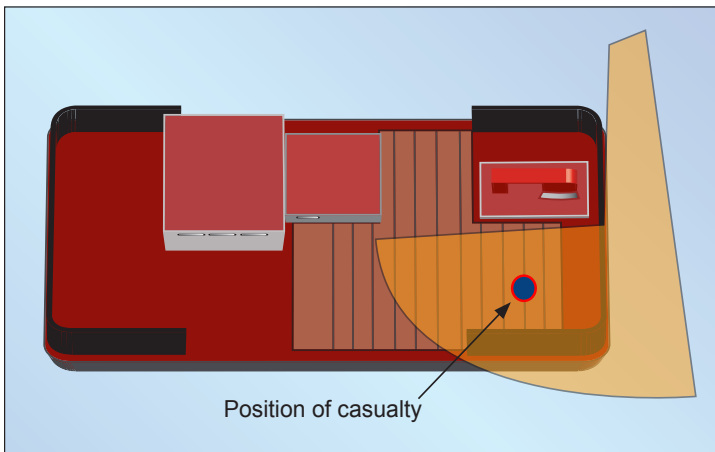
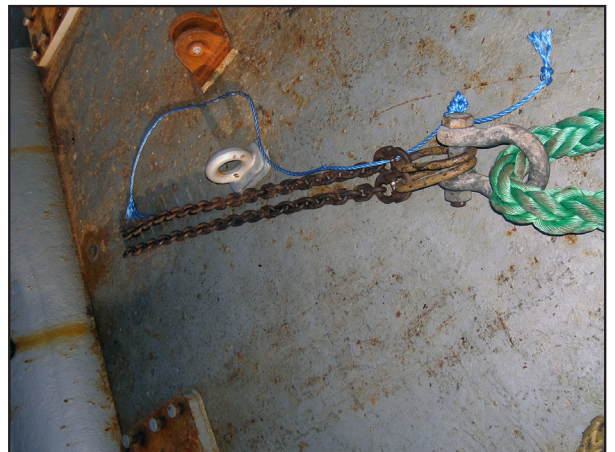
A 13mm steel chain sling, used to connect a rope stretcher to the dredger, had failed. It had been passed through a pad eye on the dredger's stern and then doubled-up and re-connected to the rope stretcher by a shackle. No thimbles were used in the hawser and the safe working load of many components, including the chain, was not known. Prior to the accident, the workboat's skipper did not hear a call from the backhoe operator informing him that the dredger was in position and that he was lowering the spud legs. The deckhand had not been told that it was safe to approach the tensioned hawser.

- **The doubled-up chain did not double its breaking strain.** The loads acting on the centre link of a chain when doubled round a single point can reduce the overall strength of the chain depending on the dimensions of the equipment used.

- **The chain was not part of the workboat’s loose gear and was uncertificated.** Loose towing gear acquired in service might ‘come in handy’ but its use can be dangerous. Only gear which is accompanied by appropriate certificates and has been checked regularly can be used with confidence.

- **The hawser was not made up in accordance with industry best practice.** When selecting equipment for use in a hawser, it is prudent to make use of the guidance available, and careful consideration should be given to the loads that the hawser may be subjected to and the properties of the loose towing gear available.
