MARINE ACCIDENT INVESTIGATION BRANCH

FLYER TO THE FISHING INDUSTRY

COLLISION BETWEEN THE BULK CARRIER *ALAM PINTAR* AND THE FISHING VESSEL *ETOILE DES ONDES*

20 DECEMBER 2009

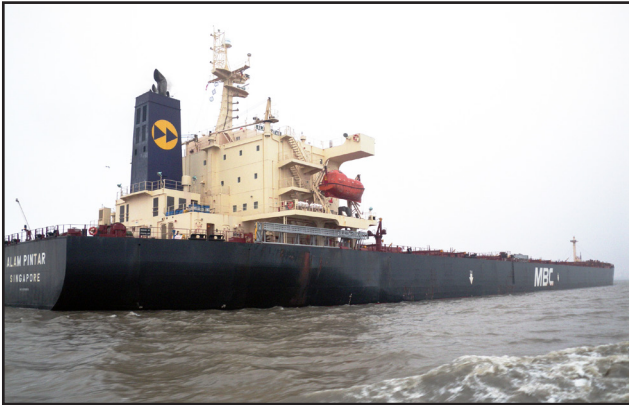
Alam Pintar

Alam Pintar's bridge was manned by an inexperienced officer of the watch (OOW) and a cadet. The OOW had seen the fishing vessel, visually and by radar. He assessed there was a risk of collision and made two changes to his course. These changes were insubstantial and were rendered ineffective when *Etoile des Ondes* made a large change of course upon arriving at the skipper's preferred position for shooting his pots. The OOW also had difficulty identifying the fishing vessel's navigation lights due to glare from the deck working lights.

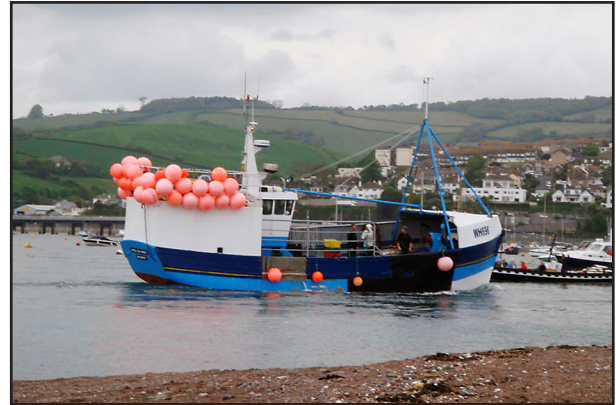
Etoile des Ondes

The skipper of *Etoile des Ondes* had not been monitoring *Alam Pintar's* actions but assumed that she would keep clear of his vessel. However, his change of course upon shooting pots was directly into the path of *Alam Pintar*, and the vessels were then so close that *Alam Pintar's* OOW had insufficient time to take any further, effective action.

- None of the crew of *Etoile des Ondes* wore any kind of flotation device. They knew where the lifejackets were located, but after the collision there was no time to reach them. This incident shows yet again the need for fishermen to wear some form of device when working on deck; had they done so, the missing crew member might also have survived.
