# MAIB

## FLYER TO THE FISHING INDUSTRY

### Fatal accidents on fishing vessels *Korenbloem, Osprey III and Optik*

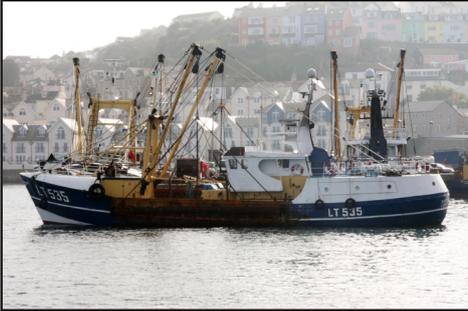
On 6 November a deckhand on board the scallop dredger *Korenbloem* fell overboard whilst preparing to shoot the gear. He was standing on top of the catch in the scallop tray, which was at much the same height as the bulwark. Although he was not seen going overboard, the injuries he sustained indicated that, at some point during the accident, he was struck or crushed against the ship's side by the towing beam as the vessel rolled heavily in beam seas. Two of his crewmates

jumped into the water and, with the help of other crew members, managed to recover him on board. Although he was airlifted to hospital, he was pronounced dead shortly after arrival.

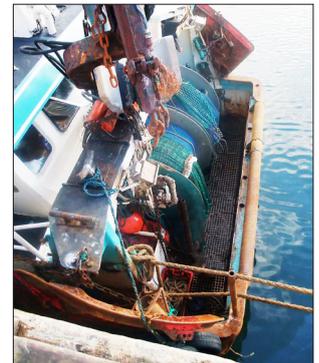
During the evening of 11 November the stern trawler *Osprey III* was returning to port after a few days fishing. A damaged net was being lowered to deck following repair, when a bight of the net entered the sea. This caused the portion of the net flaked out on deck to run over the stern, and into the water. A deckhand, who was standing next to the net drum, became entangled in the net and gear, and was carried overboard. Whilst the skipper quickly manoeuvred his vessel alongside the casualty, who had surfaced nearby, he and the other crewman were unable to recover their colleague on board with the equipment they had available. The casualty was now weak from his immersion in the cold water, and unable to help himself; he disappeared beneath the surface and was lost. His body was recovered 1 week later.

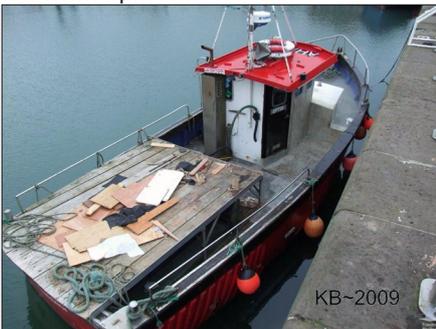
A crewman on the creel fishing vessel *Optik* was dragged overboard while shooting creels on 18 November, when his foot became entangled in the dhan rope. The skipper immediately stopped the vessel and grabbed the remaining rope on deck to place it over the hauler. He quickly hauled in the line and his crewman was pulled back to the surface, still entangled in the rope. With his crewman suspended by his ankle over the side, the skipper was unable to pull him back on board until helped by a crewman from a nearby vessel, who jumped over to *Optik* to assist. Sadly, despite CPR, and helicopter evacuation, the crewman died shortly after arrival in hospital.
