MARINE ACCIDENT INVESTIGATION BRANCH

FLYER TO SMALL HIGH-SPEED CRAFT OPERATORS ACCIDENT TO PASSENGER ON A DELTA 8.5M RIB

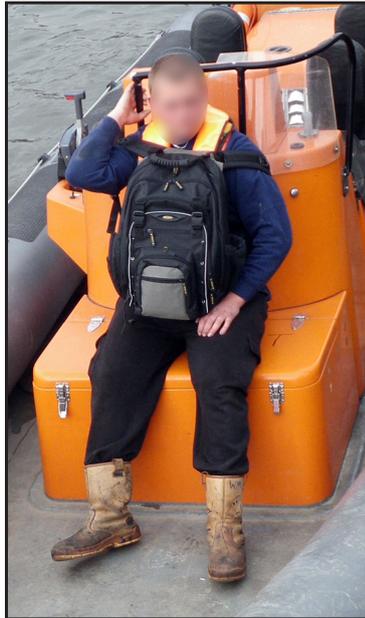
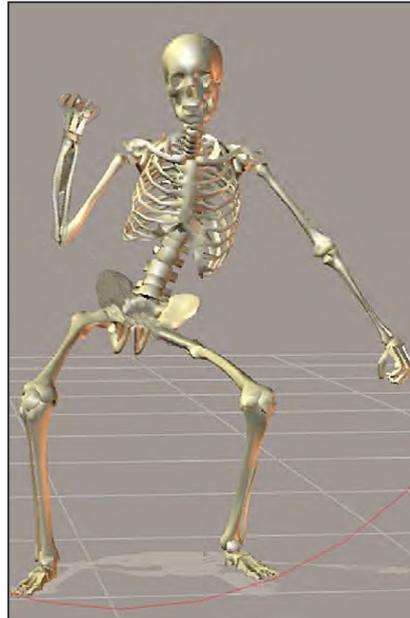
At approximately 0708 on 6 May 2010 a male passenger on a Delta 8.5m rigid inflatable boat (RIB) suffered lower back wedge compression fractures while the boat was transporting him, together with fellow workers, to a jack-up rig on the River Thames.

The injury occurred when the man landed heavily onto the lid of a locker, which was used as a seat, after he had been momentarily lifted off the lid due to the motion of the craft. At the time of the accident there was a light wind with a slight sea.

- Operators of high-speed craft should conduct Whole Body Vibration and shock impact risk assessments in accordance with the requirements of the Vibration Regulations to reduce the risk of injury to their employees and passengers to a level which is as low as reasonably practicable (MGN 353 (M+F) refers).
- Helmsmen should be made aware, through appropriate training, of the risks posed to crew and passengers from shock impacts when conducting high speed passages or when encountering large waves or wakes at lower speeds.
