MARINE ACCIDENT INVESTIGATION BRANCH

## FLYER TO THE FISHING INDUSTRY

### ***HOMELAND*: COLLISION WITH *SCOTTISH VIKING* RESULTING IN TOTAL LOSS OF THE VESSEL AND ONE FATALITY**

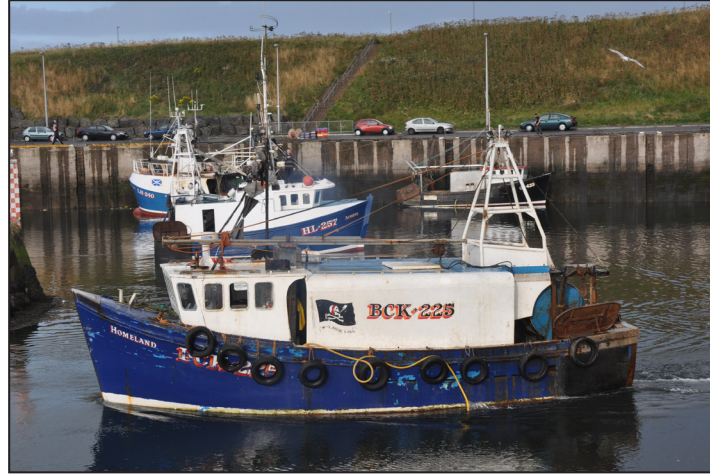
At 1946 on 5 August 2010, the UK registered fishing vessel *Homeland* was in collision with the Italian registered ro-ro passenger ferry *Scottish Viking* about 4 miles off St Abb's Head. As a result of the collision, the fishing vessel sank. The skipper was recovered from the sea, but his brother lost his life.

*Homeland's* starboard bow struck *Scottish Viking*, and she immediately started taking on water. The skipper and his brother climbed onto the wheelhouse roof to deploy the liferaft, but the vessel sank beneath them. They both entered the water without having had time to don a lifejacket. The skipper surfaced and called for his brother, but did not hear or see him. Although an extensive search and rescue operation followed, his brother was not found.
