## FLYER TO RO-RO VESSEL OPERATORS AND THE PORTS INDUSTRY

### *Commodore Clipper* – Fire on the main vehicle deck due to an overheating reefer cable connection

**Marine Accident Investigation Branch  
November 2011**

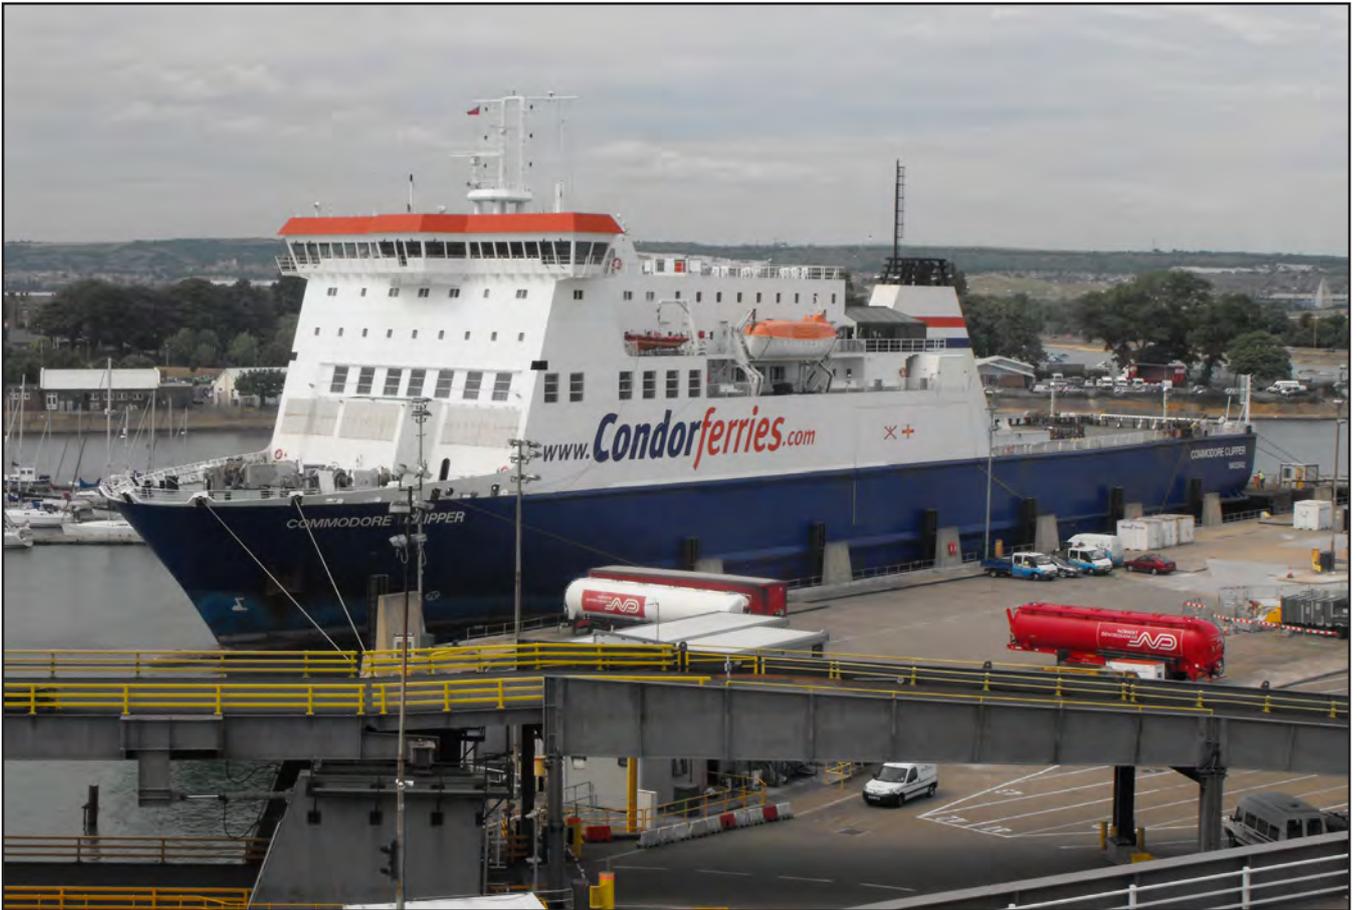
*Commodore Clipper*

During an overnight passage from Jersey to Portsmouth on 16 June 2010, a fire was detected on the main vehicle deck of the ro-ro passenger vessel *Commodore Clipper*. The officer of the watch and duty engineer initially thought the alarm was due to a fault with the fire detection system, and the vehicle deck water drenching system was not started until 20 minutes later.

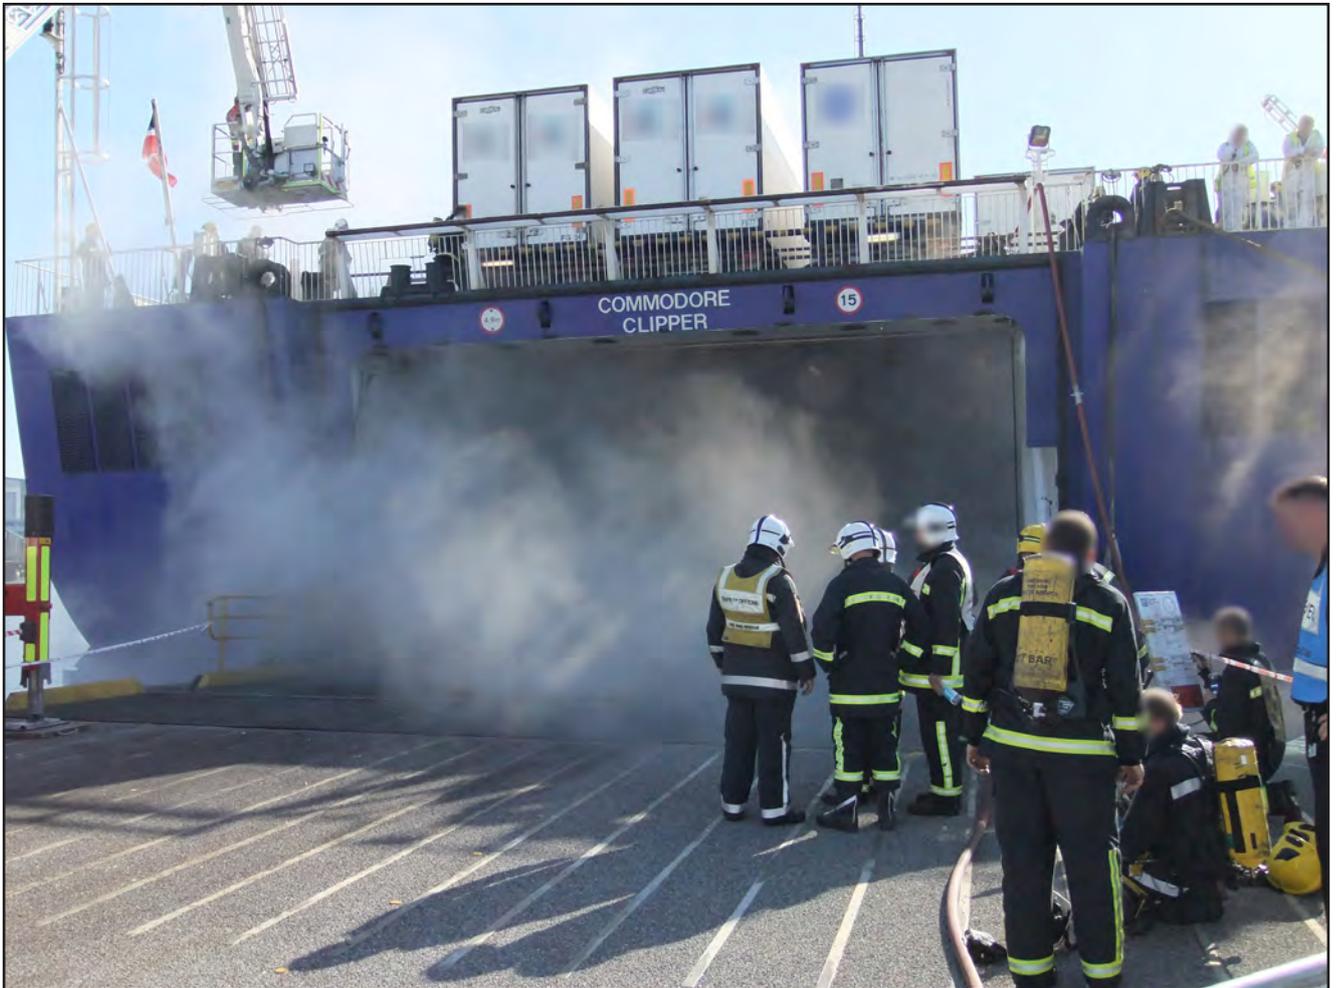
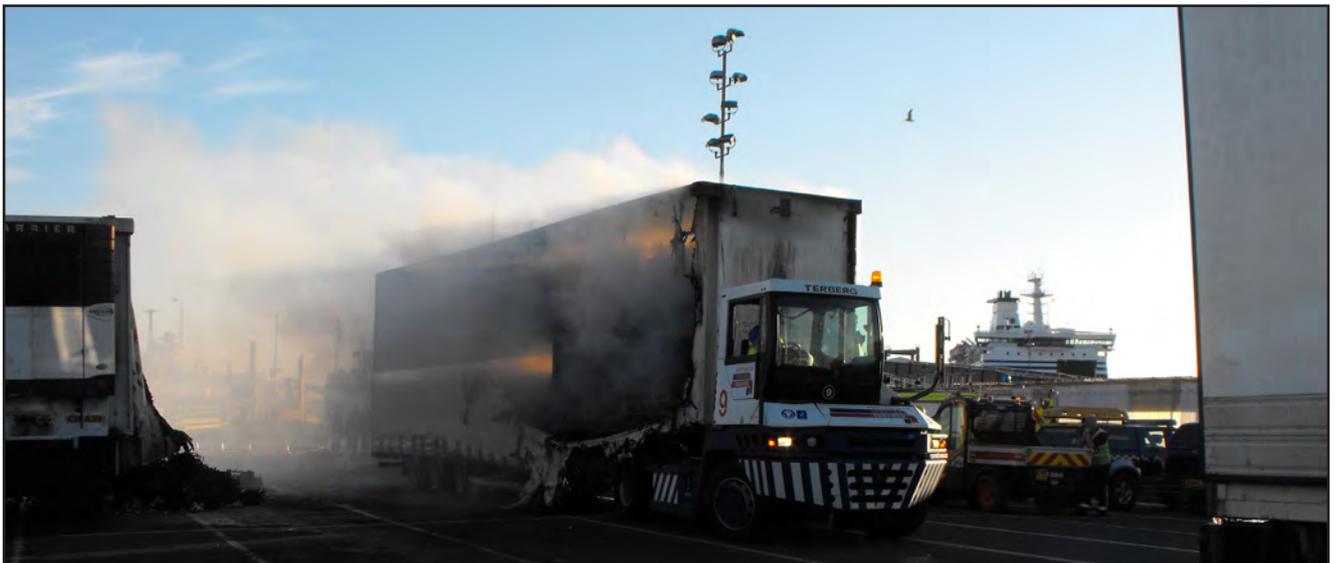
The fire developed in an unaccompanied curtain-sided refrigerated trailer that was carrying a load of potatoes. The trailer roof shielded the flames from the drenchers and the fire continued to burn. The trailers were tightly stowed; crew had great difficulty gaining access to the fire and were unable to extinguish it.

Unprotected cables and pipework running above the fire were soon damaged in the high temperatures that were generated by the burning curtain-side and cargo packaging materials. The vessel lost power to forward mooring deck winches and bow thrusters, control of the rudders was disrupted and the port rudder suddenly moved hard to starboard. Loose cargo partially blocked the deck drains and drencher water caused *Commodore Clipper* to list. Drenching was stopped while water drained to prevent further risk to the vessel's stability, but each time it was stopped, the fire grew in intensity.

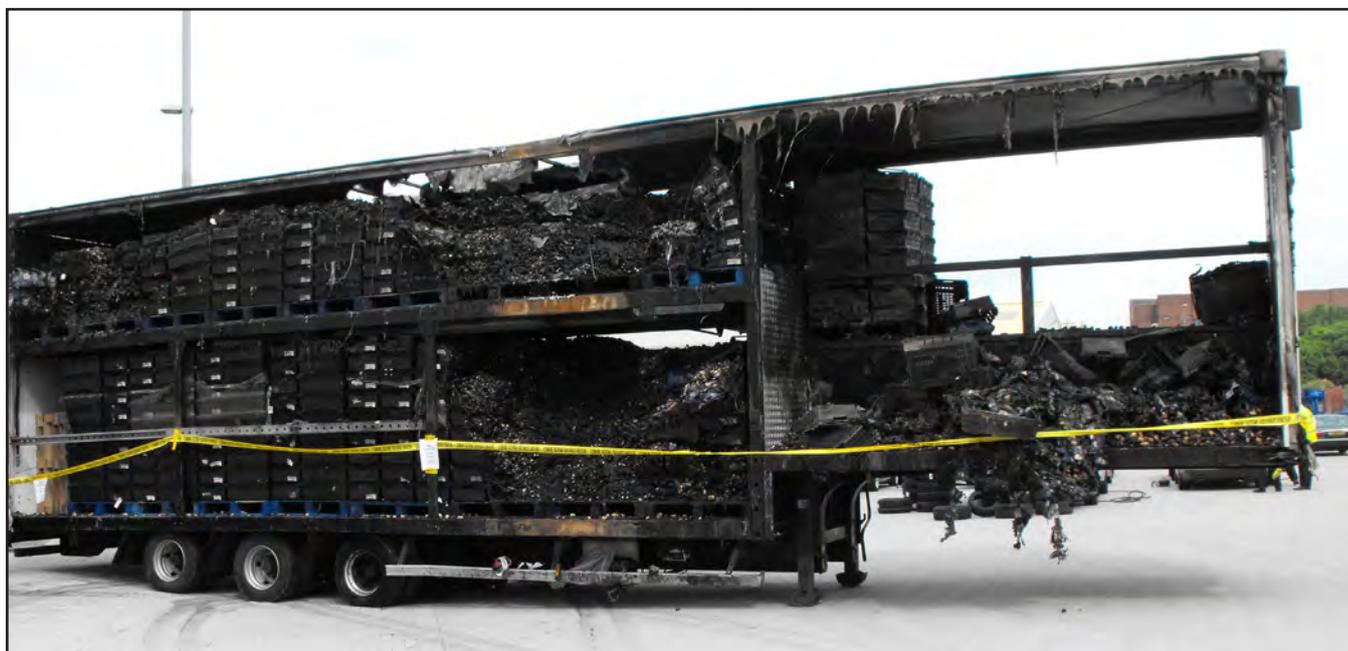
Subsequent investigation found that the fire was due to one of the ship's reefer cables being assembled incorrectly. The reefer cable plugs used 'insulation displacement connectors' (IDC) that are meant to speed up assembly by avoiding the need to strip insulation from cable ends. However, the insulation had been stripped away, and as the design relied on the insulation to help secure the cable in place, the connection became loose. This led to a local high-resistance fault and then arcing in one of the phases. The electrical protection in the vessel's circuit breakers was not able to detect this fault and heat built up inside the plug until the plastic casing ignited. The socket on the trailer was mounted close to the load-bed where the curtain-side was secured. In tests, the material ignited readily and flames spread quickly.

1. Check their vessels' vehicle decks for critical and vulnerable systems, and take action as necessary to improve their resilience to fire damage.
2. Check all reefer trailer power cables regularly. Consider upgrading existing electrical protection to a system that can detect in-line phase faults and provides residual current detection.
