FLYER TO VESSEL OPERATORS USING PROXIMITY SWITCHES ON DAVIT LAUNCHED SURVIVAL CRAFT

TOMBARRA - MALFUNCTION OF A DAVIT PROXIMITY SWITCH RESULTING IN THE FAILURE OF A RESCUE BOAT FALL WIRE WITH THE LOSS OF ONE LIFE

**Marine Accident Investigation Branch
July 2012**

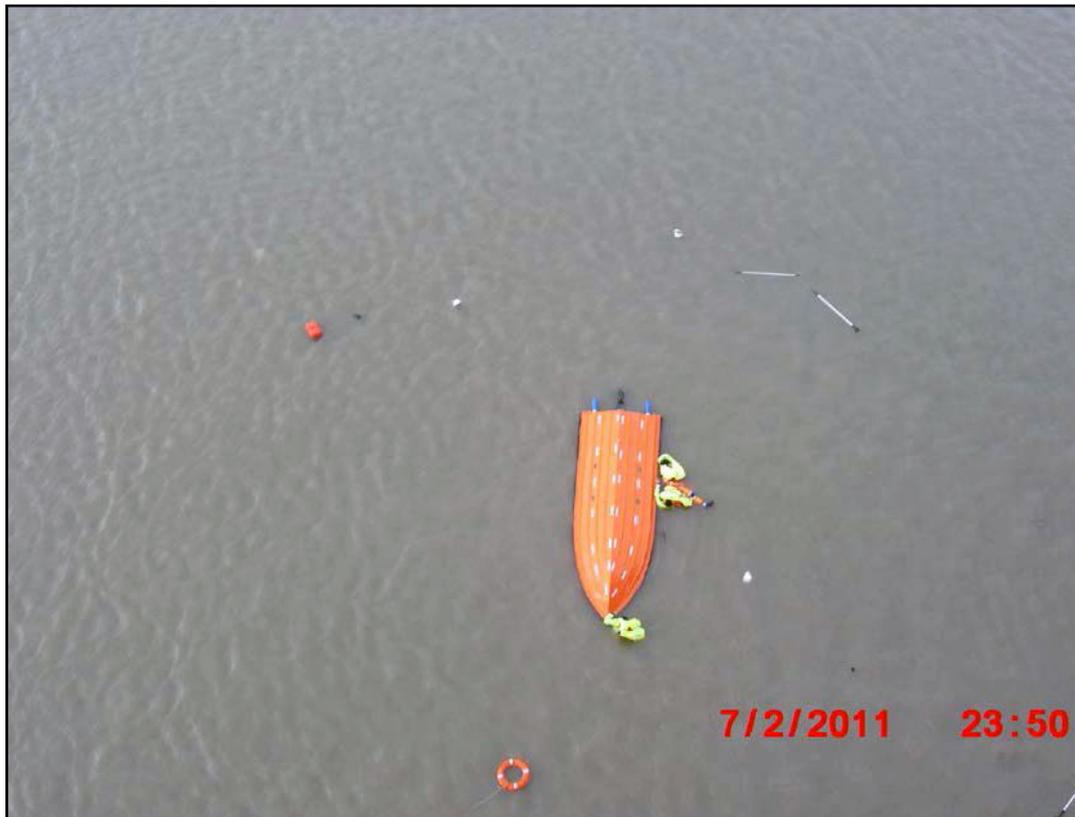
The davit proximity switch that should have cut electrical power to the winch motor before the davit arm reached its stops failed to operate. As a result, when the rescue boat reached its stowed position, the winch rapidly overloaded the fall wire. The wire parted, and the rescue boat (**Figure 1**) plummeted about 29m into the water below, killing one of its four crew.

Figure 1: The rescue boat and crew after the fall wire failure

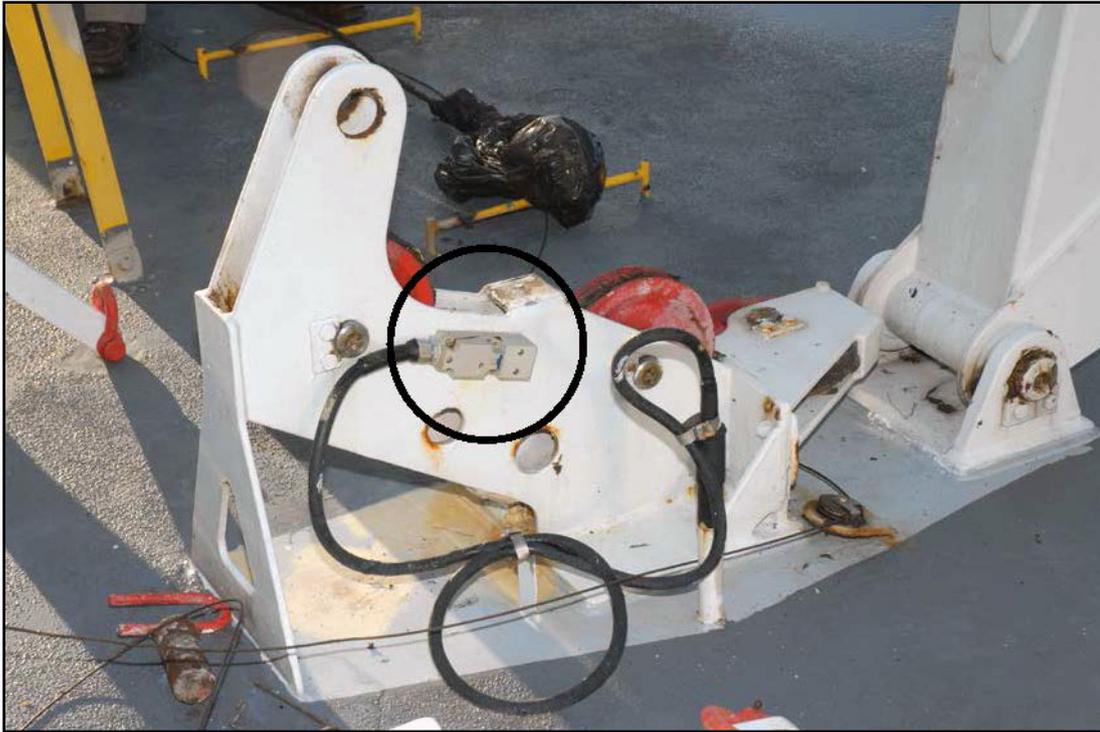
The davit proximity switch (**Figure 2**) did not operate due to a short circuit of its printed circuit board. The short circuit had been caused by either moisture ingress or by transient power surges.

Inductive proximity switches can fail in either the 'ON' or 'OFF' state, depending on the exact failure mechanisms, and therefore both the failure mode, and the time of occurrence, can be unpredictable.

Figure 2: Proximity switch on davit (circled)

1. Safety devices (both inductive proximity switches and mechanical limit switches), fitted to davits, are intended to prevent the over-stressing of the falls and davit structure. They are not fitted for ease of operation.
2. Davit safety devices must always be tested prior to a rescue boat being hoisted.
3. Davit safety devices should not be relied upon. The davit winch must be stopped prior to the davit safety device operating.
4. Visual aids to prompt when winch motors should be stopped could be extremely beneficial.
5. Care must be taken when cleaning and painting electrical equipment on deck. High-pressure hoses must be used with caution.
