FLYER TO THE SHIPPING INDUSTRY

Windlass damage when weighing anchor in gale force winds

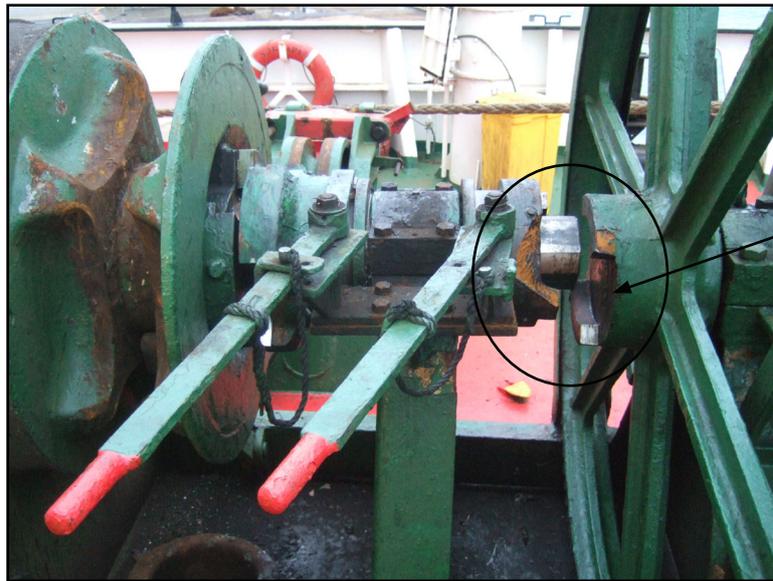
Broken dog clutch
and bent shaft on
port windlass

The wind strength was increasing steadily and the windlass struggled to recover the cable when, suddenly and without warning, the dog clutch shattered and the cable payed out to the bitter end. The cable was subsequently slipped and *Norcape* was taken out of service due to the damage to the windlass and the loss of her anchor.

The fact that the anchor cable rendered indicated that the cable had slipped through the guillotine bar arrangement. Investigation revealed that the locking pin, which should have held the bar in place, was not engaged when the cable rendered. It transpired that the vessel's SMS for anchoring operations contained no reference to the use of the locking pin when anchoring.

The guillotine/chain stopper housing is the strongest part of the anchoring equipment and is designed to take the load of the cable when a vessel lies at anchor. In this case, the load of the cable transferred to the windlass as the cable slipped, and this initiated the failure mechanism which culminated in the catastrophic failure of the dog clutch.

The severe yaw that developed was due to the windage of the vessel's superstructure, which generated forces in excess of the design load of the anchoring equipment.

To try and prevent such accidents occurring in the future, owners and operators are strongly advised to review their SMS procedures for anchoring to ensure they address the above safety issues and, specifically:

1. That masters have clear guidance on the capability of their vessel's anchoring system, including:
 - Any limitations of the anchor system components, including that of the windlass.
 - Effects of windage in various load conditions
 - Risks associated with excessive yaw.
2. That the SMS guidance on anchoring is vessel-specific and highlights that, when at anchor, the weight of the cable should be taken on the guillotine fittings, which should be correctly engaged (Nautical Institute, *Mooring and Anchoring Ships*, Volume 1, 2009. ISBN: 978 1 870077 93 4 refers).
