## FLYER TO THE SHIPPING INDUSTRY

### Catastrophic structural failure of a general cargo ship

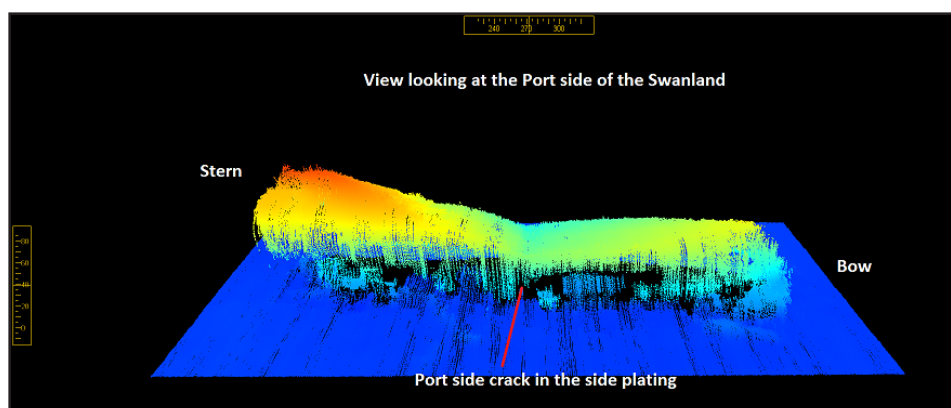
Figure 1: Sonar image of *Swanland* inverted on the seabed

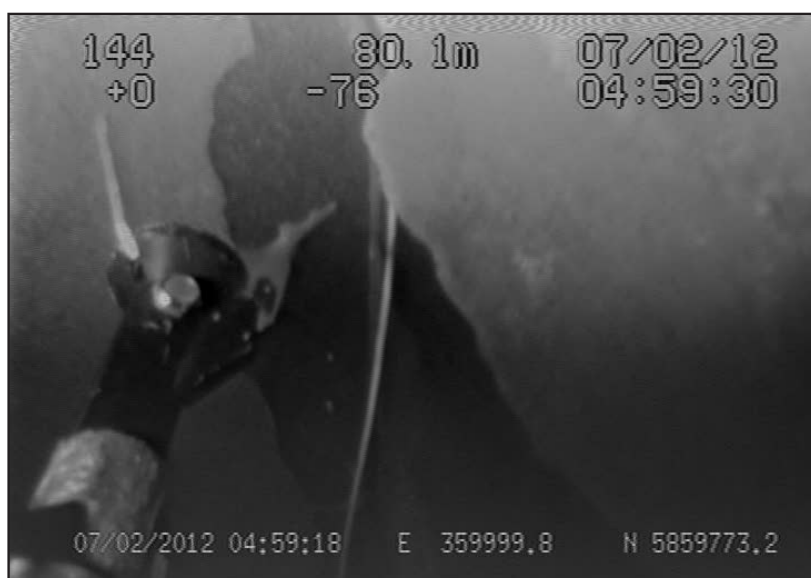
On 27 November 2011, the master and five of the crew from the 34-year old general cargo ship *Swanland* were lost when the vessel foundered about 17 minutes after suffering a structural failure amidships. The failure occurred as the vessel was heading directly into a south westerly gale in rough to very rough seas. Only the second officer and an AB survived. Underwater surveys confirmed that the vessel had suffered a structural failure amidships (**Figure 2**).

Figure 2: ROV image of the structural failure amidships

A longitudinal strength assessment of the vessel following the accident confirmed that the large sagging bending moments induced by the cargo and the wave conditions experienced on the day of the accident would have been sufficient to cause compressive failure of the upper midships structure.

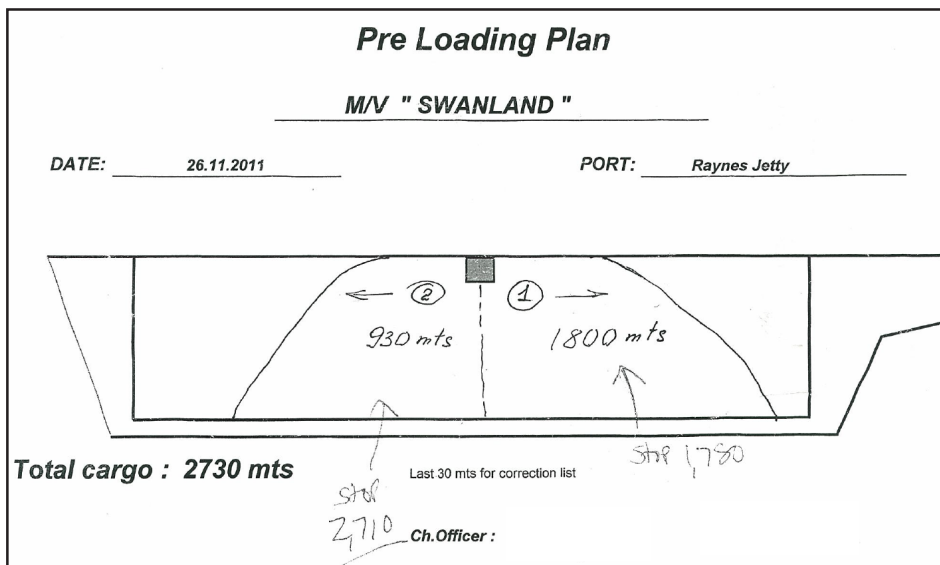
At the time of the accident, *Swanland* was carrying a cargo of 2730 tonnes of MOT Type 1 Granular Sub Base (GSB) limestone, which is a high density cargo. The limestone had been loaded in two piles biased towards the centre of the vessel's single hold in accordance with the loading plan prepared on board (**Figure 3**).

**Figure 3:** Pre-loading plan

*Swanland's* foundering is one of many cargo ship losses in recent years in which poor loading or overloading of cargo has been a significant contributing factor. In this case, the stresses on the vessel's hull would have been significantly reduced had the limestone cargo been loaded and trimmed in an even or more 'homogenous' distribution within the vessel's single hold.

- Adhere to the requirements and best practice contained in SOLAS and the IMSBC Code, particularly regarding:
  - The provision of sufficient information on a vessel's longitudinal and tank top strengths and the proper distribution of the cargo in order to prevent the structure from being overstressed.
  - The importance of cargo trimming; a single pile of cargo will inevitably lead to increased bending moments and might also overload the tank tops in the cargo hold.
- Ensure that appropriate authorisation to carry solid bulk and high density cargoes has been obtained from the vessel's flag state administration and/or classification society.
- Where possible, reduce the wave-induced bending moments and stresses on a vessel's structure in heavy weather by weather routing, sheltering, or adjusting course and/or speed.
