## PUBLISHED PROJECT REPORT PPR724

### Technical Assessment of Petroleum Road Fuel Tankers Summary Report (all Work Packages)

**B Robinson (TRL), D Webb (HSL), J Hobbs (HSL) & T London (TWI)**

**Prepared for:** Department for Transport, Dangerous Goods Division

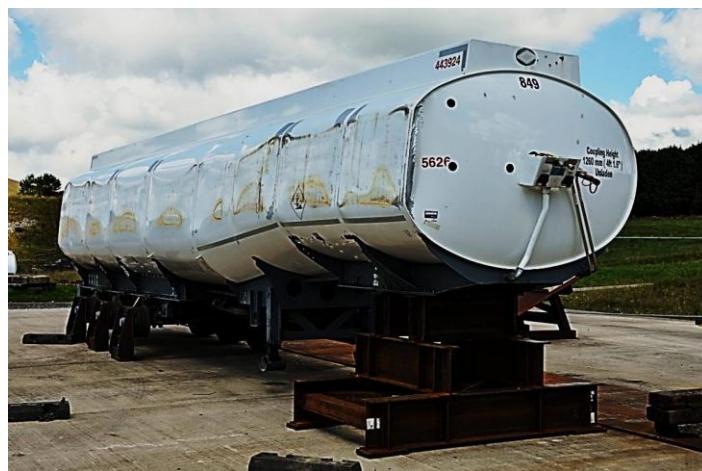
After the test, the offside (impact side) of both the tankers had a similar deformation shape with the impact area flattened - Figure 11 illustrates the damage to one of the non-compliant tankers. The deformation profile was similar along the length of the tankers, with the level of deformation increasing from front to rear. The deformation data, both as a reduction in tanker diameter and as the length of the flattened impact chord, were similar for both tankers. Comparison of laser scan images taken before and after the tests showed that the impact had caused permanent reduction in tanker diameter of approximately 100 mm at the rear and 82 mm at the front of the 2008 tanker; and of approximately 107 mm at the rear and 82 mm at the front of the 2011 tanker.

**Figure 11. Impact damage to a non-compliant tanker, viewed from front**

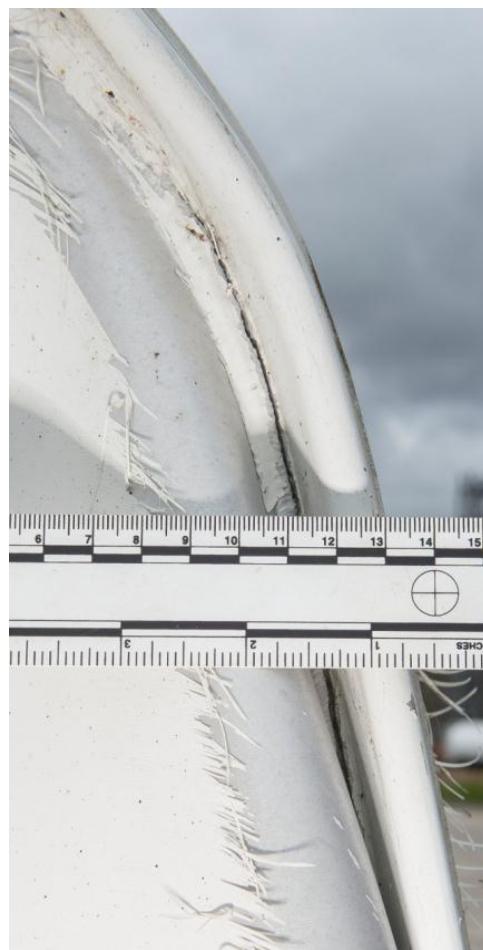
**(2008 tanker).** During impact, a small amount of water was lost through the pressure relief valves. Immediately after the test, the only visible leak from the tanker was between the rear bulkhead and extrusion band at the top of the impact area. Subsequent visual inspection found a rupture within the weld between the rear bulkhead and extrusion band at the top of the impact area (Figure 12). Folding of the rear bulkhead over the weld along most of the impact area prevented assessment of the extent of this rupture across the impact area. However, there was no visible damage at the bottom of the impact area where the rear bulkhead was not folded over the weld. Before the water was pumped out of each compartment, no obvious lowering of the water level in the adjacent compartments was observed; so it was unclear if there had been any breaches between compartments. Once the tanker had been lifted back onto its wheels, pneumatic pressure tests found that all compartments had lost their internal integrity. On this tanker the bulkheads were welded to the extrusion bands on one side, the convex side of the bulkhead curvature, and not to both sides of the extruded band. The convex side of the rear bulkhead was the outside.

**Figure 12. The 2008 tanker – rupture in the weld at top of impact zone**

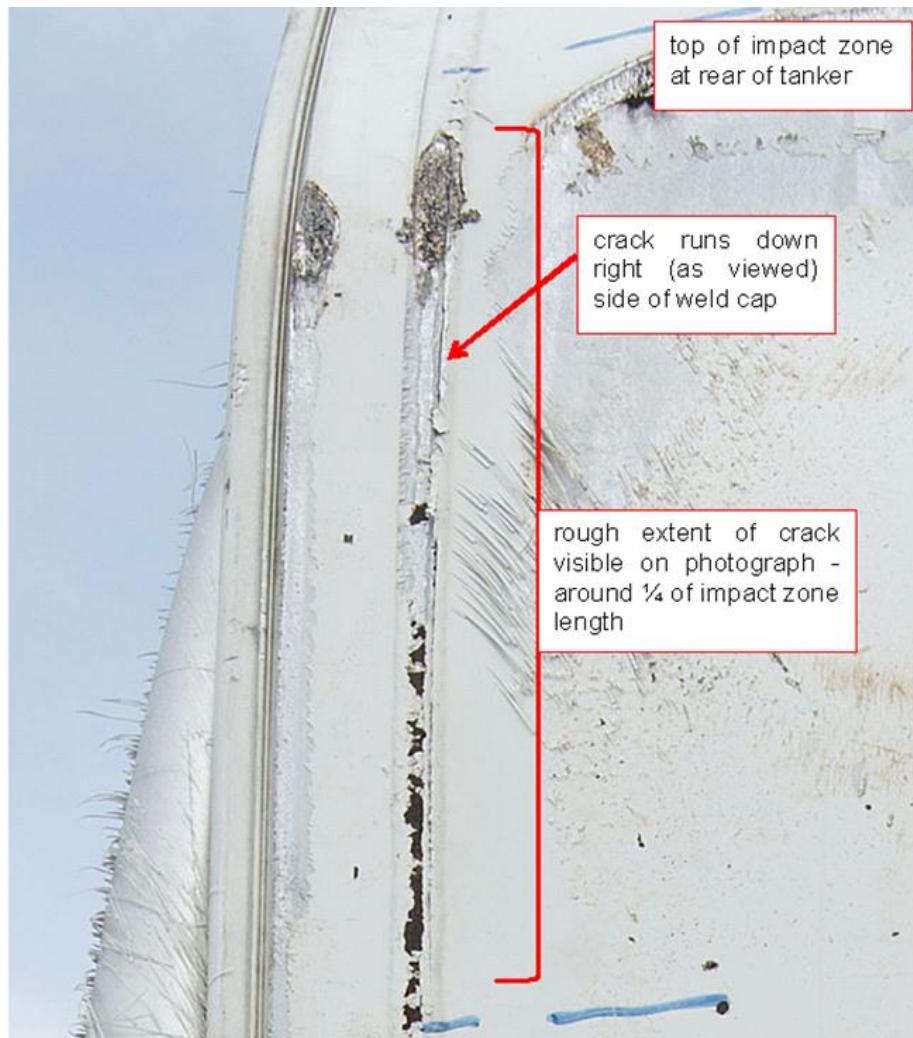
During post-mortem examination, an apparent through-wall crack along the circumferential weld at the top of the impact zone was observed. This apparent crack can be seen in Figure 13, which is taken from close examination of a photograph of the tanker after being lifted back onto its wheels.

**Figure 13. The 2008 tanker – apparent through-wall crack along the circumferential weld at the top of the impact zone at the rear**

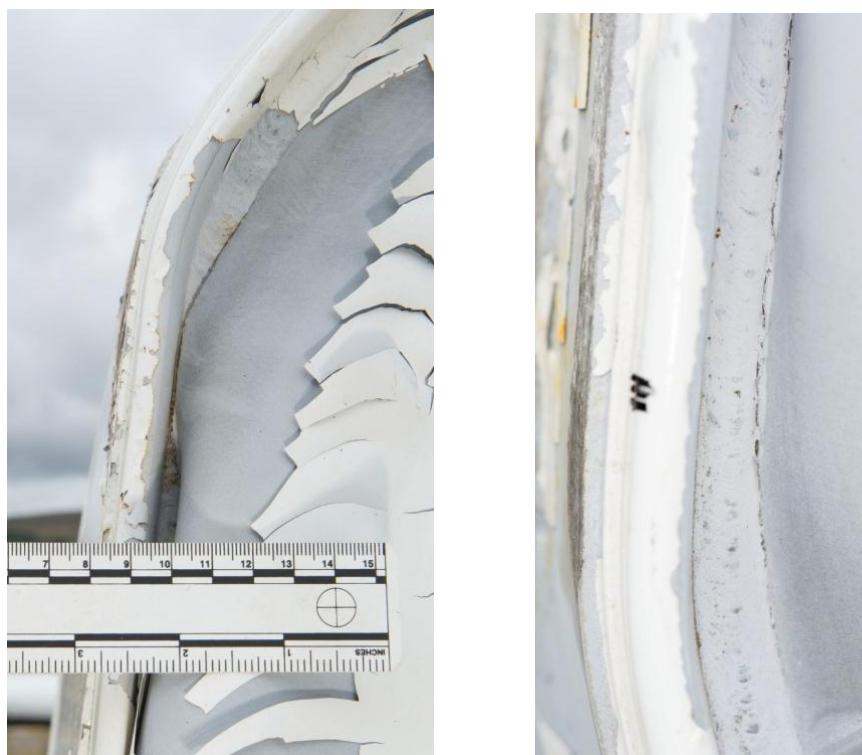
**(2011 tanker).** During impact, a similar amount of water was lost through the pressure relief valves as for the 2008 tanker. Immediately after the test, the only visible leak from the tanker was between the front bulkhead and the extrusion band at the top of the impact area. Subsequent visual inspection found a rupture in the toe of the weld between the front bulkhead and the extrusion band at the top of the impact area (Figure 14, left). Folding of the front bulkhead over the weld along most of the impact area prevented assessment of the extent of this rupture across the impact area. However, there was also a crack in the toe of the weld at the bottom of the impact area where the front bulkhead was not folded over the weld (Figure 14, right).

**Figure 14. The 2011 tanker – rupture at toe of weld at top of impact zone (left) and crack at toe of weld at bottom of impact zone (right).**

In the context of inspecting the damage sustained by the tankers used in the testing, the manufacturer of the non-compliant tankers indicated that the damage around the joints between the extrusion band and the bulkhead/baffles for both tankers is consistent with real-world rollovers.

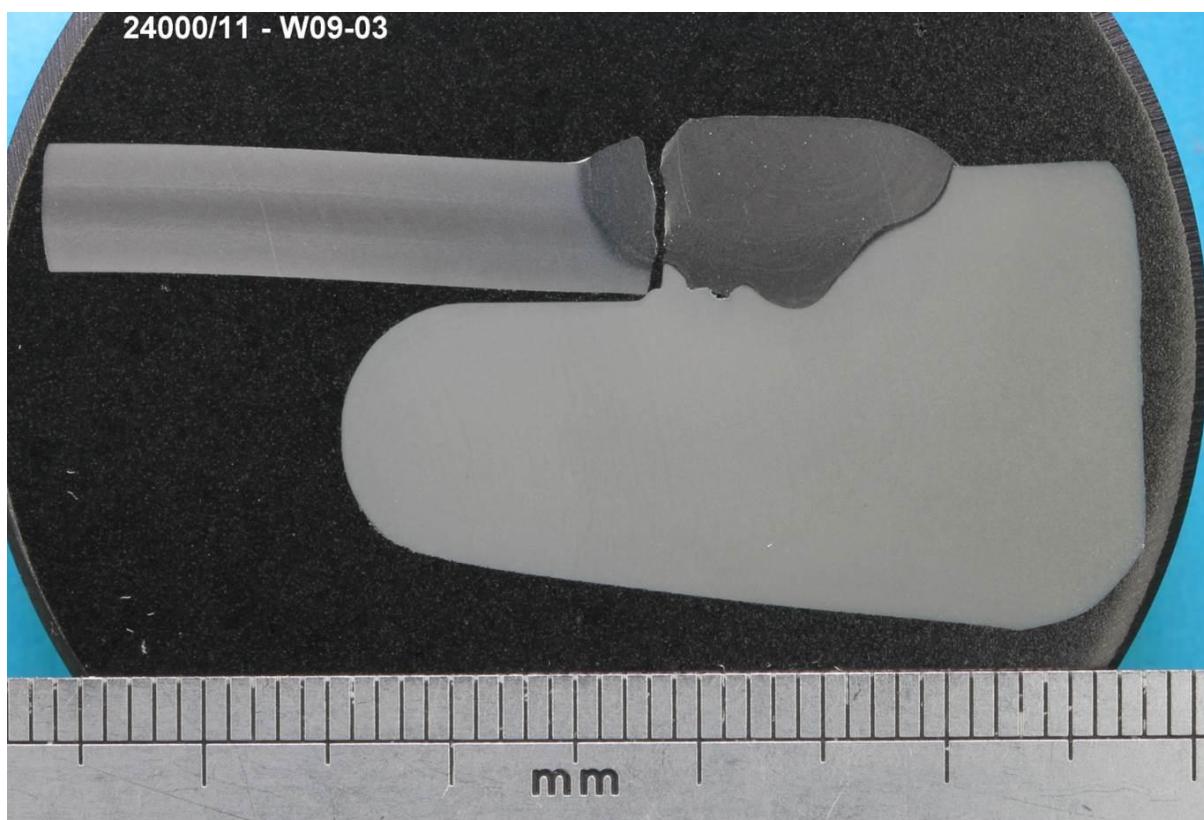
- This critical defect height agrees well with the experimental observation of the through-wall rupture of a circumferential weld resulting from a lack of fusion defect 1.0 mm deep and longer than 230 mm in a section taken from the impacted side of the 2008 tanker, paying due regard to the specific geometry of the weld involved. Less severe embedded flaws observed in the 2011 tanker have not been analysed to a similar degree but are considered to be much less problematic. The difference between the tankers is thought to be due to a change in the welding process during manufacture, which occurred in mid-2010.

A macro image of the cross section of the failed joint is shown in Figure 32.

**Figure 32. Cross-section of the sample from the 2008 tanker that ruptured through-wall thickness as a result of the lack-of-fusion defect at the positioner lip under the topple test experiment**
