Published 11 September 2014

CONTENTS**SPECIAL BULLETINS / INTERIM REPORTS**

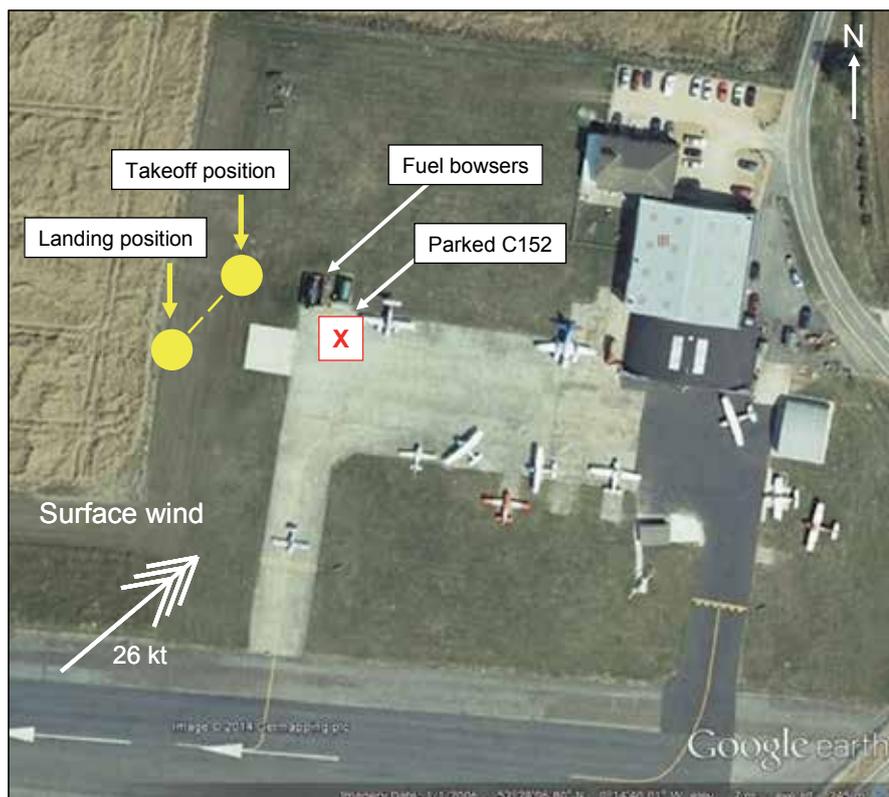
Figure 1
Apron area

The helicopter pilot commented that the Cessna 152 had been parked in a largely downwind position at the fuel installation to facilitate refuelling, and he considered this to be a contributory factor. The airfield operator reported that both aircraft were parked in normal locations before the accident. Although not a stipulation, it was common for helicopters departing from the same area to taxi further west initially, placing themselves over part of the airfield used for agricultural purposes before turning towards the runway, so achieving greater separation from the apron.

In this case, the helicopter (which had a rotor diameter of 10.69 m) was moving away from the Cessna, but as it did so it started to pass upwind of it. The guidance above applies to still air conditions, and may have to be modified when operating in relatively strong winds. In this case, a combination of the Cessna's aspect relative to the wind, the strength of the wind and the helicopter's rotor wash appear to have combined to cause the Cessna to overturn.

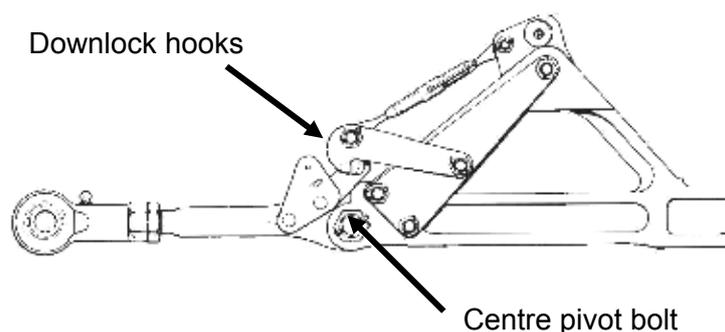
Figure 1

The main gear downlock mechanism comprises a conventional over-centre sidestay, kept in lock by a pair of hooks engaging on a pin (Figure 1). Engagement of the hooks also actuates a microswitch to illuminate the associated down-and-locked green light in the cockpit. Under a normal, powered extension, the final movement of the actuator engages the hooks, but in a free-fall extension, a spring is used to engage the downlock hooks. If any one of the three gears fails to downlock, a gear-unsafe red warning light illuminates.

MLG downlock with hooks shown correctly engaged on pin

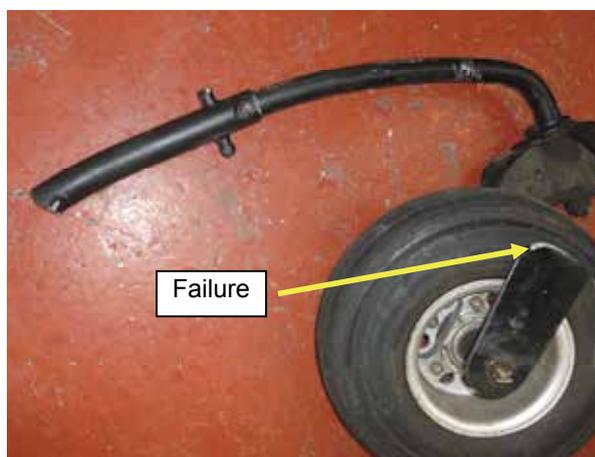
Figure 1

The event occurred as a result of the failure of one side of the fork on the nose landing gear leg. See Figure 1. The owner and the maintenance organisation that examined the landing gear leg reported visual evidence of a fatigue failure. Neither the AAIB nor the Light Aircraft Association had the opportunity to inspect the leg before it was repaired.

Failure of the nose landing gear
