# ***AAIB Bulletin***

***6/2014***

<b>Aircraft Type and Registration:</b>	Piper PA-28-140 Cherokee, G-ATRR	
<b>No &amp; Type of Engines:</b>	1 Lycoming O-320-E3D piston engine	
<b>Year of Manufacture:</b>	1966 (Serial no: 28-21892)	
<b>Date &amp; Time (UTC):</b>	19 May 2013 at 1018 hrs	
<b>Location:</b>	Caernarfon Airport, Gwynedd	
<b>Type of Flight:</b>	Private	
<b>Persons on Board:</b>	Crew - 1	Passengers - 2
<b>Injuries:</b>	Crew - 1 (Serious)	Passengers - 1 (Fatal) 1 (Serious)
<b>Nature of Damage:</b>	Aircraft destroyed	
<b>Commander's Licence:</b>	Private Pilot's Licence	
<b>Commander's Age:</b>	61 years	
<b>Commander's Flying Experience:</b>	90 hours (of which 72 were on type) Last 90 days - 9 hours Last 28 days - 2 hours	
<b>Information Source:</b>	AAIB Field Investigation

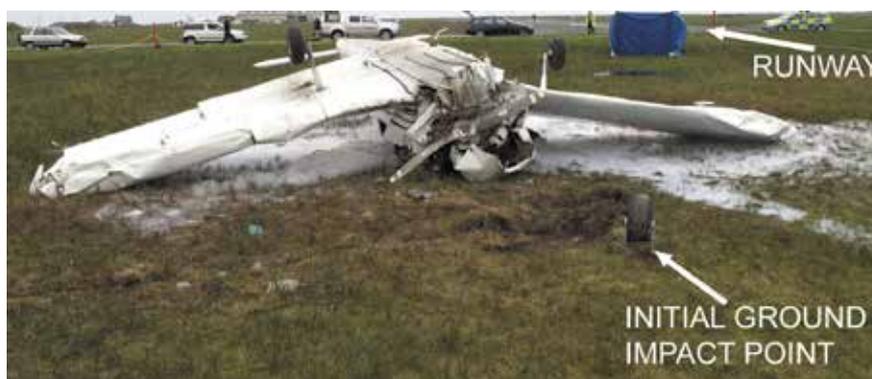
**Figure 7**

The aircraft suffered significant structural damage to its forward fuselage and wing leading edges and the right wing spar had failed. The propeller blades were slightly bent rearward but did not have any leading edge or tip damage. There were two clear propeller strike marks in the ground at the initial impact point, spaced about 70 cm apart. Based on an estimated impact groundspeed of 40 kt the propeller would have been rotating at about 900 rpm. If the groundspeed had been 50 kt the propeller rpm would have been about 1,100 rpm.

Accident site

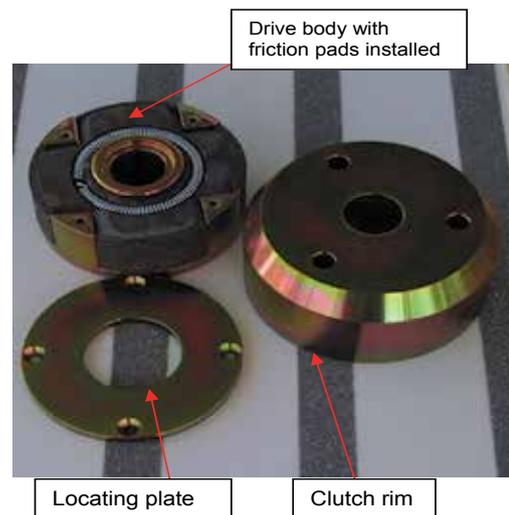
**Figure 2**

This type of clutch (Figure 2) consists of a drive body secured to the engine output shaft, four friction pads (held together by two circular springs) which locate in the drive body, a locating plate and the clutch rim, which is secured to the gearbox coupling flange. The clutch is designed to remain disengaged until the engine speed reaches approximately 2,400 rpm, at which point the friction pads move outwards, contacting the clutch rim and causing the gearbox to rotate. The installation of this clutch reduces engine vibration during engine start and at idle speed, and allows the installation of a larger propeller than would normally be fitted to a 'direct drive' engine. In flight, however, the engine speed must be maintained above 2,400 rpm to prevent the clutch from disengaging and allowing the propeller to windmill. If this were to occur it would affect the gliding performance of the aircraft.

RK400 clutch assembly

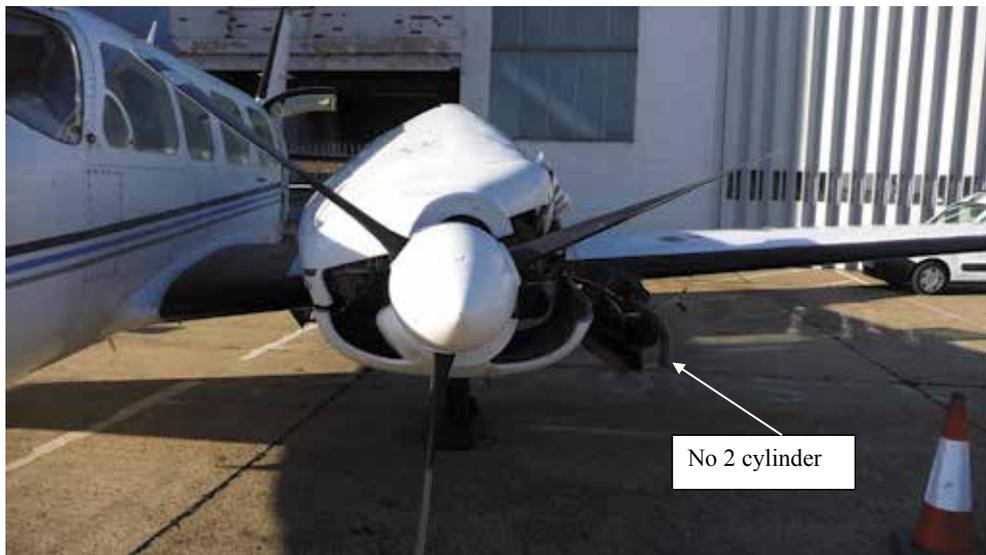
**Figure 1**

A preliminary examination of the aircraft revealed that the No.2 piston and cylinder assembly on the left engine had detached from the crankcase, but had remained attached to the

aircraft by the spark plug ignition leads. The cowlings had been disrupted and pushed apart (Figure 1).

Disruption to left engine cowlings and No.2 cylinder detached from crankcase

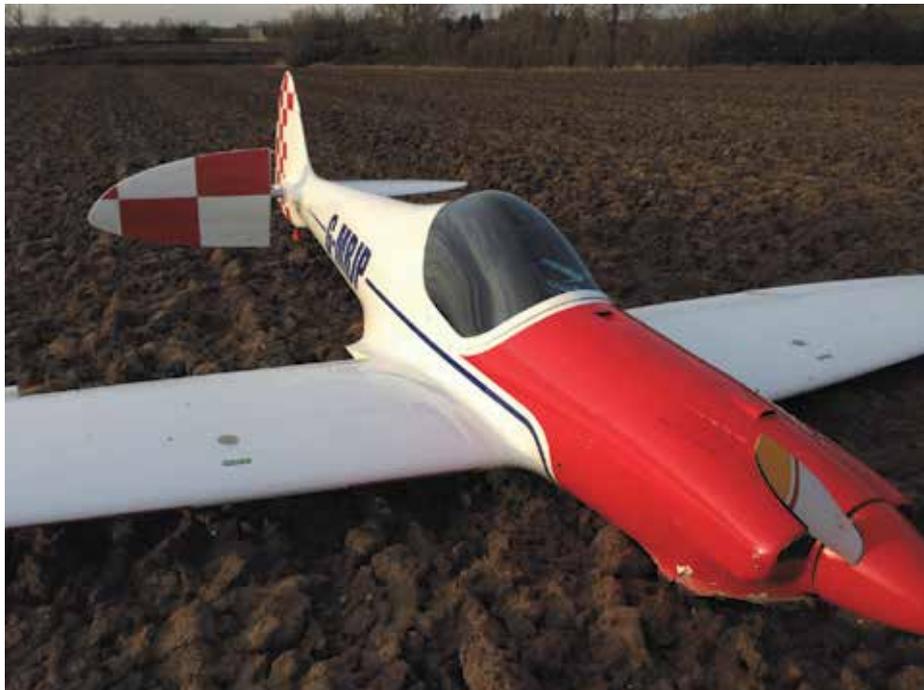
**Figure 1**

As he evacuated the aircraft, the pilot saw that the right tailplane had rotated through 90° about its mainspar (Figure 1).

G-MRJP after landing showing right tailplane rotated through 90°

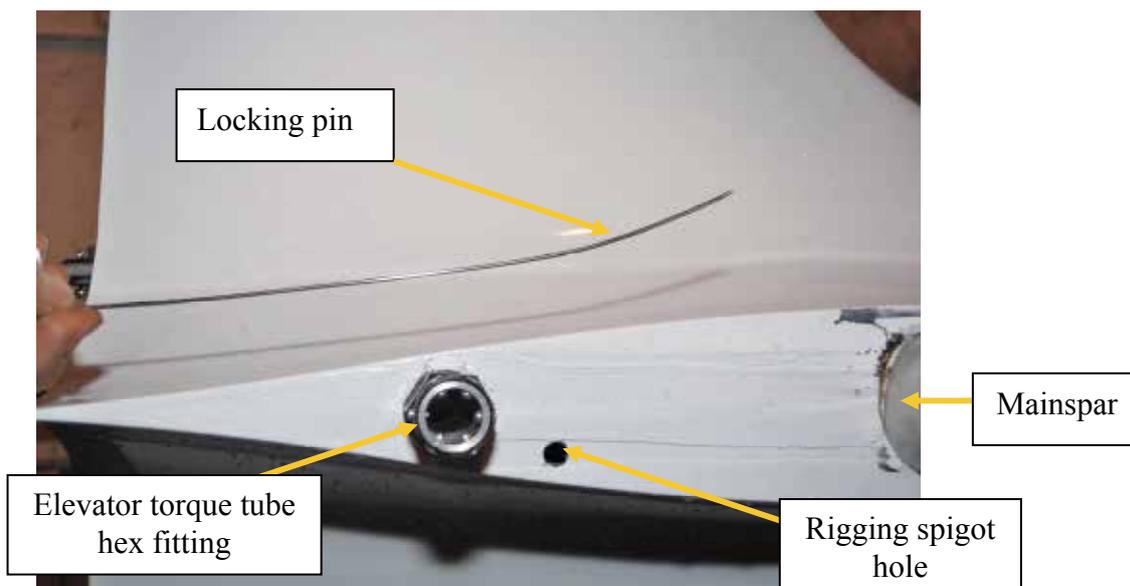
**Figure 2**

In the case of G-MRJP, the locking pin had missed the hole in the rigging spigot because it had exited the guide tube through a hole before reaching the end. The hole had been worn in the tube because it had been rubbing on the elevator torque tube. The unlocked tailplane had then migrated spanwise, disengaging the hexagonal elevator drive and allowing the tailplane to rotate about the main spar. The aircraft had previously been derigged to conduct minor maintenance and, when subsequently reassembled, had been independently inspected by two people without spotting that it not been properly locked.

View of rear fuselage showing tailplane/elevator attachment features. The locking pin has been withdrawn completely. Note that the pin is angled upwards as it and the guide tube have to pass under the elevator torque tube. (Photo courtesy LAA)
