Air Accidents Investigation Branch  
Farnborough House  
Berkshire Copse Road  
Aldershot  
Hants GU11 2HH

Published 8 May 2014

**CONTENTS****SPECIAL BULLETINS / INTERIM REPORTS**

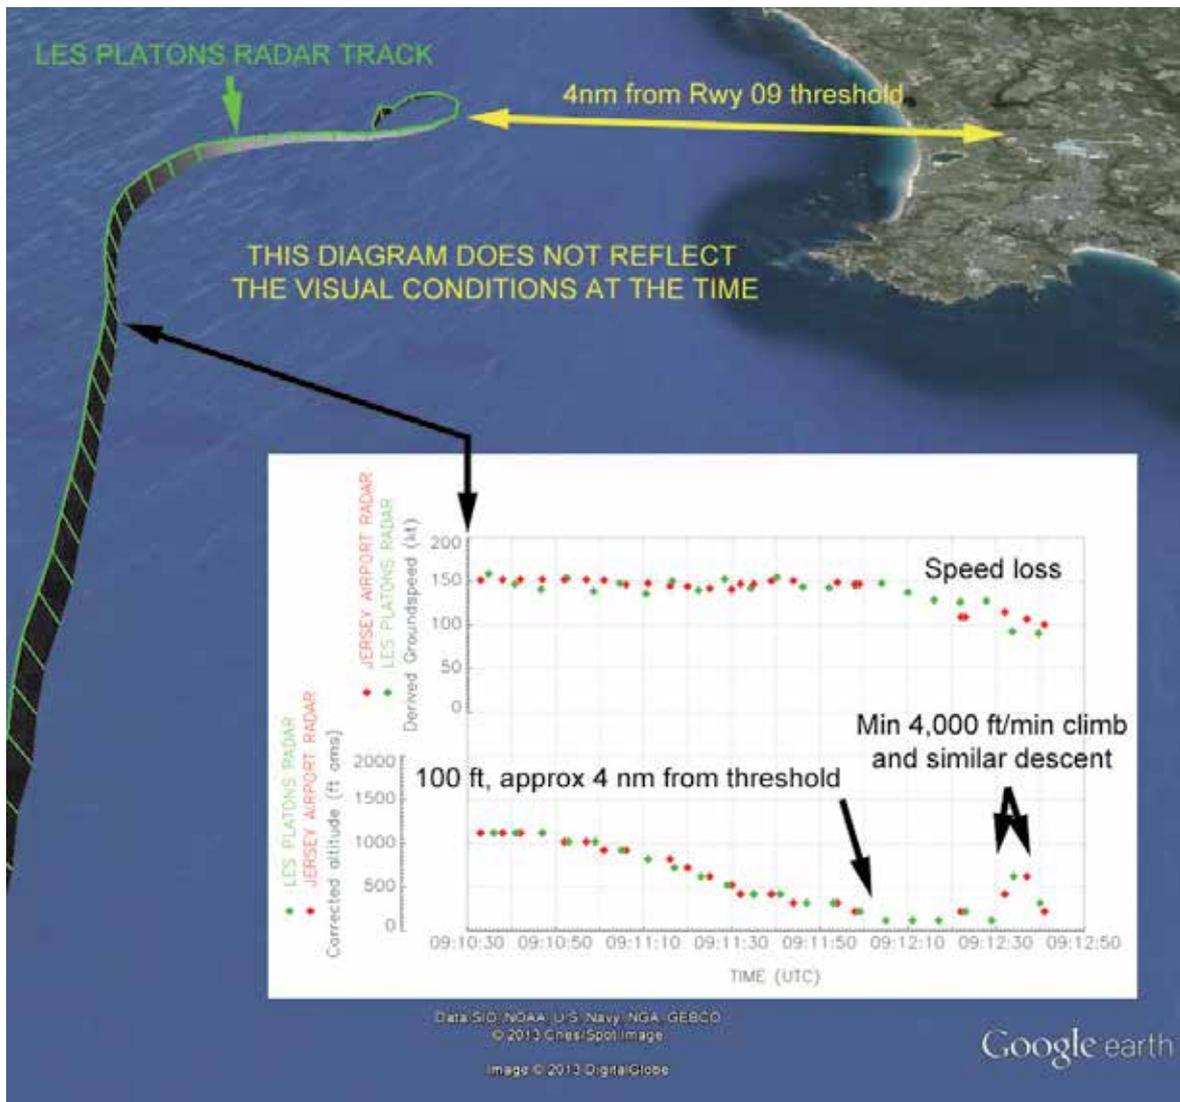
**Figure 2**  
End of radar track

The aircraft passed through the extended centreline of Runway 09 at 0911 hrs at an altitude of 600 ft and continued to descend to 100 ft. At this point the aircraft was about 4 nm from the runway threshold and slightly left of the centreline. The aircraft then commenced a left turn during which the pilot transmitted to Jersey tower "ERM SORRY MAAM CAN YOU GIVE ME THE FREQUEN ... SORRY I'VE DONE ... COMPLETELY GONE WRONG WAY ROUND THERE JUST EH ... ONE MOMENT." The aircraft continued in the turn at 100 ft and the groundspeed decayed from 150 kt to 100 kt. After turning through 180°, the aircraft entered a rapid climb to 600 ft at a minimum rate of climb of 4,000 fpm. It then descended, at a similar rate of 4,000 fpm, to below the coverage of the radar.

The rapid pull up manoeuvre suggests that the pilot suddenly became aware of his low height or saw the immediate proximity of the surface of the sea. Depending on how much engine power was set, the high rate of climb suggests a nose-high pitch attitude that may have resulted in a significant loss of airspeed and a stall at 600 ft. Whilst the aircraft may have cleared the top of the fog and permitted external visual references, the subsequent recovery from the stall would probably have caused the aircraft to re-enter the fog. In this type of aircraft, the altitude loss for a conventional stall is about 650 ft; the pilot therefore had limited height from which to regain controlled flight. The aircraft's speed would have increased rapidly during the final descent and this resulted in a high energy impact with sea.
