AAIB Bulletin

4/2014

Published 10 April 2014

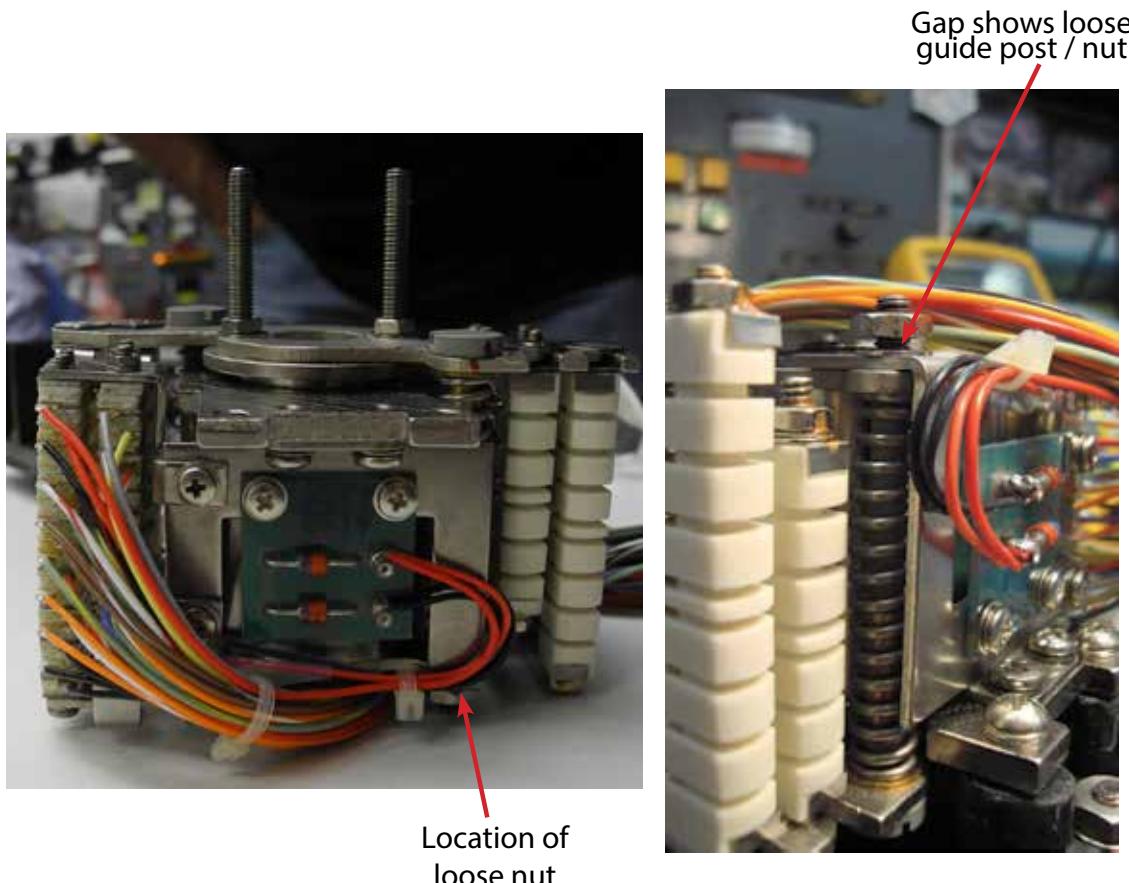
**Figure 9**

BTB 3 was tested in accordance with the manufacturer's ATP. When voltage was applied to command the BTB to trip, only some of the main and auxiliary contacts transitioned to the expected positions. This resulted in the contactor being in an intermediate state, which did not correspond to either the tripped or the closed condition. When voltage was then applied to command the BTB to close, it did not change state. However when the BTB was subjected to a light external impact on the outer case, the contacts moved and it returned to the closed state. Repeated testing confirmed that it was not possible to predict which contacts would move to the expected positions when the BTB was commanded to trip or close.

After removal of the BTB outer housing, a nut on one of the armature guide posts was found not properly secured, causing the armature to be misaligned (Figure 9). Loctite⁹ was evident on the nut and threads of the guide post, in accordance with the design.

The lock washers on both guide posts had been compressed, as designed, when the nuts were tightened. This suggests either that the nut had backed off over time, perhaps due to airframe vibration, or that the contactor had been disassembled at some point after original assembly. The BTB manufacturer was not aware of any previous cases of the guide post nut loosening in service. The manufacturing drawing did not specify a torque requirement for the nut.

BTB loose guide post nut

After tightening the loose nut and replacing the washers, the contactor operated correctly.

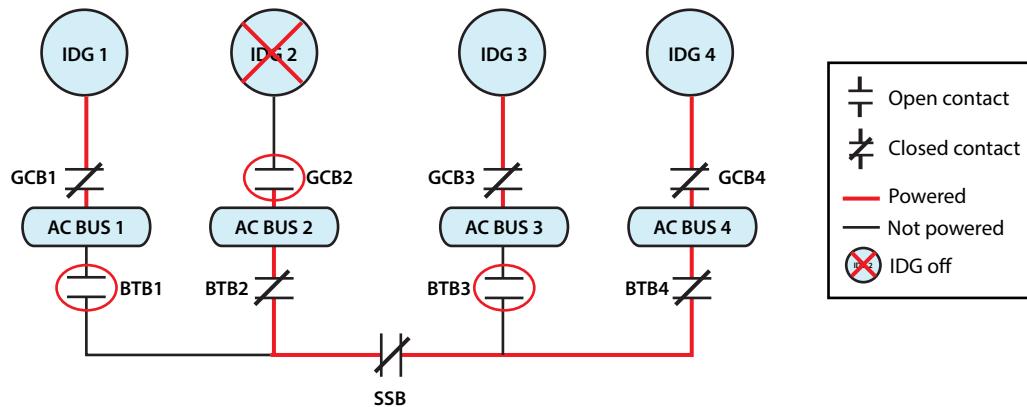
Figure 10
Configuration of electrical system at time 2301:55 hrs

When all three autopilots were engaged to perform an autoland at 2301:55 hrs, the autoland request was sent to the BCUs by the FCCs and the electrical system automatically reconfigured to provide three independent channels for each of the FCCs. This was achieved by BTB 1 and 3 tripping to isolate AC Bus 1 and AC Bus 3; BTB 2 and 4 remained closed so that AC Bus 2 was powered by IDG 4 via the sync bus (Figure 10).

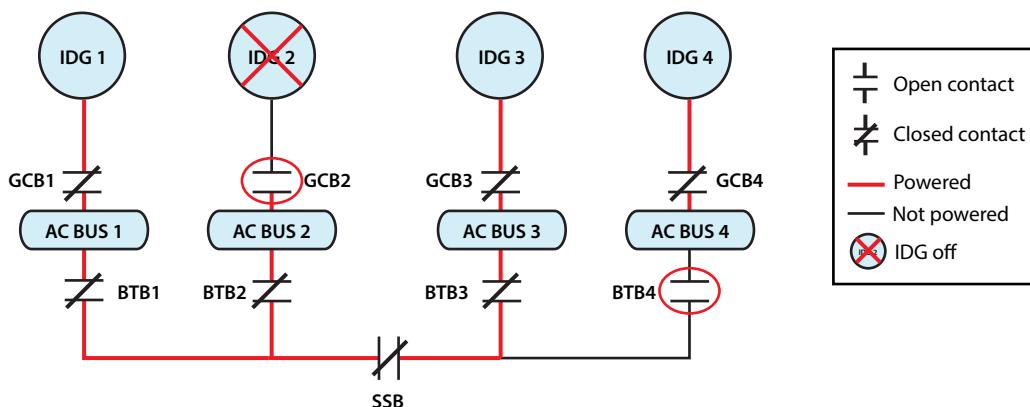
Figure 11
Configuration of electrical system at time 2302 hrs

Eleven seconds later, BTB 4 tripped because Difference Current Protection isolated AC Bus 4 from the sync bus. Momentary power interruptions to AC Bus 2 and the First Officer's Transfer Bus were recorded. As three independent power supplies could no longer be assured the autoland operation was cancelled, indicated by the 'BUS CONTROL UNIT / FCC-C FAIL' and 'BUS CONTROL UNIT / FCC-L FAIL' faults. BTB 1 and 3 were commanded to return to their previous position and AC Bus 2 then became re-powered (Figure 11).

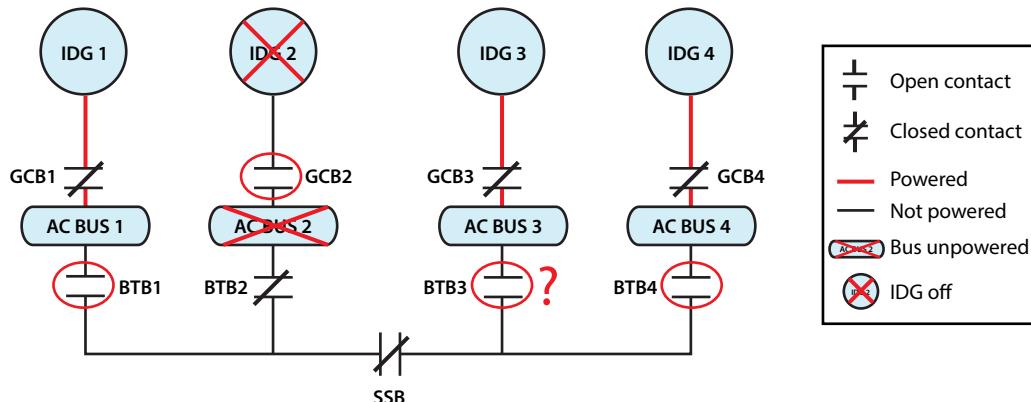
Figure 12
Configuration of electrical system at time 2305 hrs

This configuration was sustained for a further three minutes until 2305 hrs, when BTB 1 also tripped due to Difference Current Protection, isolating AC Bus 1. DFDR and CMC data showed that power to AC Bus 2 was lost at this point. AC Bus 2 should still have received power from IDG 3 via BTB 3 but the loss of AC Bus 2 indicates that BTB 3 did

not successfully close and re-parallel to the sync bus when commanded (Figure 12). It is therefore likely that the mechanical failure of BTB 3 prevented some or all of its main contacts from re-closing, leaving it in an intermediate state.

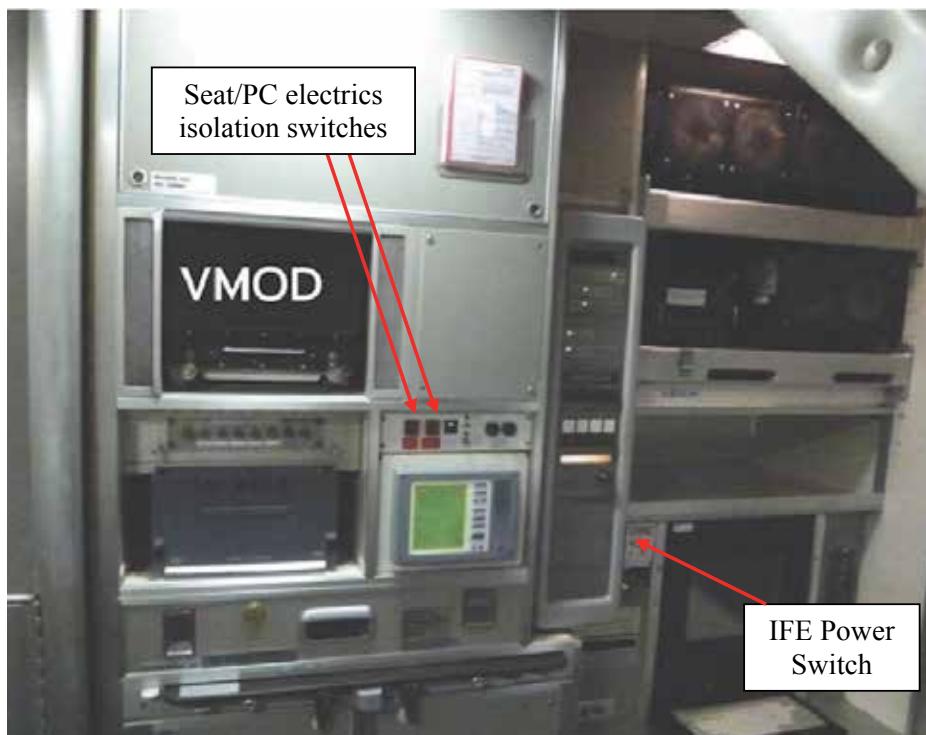
About 2 minutes later, the commander received calls from two cabin crew members who stated that flames were visible in Galley 4, situated between doors 2 left and 2 right, and these were being tackled with BCF extinguishers. An open communication line to the flight deck was maintained throughout the event. The smoke and flames were emanating from a component of the IFE equipment called the Video Modulator (VMOD), situated in the Cabin Service Director's (CSD) office in Galley 4 (Figure 1). A third cabin crew member tried to discharge the first extinguisher but mishandled it, so another crew member took over. Ultimately, five extinguishers were used because the fire appeared to re-ignite repeatedly. Eventually the cabin crew were able to report that the fire was out.

Figure 1
View of Galley 4 and CSD's office showing location of IFE VMOD and associated switches

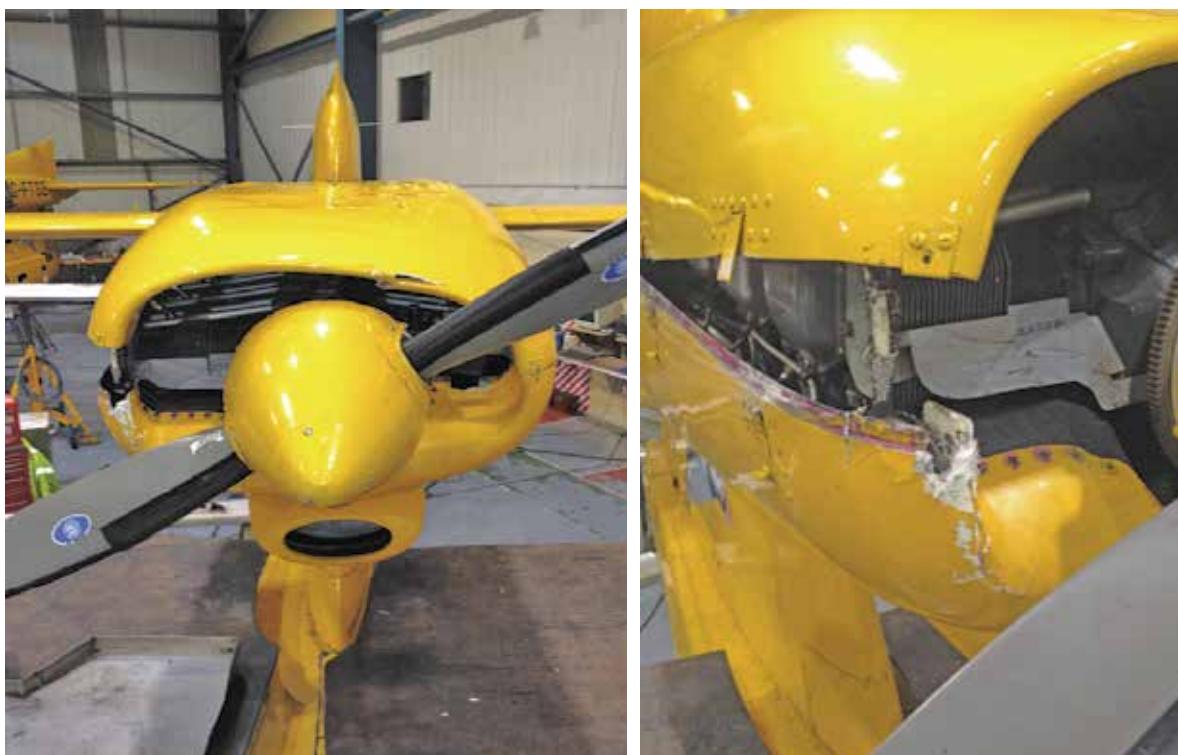
Photos: Aurigny Air Services Ltd

It can be seen that the cowling is made up of upper and lower fibreglass 'clamshells'. It was apparent that the front right hand fitting on the lower section had pulled out of the fibreglass and was missing. The resultant loss of structural rigidity would have allowed movement to occur in the upper cowling, which probably accounted for two clips, securing the upper

and lower sections together, having become undone on the right-hand side. The degree of movement was such that the upper cowling had made light contact with the propeller blades, leaving rub marks on them that subsequently required repair.

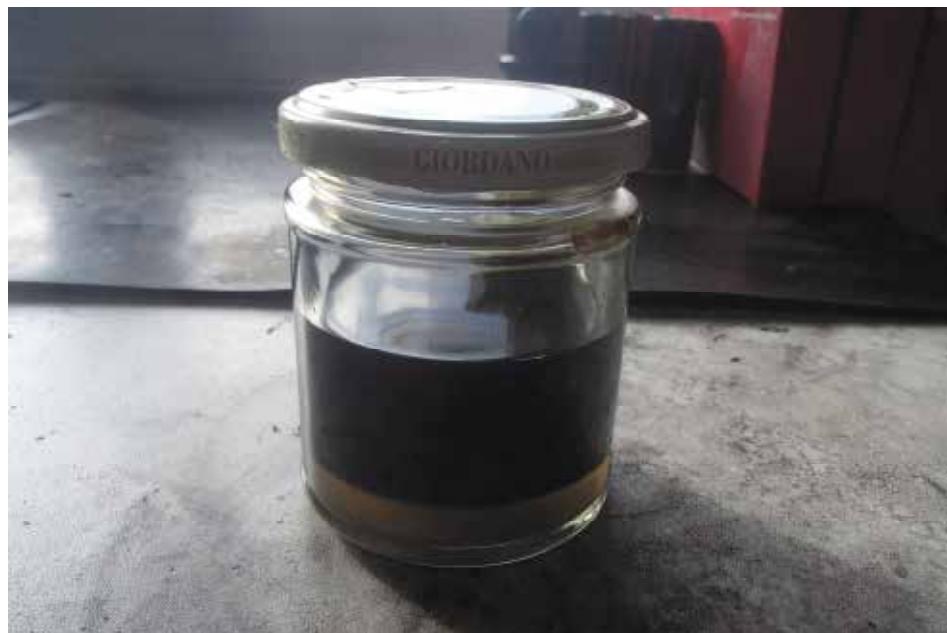
Figure 2

As part of the engine dismantling, the manufacturer had emptied the fuel filter bowl and was concerned at what was found (Figure 2). The fuel was a dense black colour and there was a high percentage of water present: in the manufacturer's estimation, there was enough to cause the engine to stop.

Photograph of fuel taken from filter bowl. Upper, dark layer is discoloured fuel and the lighter, lower layer is water
