# ***AAIB Bulletin***

# ***2/2014***

**SERIOUS INCIDENT**

<b>Aircraft Type and Registration:</b>	Britten-Norman Islander BN-2B-26, VP-MNT	
<b>No &amp; Type of Engines:</b>	2 Lycoming O-540 piston engines	
<b>Year of Manufacture:</b>	1987 (Serial no: 2186)	
<b>Date &amp; Time (UTC):</b>	16 October 2012 at 1340 hrs	
<b>Location:</b>	John A Osborne Airport, Montserrat	
<b>Type of Flight:</b>	Commercial Air Transport (Passenger)	
<b>Persons on Board:</b>	Crew - 1	Passengers - 6
<b>Injuries:</b>	Crew - None	Passengers - None
<b>Nature of Damage:</b>	None	
<b>Commander's Licence:</b>	Federal Aviation Administration Commercial Pilots Licence with Air Safety Support International validation	
<b>Commander's Age:</b>	31 years	
<b>Commander's Flying Experience:</b>	700 hours (of which 348 were on type) Last 90 days - 92 hours Last 28 days - 31 hours	
<b>Information Source:</b>	AAIB Field Investigation

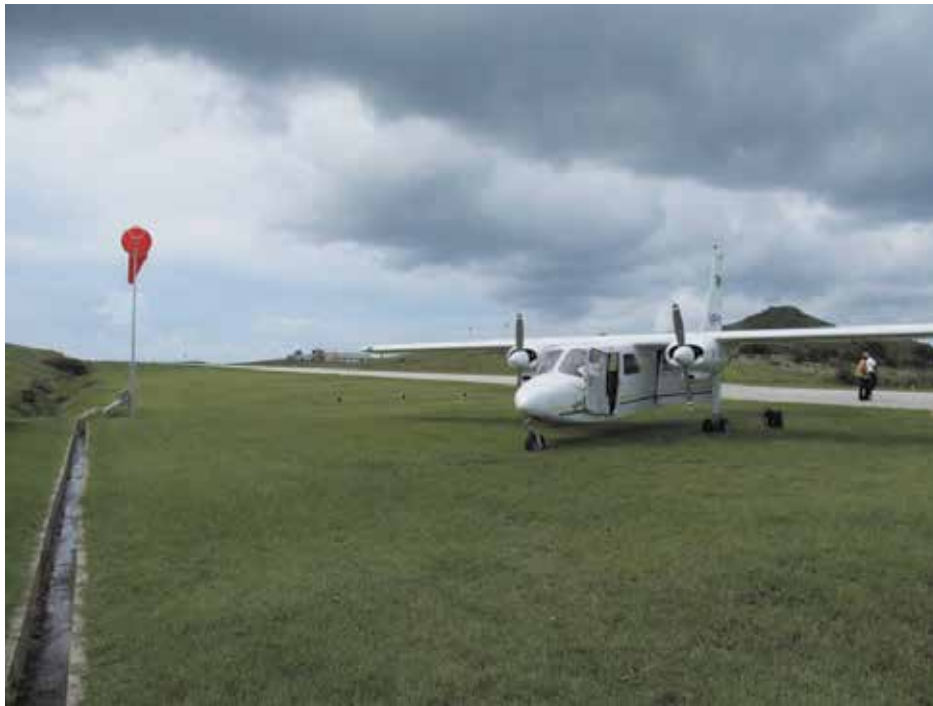
**Figure 1**

The pilot then perceived that the aircraft would not stop before the end of the runway. So he elected to manoeuvre it off the runway to avoid running over the cliff beyond the runway end. He turned the aircraft to the right onto the grass south of the runway stop-end (Figure 1).

The aircraft at rest after the runway excursion

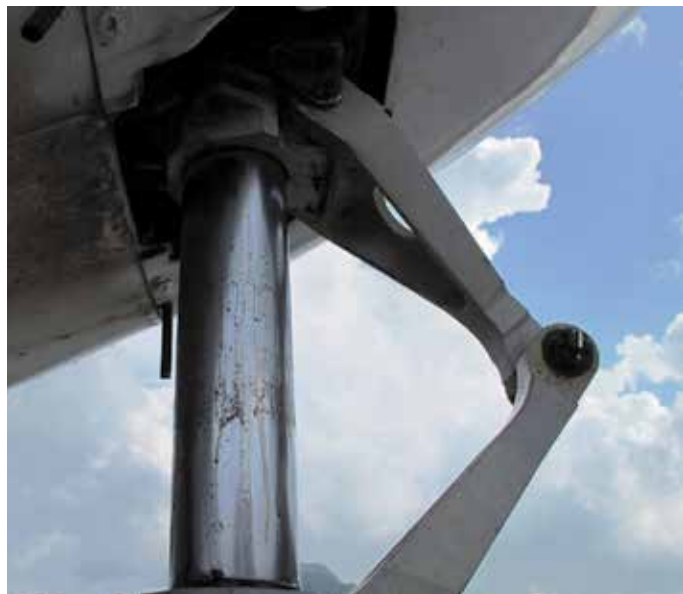
**Figure 2**

The tyres were examined for wear or flat spots and appeared to be satisfactory. The nose of the aircraft was supported on a trestle and the nose landing gear examined for play; none was apparent. Hydraulic fluid had leaked from the oleo assembly onto the 'Fescolized' portion<sup>2</sup> of the nose landing gear strut, as shown in Figure 2. It was not possible to determine if the leak had resulted from the incident but there was no evidence that the fluid had been blown back by airflow as might occur in flight. The operator's engineer, who had conducted checks on the aircraft that morning, recalled that there was no evidence

The nose landing gear oleo

of such a leak during his checks. The aircraft brakes operated satisfactorily when checked.

The operator decided to replace the nose landing gear assembly, but facilities for that task were not available on Montserrat. Following taxi trials, during which the aircraft behaved normally, it was flown to the operator's contracted maintenance facility where the work was carried out. The pilot who flew the aircraft to the maintenance facility reported that it behaved normally, with no shimmy apparent. The maintenance organisation did not report any abnormality discovered during the component change.

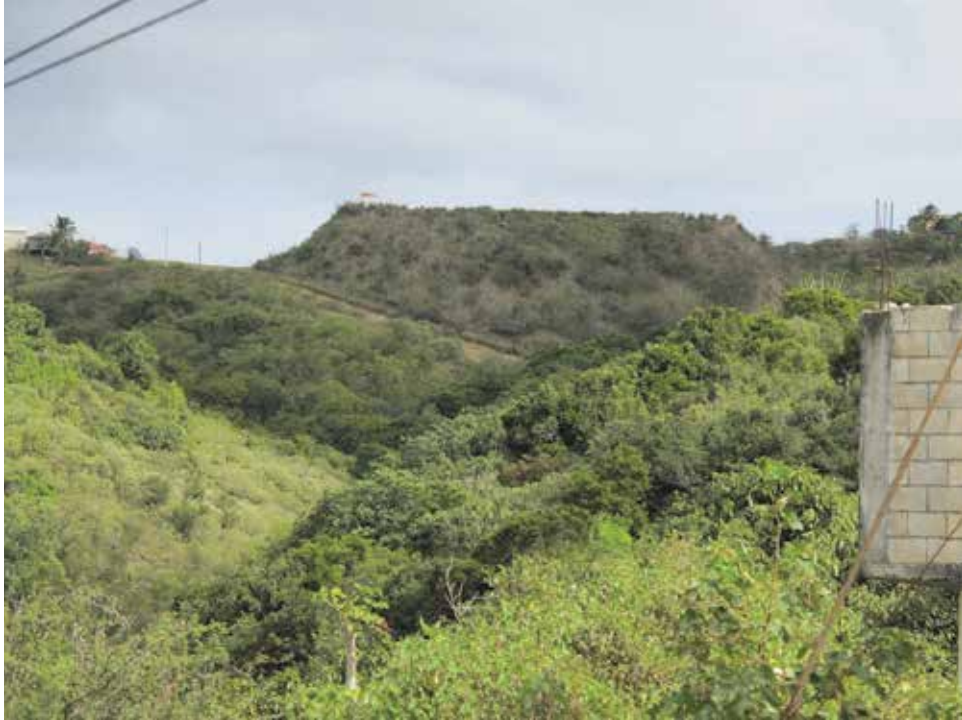
**Figure 3**

The aerodrome has a runway strip which complied with the regulations, though in places embankments had been constructed that might pose a hazard to an aircraft following a runway excursion<sup>4</sup>. The terrain falls away steeply beyond the ends of the strip. The ends of the runway are shown in Figure 3 and Figure 4.

The western end of the runway viewed from below

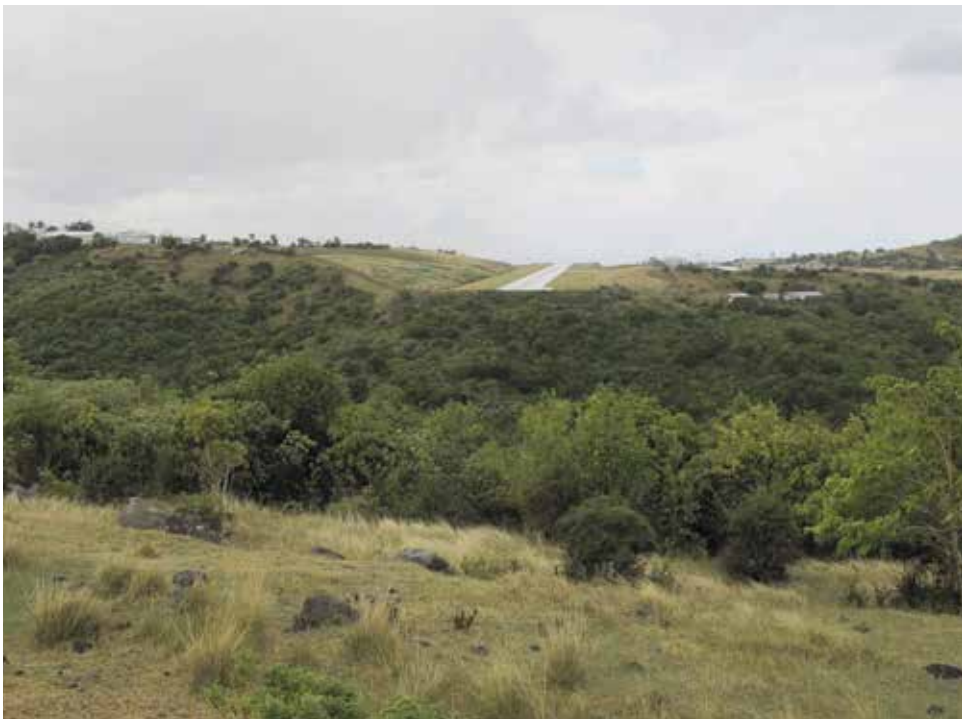
**Figure 4**

The eastern end of the runway

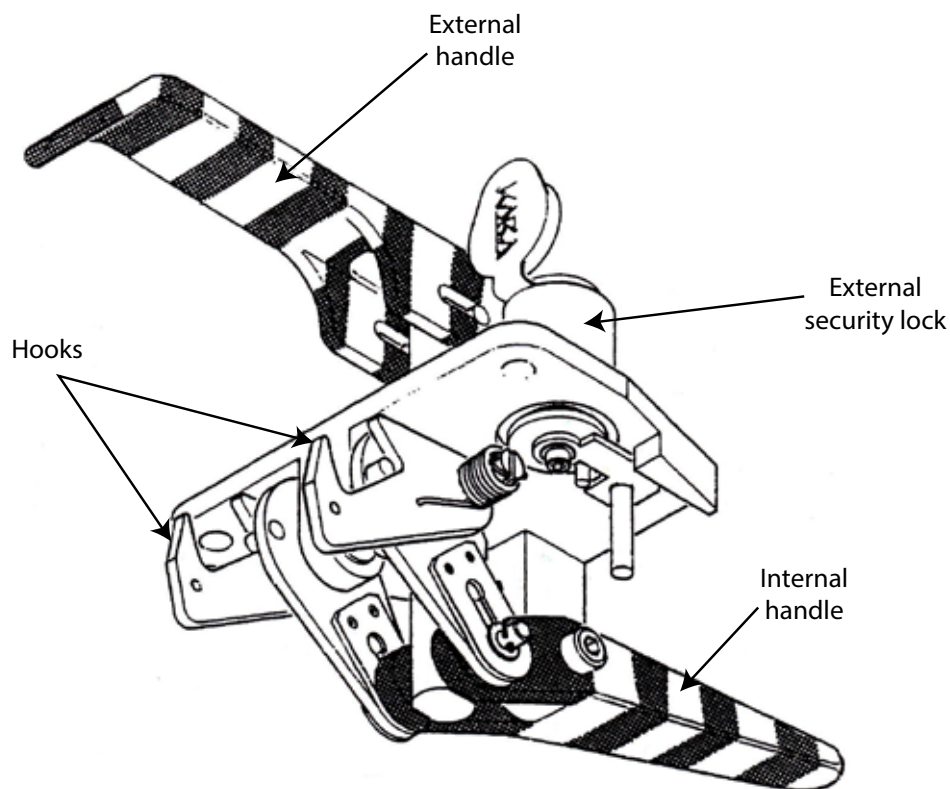
**Figure 1**

The canopy opens by sliding upwards and rearwards and is locked using two hooks, operated by a single internal lever and external lever (see Figure 1). The hook mechanism

is attached to the moving canopy and the pins with which they engage are on the fixed windscreen arch section. As originally designed, the means of visually checking that the hooks were correctly engaged was to ensure that the internal handle was aligned with a line painted on the plastic trim covering the mechanism.

Firefly canopy latch mechanism with pins not shown for clarity

The SB improved visual inspection by advising that parts of the trim around the hook and pin mechanism should be cut away so that pilots could actually see when the hooks were correctly engaged on the pin. G-RAFG did not have this modification embodied, even though it was *'highly recommended'*.

The maintenance company charged with repairing the aircraft fitted a temporary replacement canopy for a ferry flight and reported that, after adjusting the latches to suit the new canopy, they worked normally and exhibited only normal wear and tear. They are of the opinion, however, that it is possible that the latches may have been maladjusted but advise that they will be incorporating SB 173 before returning the aircraft to the owner.

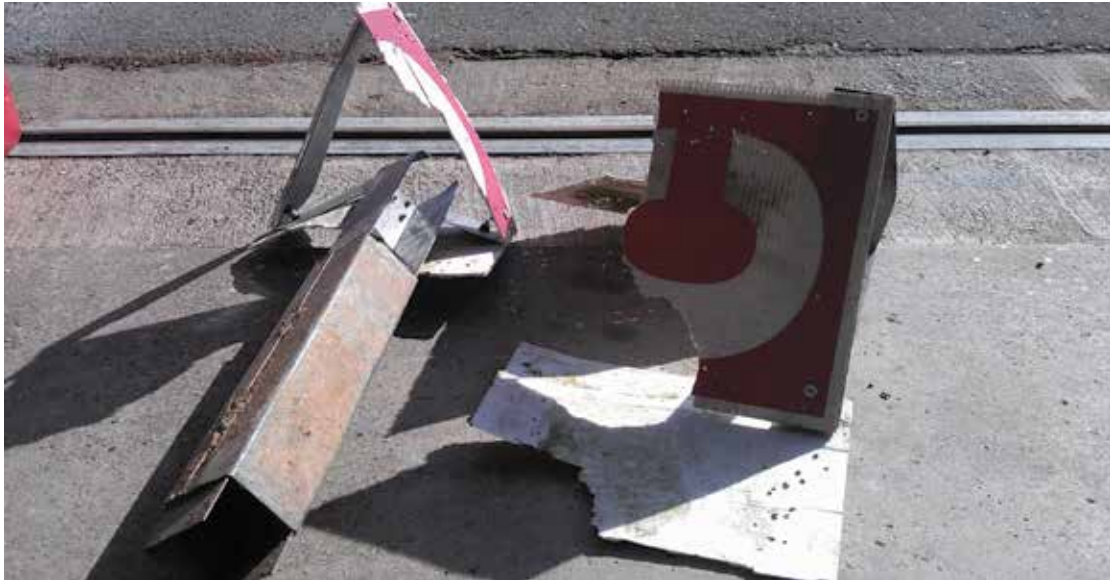
After landing on Runway 23 at North Coates Airfield the aircraft drifted to the right off the runway and hit a marker, causing damage to the aircraft and the marker. The CAA provides guidance concerning frangible markers in CAP 168 - *Licensing of Aerodromes*, which is also referenced by CAP 793 - *Safe Operating Practices at Unlicensed Aerodromes*. The airfield has since replaced their markers with ones of a different design.

The marker consisted of a triangle of plastic signs held up with a metal frame that was embedded in the ground (Figure 1).

**Figure 1**  
Damaged marker

Following this accident, the markers at North Coates Airfield have been replaced with markers of a different design.
