AAIB Bulletin

1/2014

Published 9 January 2014

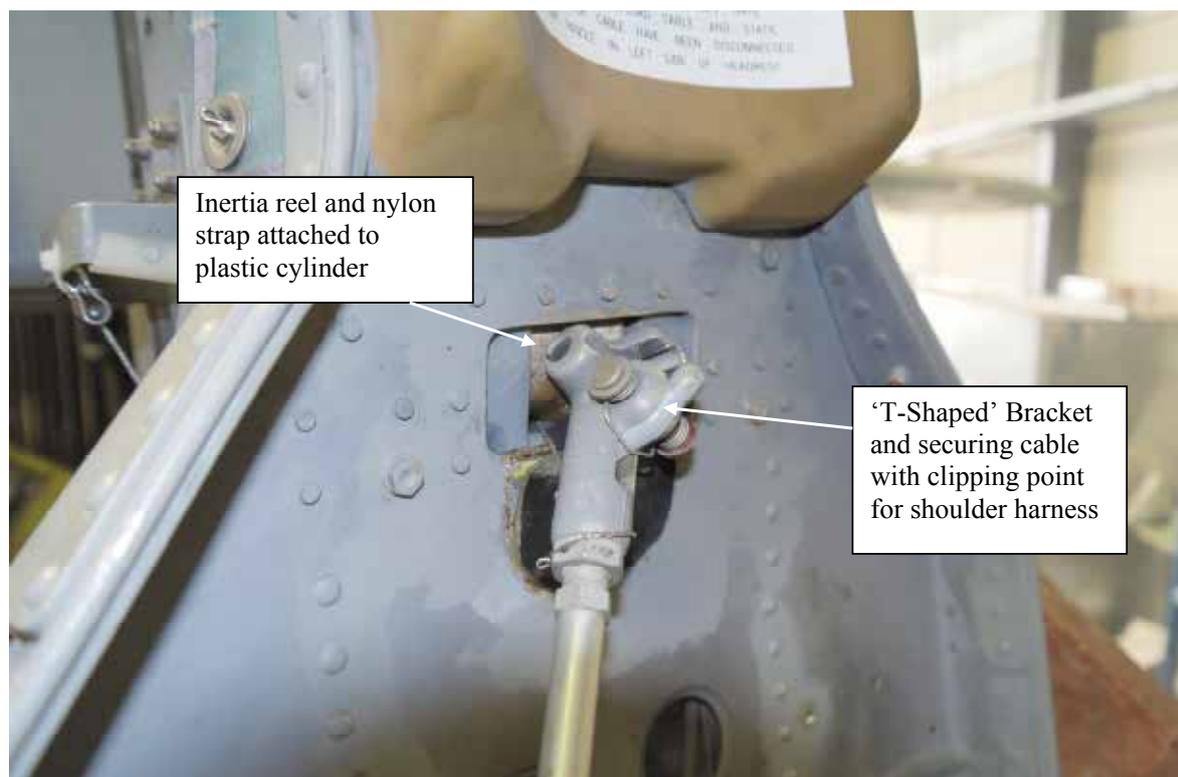
Figure 2

Seat shoulder harness attachment

The photographs of the aircraft during the initial impact showed that the pilot had not been restrained by the seat shoulder harness, causing him to be thrown forward and receive a head injury, despite wearing a helmet. Inspection of the pilot's seat identified that the plastic cylinder on the end of the inertia reel strap was intact and the strap had wound back onto the reel. However, the cylinder was no longer located within the clamp of the shoulder harness bracket. The plastic cylinder appeared to have pulled out sideways from the open end of the bracket clamp. Its retaining split pin was not present and there was no evidence that it had been in place at the time of the accident.

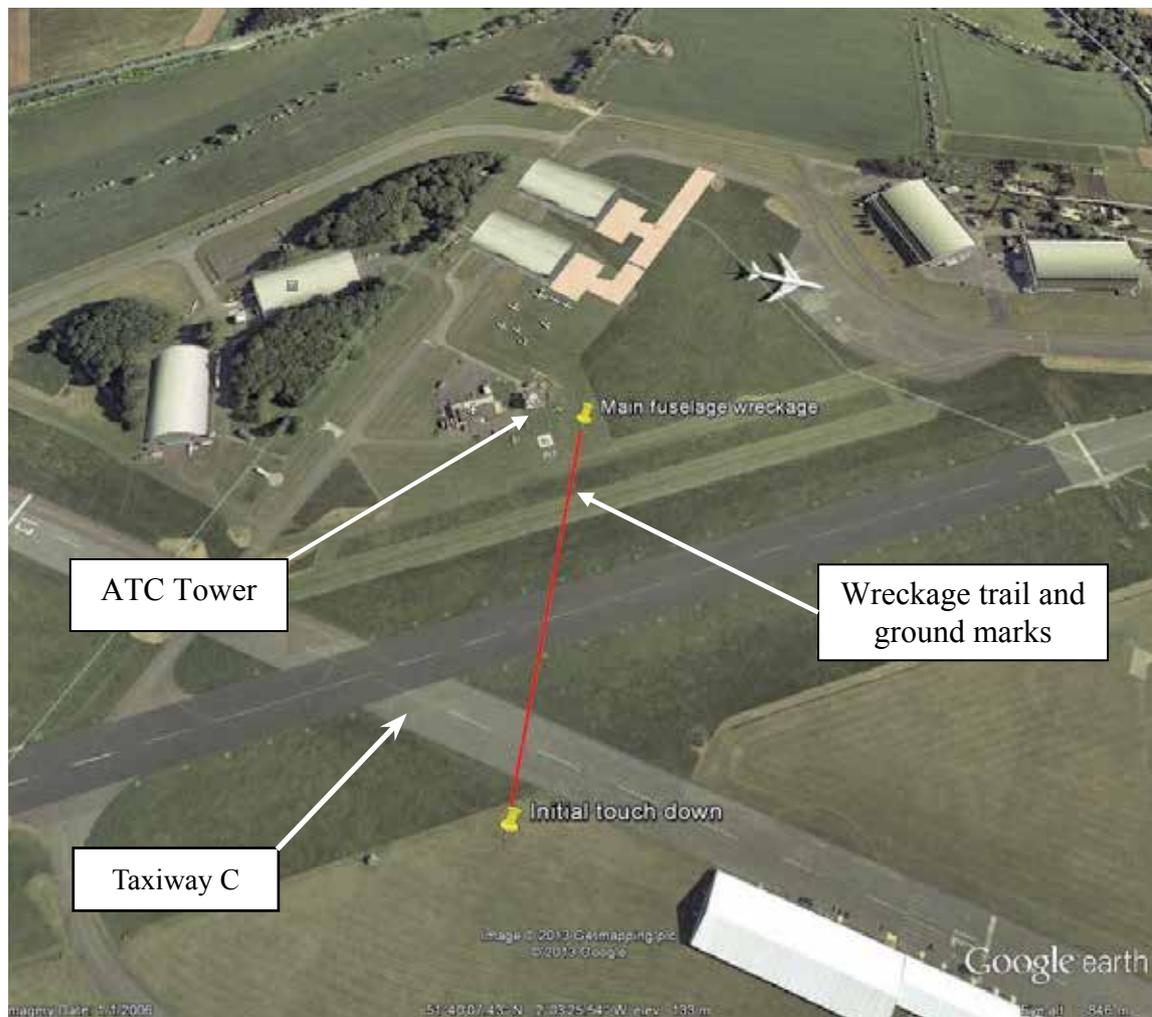
Figure 4
Accident site, looking north

The aircraft had been significantly damaged during the impact with the ground and the subsequent slide to its final position. The centreline-mounted drop tank, which was full of fuel, was destroyed and the fuel within it ignited. Various burnt components from the tank were scattered across the airfield. The right main landing gear leg had completely detached from the aircraft, as had the right engine and propeller blades. The left main landing gear leg was down and supporting the wing structure and left engine, which had rotated 90° vertically down from its normal orientation but remained attached by the service couplings. All but one of the propeller blades remained in the hub on the left engine but were significantly distorted, consistent with being under power at impact.

The right side of the wing was in contact with the ground. The right tail boom was intact but almost completely detached from the right engine nacelle and the horizontal stabiliser. The left tail boom remained attached but had fractured between the landing gear bay and the vertical fin, such that it leaned over at a 90° angle relative to the left engine nacelle. It was fully detached from the horizontal stabiliser. The entire fuselage had suffered significant fire damage, with the rear fuselage almost completely consumed. The wing had structurally detached from the fuselage and the five wing tanks contained a significant amount of fuel, which continued to leak from the aircraft after the fire had been extinguished. The forward fuselage, containing the two seats, remained intact but was severely damaged by the fire.

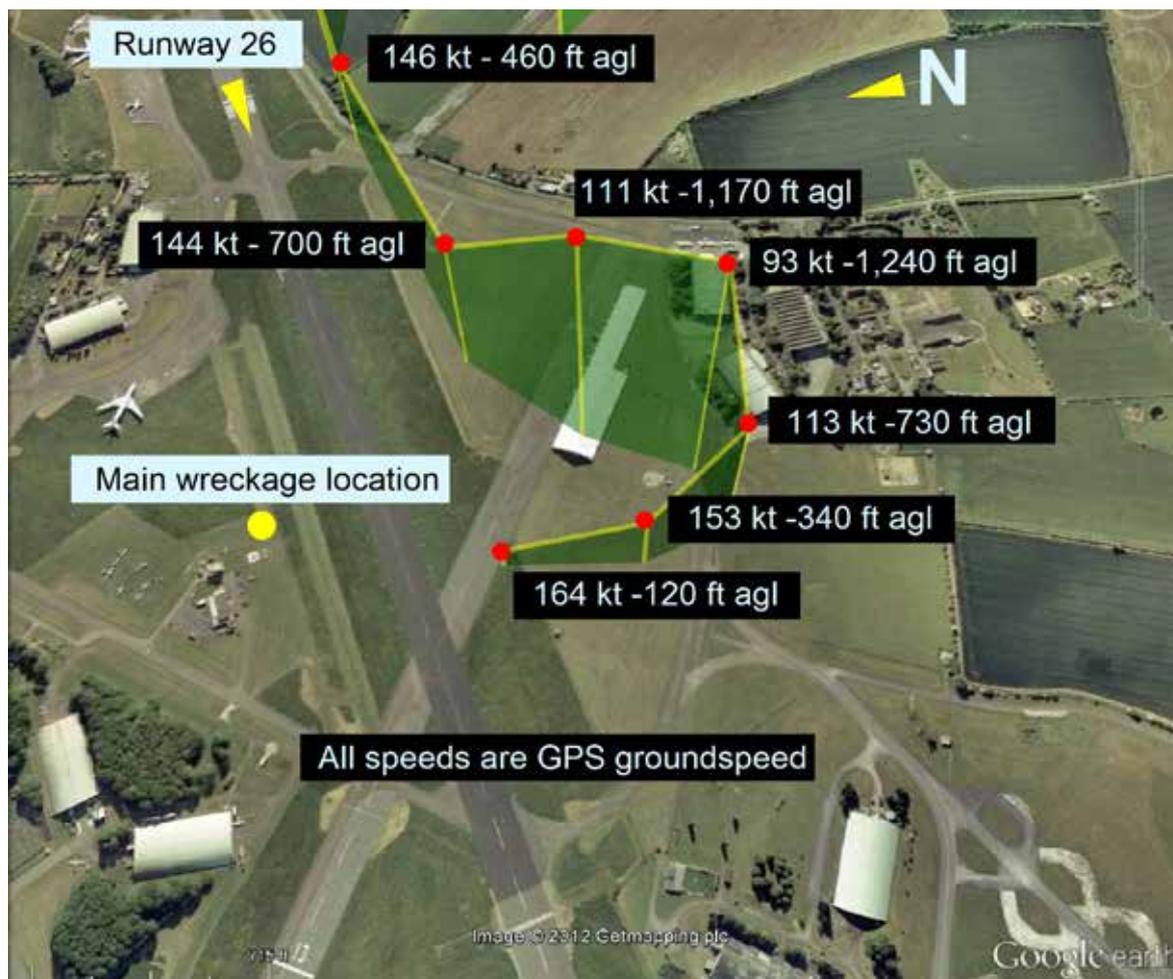
Figure 6

G-BZGK – Final manoeuvre

The pilot's display was one which he practised on a regular basis. Witnesses observed that the aircraft deviated from the intended barrel roll manoeuvre when it was in an inverted attitude and pitched down unusually rapidly. At this stage, they considered that a successful recovery could have been made. However, the aircraft continued to pitch down, with insufficient roll, and a steep nose-down attitude developed. The pilot recognised the problem after the aircraft had pulled through the vertical into an upright, nose down attitude, by which time, however, there was insufficient height to recover. An additional effect of continuing to pitch 'up', in the aircraft's normal axis, with insufficient roll, was to alter the trajectory of the aircraft, taking it towards and subsequently through the notional crowd line.

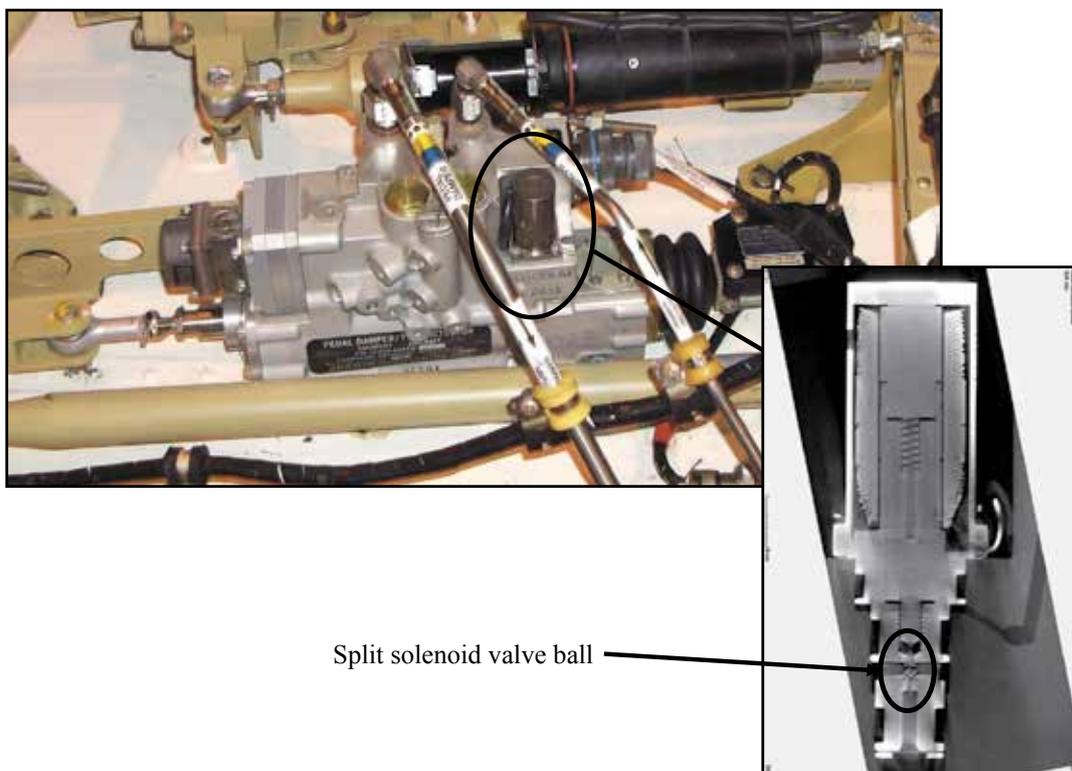
A Computerised Tomography (CT) scan was carried out on the PDTA and it was found that a small steel ball, part of the trim solenoid valve, had split in half. PDTA functional checks by the manufacturer on a hydraulic test bench demonstrated that the broken ball produced identical symptoms to those experienced by the pilot. Figure 1 shows the PDTA in position and the CT scan of the servo valve ball.

Analysis and testing of the PDTA indicated that the split ball was allowing hydraulic pressure to leak internally past the solenoid valve to act on the trim-on control valve, thus placing the PDTA in trim mode continuously. In addition, the leakage acted within the PDTA against the damping circuit, which, with the actuator moving constantly, needed a significant force to overcome.

The new steel ball had been fitted at overhaul prior to the PDTA release to service and is most likely to have fractured during the flight from London to Denham. A detailed metallurgical

analysis of the ball by the NTSB on behalf of the AAIB is continuing. However, the most likely cause of the ball fracture was an anomaly in its heat treatment process during manufacture.

PDTA and servo valve CT scan

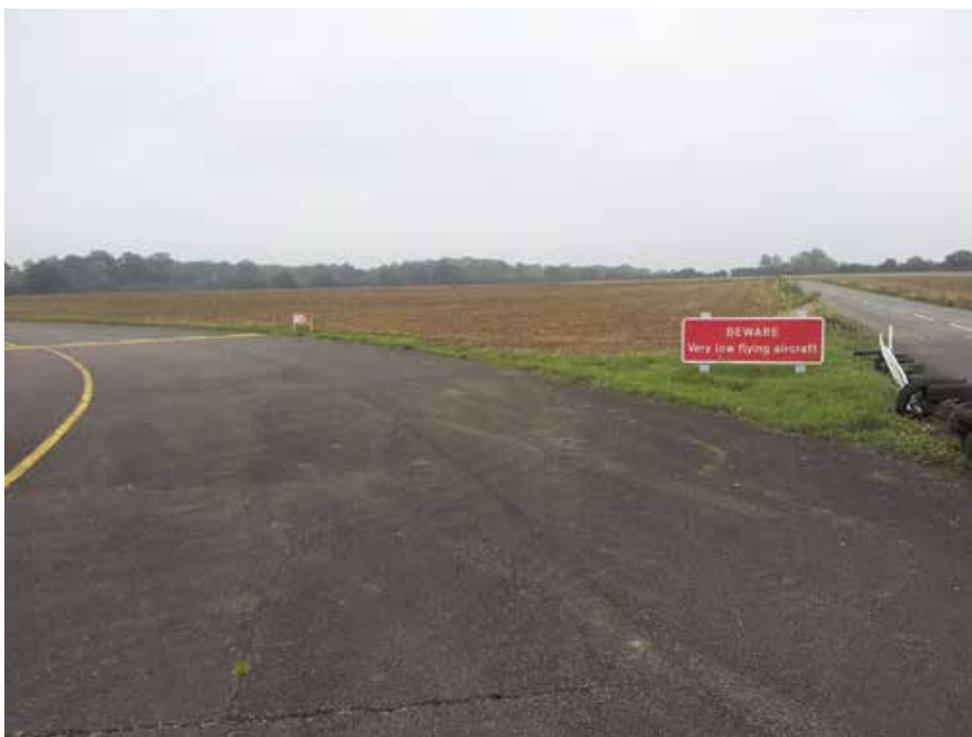
Figure 1

Holding Point C, the taxiway and the warning sign

The pilot had not been aware of the full extent of the damage, which was not visible from the cockpit, before departing from Turweston. He concluded that he had not seen the warning sign due to its end on aspect when he taxied off the runway and possibly because he was looking to the right, into the turn. On reflection, having felt a bump and seen a dent
