Rail Accident Report

**Fatal accident involving a track worker near
Newark North Gate station
22 January 2014**

Report 01/2015
February 2015

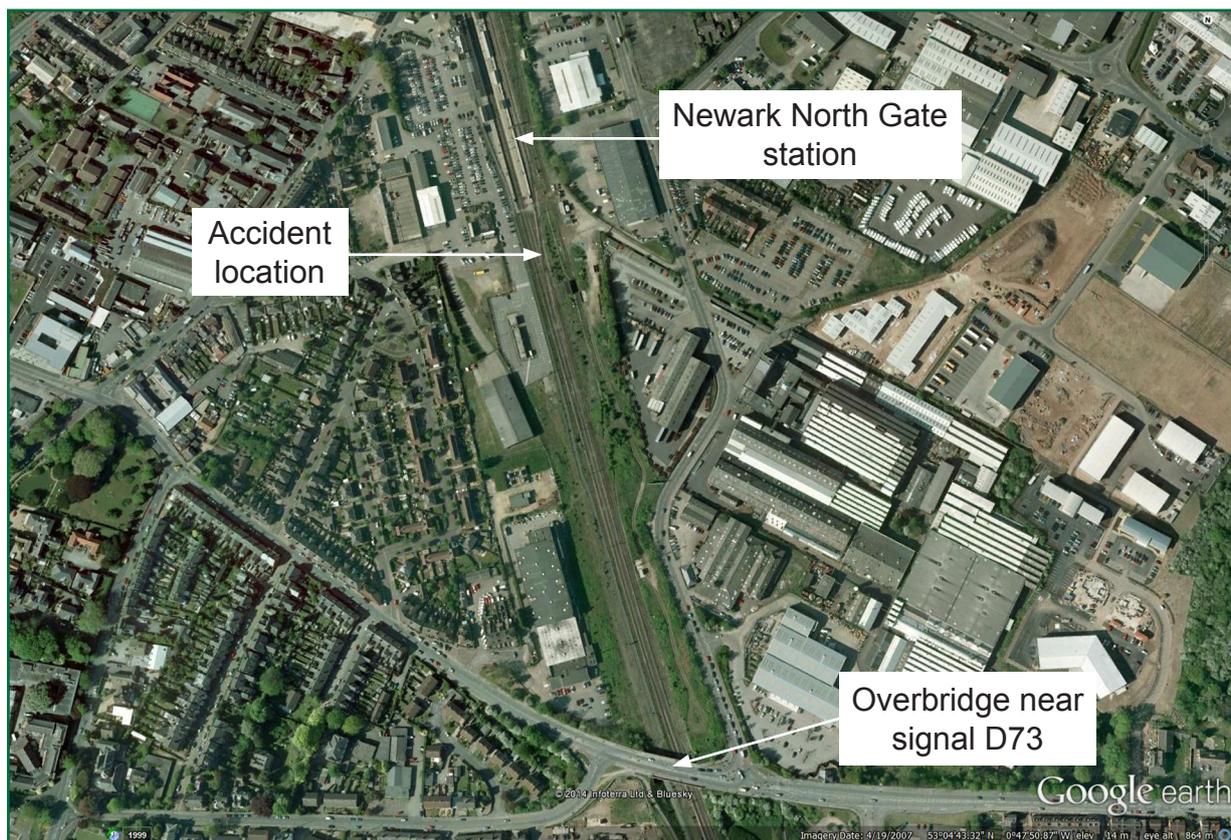
Figure 2: Google earth image of the accident site

- 9 The accident occurred around 70 metres south of the platform ramps at Newark North Gate station (figure 3), which is located on the East Coast Main Line (ECML) at 120 miles 8 chains from London Kings Cross.

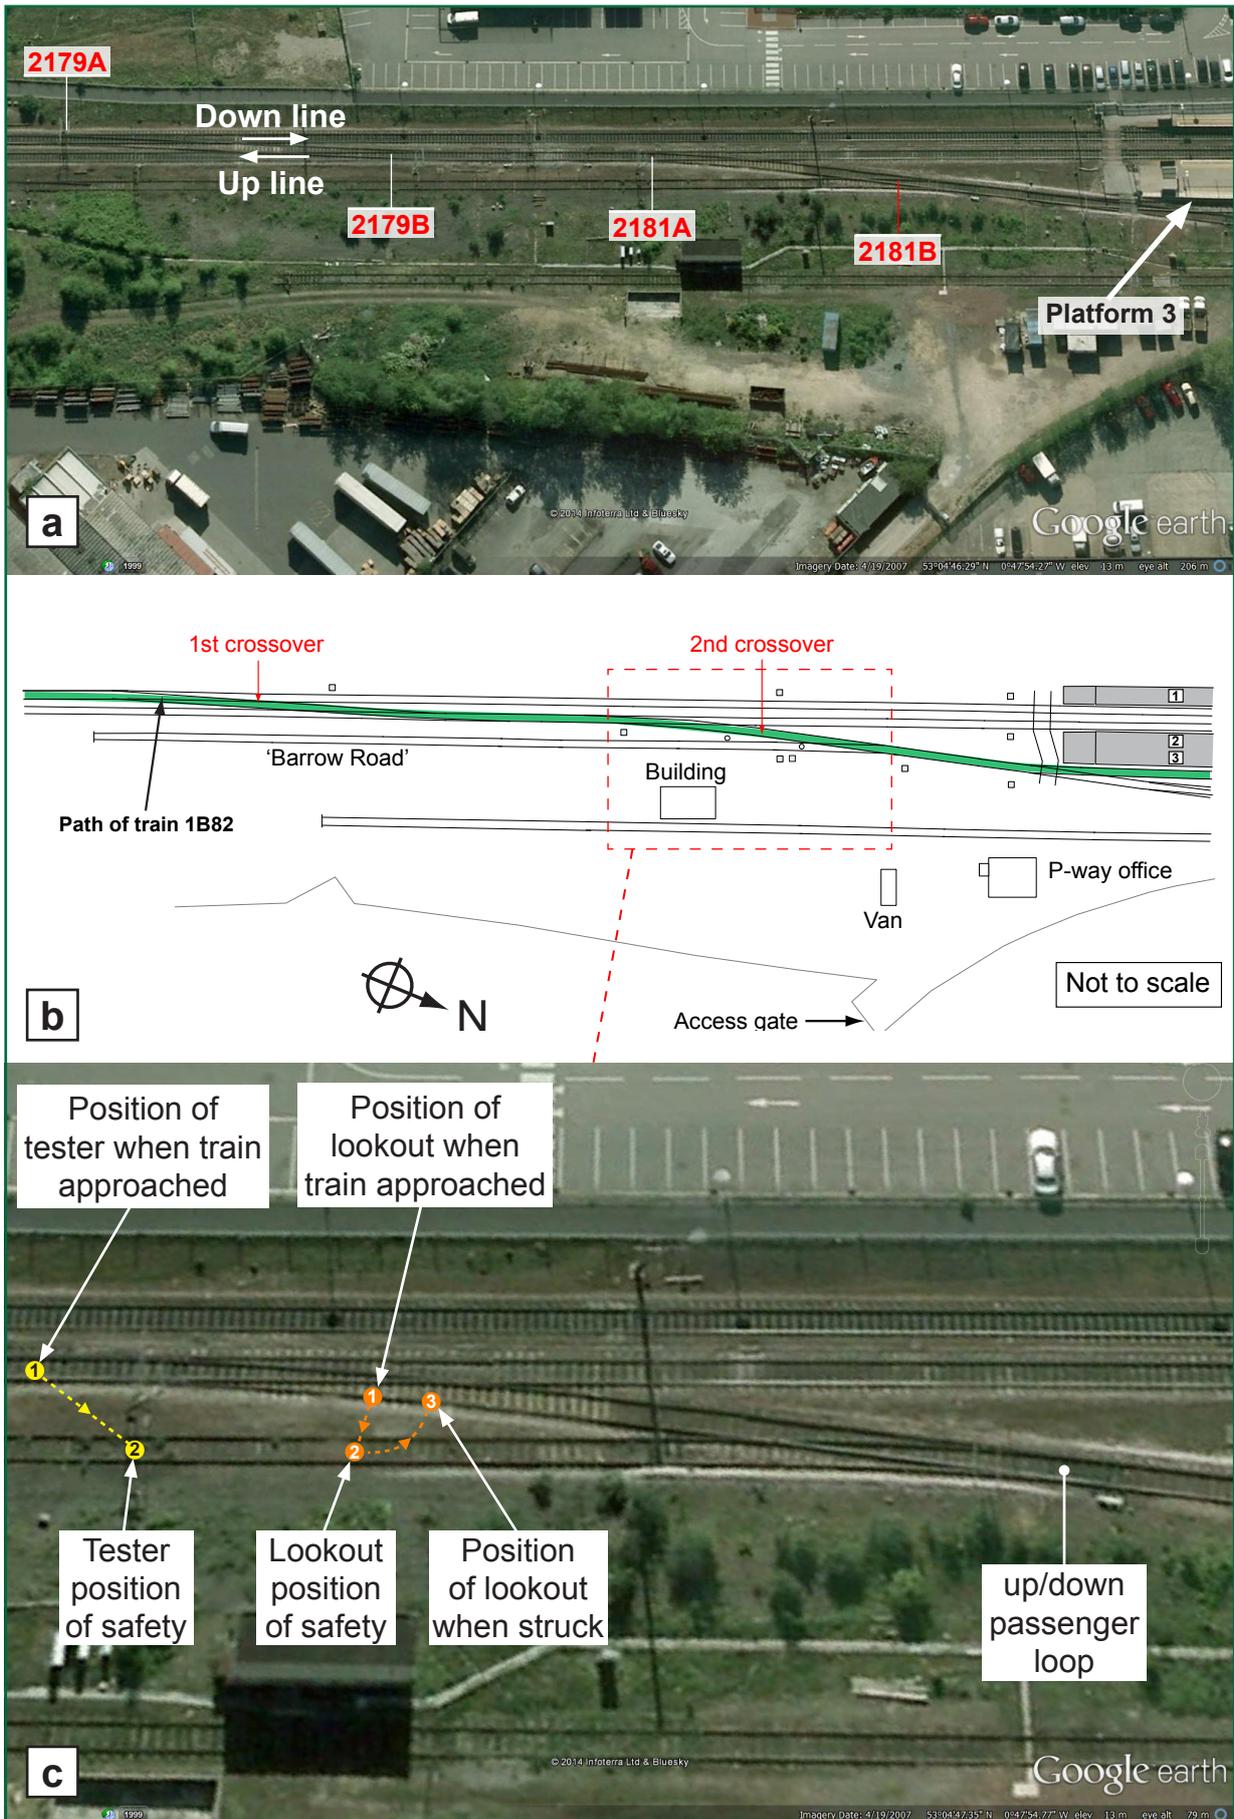
Figure 3: Layout of the tracks at Newark South Junction (located at 119 miles 73 chains)

- 12 The train involved in this accident had been routed over two crossovers. The first is between 2179A points and 2179B points (figure 3a) and takes northbound trains (approaching from the left in figure 3) from the down main line onto the up main line. The second crossover is between 2181A points and 2181B points and takes northbound trains from the up main line onto the up/down Passenger Loop. The maximum permitted speeds through both crossovers is 30 mph (48 km/h). The lookout was standing on the right hand rail of the second crossover (viewed in the direction of travel of the train) at the position shown in figure 3c when he was struck by train 1B82.

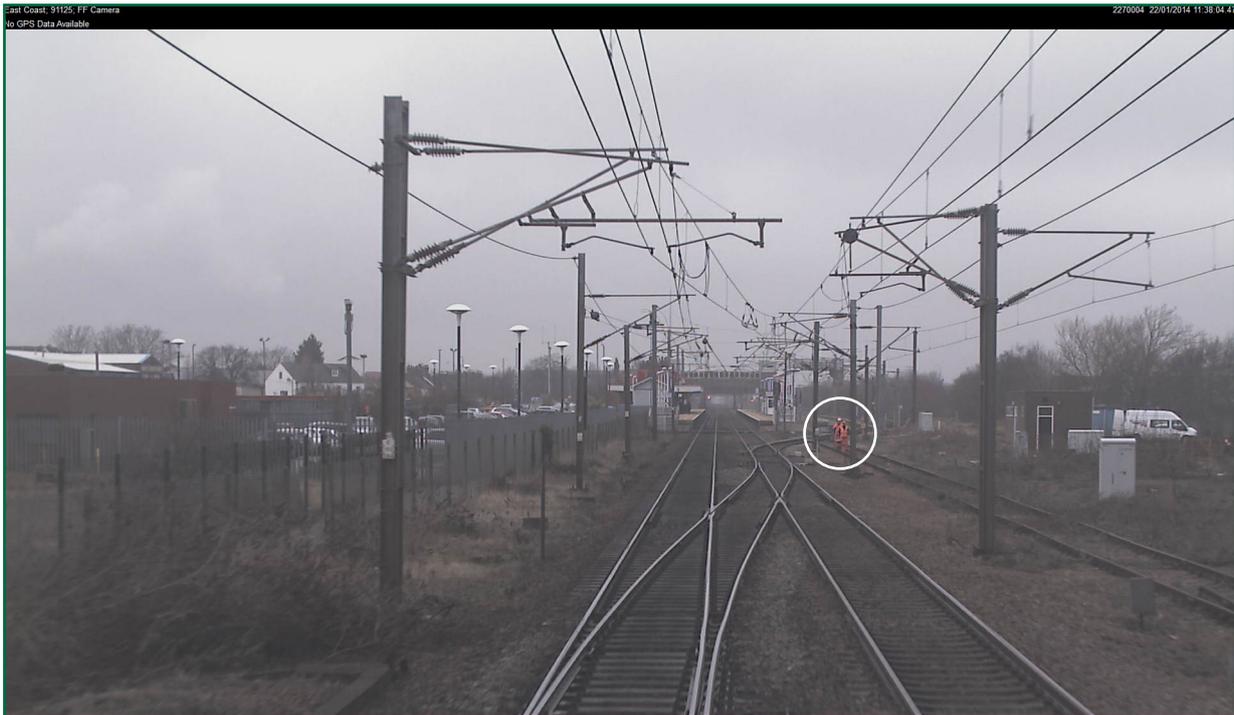
Figure 5: The lookout and tester in the position of safety (image courtesy of East Coast Railways Mainline Company Ltd)

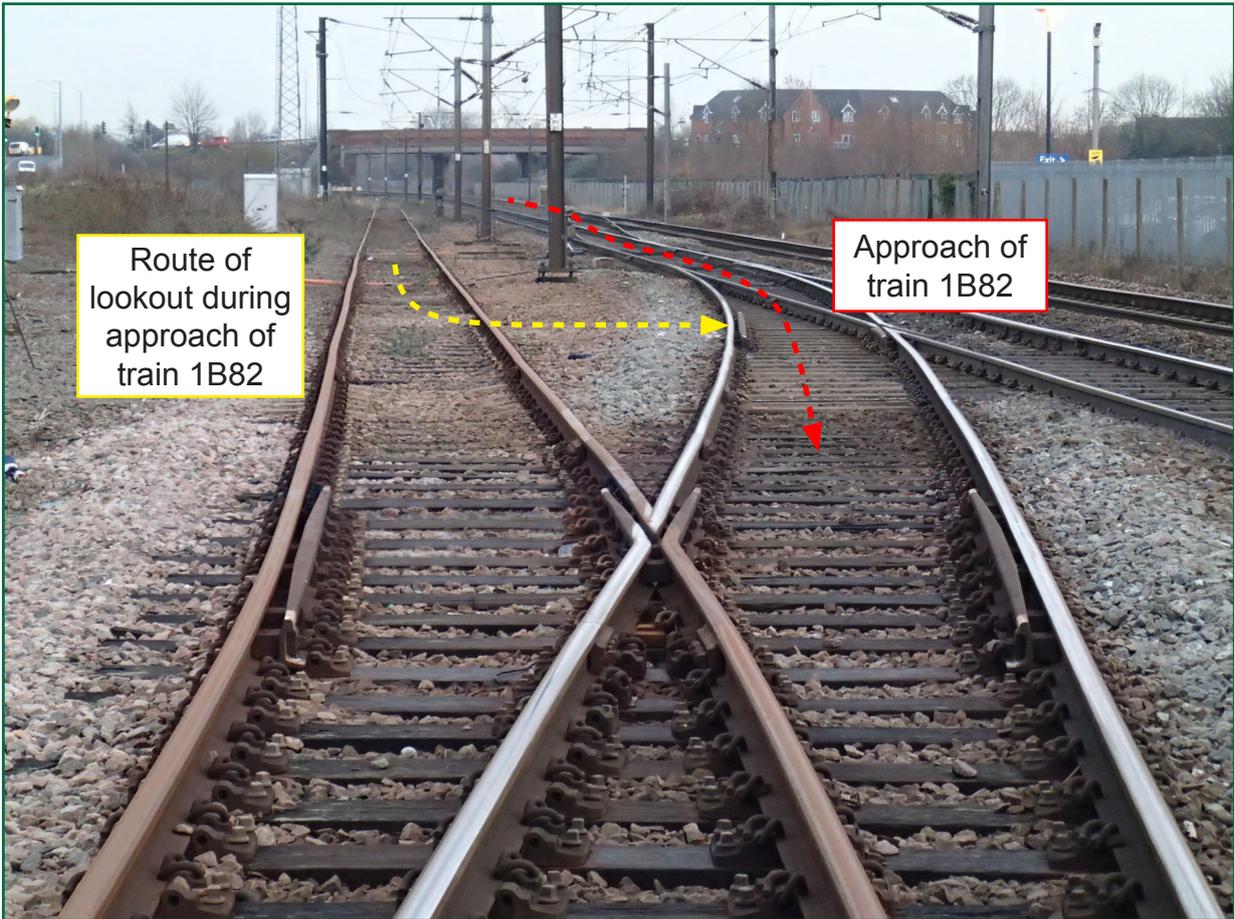
- 35 The lookout reached the right hand rail of the second crossover (position shown in figure 3c) at 11:34:10 hrs (around 3 seconds before being struck). The proximity of the train to the lookout as he approached the crossover is shown in figure 7. The lookout stood on the right hand rail while continuing to look in the direction of the station. Data from the train's OTDR shows that at this time the train driver simultaneously blew the train's warning horn and applied the emergency brake. The speed of the train at that time, recorded by the OTDR, was 26 mph (42 km/h) and its distance from the lookout was around 35 metres. The tester has stated that when he heard the blast from the train horn as the train was passing him, he first wondered why the driver had used the horn a second time because he believed both he and the lookout were in the position of safety, and he had already acknowledged the first train horn a second time from the position of safety.

Figure 6: The path taken by the lookout toward the up/down Passenger Loop and the position he was struck.

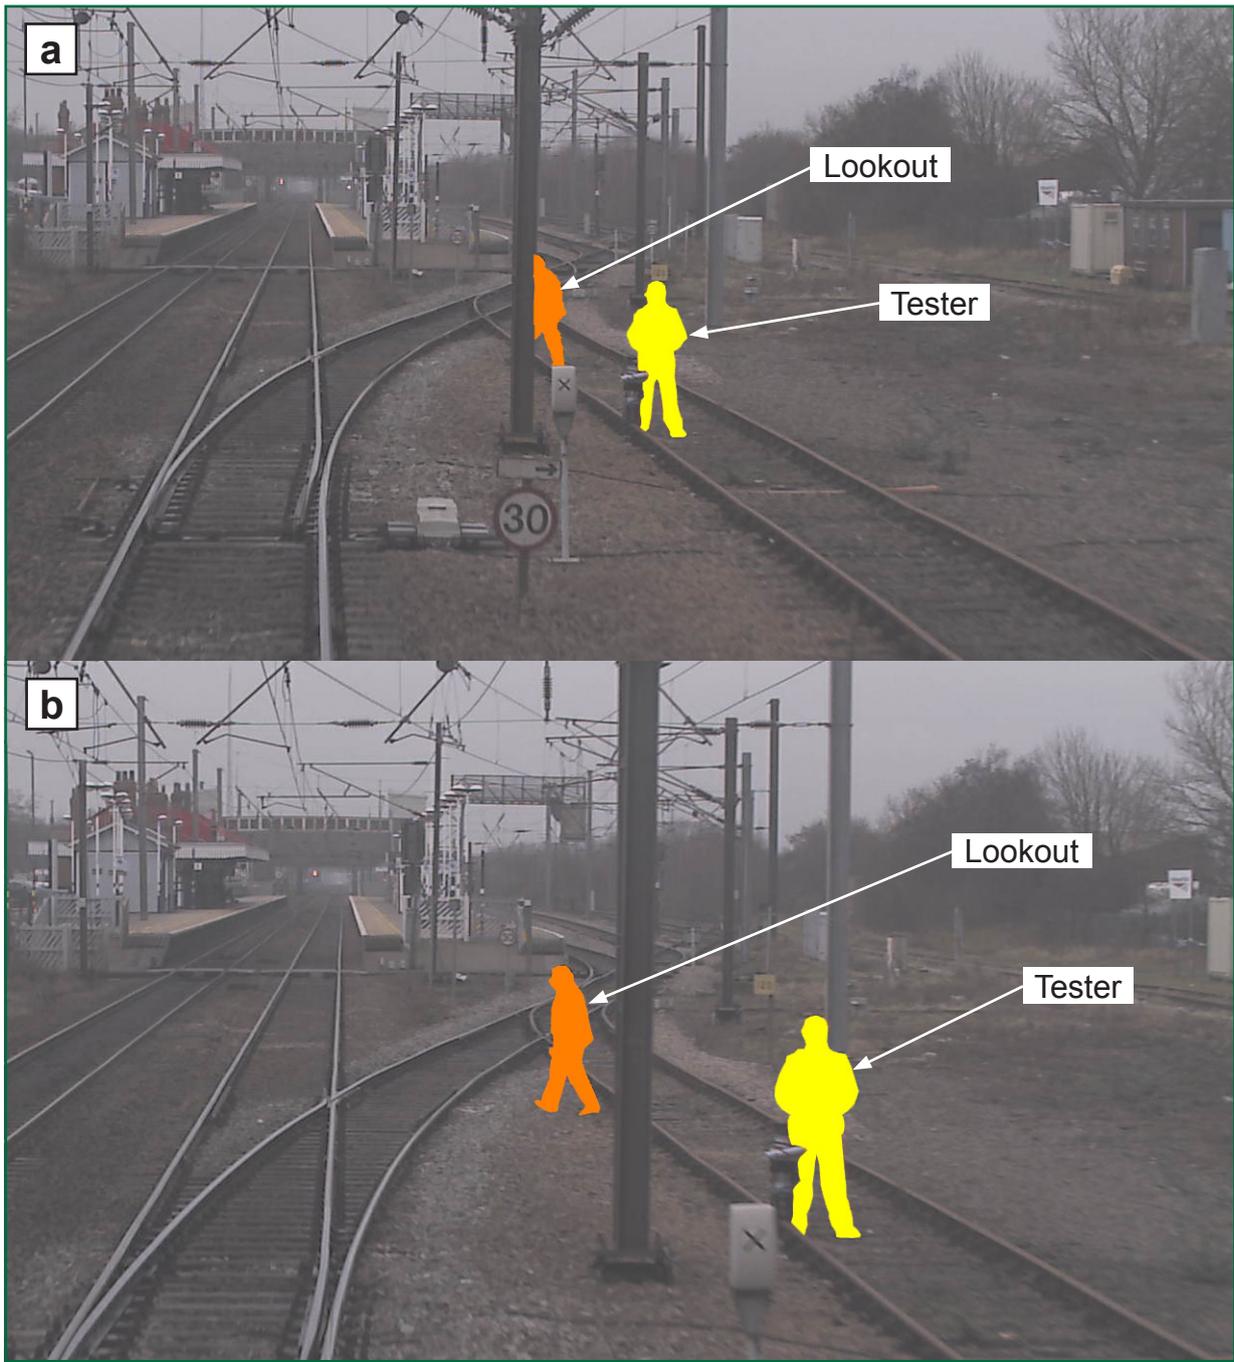
Figure 7: Forward facing CCTV images showing position of lookout approximately 2 seconds (a) and 1 second (b) before the train's second horn and emergency brake (images courtesy of East Coast Railways Mainline Company Ltd)

- 63 The expected reaction time for a driver responding to a familiar but unexpected hazard is likely to be around 1.5 seconds³. The positions of the lookout at one and two seconds before the emergency brake and horn were applied (based on CCTV images), are shown in figures 7a and 7b respectively. These indicate that the driver reacted as soon as it was clear the lookout had left the position of safety and was moving towards the up/down Passenger Loop.

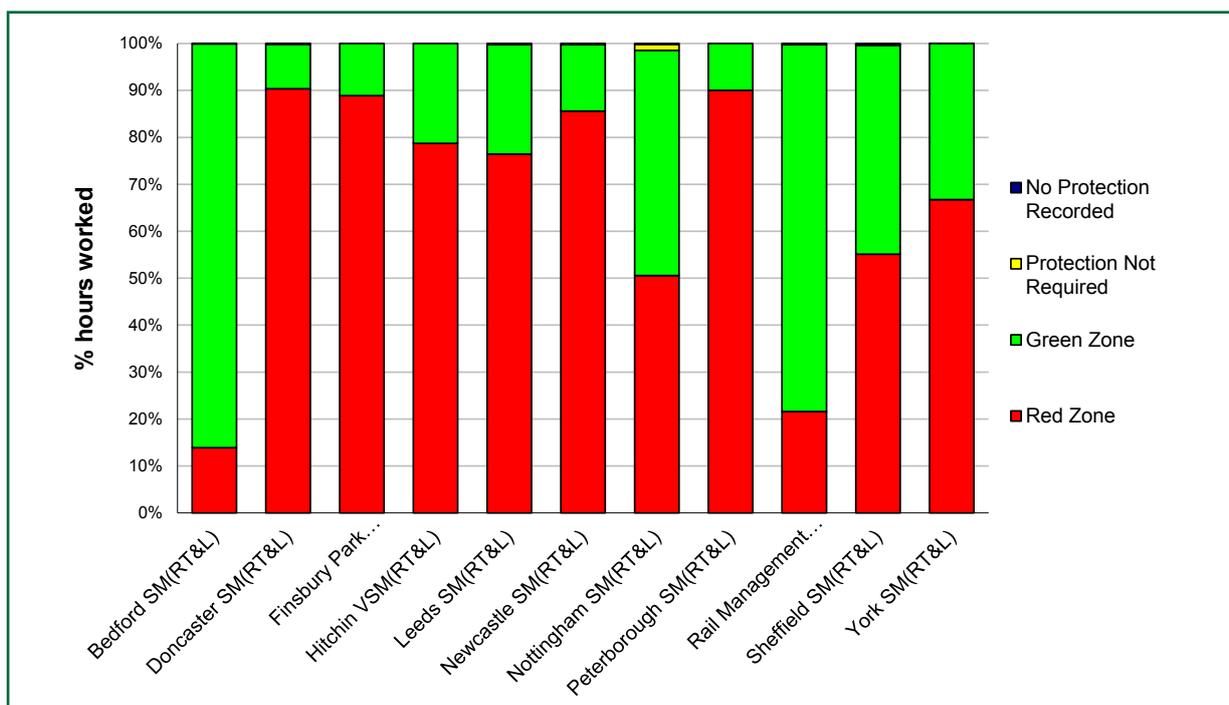
- 84 Figure 8 shows data provided by Network Rail on the proportion of red and green zone working for the rail testing and lubrication teams of each *delivery unit* of the LNE&EM route between August 2013 and January 2014. For some units, such as Doncaster, Finsbury Park and Peterborough, which mainly service the ECML, the proportion of red zone working was around 95%. For others such as Bedford, the proportion was much lower at around 15%. The overall target for the proportion of red zone working in the LNE&EM route was 30% at the time of the accident⁸. However, the overall average proportion of red zone working for the rail testing and lubrication team, across the route, was 61%.

Figure 8: Proportion of red zone to green zone working on the Network Rail's LNE&EM route for each delivery unit

89 Although not linked to the cause of this accident, the RAIB observes that the SSOW planning at Doncaster Marshgate Depot was not being implemented in accordance with the hierarchy of risk set out in Network Rail standard NR/L2/OHS/019. The intention of the standard is that the planner should choose the safest practicable system of work. However, in the case of the rail testing and lubrication teams, this was being disregarded in favour of the most flexible and convenient system of work for the availability of staff and equipment or one that fitted with custom and practice. The amount of red zone working undertaken by the rail testing and lubrication teams based in the Doncaster delivery unit was significantly higher than the target for the LNE&EM route (**paragraph 84, Recommendation 2**).

- 2 *The intent of this recommendation is to improve the implementation of Network Rail's procedures for planning safe systems of work, so that the hierarchy of risk is used in the intended way.*
