# Rail Accident Report

**Derailment of a freight train at Barrow upon Soar,  
Leicestershire  
27 December 2012**

Report 22/2013  
December 2013

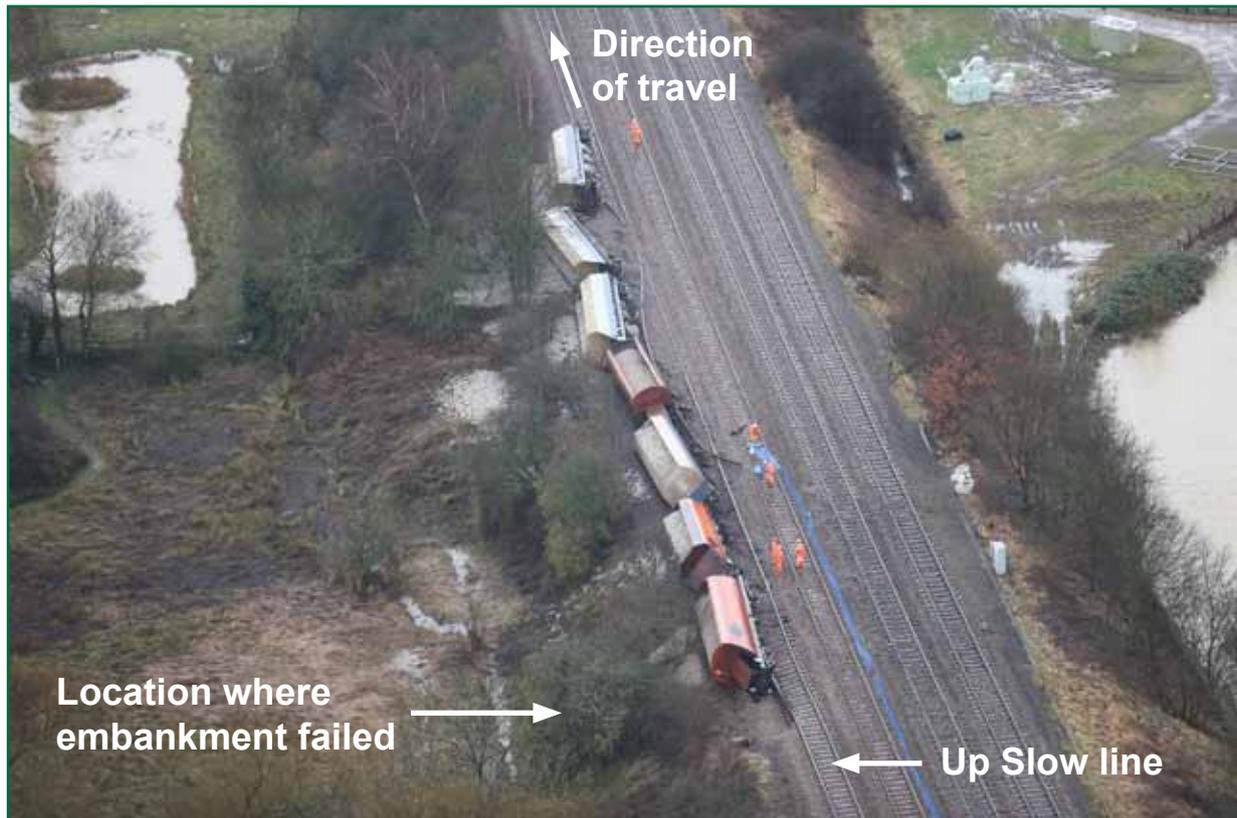
- 7 The locomotive and first ten wagons remained on the track; the eleventh and twelfth wagons derailed by their leading *bogies* only; the thirteenth remained on the track; and the rear seven, which separated from the rest of the train, derailed and tipped over (figure 2).
- 8 No one was hurt in the accident and there were no other trains in the vicinity at the time. The slow lines remained closed for twelve days for recovery of the wagons and repairs to the embankment and track.

Figure 2: Aerial view of the accident site (photograph courtesy of Network Rail)

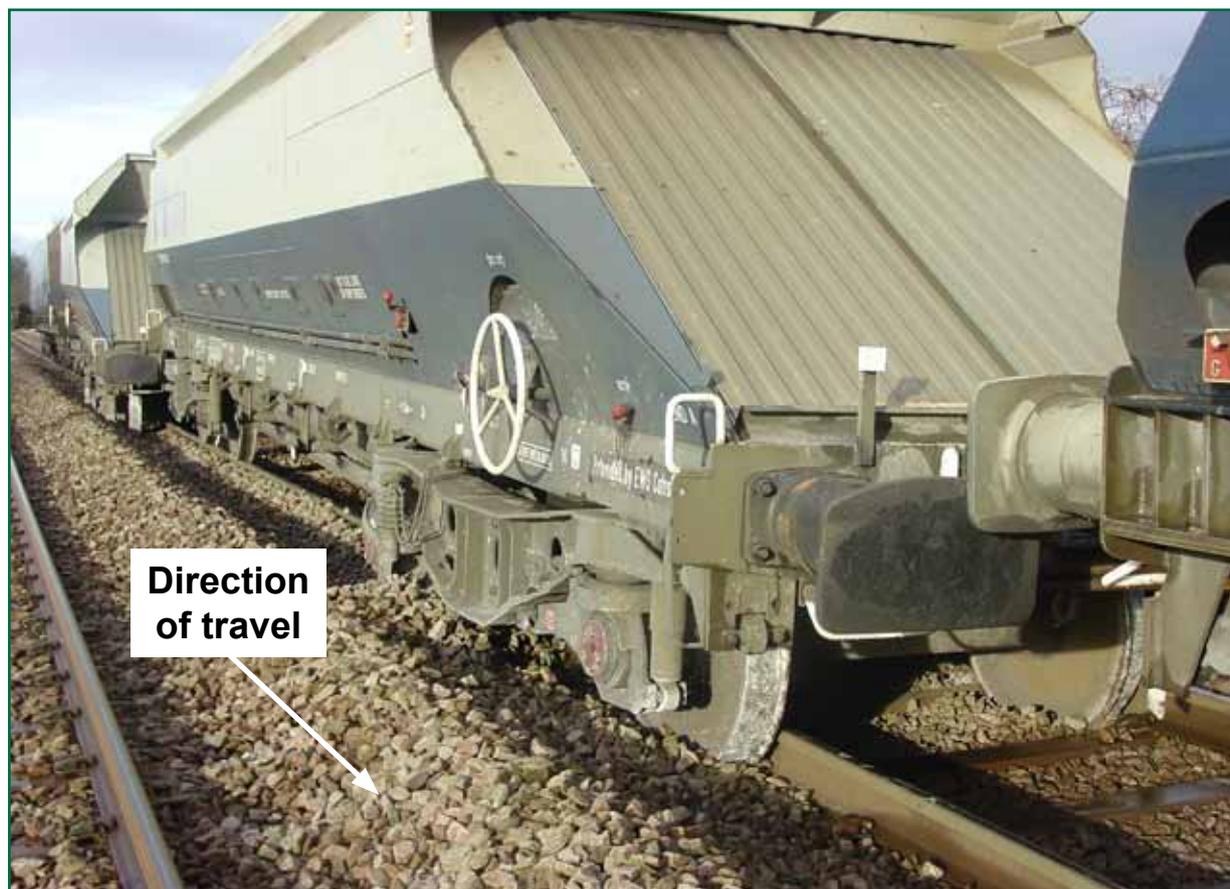
- 23 After slowing for a 20 mph (32 km/h) speed restriction through Loughborough station which applied to train 6L73 due to its weight, the driver slowly accelerated. At about 04:50 hrs, the train crossed bridge 64 over the River Soar while travelling at 36 mph (58 km/h).
- 24 About 51 metres further on, while travelling at 37 mph (60 km/h), the driver felt the locomotive lurch sharply to the left. As the train continued on, a short length of the embankment progressively slipped underneath it, causing the rail on the cess side to drop. The locomotive and first ten wagons passed over the embankment slip before it worsened sufficiently under the train to cause the leading bogies of the eleventh and twelfth wagons (both type IIA) to derail to the right (figure 5). The thirteenth wagon (type HOA) did not derail.

Figure 5: Derailed eleventh and twelfth wagons

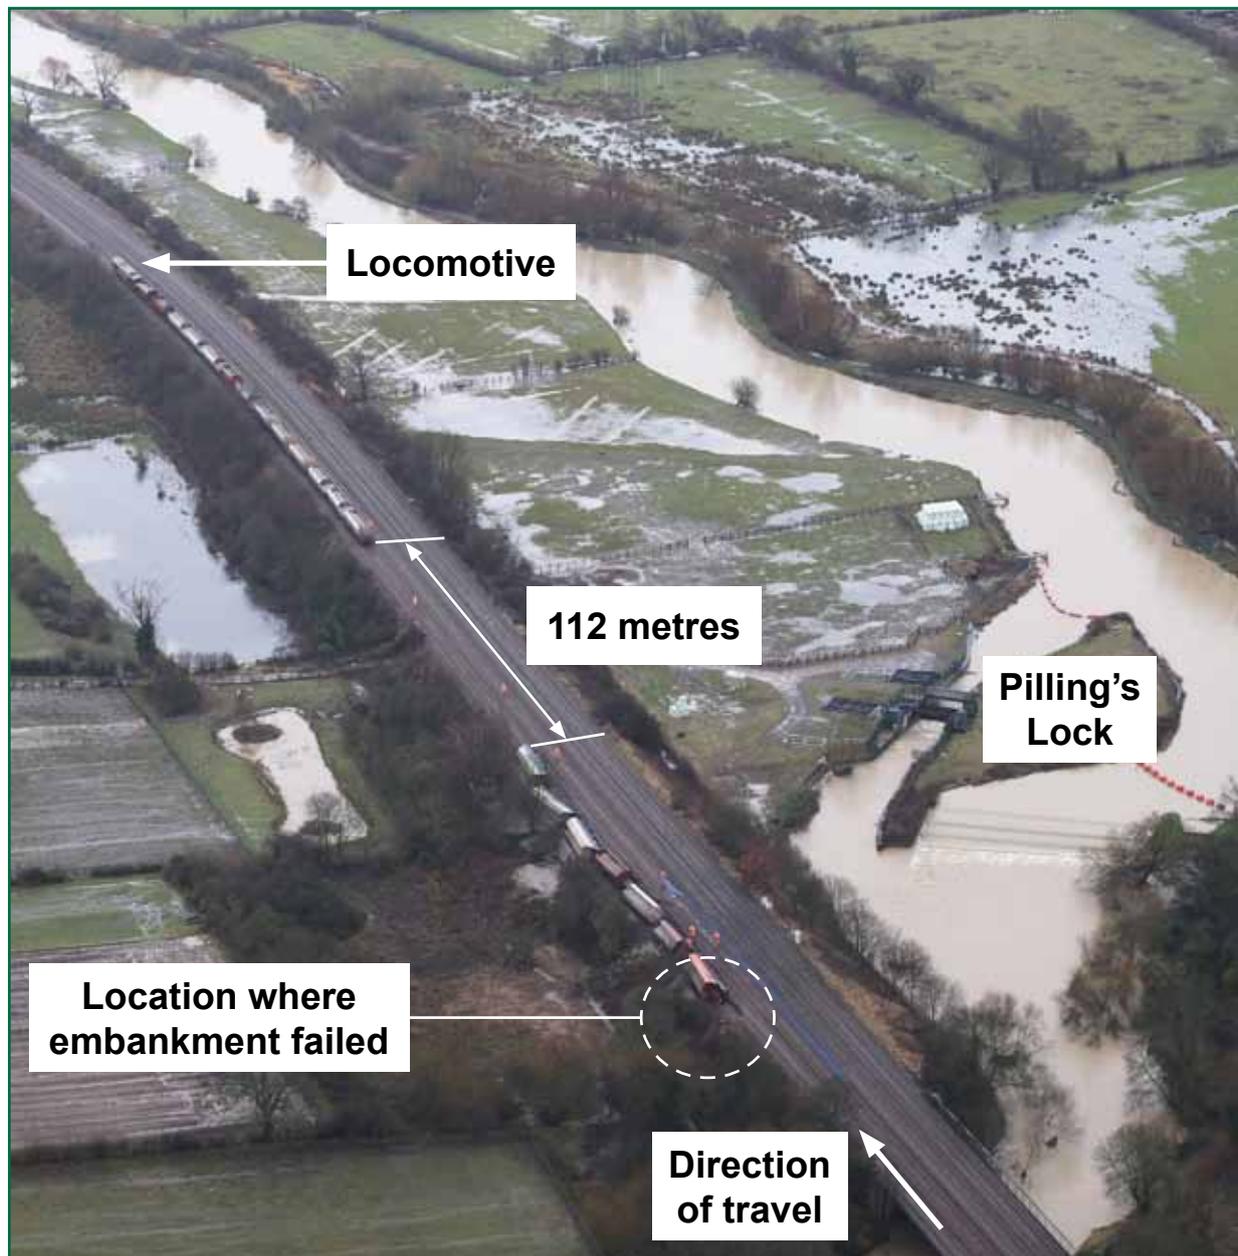
- 25 The embankment slip continued to worsen under the train and caused all of the wheels on the remaining seven wagons to derail to the left towards the cess and these wagons then overturned. This caused the coupling between the thirteenth and fourteenth wagons to break, which in turn ruptured the train's *brake pipe*. This caused the train's brakes to apply and the front of the locomotive came to a stop 436 metres beyond the start of the embankment slip. The two portions of the train came to rest 112 metres apart (figure 6).

Figure 6: Where the two portions of train 6L73 came to rest (photograph courtesy of Network Rail)

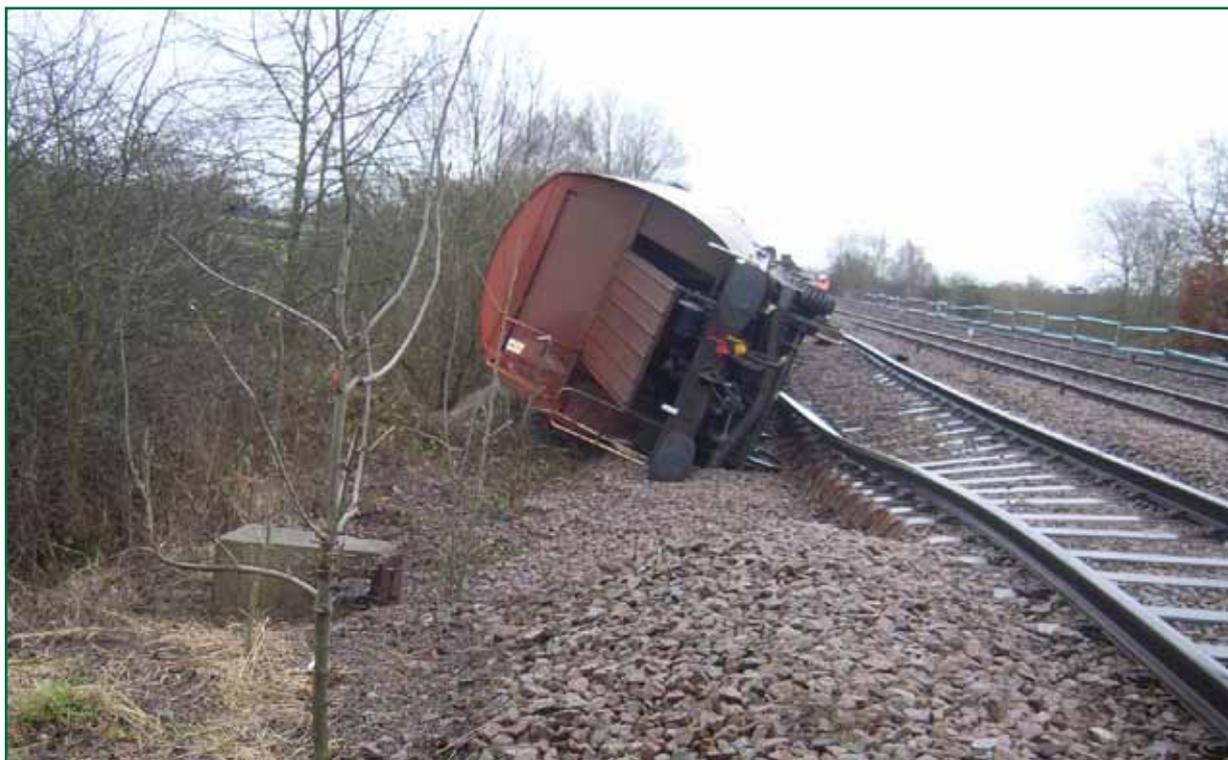
- 32 The fourteenth and following six wagons all derailed towards the cess and tipped onto their sides (figure 7). These wagons almost certainly derailed due to the embankment slip worsening as the fourteenth wagon passed over it, resulting in a greater vertical deflection of the cess rail and complete loss of support under it as shown in figure 7.

Figure 7: The rearmost wagon and loss of support under the cess rail of the Up Slow line

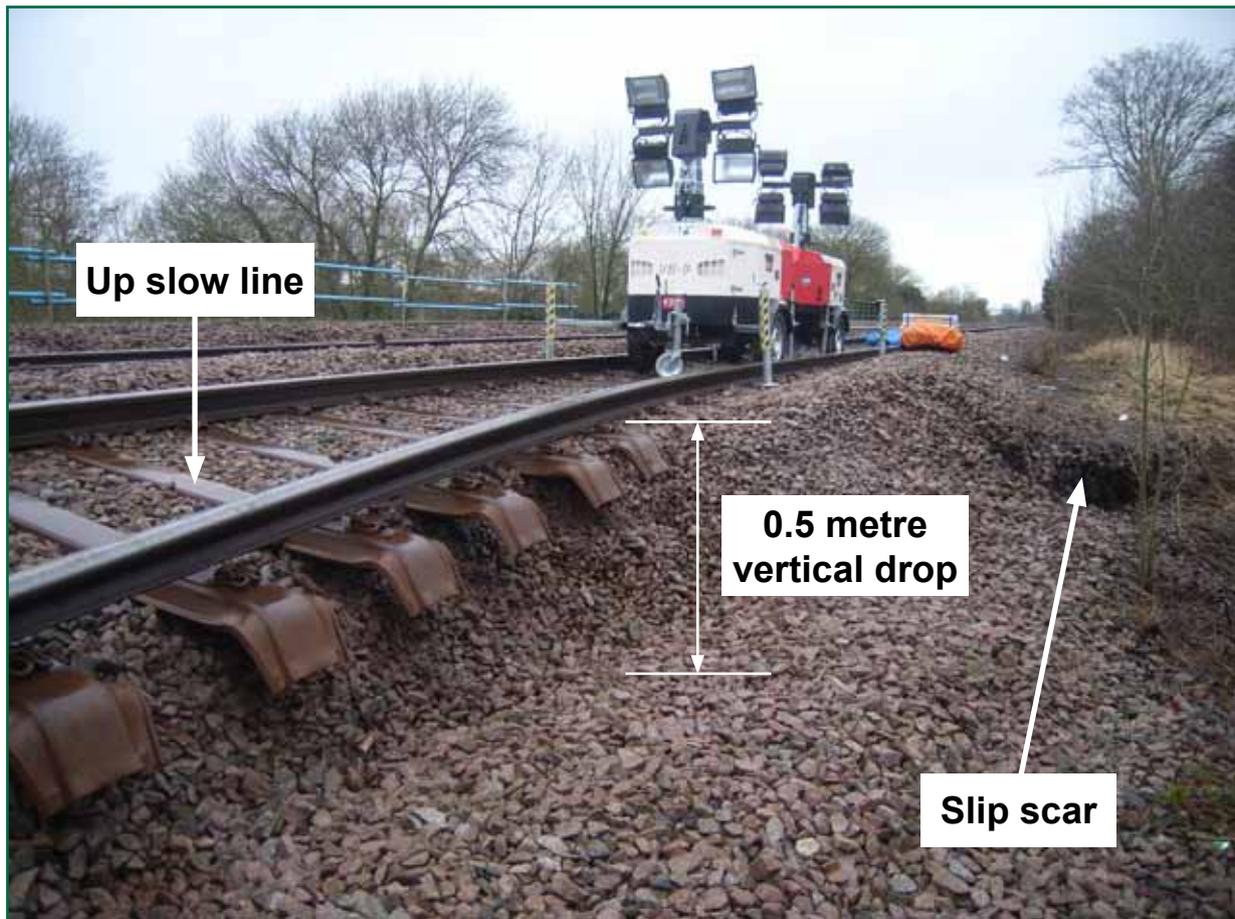
- 33 A section along the top of the embankment, over a length of about 25 metres, had dropped down by about 0.5 metres. This extended inwards from the cess towards the centre of the up slow line, removing all support under the cess rail. Scars within the embankment showed the extent of the movement (figure 8).

Figure 8: Scars showing embankment slip

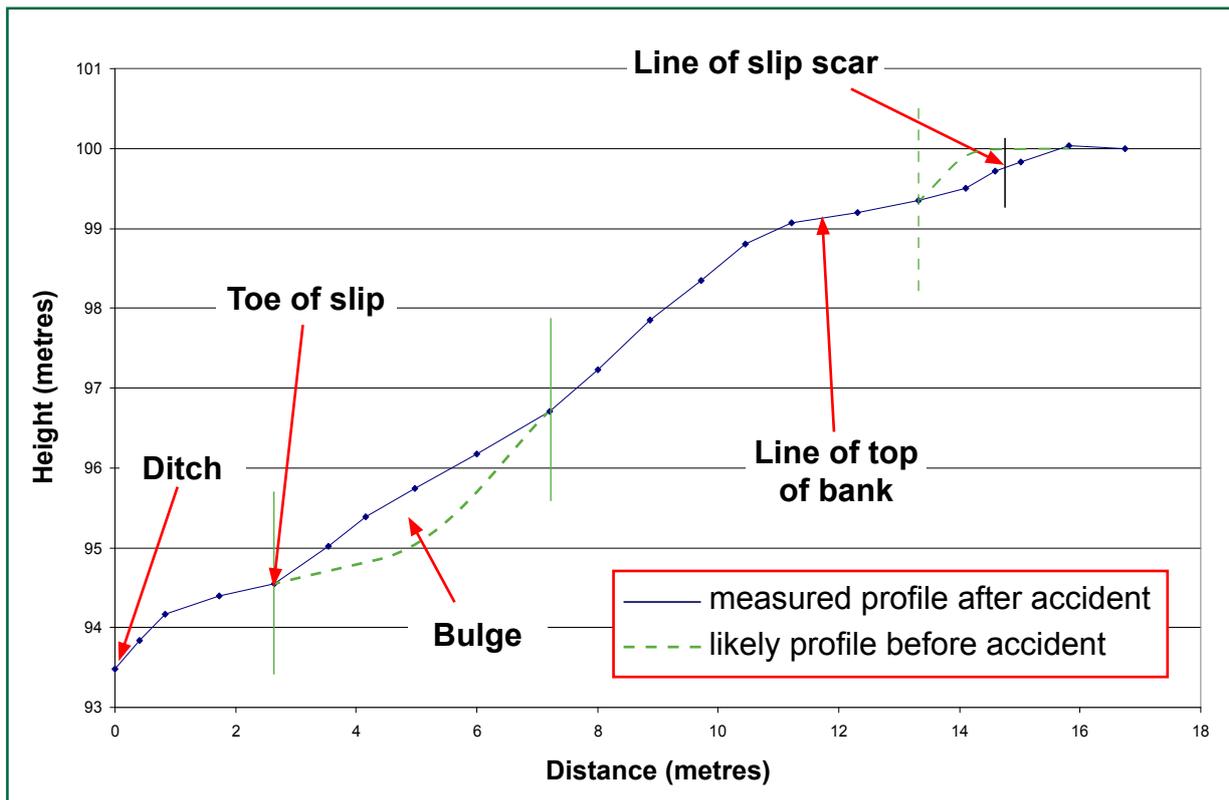
- 34 The RAIB measured the profile of the embankment and found a small bulge in the horizontal plane towards the bottom of the slope (figure 9). Network Rail also surveyed the bottom of the embankment and found that the drainage ditch running along the foot narrowed where the slip had occurred, suggesting that the foot of the embankment had moved outwards. Network Rail took samples from the embankment to identify the materials within it and carried out tests to determine the strength of these materials. As part of the remedial works to repair the embankment, Network Rail employed a contractor to dig a trial trench to establish the extent of the failure within the embankment and the failure mechanism. This work identified that a single *rotational failure* (figure 10) had occurred within the embankment, where a layer of clay met a layer of ash material<sup>2</sup>. The cause of this failure is discussed later in the report (paragraph 41).

Figure 9: The embankment profile after the failure

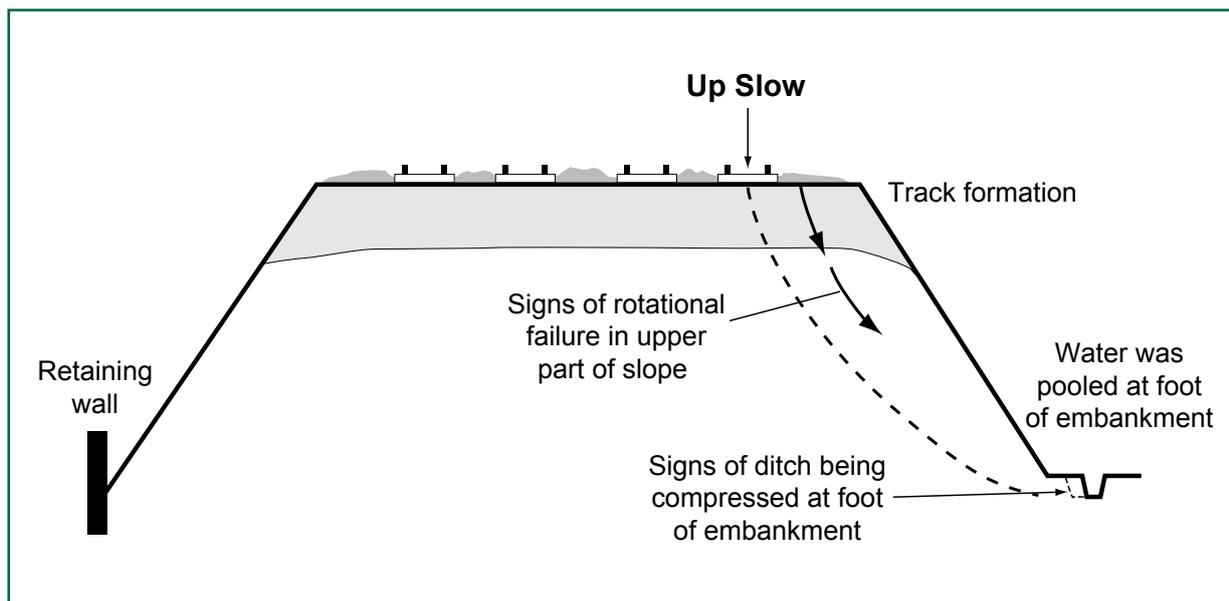
Figure 10: The rotational failure within the embankment

52 Site investigations after the accident found a bulge which narrowed the drainage ditch running along the foot (figures 10 and 13). This restriction in the drainage probably happened as a result of the slip. If it had been present before the accident, it would not have caused the levels of flooding seen at the foot of the embankment beforehand; all of the drainage was overwhelmed by surface water from the adjoining land and flood water backing up from the nearby River Soar.

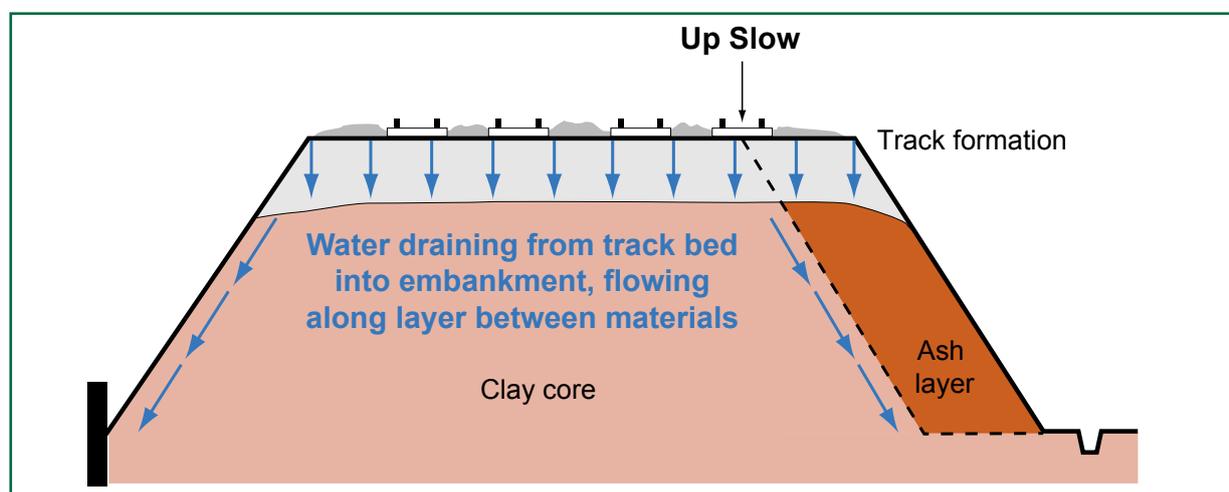
- 42 The up slow line was located above a layer of clay with a layer of ash material built up on top of the slope of the original embankment side (figure 11). This ash layer was added by the Midland Railway Company in the 1870s when the railway was widened at this location from three to four tracks. This was a common construction method at the time as ash material was freely available.

Figure 11: The layers within the embankment

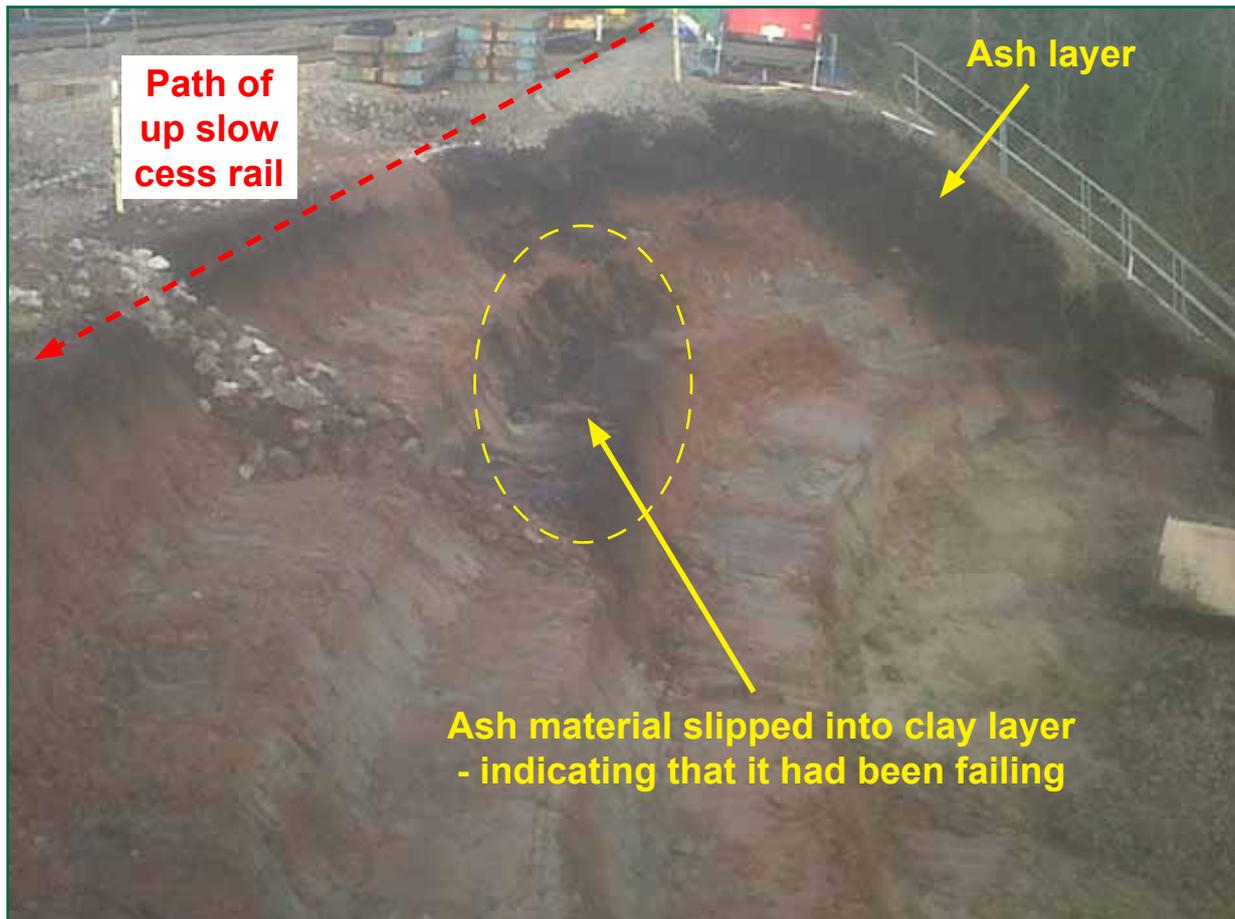
- 43 Over time, the material within the embankment, where the clay and ash layers met, had weakened due to water flowing along a path between the layers. When Network Rail's contractors cleared the vegetation and dug out the embankment after the accident to investigate the cause of the slip and undertake repairs, they found that water had saturated the ash material. The water had also softened the first 300 to 400 mm of clay where it met the ash layer (figure 11), reducing the strength of this clay material. The contractors found the slip had occurred along the plane where the clay and ash layers met, over a length of about 25 metres (figure 12).

Figure 12: The embankment after being dug out (photograph courtesy of Network Rail)

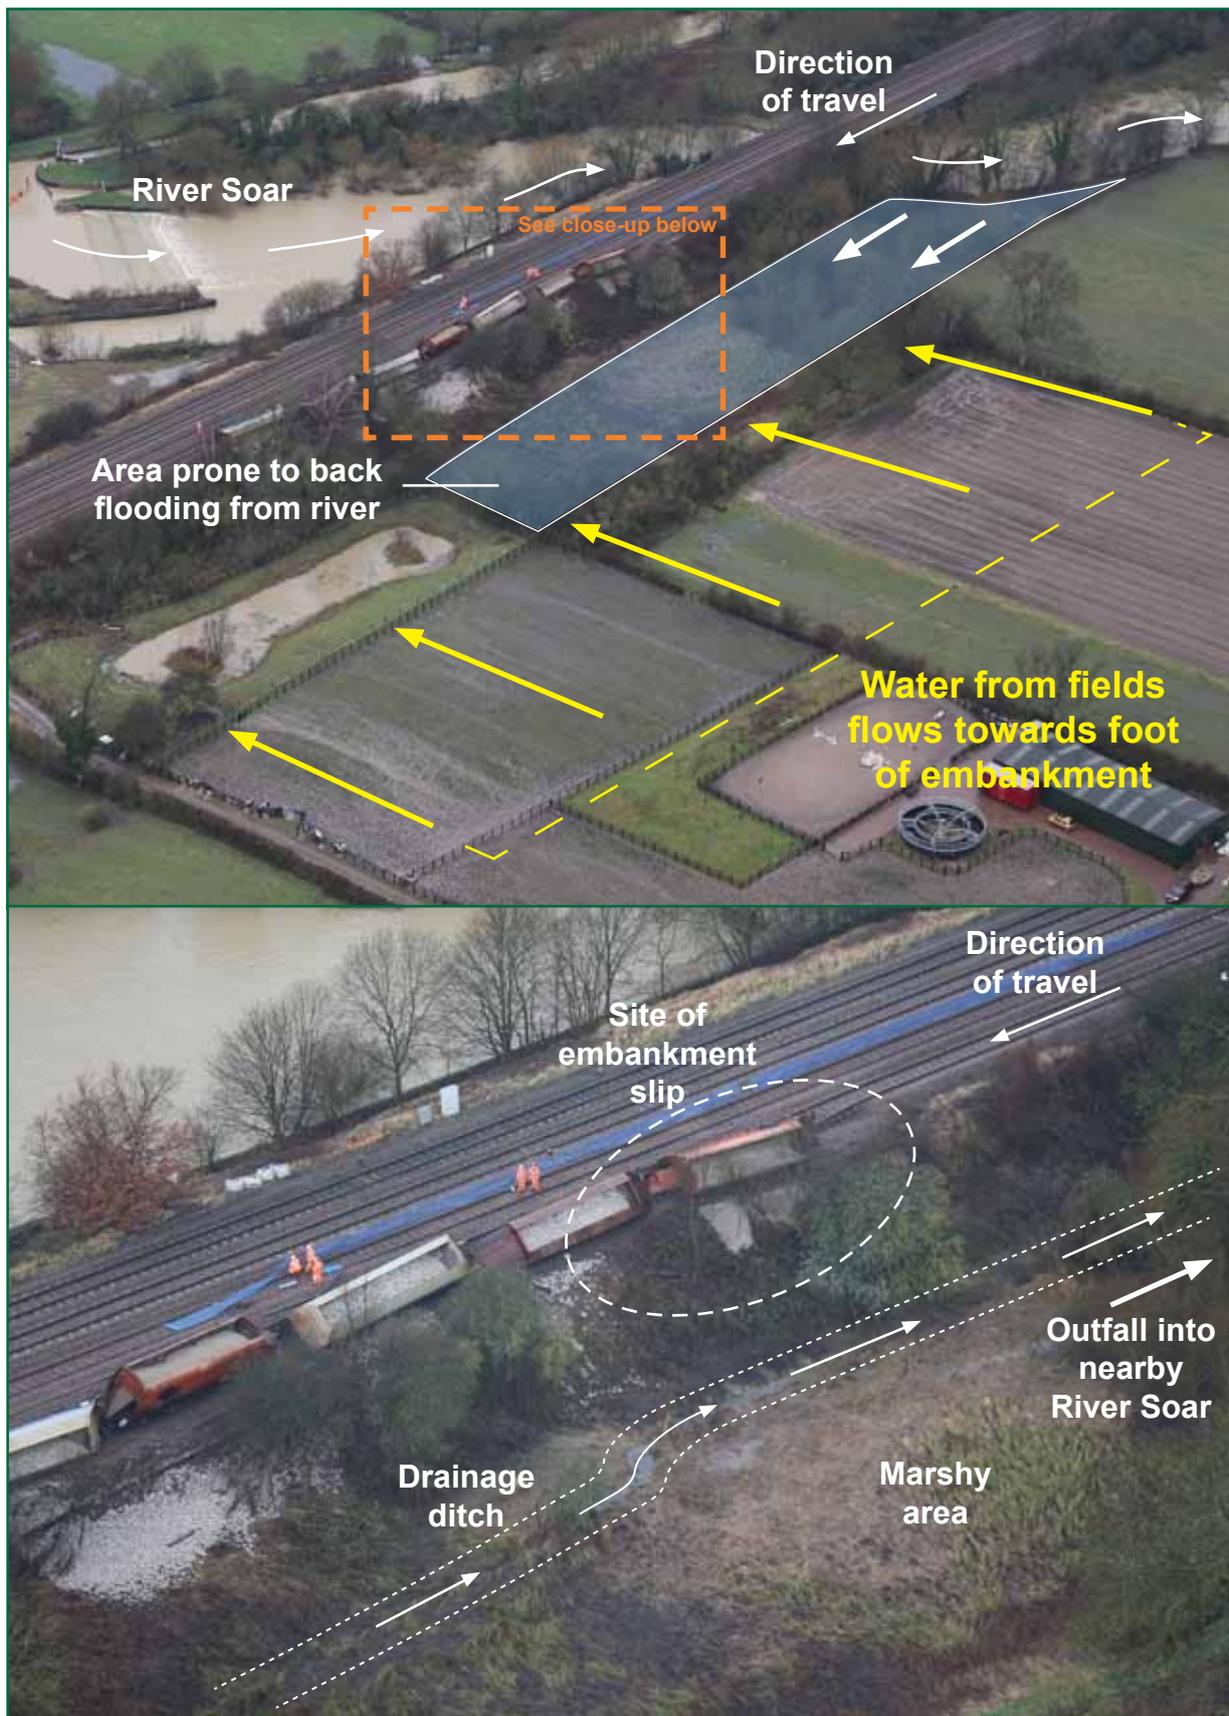
- 47 The material at the foot of an embankment is a key factor in governing an embankment's stability as it supports the rest of the embankment. The foot of this embankment is naturally wet as it is the water catchment area for the nearby fields that slope down towards the railway. Maps dating back to 1884 show this location as a marshy area. The water that flows into this area is collected in a drainage ditch that runs along the foot of embankment, with an outfall into the nearby River Soar (figure 13).

Figure 13: Drainage from the foot of the embankment to the River Soar (photographs courtesy of Network Rail)

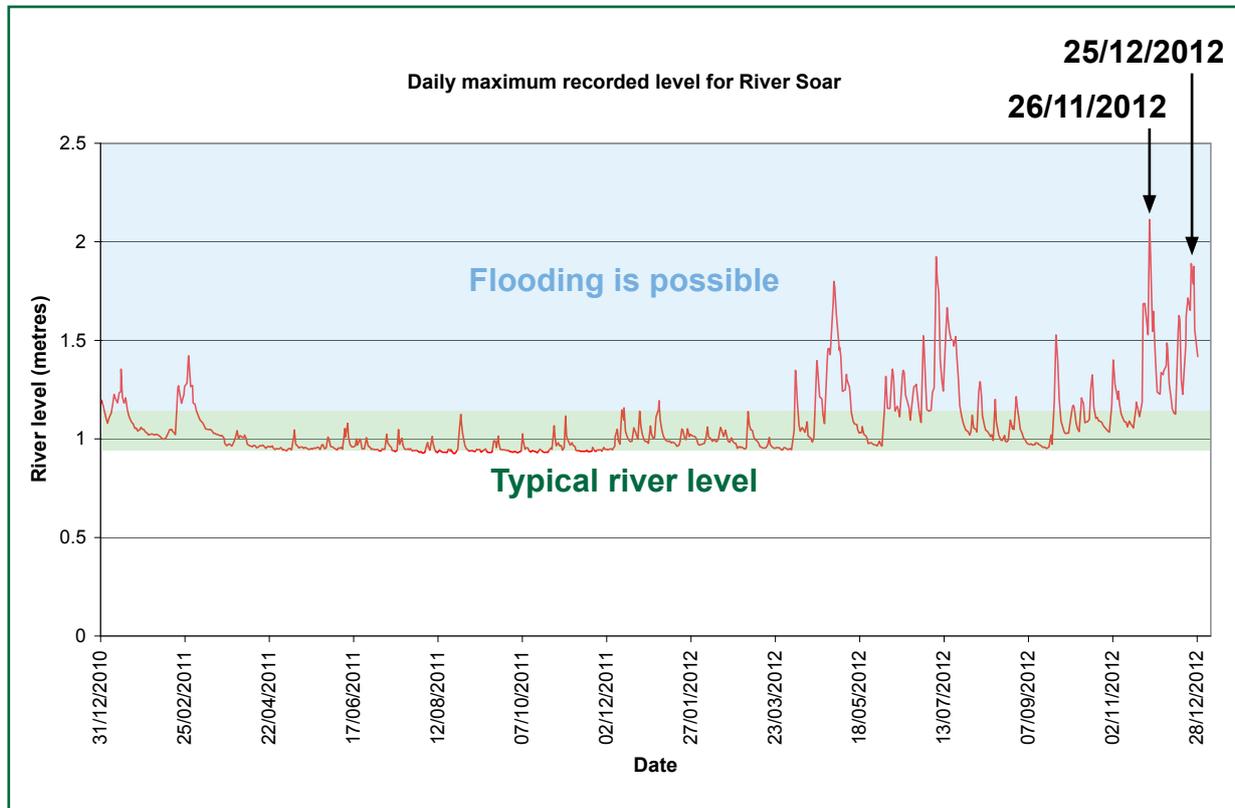
- 48 There was persistent rainfall in this area throughout November and December (paragraph 44) which caused the River Soar to flood. The water from the river then back flooded along the ditch and pooled at the foot of the embankment (figure 13). The highest river level recorded at Pilling's Lock in 2012 was 2.1 metres which was on 26 November (figure 14). The river level then remained higher than normal for most of December (paragraph 19).

Figure 14: Graph showing level of River Soar recorded at Pilling's Lock for 2011 and 2012

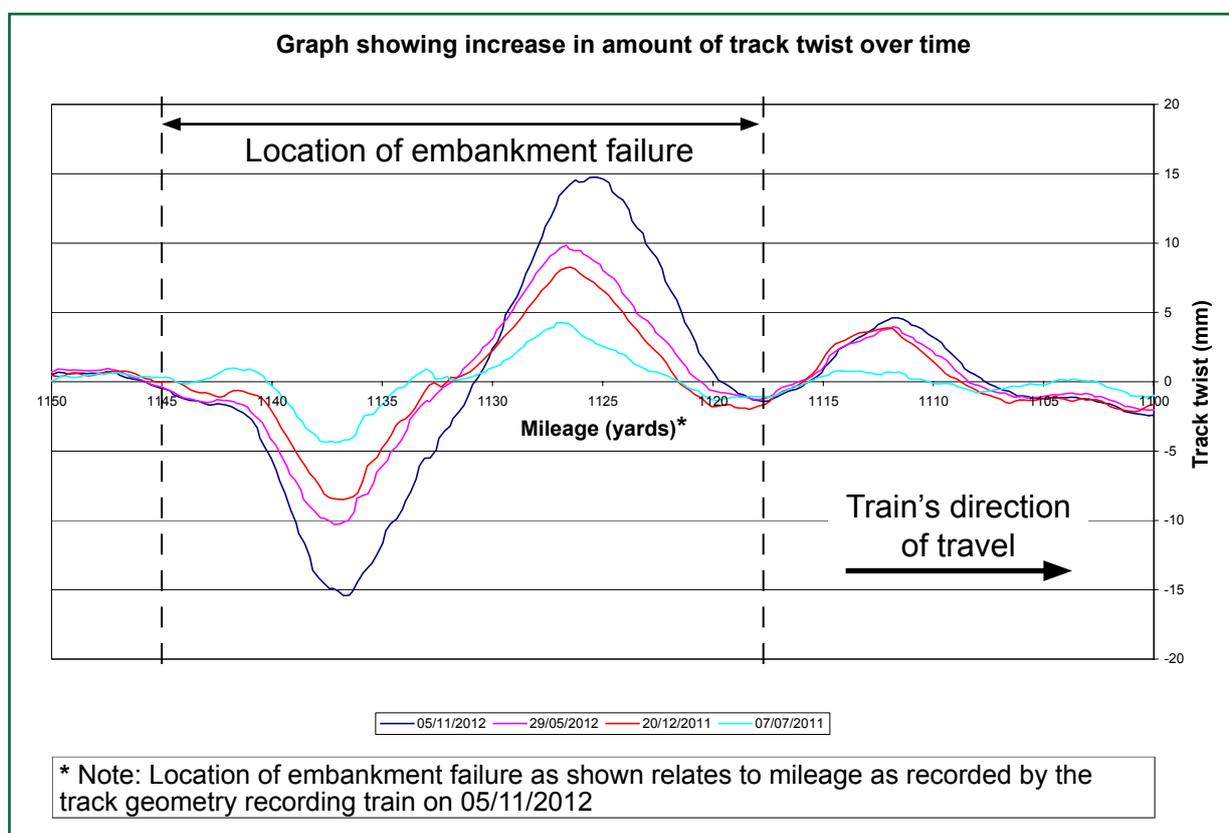
- 54 The RAIB analysed the track geometry data recorded by a track geometry recording train, to identify how the dynamic track twist had grown over the previous two years. The data shows that the twist fault developed over an 18 month period, with very little track twist in July 2011 increasing to over 15 mm of track twist in November 2012 (figure 15). The period when the track twist grew the most coincided with the high levels of rainfall and flooding during the second half of 2012.

Figure 15: Track twist at the point where the embankment failed

- 74 The track geometry data recorded about one month later showed the track twist above the embankment had increased to 8 mm by this time (figure 15). Although this indicates that the embankment's stability was starting to reduce, it is unlikely that this small amount of movement in the embankment would have caused any signs of a problem that would have been visible to the examiner. It was reasonable that the examiner did not find the problem at this time.

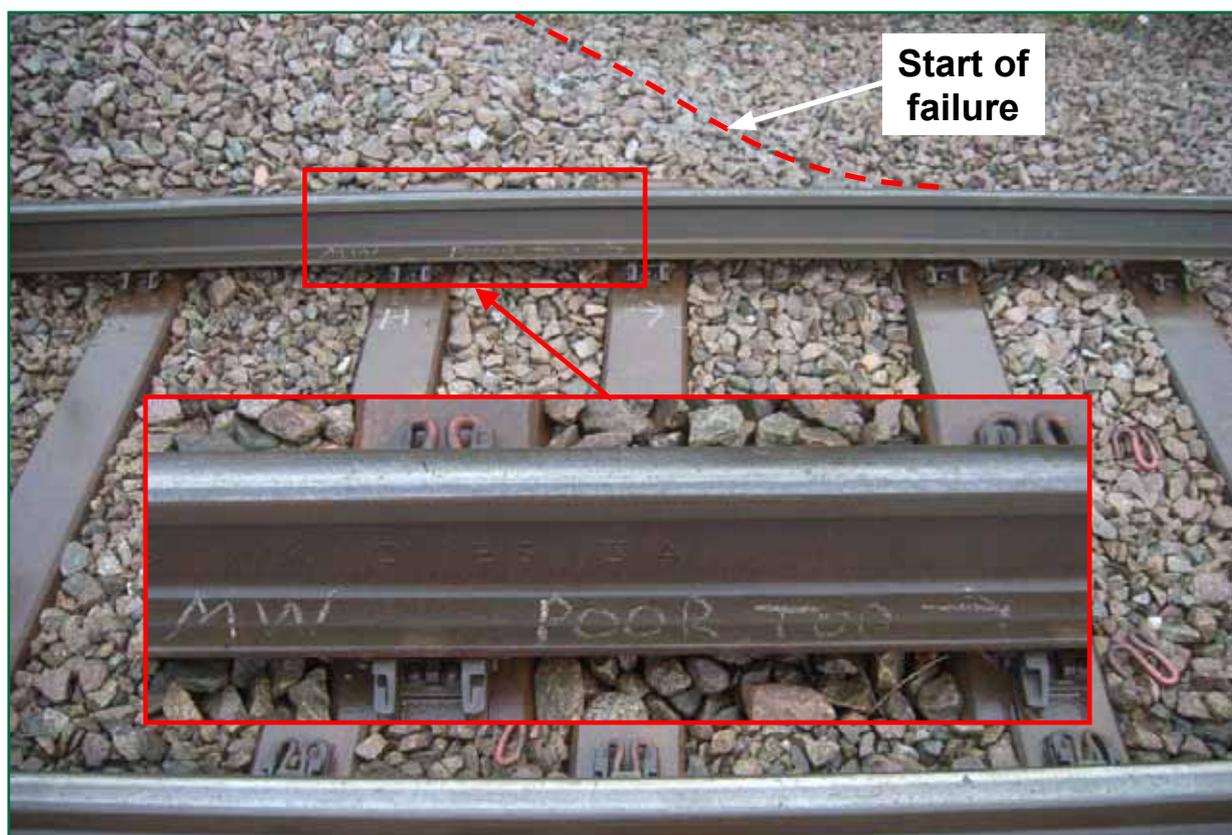
- 59 On 2 October, during a basic visual track inspection, a *patroller* found a dip in the cess rail. The patroller marked the location of the dip by writing on the foot of the cess rail (figure 16). The dip was not large enough to warrant any immediate action, but the patroller made a note of it and reported it to his supervisor after completing the inspection. The supervisor arranged for an entry to be created on Ellipse (Network Rail's system for managing the maintenance of its infrastructure) and gave it a priority of M4, meaning the dip needed to be repaired within four months.

Figure 16: Marking on rail on up slow line
