Rail Accident Investigation Branch

Rail Accident Report

Freight train derailment near Gloucester 15 October 2013

Report 20/2014
October 2014

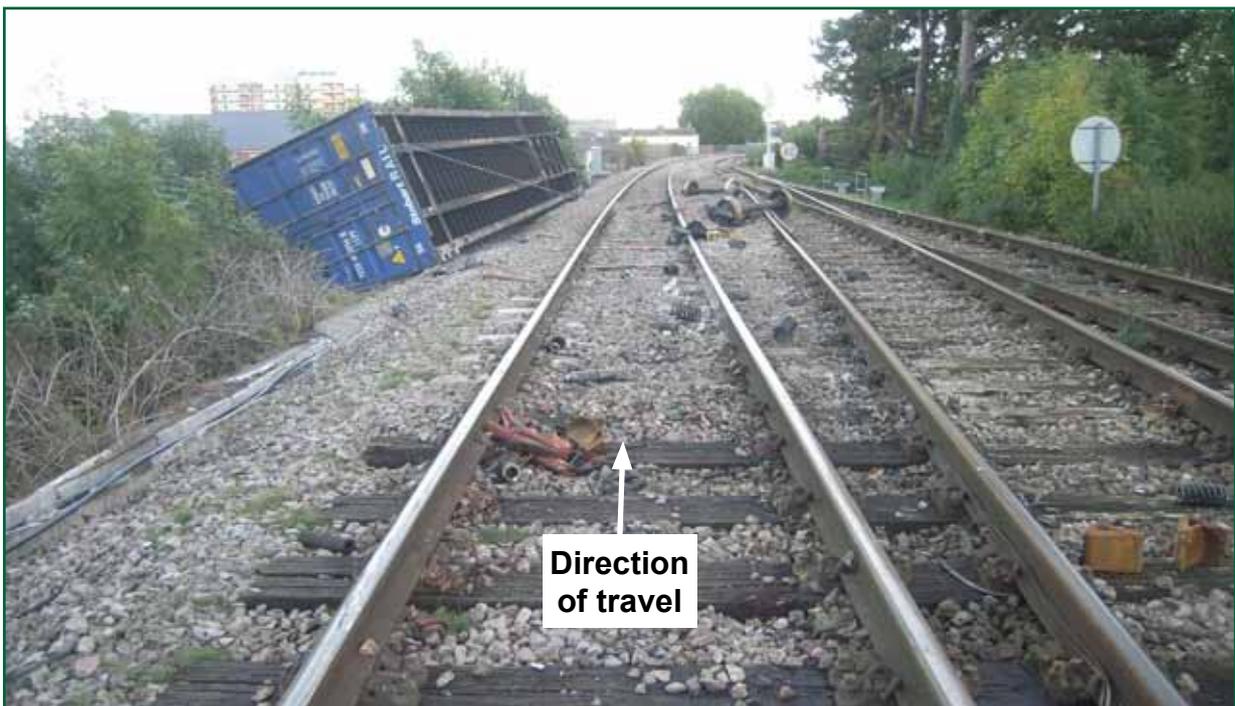
Figure 3: The debris and dislodged container at Gloucester West Junction

- 7 The train driver was unaware of the derailment and the train continued with one wheelset derailed for a distance of around 3.8 miles (6.1 km) until, at Gloucester West Junction (figure 2), the derailed wagon collided with a set of *facing points* while travelling at 22 mph (35 km/h). Here both wheelsets were torn from the rear *bogie* and the empty container on the rear of this wagon was thrown off into the *cess* (figure 3).

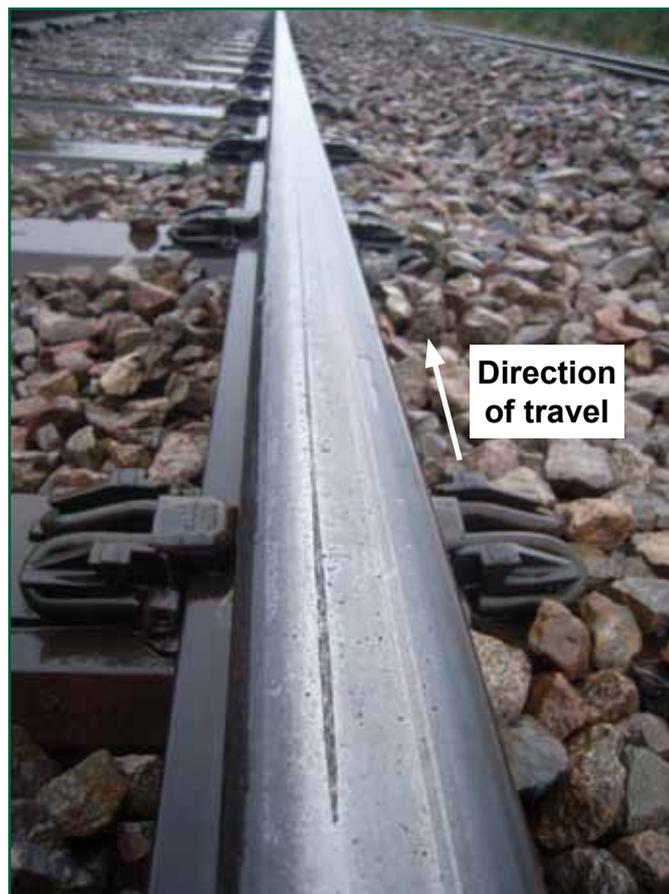
Figure 6: The flange mark on the head of the six foot rail

- 26 The train passed over the section of track containing cyclic top while travelling at 69 mph (111 km/h). The locomotive and following 27 vehicles did not derail but the rear wheelset of the 28th vehicle, at the rear of the train, lifted clear of the rail. Marks found on the head of the six foot rail show the flange of its right-hand wheel landed on top of this rail at 118 miles 46.64 chains (figure 6).

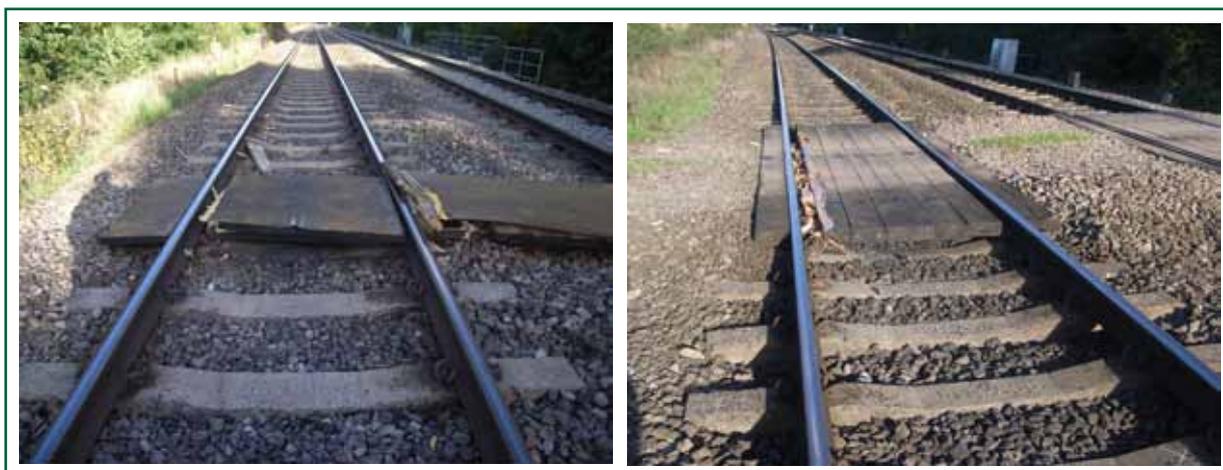
Figure 7: Examples of the damage caused by the derailed wheelset to level crossing surfaces

- 28 The train continued with the rear wheelset running derailed for the next 3 miles. There was no indication to the driver of a problem with the train as there was no damage to the train's *brake pipe* so its brakes did not unexpectedly apply (the braking system of rail vehicles is such that if the air pressure in the brake pipe reduces, the train's brakes will apply). The rear wheelset was kept roughly in line by the leading wheelset of the rear bogie and ran on top of the clips that hold the rail in place (evidenced by damage to the clips and sleepers). The derailed wheelset ran over four level crossings, damaging the wooden decking (figure 7). As the train approached Gloucester, it began to slow down as the permitted speed on the up main line reduces to 60 mph (97 km/h) at 115 miles 70 chains.

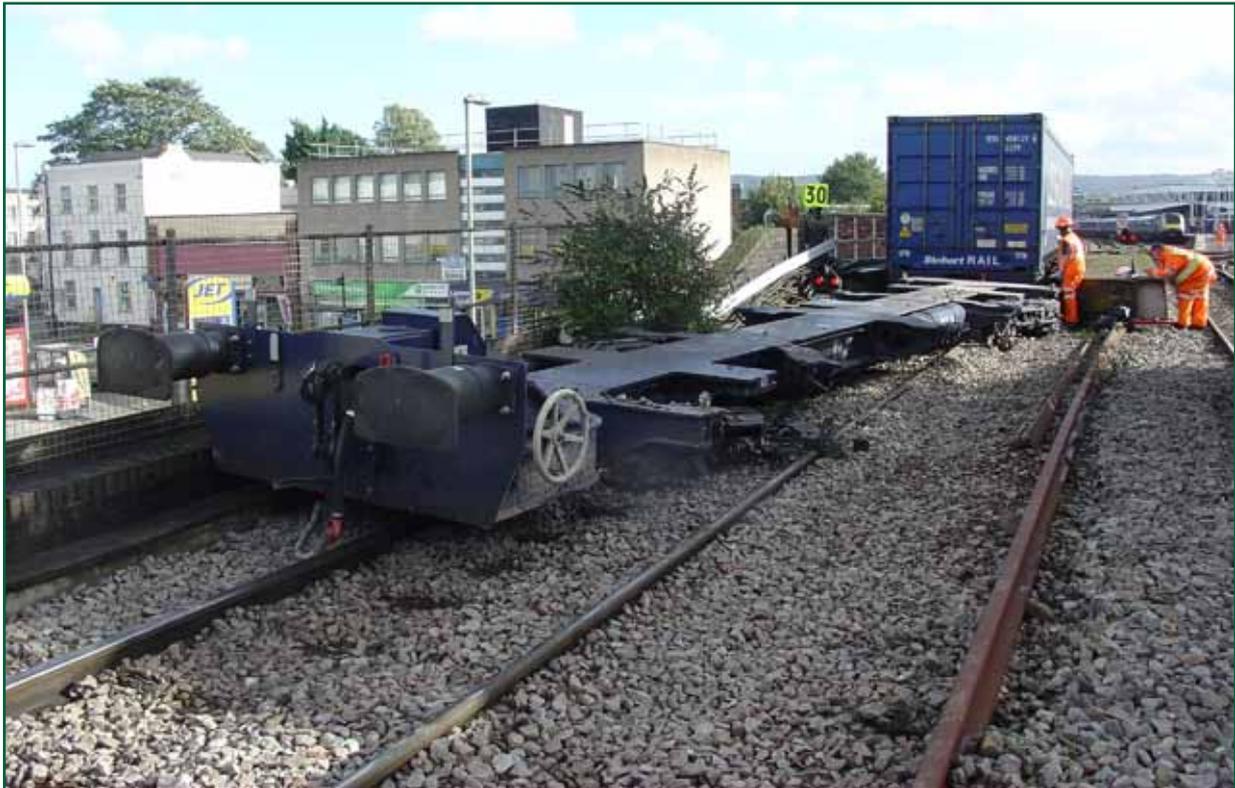
Figure 8: The severely damaged vehicle at the rear of train 4M36

- 30 The train travelled for a further 0.25 miles (0.4 km) before stopping. During this time, the derailed vehicle collided with Worcester Road bridge causing both wheelsets on its leading bogie to derail and debris to fall onto the road below. The debris included a suspension spring³ from the derailed vehicle that landed on top of an unoccupied parked car. The derailed vehicle also collided with London Road bridge just as the train stopped. By the time the train stopped, the rear vehicle was severely damaged (figure 8) although the brake pipe remained intact so there was no automatic application of the train's brakes.

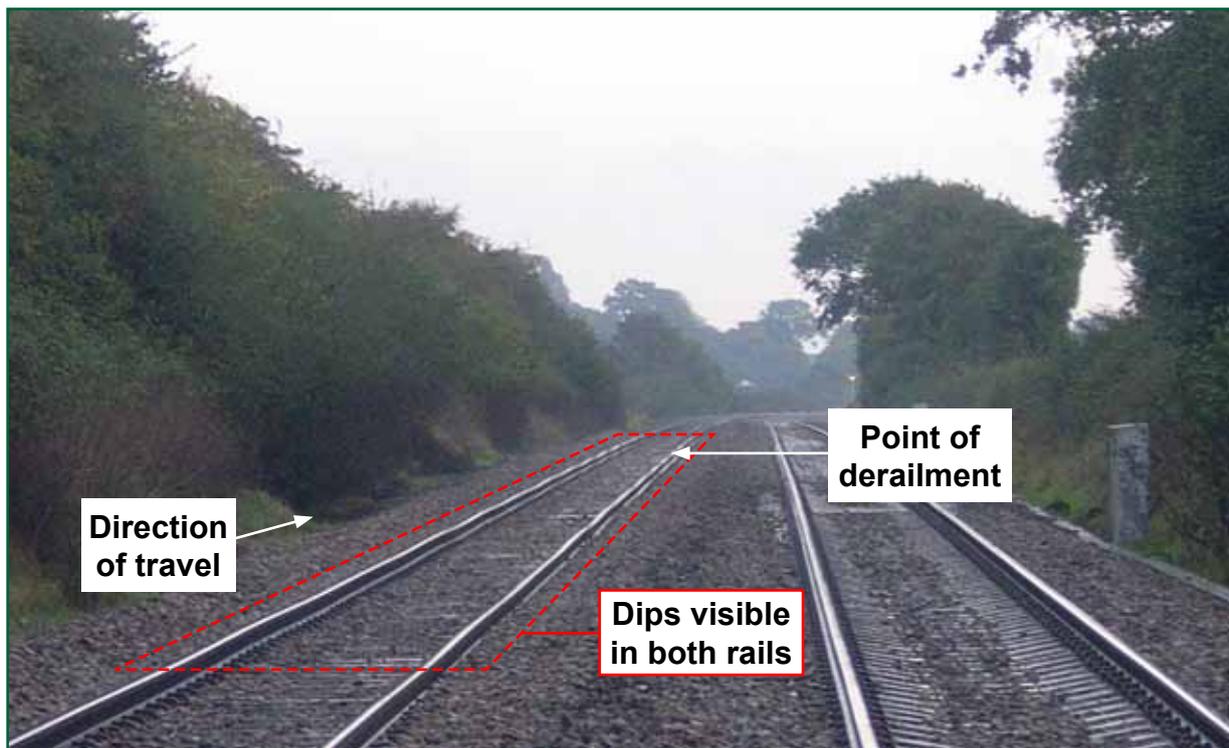
Figure 9: The cyclic top track defect on the up main line

58 The rear wheelset of the last wagon in the train derailed on plain line when it passed over a cyclic top track defect.

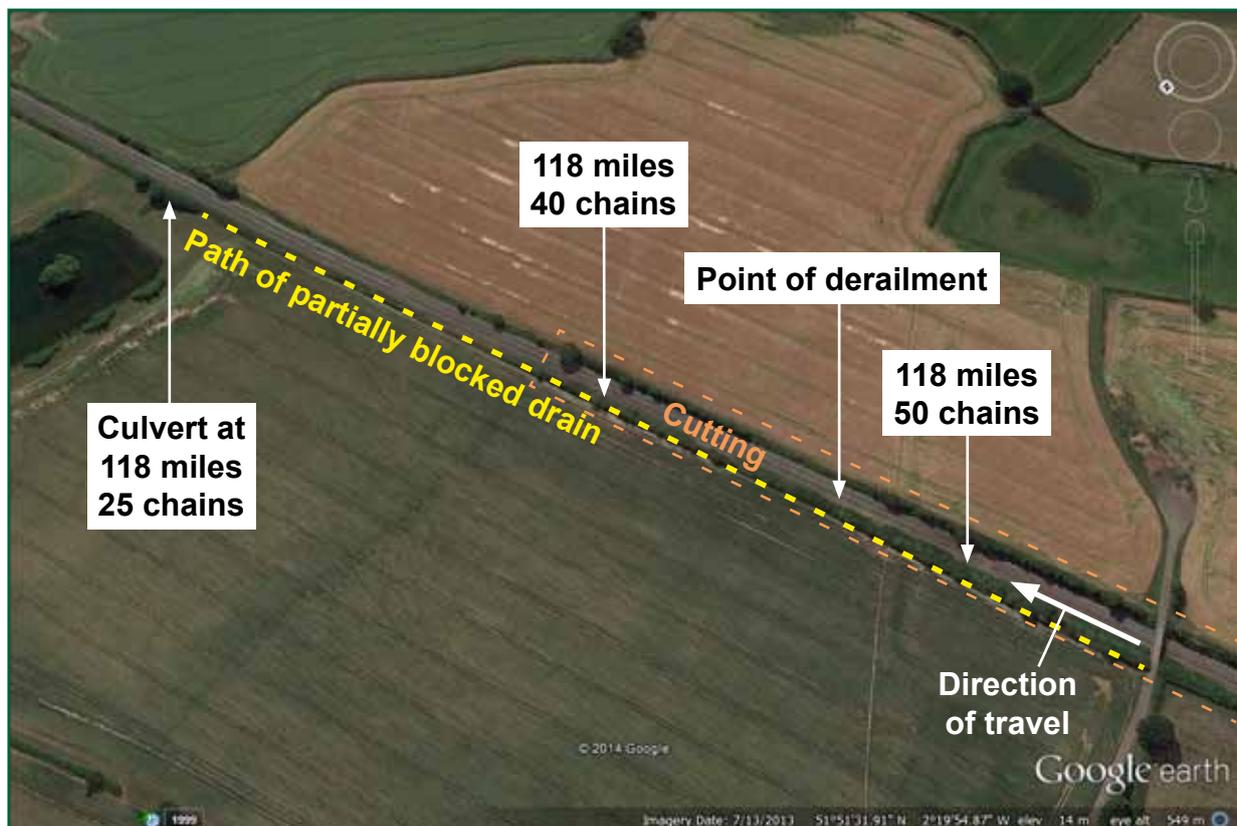
Figure 14: Location of the drain running along the top of the cutting

- 73 The only drainage present was a drain running along the top of the cutting which might have intercepted some surface water from the adjacent field (figure 14). This drain was partially blocked by vegetation (paragraph 180). However, even if it had been fully functional, due to its position at the top of the cutting, it would not have intercepted the water in the local water table that was flowing downhill under the cutting and beneath the up main line.

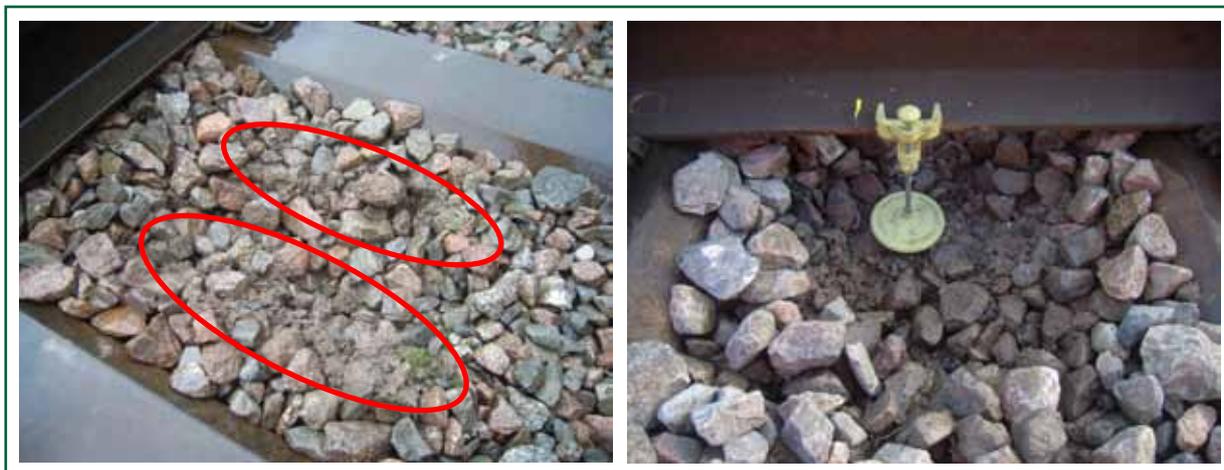
Figure 15: Mud on the surface and contaminated ballast just below the surface

- 74 The RAIB examined the track in the cutting and noted mud from the formation on the surface of the track throughout the cutting (figure 15). When the top 100 mm of ballast was removed to measure the amount of voiding (paragraph 64), contaminated ballast and mud was found just below the surface (figure 15). The places where the ballast was the most contaminated coincided with the location of the dips in the track.

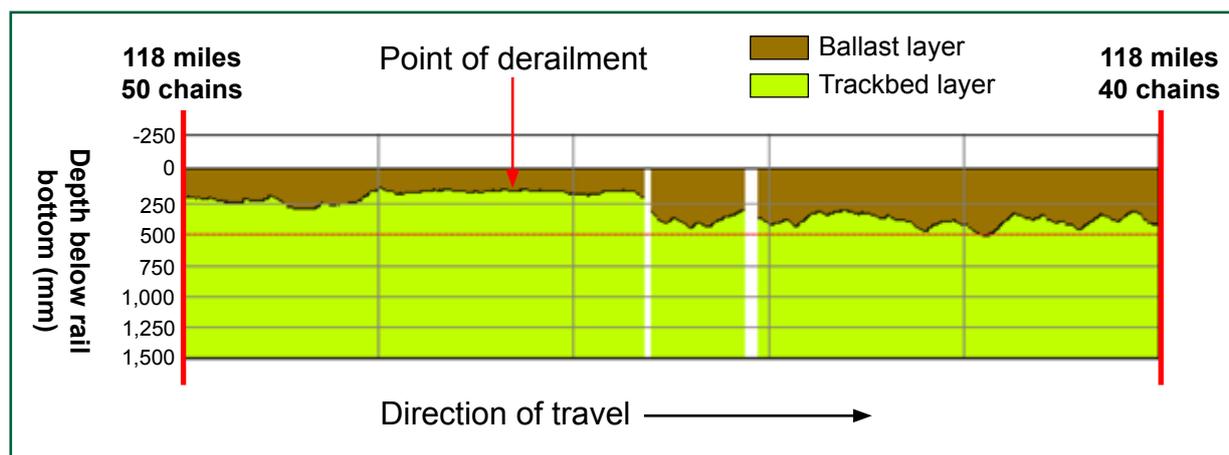
Figure 16: Ground penetrating radar data processed to show the ballast depth where the train derailed

- 75 To understand the extent of the ballast contamination, the RAIB obtained data from one of Network Rail's trains that is fitted with ground penetrating radar. The data recorded when the train last ran over the up main line on 25 July 2013 showed that the ballast was contaminated with mud in a number of places near to where the train derailed (figure 16). The depth of clean ballast is very shallow; it was as shallow as 100 mm in places, which again coincided with the location of the dips in the track.

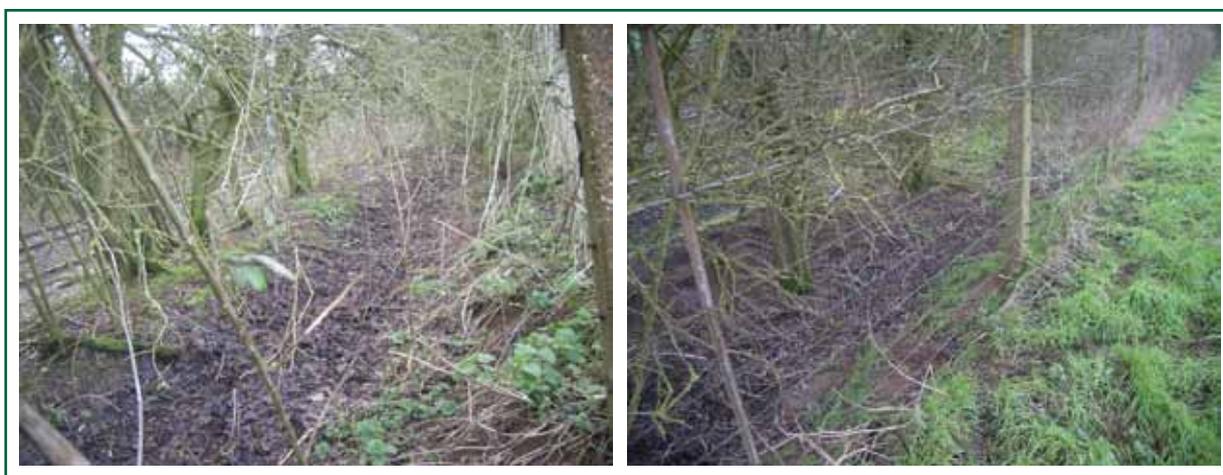
Figure 31: The drain along the top of the cutting (as recorded on 14 January 2014)

180 The only drainage near to the point of derailment was a drain running along the top of the cutting on the up main line side (paragraph 73). It was blocked by vegetation (figure 31). During an examination of the cutting in 2009, the examiner noted that this drain was partially blocked. However, the examiner did not record that the drain was affecting the stability of the cutting, so the Network Rail team responsible for managing this cutting did not initiate any maintenance action to clear the drain out. Based on the examiner's findings, the team classified the cutting's condition as marginal¹⁹. This classification meant Network Rail did not consider including the cutting in a program of works to rectify drains at the top of cuttings before they caused a problem. This work had started in 2010, after a number of cutting failures due to blocked drains, but only included cuttings which were classified as poor¹⁹.
