Rail Accident Investigation Branch

Rail Accident Report

Locomotive failure near Winchfield 23 November 2013

Report 13/2014
June 2014

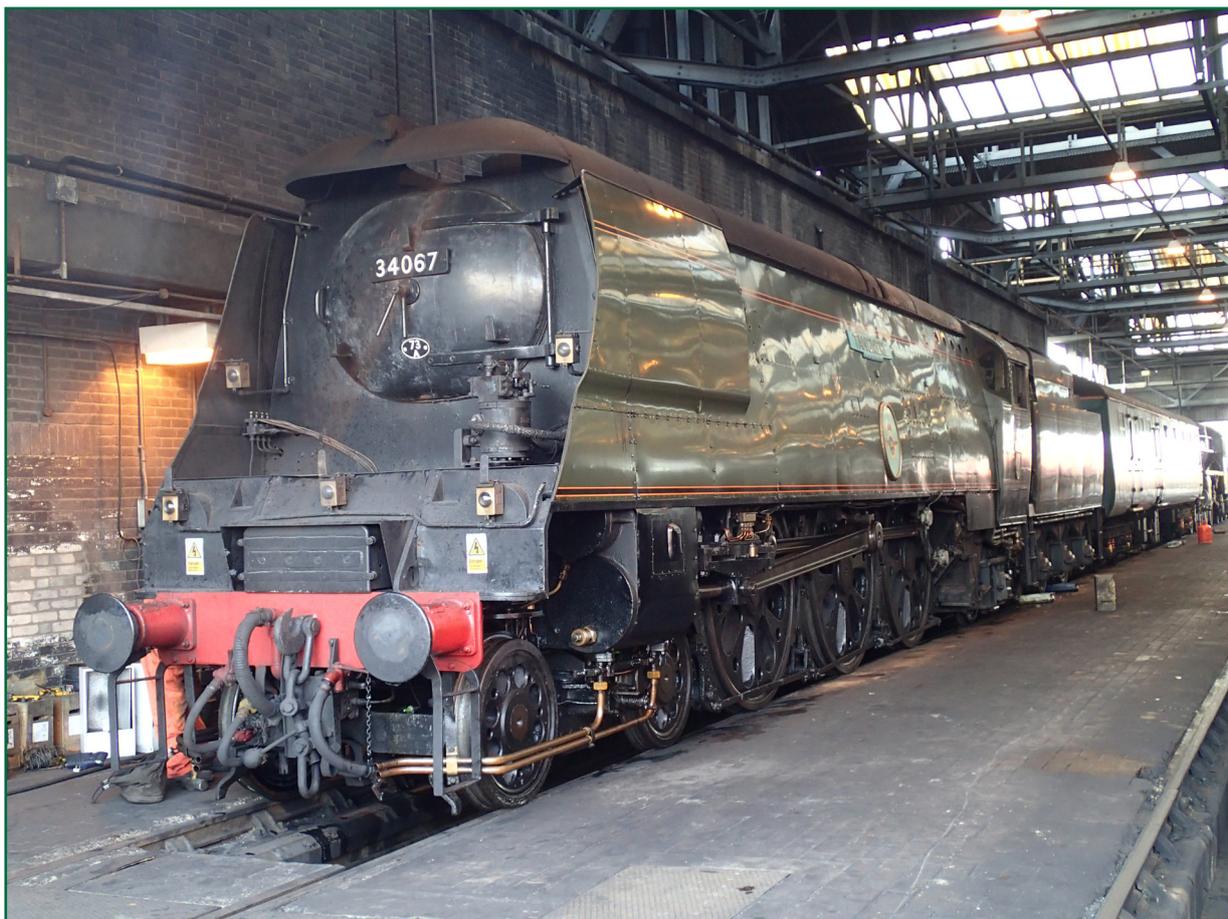
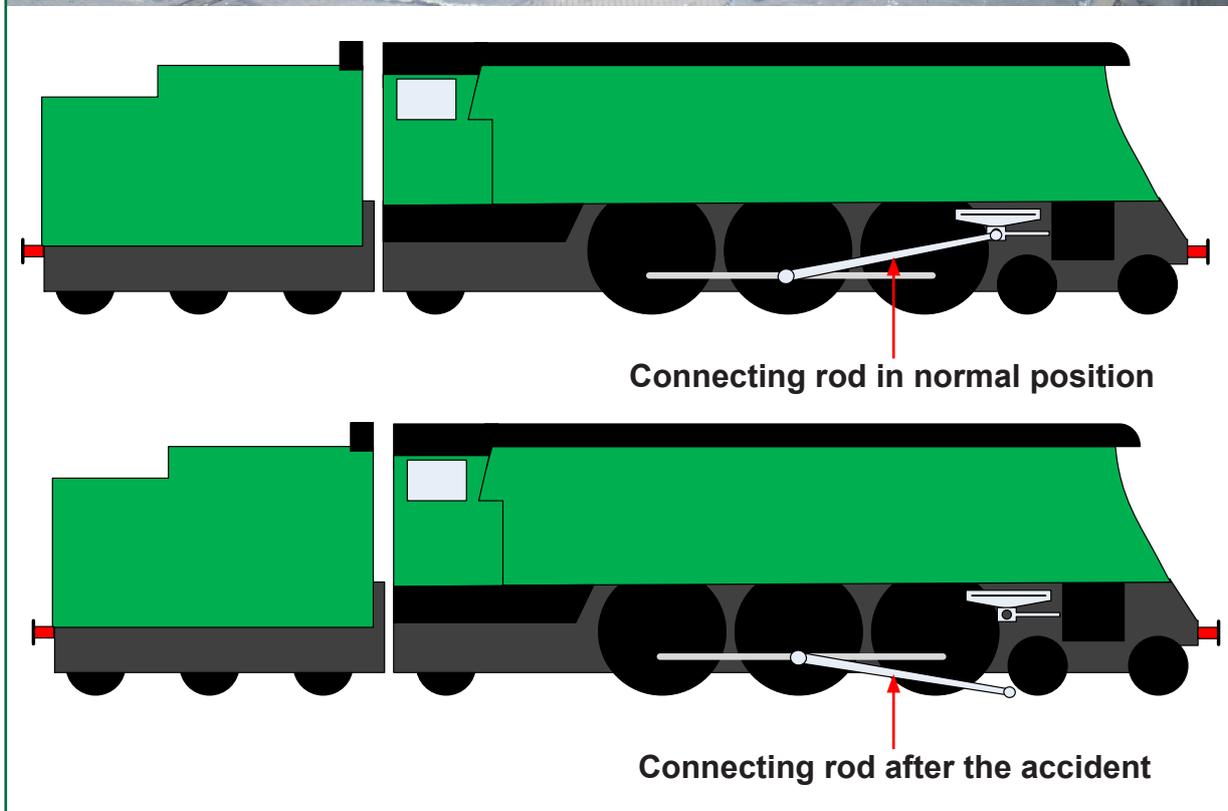
Figure 2: the locomotive 'Tangmere', showing how the connecting rod dropped

- 41 **The immediate cause of the accident was that the small end assembly came apart.**
- 42 After the accident, the connecting rod was found with its small (leading) end resting on the ground. The gudgeon pin was lodged on the bogie *splasher* of the locomotive. The nut and cotter which secured the gudgeon pin have not been found.

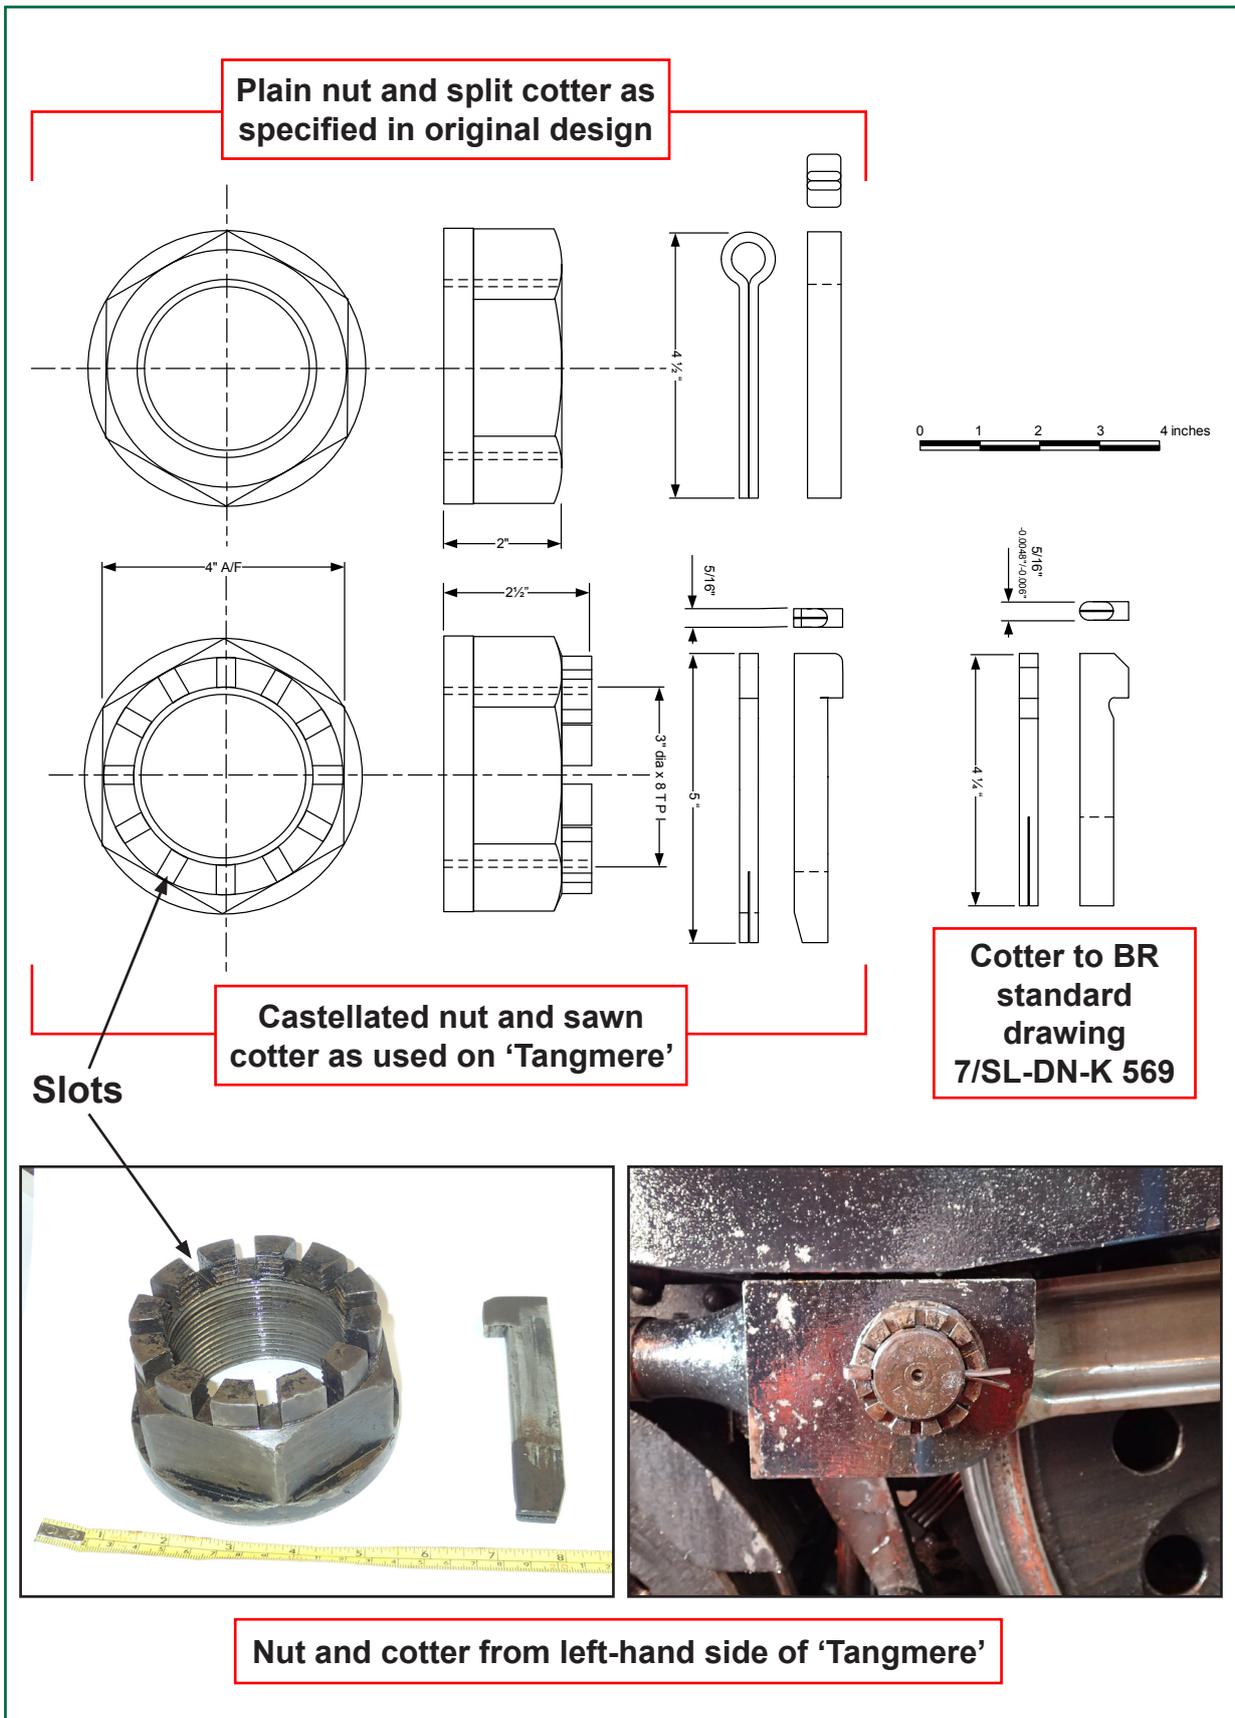
Figure 6: Nut and cotter

- 40 The original design of this assembly used a plain nut. However, when the locomotive was restored from scrapyard condition between 1981 and 2004, new gudgeon pins and nuts were manufactured. The nuts, which in the original design were 2" (51 mm) thick, were given an extra thickness of ½" (13 mm), and twelve slots 5/16" (8 mm) wide were machined in this ring to make a *castellated nut*. These slots have no radius at the base (a drawing and photograph of the modified designs of nut and cotter are in figure 6). The original design used a split cotter, but for the restoration a cotter was made from 5/16" (8 mm) thick plate with a saw cut to form the 'legs' (paragraph 62 and figure 6).

- 65 Making the slot in the cotter of this length is undesirable, firstly because having the base of the legs beyond the outer diameter of the gudgeon pin will permit the cotter to move in the slot if it becomes loose for any reason (paragraph 49), and secondly (in this application with a castellated nut) because the castellations of the nut can bear on the hinge point, where the stress concentration is greatest and the material has been weakened by the bend, and act as an initiating point for a fatigue crack as described in paragraph 49.

- 66 The sharp corner under the head of the cotter will also create a stress concentration, and may initiate development of a crack which could eventually lead to detachment of the head.

- 76 The gudgeon pin nut used on 'Tangmere' had twelve slots, in which the cotter could be located (figure 6). Each of these slots had sharp corners at the base. If the nut experienced high levels of stress and/or vibration, it is possible that fatigue cracks could be initiated at these corners: these might over time develop to the point where the nut fractured.

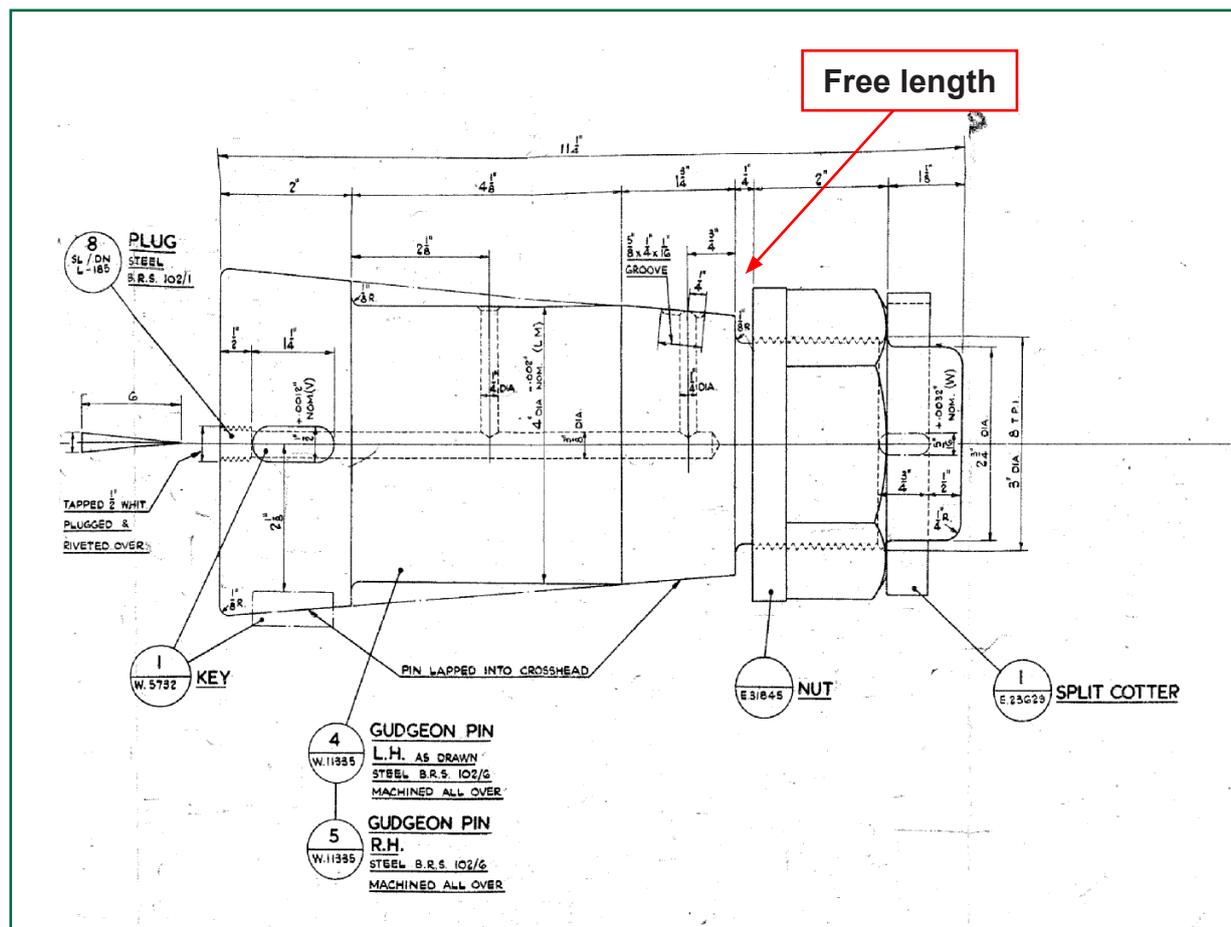
Figure 7: Detail drawing of gudgeon pin (extract from British Railways (Eastleigh) drawing W11335). Drawing reproduced by courtesy of the National Railway Museum/Science & Society Picture Library

- 50 The original design of the Bulleid pacific small end had the cotter in a vertical plane, ensured by the keyway slot and cotter slot in the gudgeon pin being at right angles to each other (figure 4). When 'Tangmere' was restored from scrapyard condition, new gudgeon pins were manufactured which had the two slots in line. RAIB has not been able to establish whether the restorer intended to make this modification to the design, or if it arose from a misreading of the only available detail drawing (figure 7). The effect of this was that when the components were assembled on the locomotive, the cotters lay horizontally. RAIB's examination of other steam locomotives now used on the main line and on heritage railways shows that vertical cotters predominate, but there are many examples of horizontal ones, and some locomotives have a vertical cotter on one side and a horizontal one on the other. At least one other Bulleid pacific has had new gudgeon pins made with the same modification to the design, during restoration from scrapyard condition.

- 57 The original design of this assembly used a plain, rather than a castellated nut (figure 7). There is no evidence that this design caused any problems when the locomotives were in service with British Railways (BR), and many of the locomotives that have been preserved, either directly after leaving BR service or via the Barry scrapyard, have plain nuts on the small end assembly.

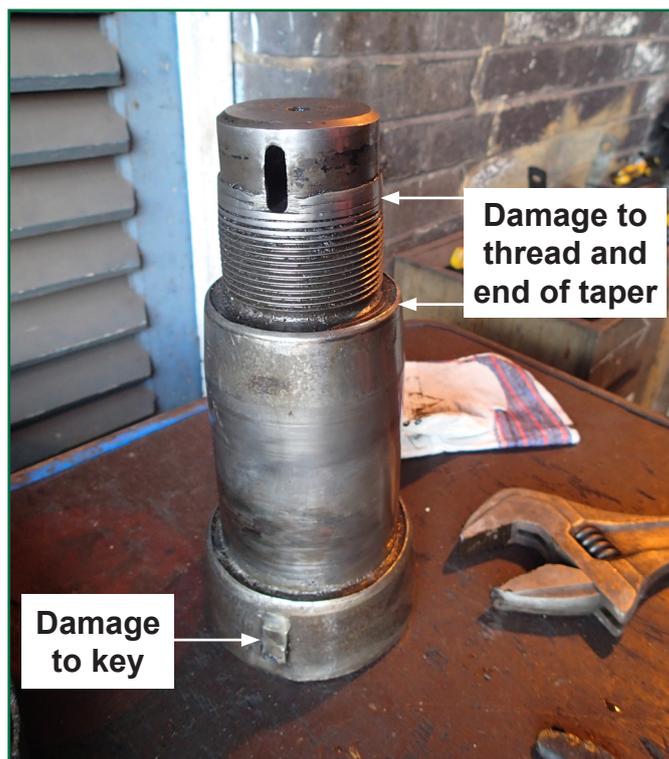
Figure 8: Gudgeon pin of 'Tangmere' after the accident

- 56 The final loss of the gudgeon pin nut was probably accompanied by the violent movement of the pin in the crosshead. The energy imparted to the nut was evidently sufficient to fracture the studs which secure the oil cup which is fitted to the upper part of the crosshead, directly above the gudgeon pin. The oil cup has not been found, but RAIB believes that its loss was a consequence of the small end failure, and was not among the causes of the event. There was no evidence of any heating of the gudgeon pin surface, as would have been the case if it had been starved of oil for any length of time. Following the detachment of the nut, the gudgeon pin was free to move in the taper bore of the crosshead. This movement damaged the end of the thread and the small end of the taper on the pin (figure 8). The gudgeon pin finally came out of the back of the crosshead, catching on the brake rigging and breaking the hanger of the brake block of the right-hand leading coupled wheel. It then lodged on the top of the bogie wheel splasher¹⁶ of 'Tangmere', where it was found after the accident.

- 122 WCRC reports that it has repaired 'Tangmere' and returned it to service. On the locomotive itself, the right-hand side gudgeon pin, nut and cotter have been renewed in accordance with the original BR (Southern) drawing number W11335. This means that the castellated nut previously fitted has been replaced with a plain nut and a Southern Region style split cotter which is now aligned vertically. The left-hand side and middle cotters have been renewed and the nuts have been examined and subjected to non-destructive testing. All motion cotter pins have been renewed. The piston rod/crosshead, connecting rod and brake hanger have all been stress relieved by a specialist contractor and checked for straightness and alignment. The right-hand connecting rod has been through a thorough non-destructive testing process using an Eddy Current system.

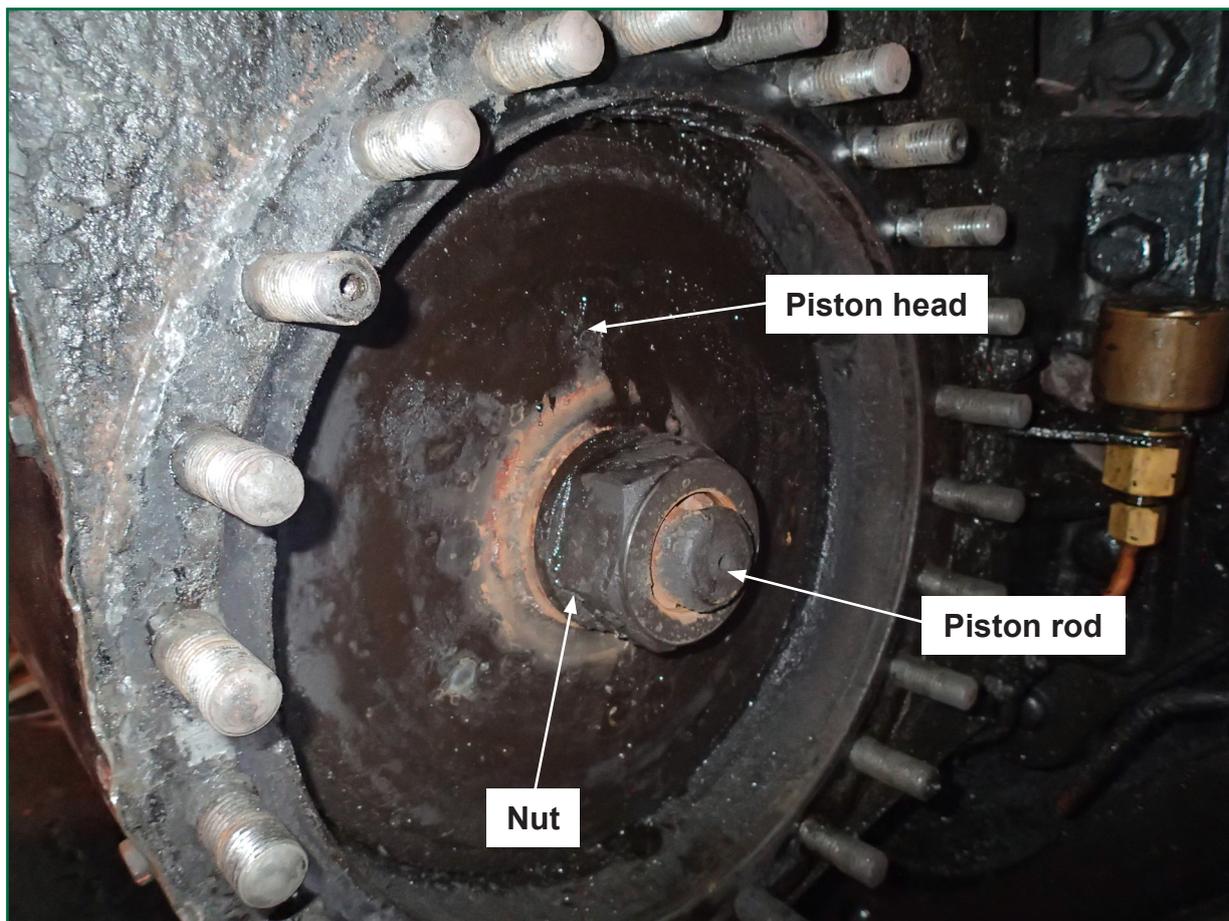
Figure 9: Loose piston head

- 92 When the front cover of the right-hand cylinder of 'Tangmere' was removed at Southall depot after the accident, under the supervision of RAIB, the piston head was found to be loose on the piston rod. The piston head is held on a steep cone (tapered 1 in 2 on diameter) by a nut with a 2³/₄" (70 mm) diameter thread, which is secured by a split cotter in a 1/4" (6 mm) slot in the end of the rod.
- 93 The remains of part of the cotter were found in the cylinder (figures 9 and 10). The body of the cotter and one of the legs were present, though detached, and the other leg could not be found.

- 94 The nut had unwound by about one turn when found, so that the piston head had about 1/8" (3 mm) free movement on the rod. There was evidence that the piston head had contacted the cylinder cover. The method of securing the piston on the rod had not been modified from the original design.

- 97 If the piston head had come loose before the small end failure, the slack between the piston head and piston rod would have created some additional shock loading on the small end joint, which would have been transmitted through the gudgeon pin. However, the small amount of movement that was present after the accident is unlikely to have had a significant effect on the loading of the joint. More importantly, the piston head nut, once loose and without its cotter, would have unwound quite quickly, because of the vibrational and inertial forces on it, leading to complete failure of the right-hand cylinder in a short time. RAIB therefore discounts this as a cause of the small end failure, and concludes that the looseness of the piston head was a consequence of the failure of the small end assembly.

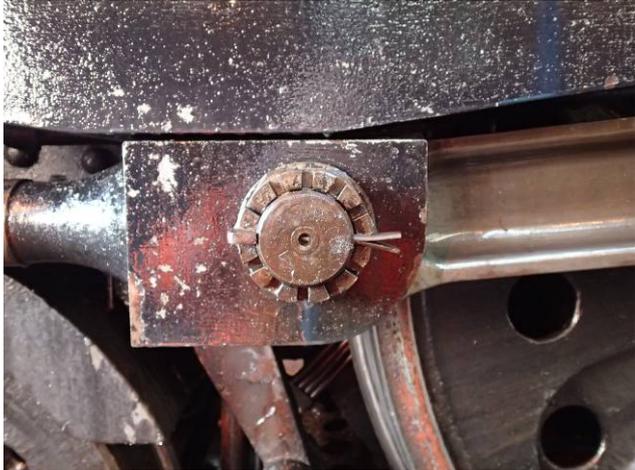
<p>As installed, this meant that the legs of the cotter were bent outwards at the root of the saw cut (see photo), potentially giving rise to stress concentration in that area. It is not possible to be certain that this contributed to any failure of the cotter, but it represents poor practice in the design and manufacture of the component.</p>
