Rail Accident Investigation Branch

Rail Accident Report

Class investigation into landslips affecting Network Rail infrastructure between June 2012 and February 2013

Report 08/2014
April 2014

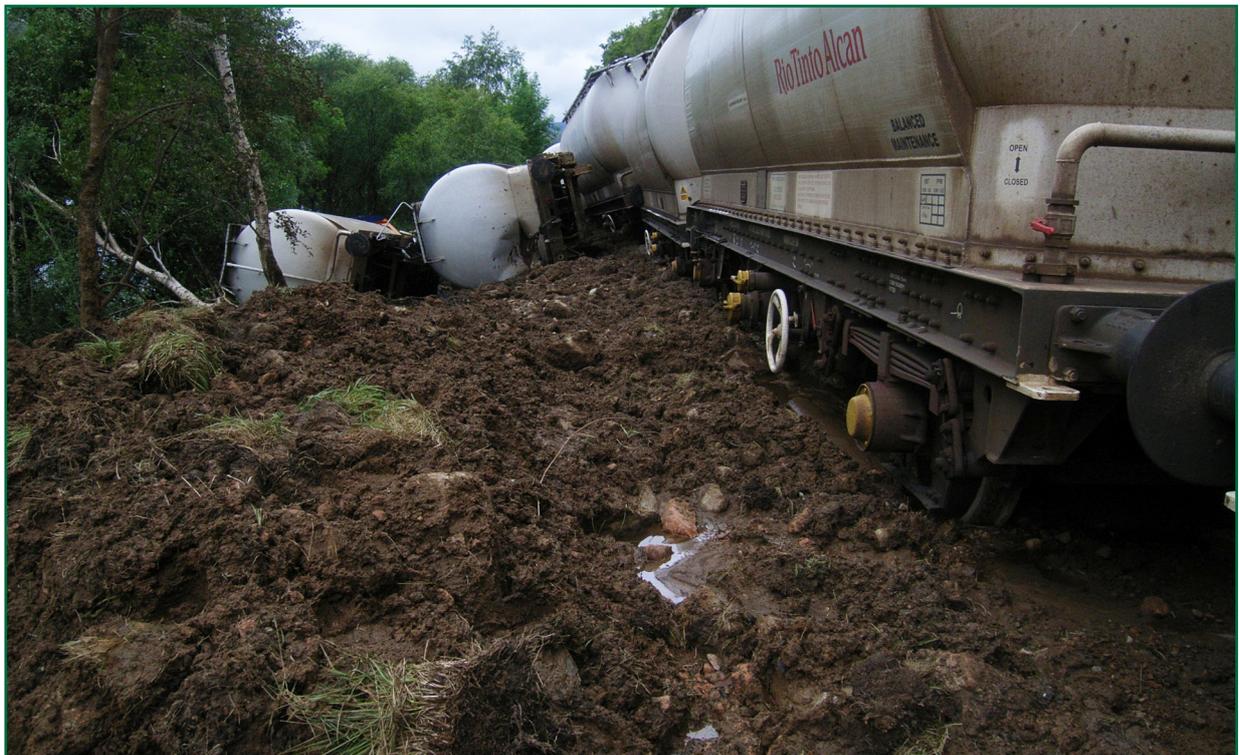
Figure 3: Loch Treig: derailed wagons

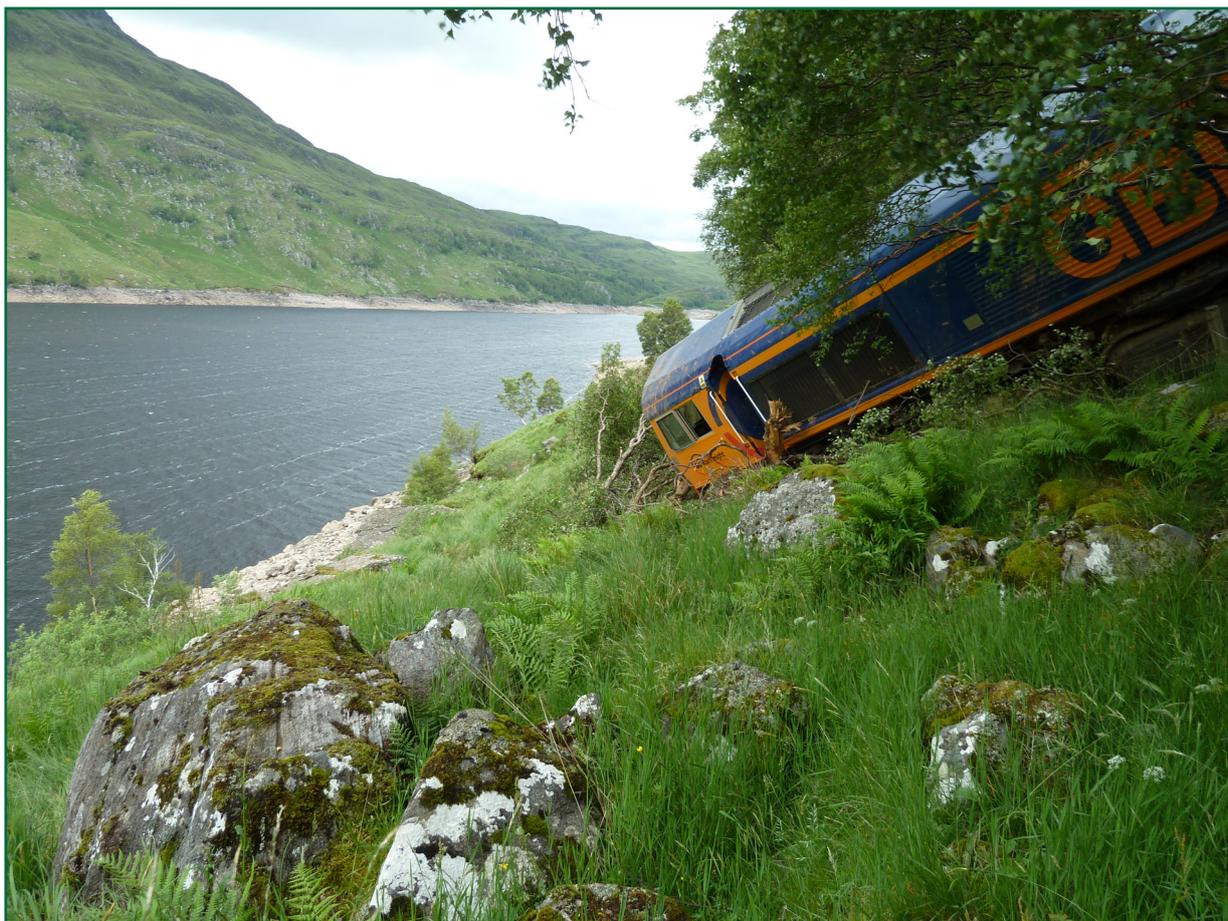
Figure 4: Loch Treig: derailed locomotive (image courtesy of Network Rail)

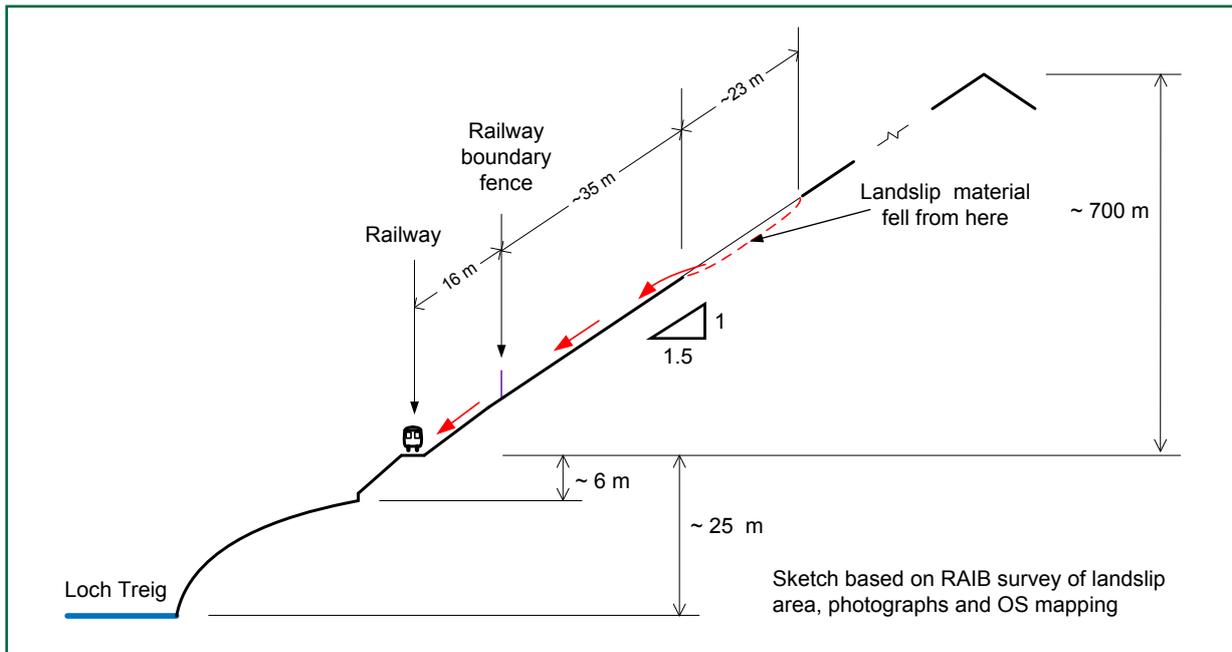
Figure 5: Loch Treig: slope geometry (cross-section)

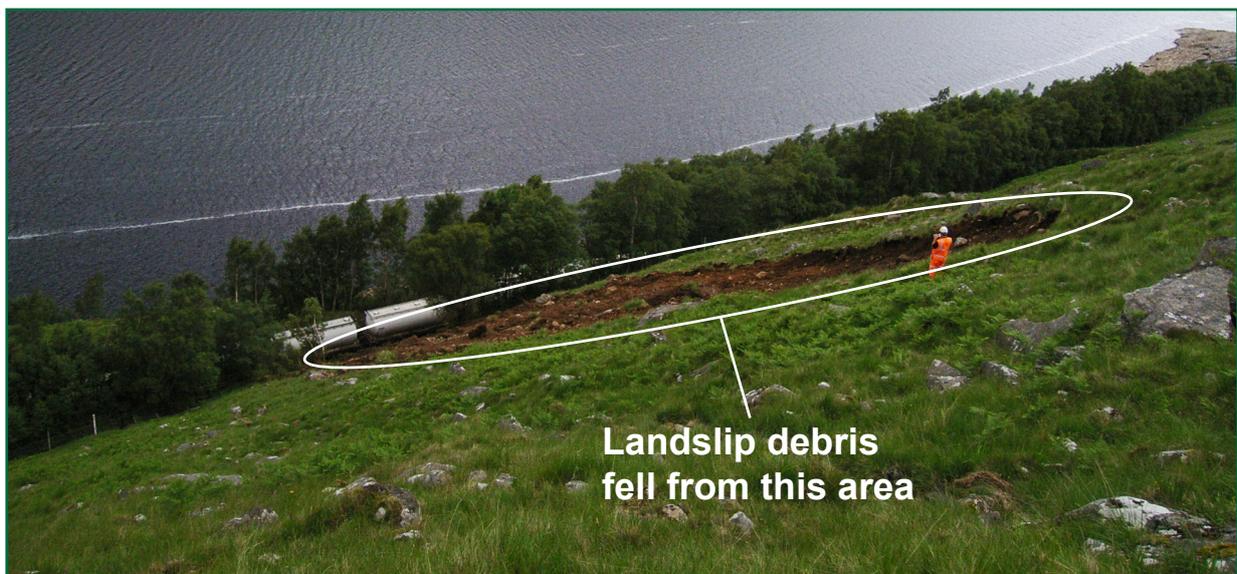
- 12 The debris had come from a landslip which had occurred in the natural slope about 35 metres upslope of the railway boundary (figure 6). RAIB noted that the slip had developed in a shallow valley area which was waterlogged. RAIB (and Network Rail) consider that the slip was triggered by water accumulating in this valley and destabilising the soil.

Figure 6: Loch Treig: landslip

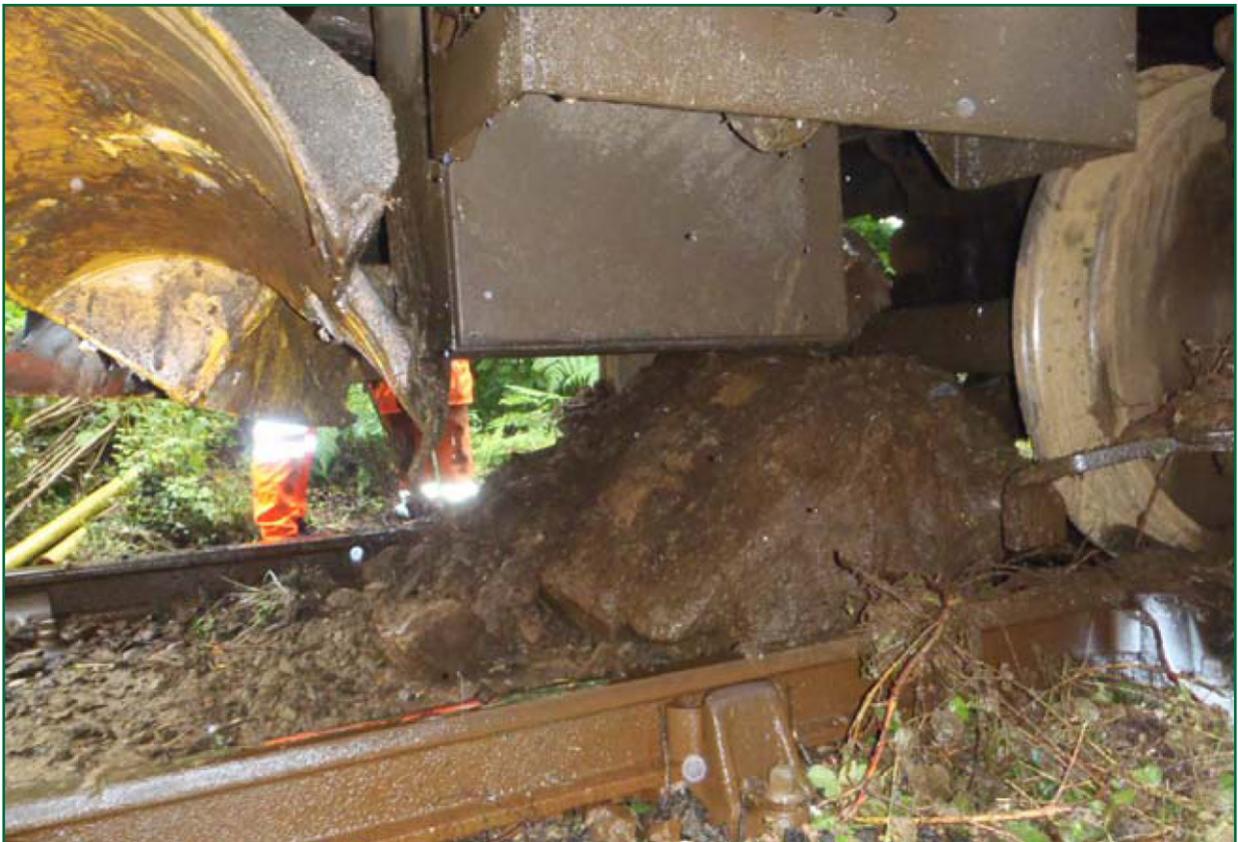
Figure 8: Falls of Cruachan: debris preventing train movement (image courtesy of Network Rail)

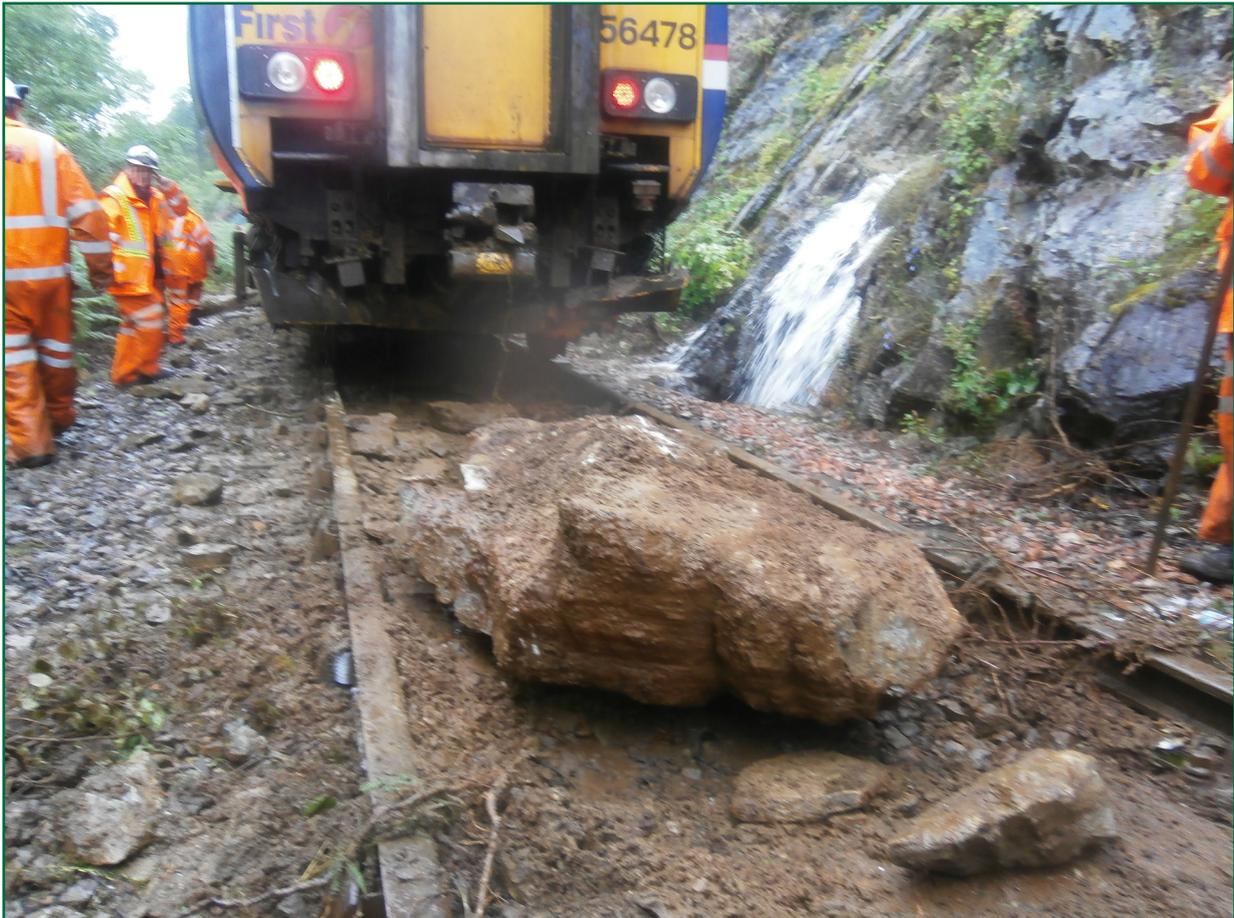
Figure 9: Falls of Cruachan: view after train moved clear of boulder shown on figure 8

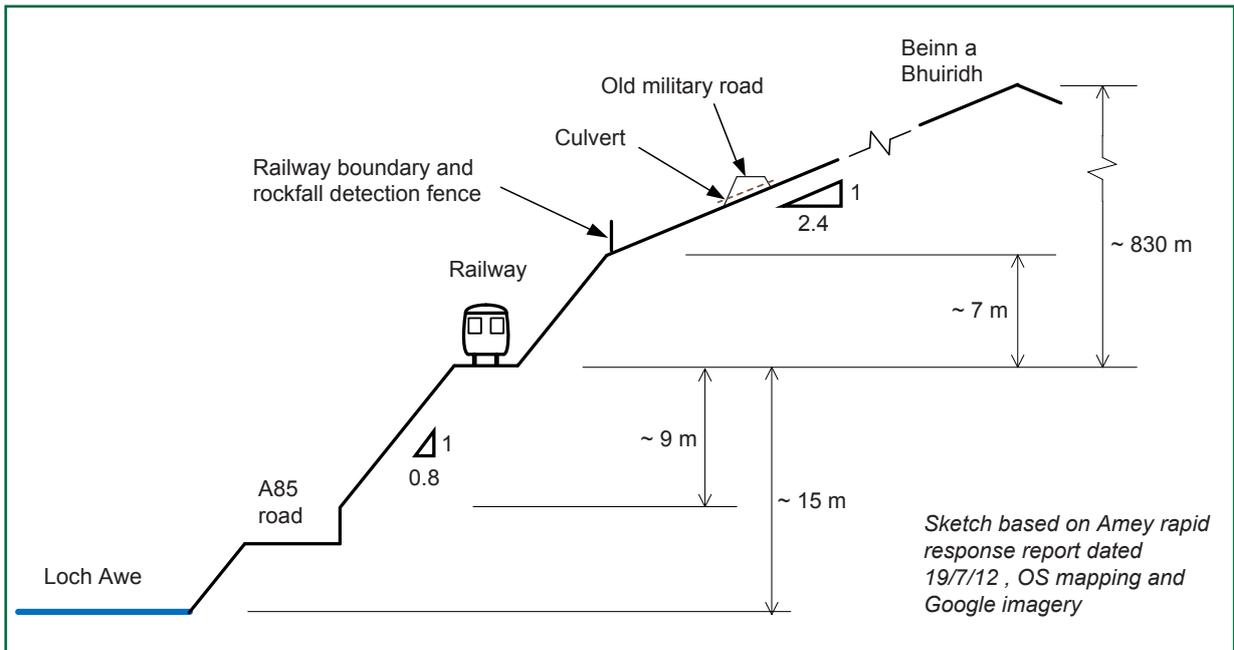
- 26 At this location, the railway comprises a single line running through the Pass of Brander on a ledge some 15 to 20 metres above Loch Awe. The north side of the railway comprises a rock *cutting* about seven metres high with a slope of about 1 in 0.8 with a fence at the top of the cutting marking the railway boundary. Beyond the fence, a natural hill slope rises at a slope of about 1 in 2.4 towards the summit of Beinn a Bhuiridh about 830 metres above the railway. On the south side of the railway, the ground slopes downwards at about 1 in 0.8 for a vertical height of about nine metres to the top of a retaining wall which runs alongside the A85 trunk road (figure 10).

Figure 10: Falls of Cruachan: slope geometry (cross-section)

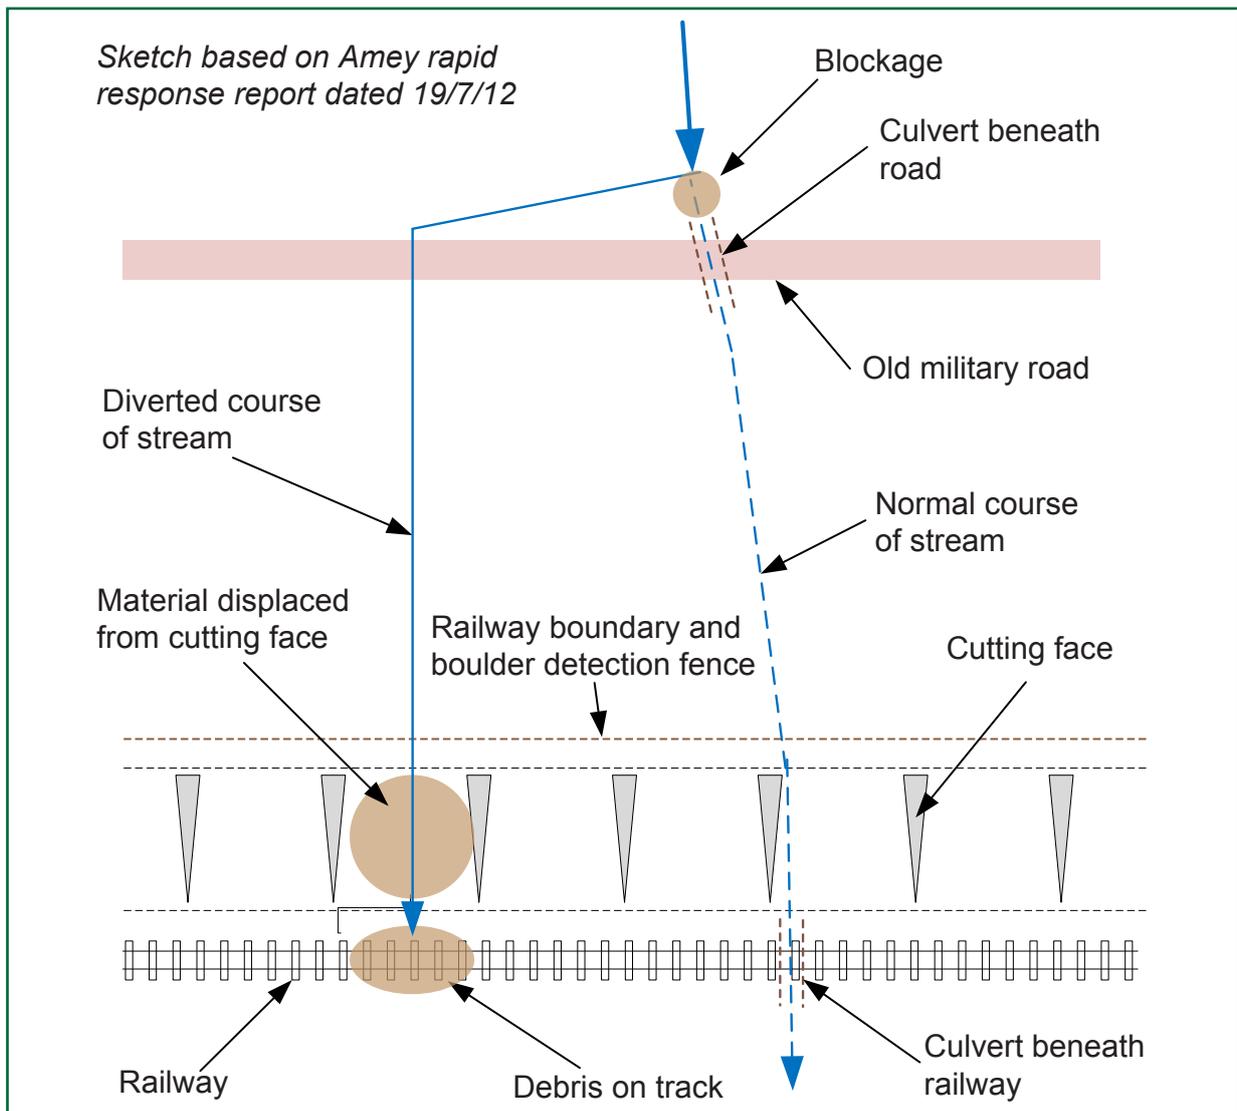
Figure 11: Falls of Cruachan: sketch plan

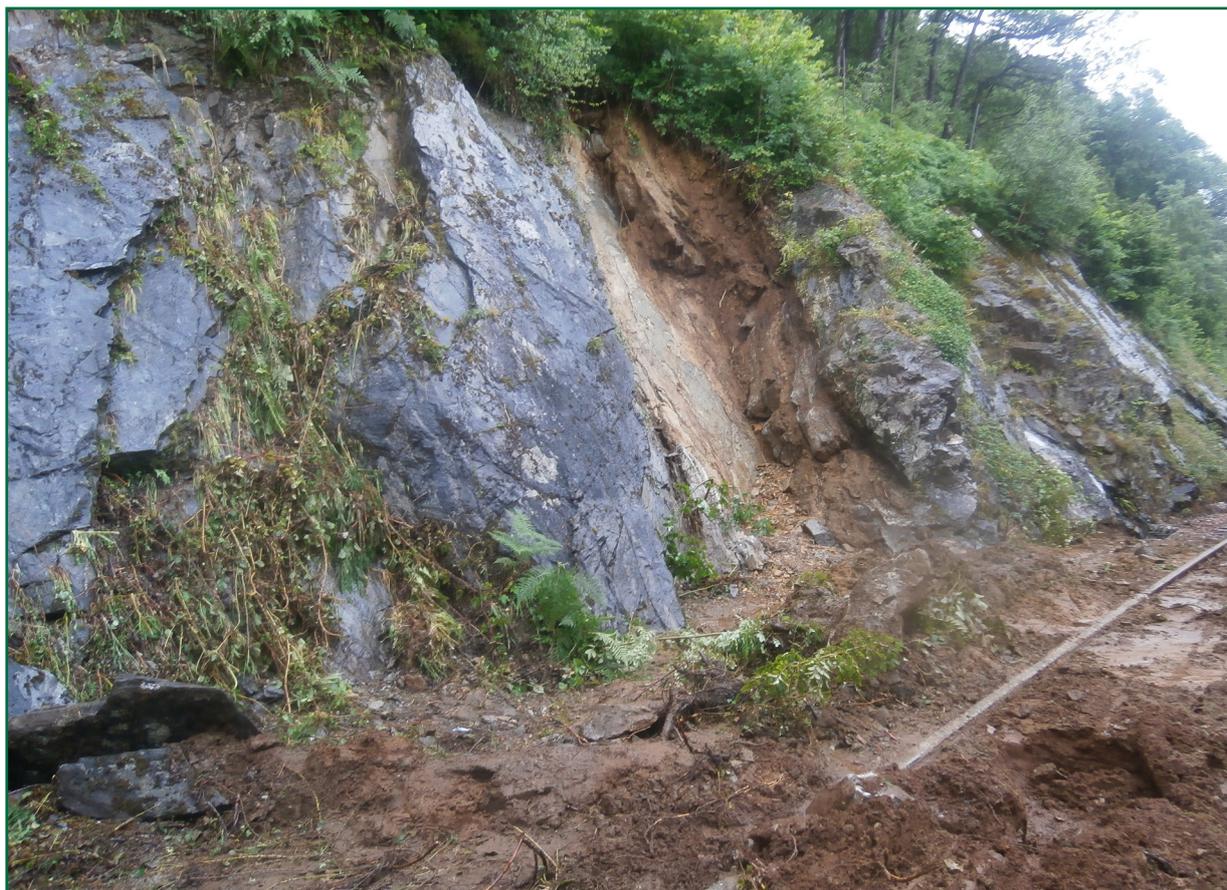
- 27 A post-incident inspection of the site undertaken by Amey staff on behalf of Network Rail⁸ showed that the landslip had been triggered by a flow of water which had been diverted from its normal course by a blocked culvert about 60 metres upslope of the north side of railway (figure 11). The flow had therefore entered the cutting at a location where there was no channel to control the flow of water and the uncontrolled flow was sufficient to dislodge soil and boulders from the cutting face (figure 12).

Figure 12: Falls of Cruachan: material washed from cutting face

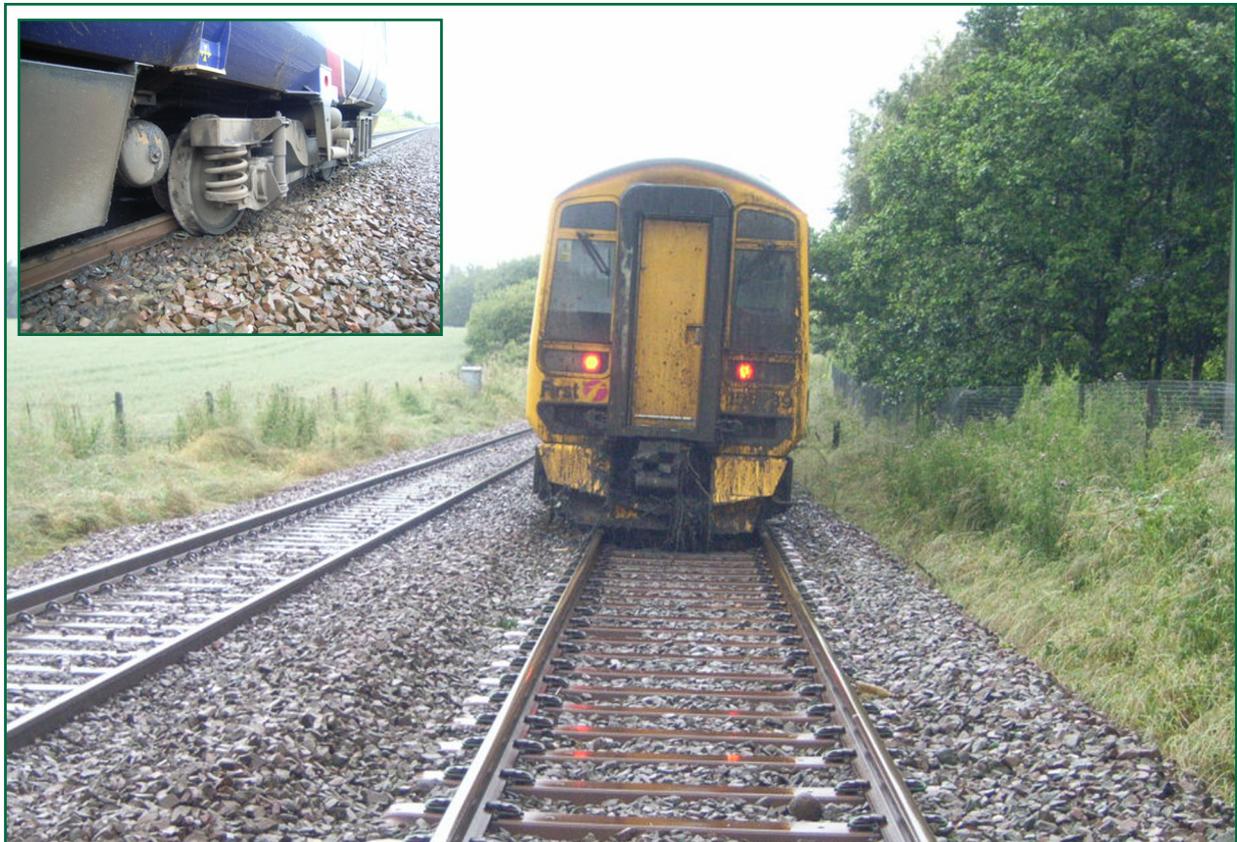
Figure 14: Rosyth: derailed train

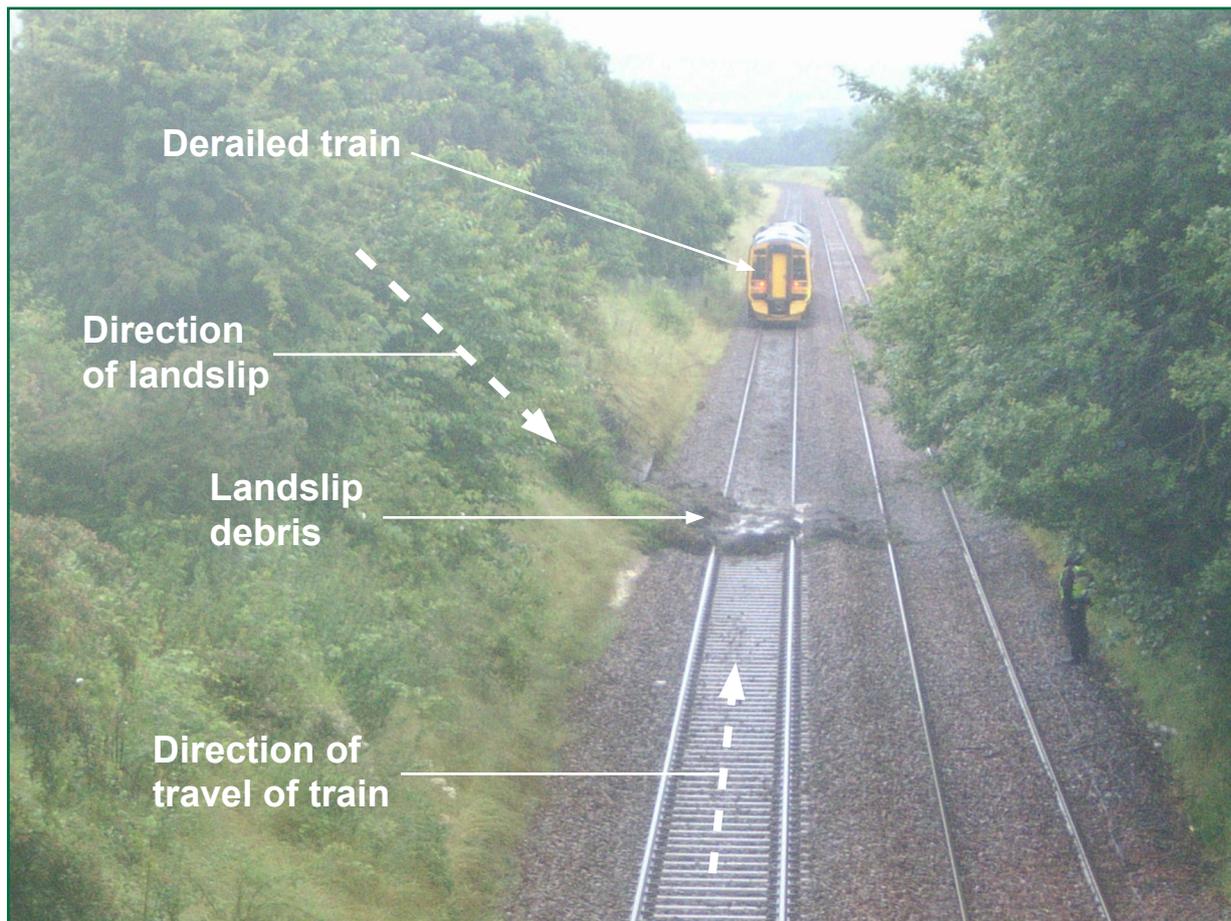
Figure 15: Rosyth: landslip

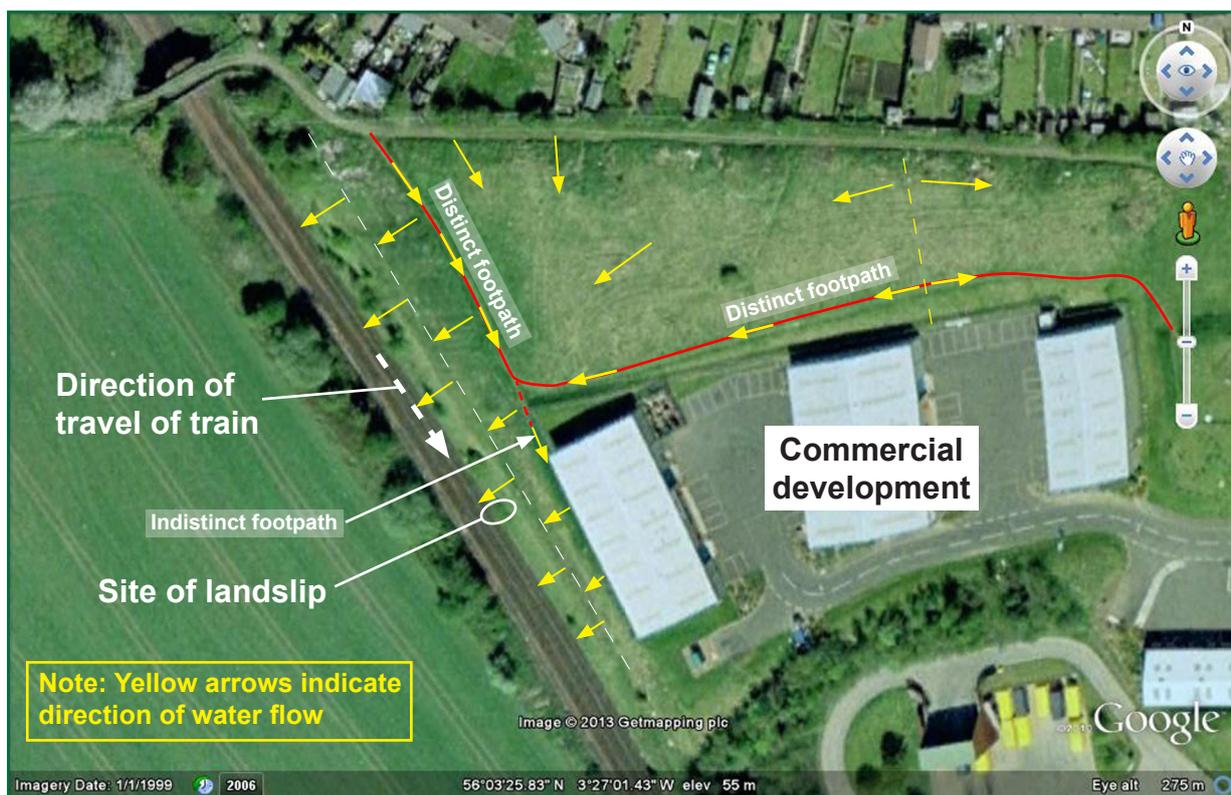
Figure 16: Rosyth: landslip and surrounding land features (pre-incident photograph)

- 40 The waste ground is roughly grassed and slopes at typically 1 in 50 in a direction which encourages surface water to flow almost, but not directly, towards the railway. No distinct drainage system serves the waste ground but informal footpaths provide preferential drainage routes which encourage surface water flows towards the top of the railway cutting close to the location of the landslip (figure 16).

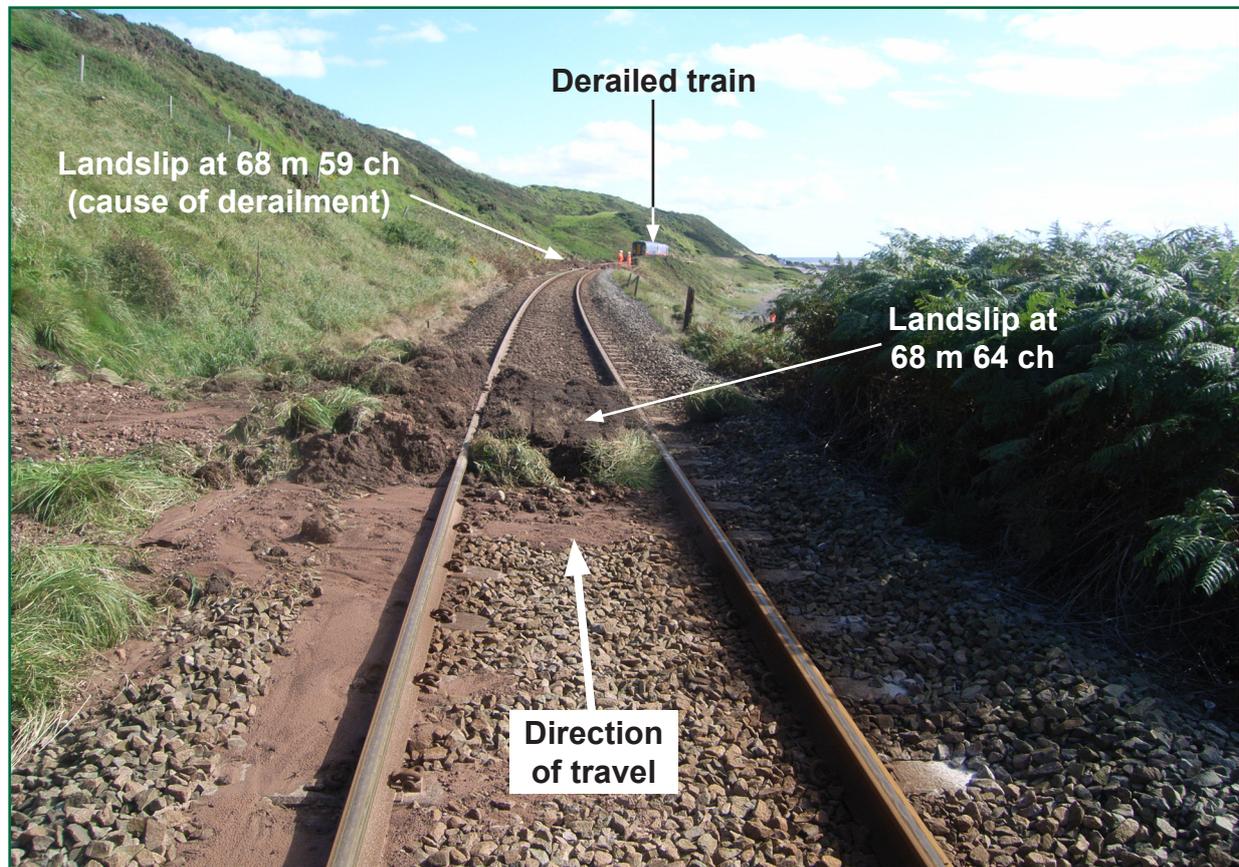
Figure 18: St Bees: landslip at 68 miles 64 chains

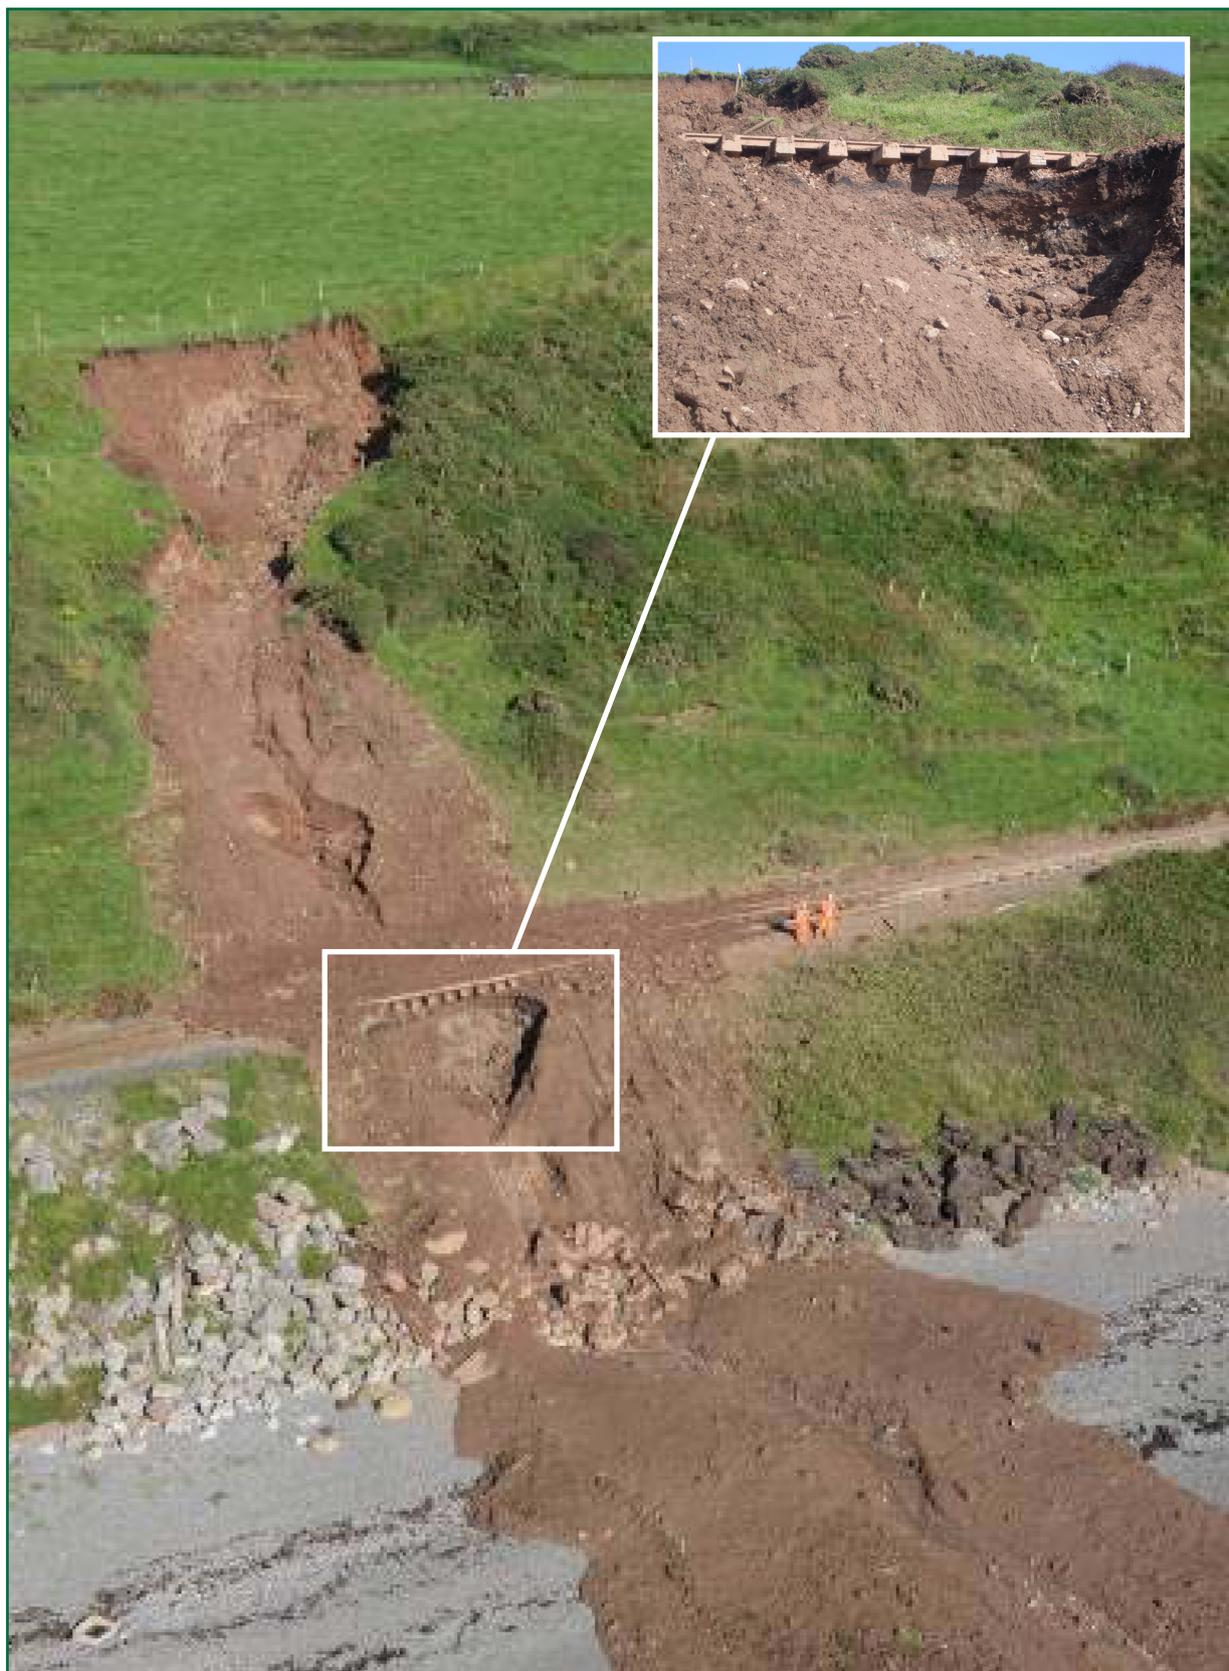
Figure 19: St Bees: landslide at 68 miles 59 chains (main image courtesy of Network Rail)

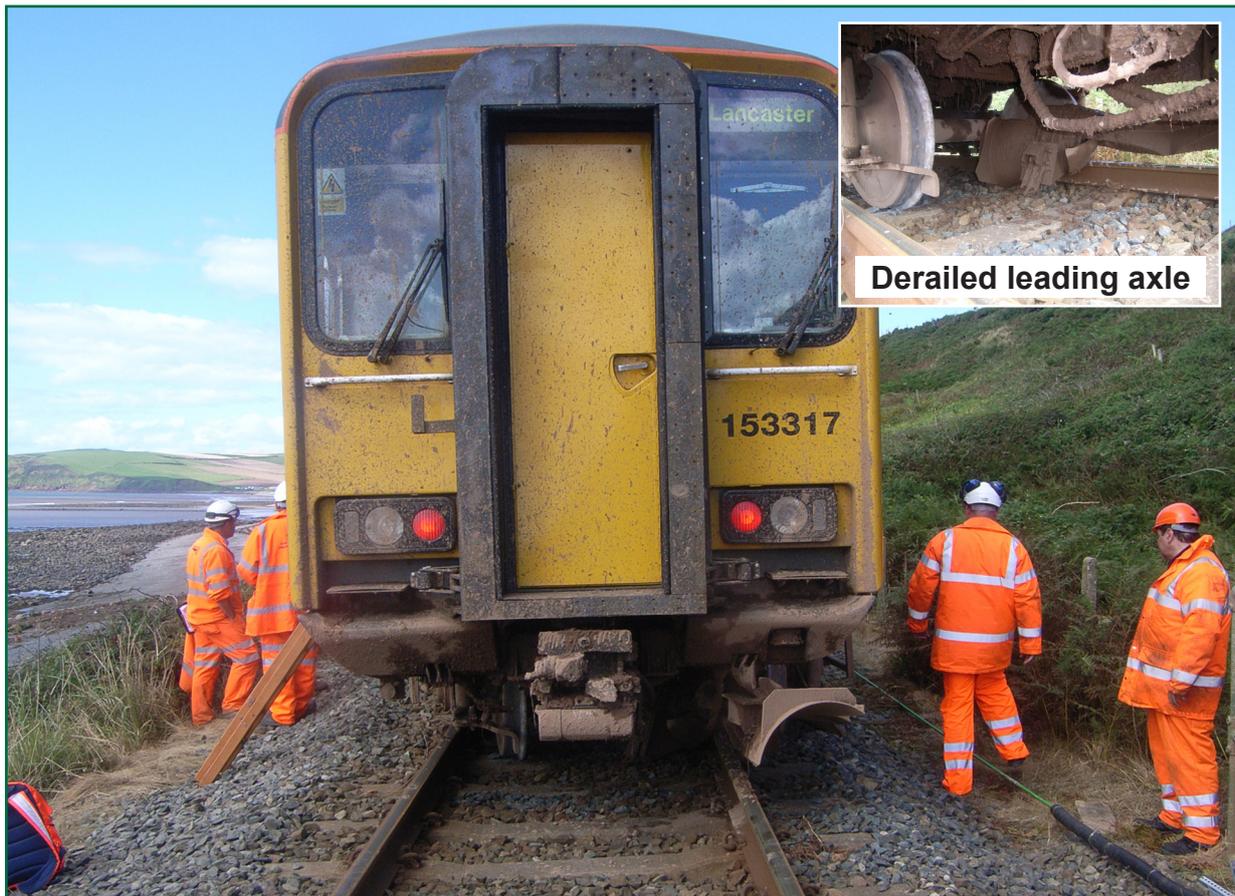
Figure 20: St Bees: derailed train

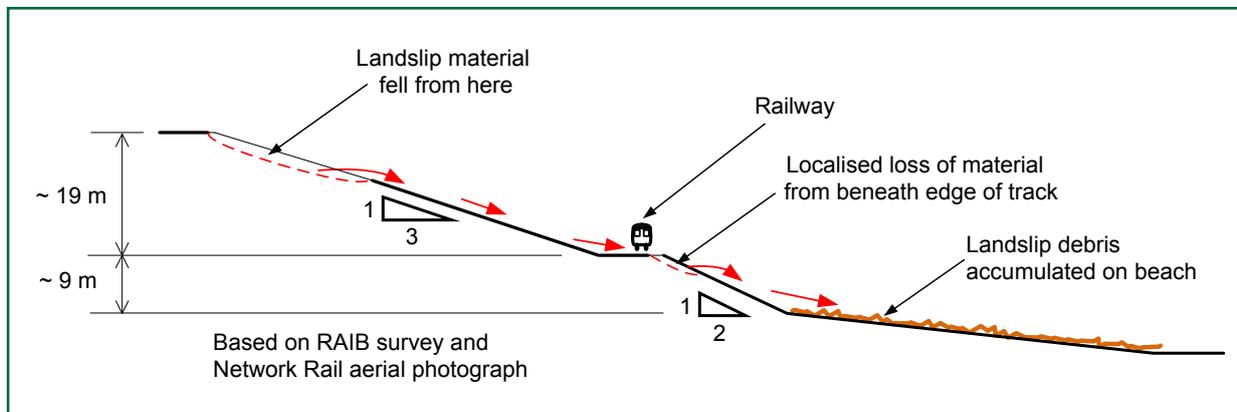
Figure 21: St Bees: slope geometry (cross-section)

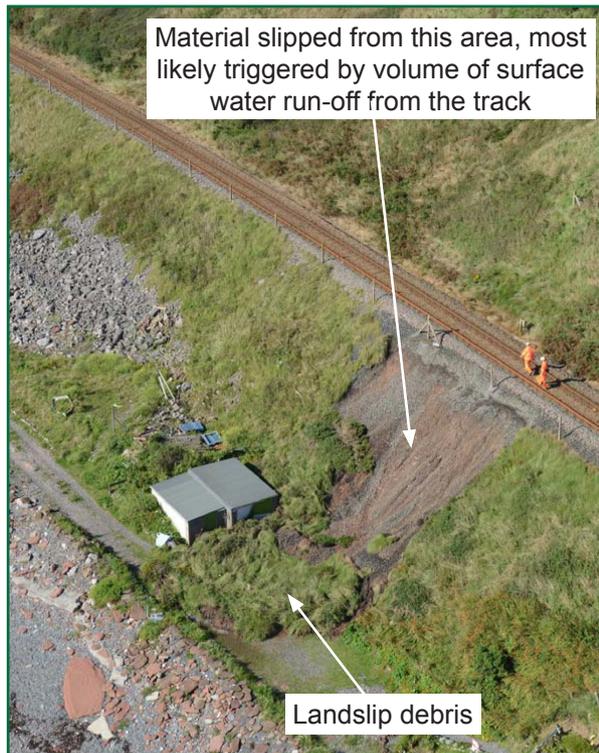
- 59 The landslip at 67 miles 61 chains occurred in the natural slope below the railway and undermined the track. It was probably triggered by water running off the slope above the railway. The washout of material from beneath the track at 66 miles 60 chains was caused when a build up of water on one side of an embankment resulted in water forcing its way through poorly compacted embankment material around a culvert. This culvert was intended to prevent water building up behind the embankment but it lacked the capacity to carry the exceptional amounts of water draining from the surrounding land.

Figure 22: St Bees: landslide at 67 miles 61 chains (image courtesy of Network Rail)

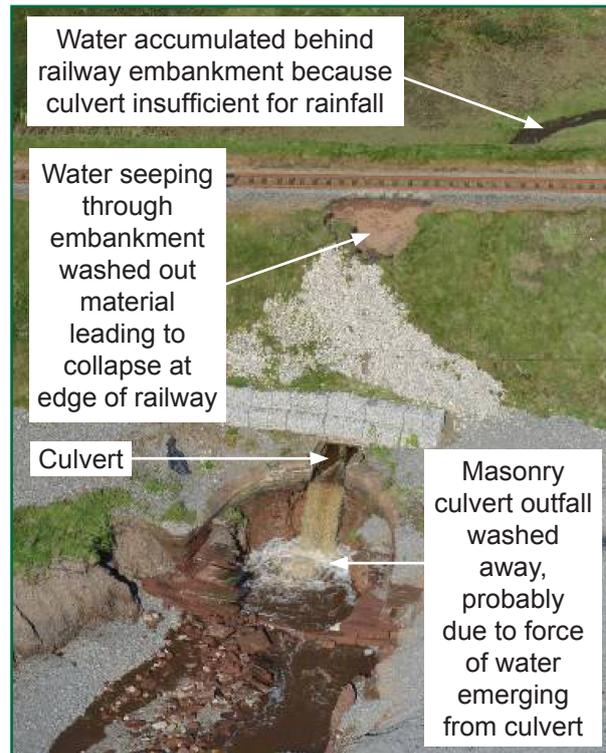
Figure 23: St Bees: landslide at 66 miles 60 chains (image courtesy of Network Rail)

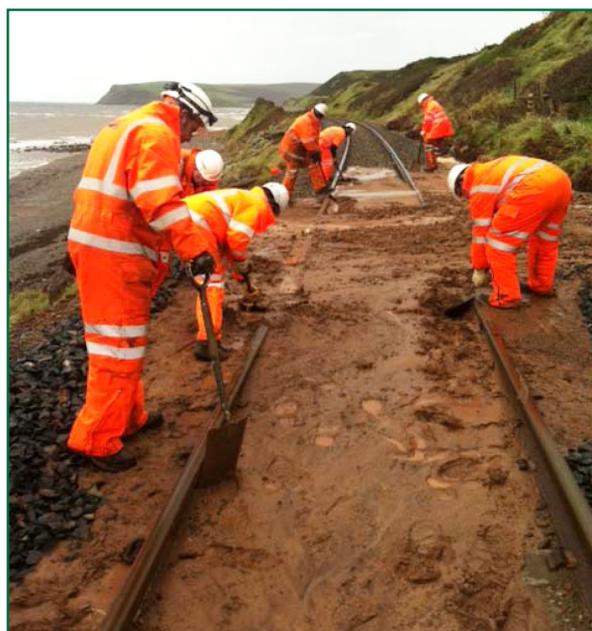
60 Permanent repair works were still awaiting completion at 68 miles 59 chains when a further incident occurred on 17 October 2012. Network Rail reported to RAIB that heavy rain (24 mm in 5 hours) during the afternoon of 17 October caused soil to be washed out from the slope above the railway in the area of the August 2012 landslide. A small amount of this material passed around the ends of a temporary barrier wall and was deposited on the railway (figure 24). The presence of this material was reported by the driver of a passing train and train services were suspended until the debris was removed from the track.

Figure 24: St Bees: October 2012 incident (image courtesy of Network Rail)

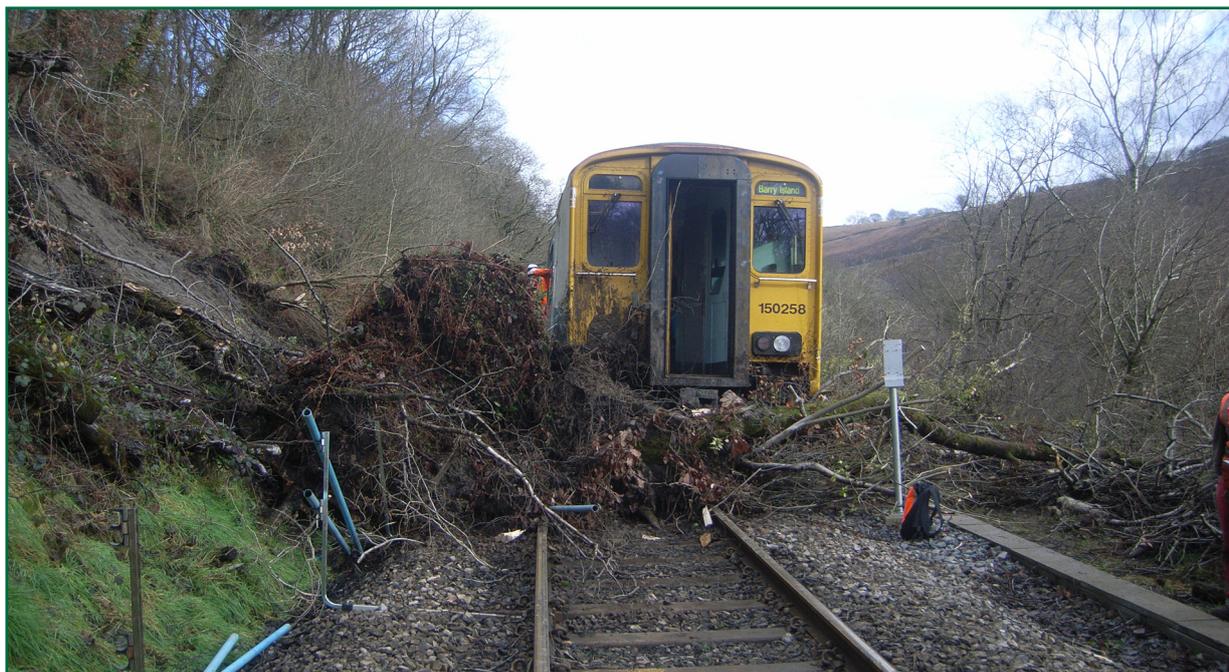
Figure 26: Bargoed: derailed train

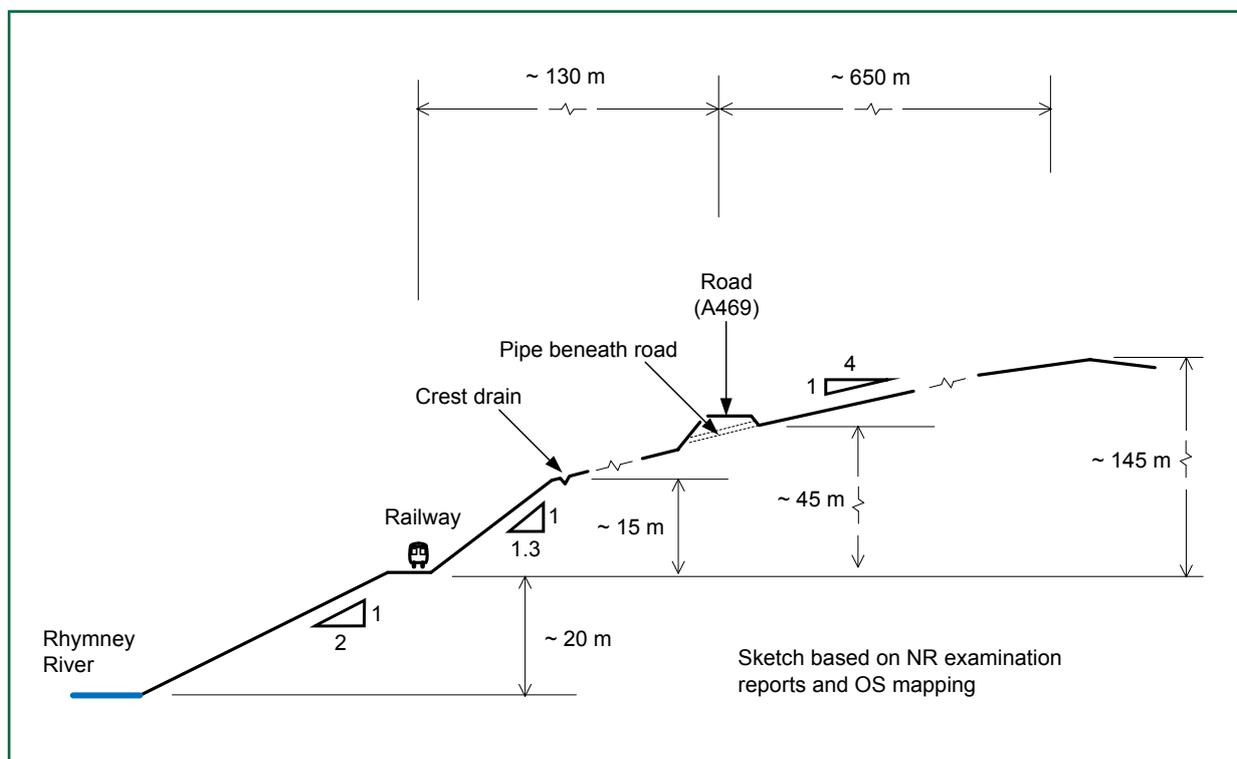
- 63 The landslip occurred at 18 miles 38.5 chains¹¹ alongside a section of single track railway running on a ledge cut into a hillside above the Rhymney River. Construction of the railway created a cutting face approximately 15 metres high and with a slope of 1 in 1.3 on the west side of the railway. Above this, the natural hillside rises a further 30 metres at a slope of about 1 in 4 to a road. The natural hillside continues to rise a further 140 metres above the road to a ridge. Below the railway, the natural hillside slopes at about 1 in 2 down to the Rhymney River which is about 20 metres below the railway (figure 27).

Figure 27: Bargoed: slope geometry (cross-section)

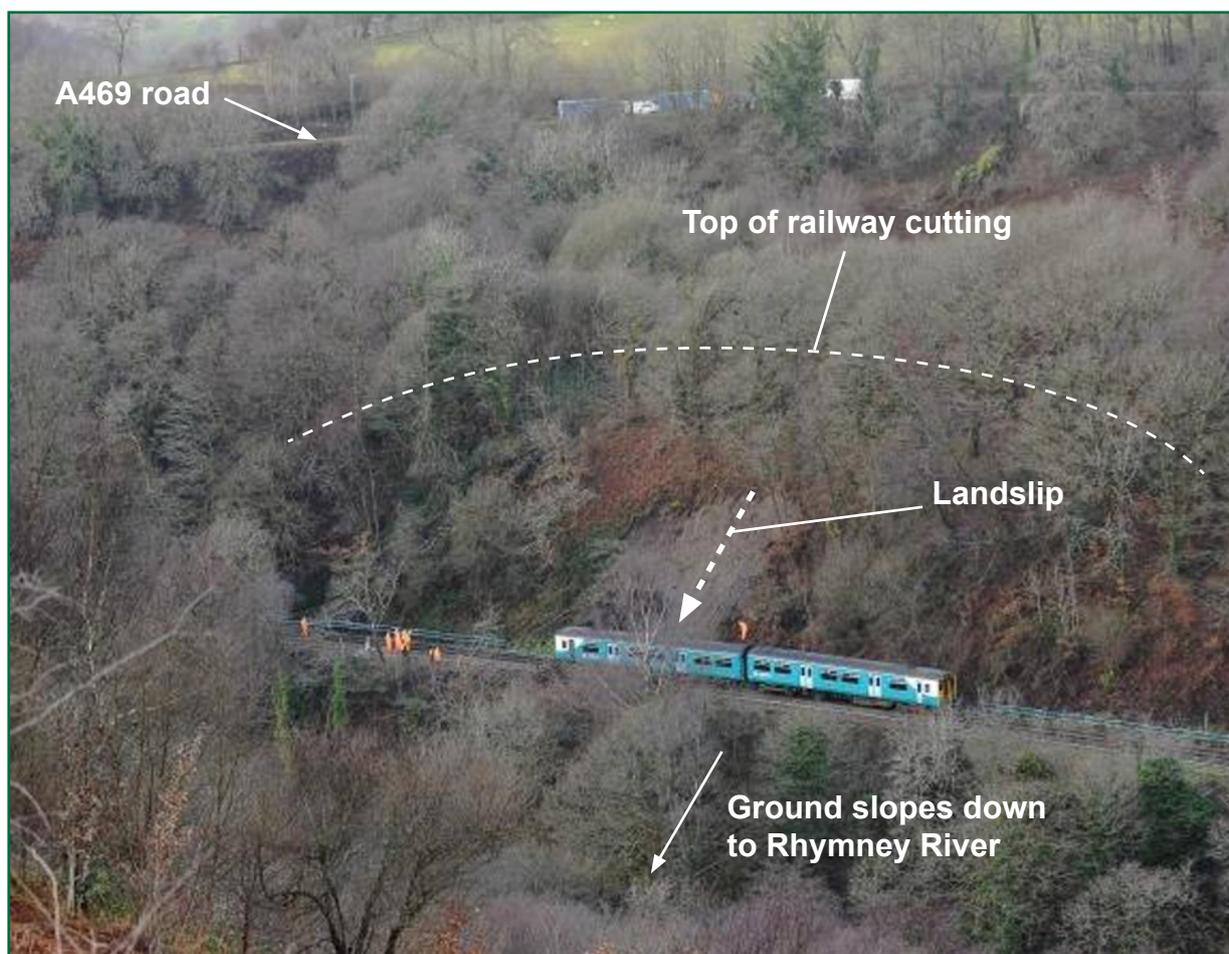
- 64 The hillside above the railway forms a natural valley directing surface water towards the area of the slip. There was no formal stream channel within the valley but, a few hours after the accident, RAIB observed water being discharged from a pipe into the valley immediately downslope of the road. It is likely that this pipe was acting as a drain intended to prevent water accumulating upslope of the road (figure 28).

Figure 28: Bargoed: site overview (image courtesy of ITV Cymru Wales)
