Rail Accident Investigation Branch

Rail Accident Report

Class investigation into landslips affecting Network Rail infrastructure between June 2012 and February 2013

Report 08/2014
April 2014

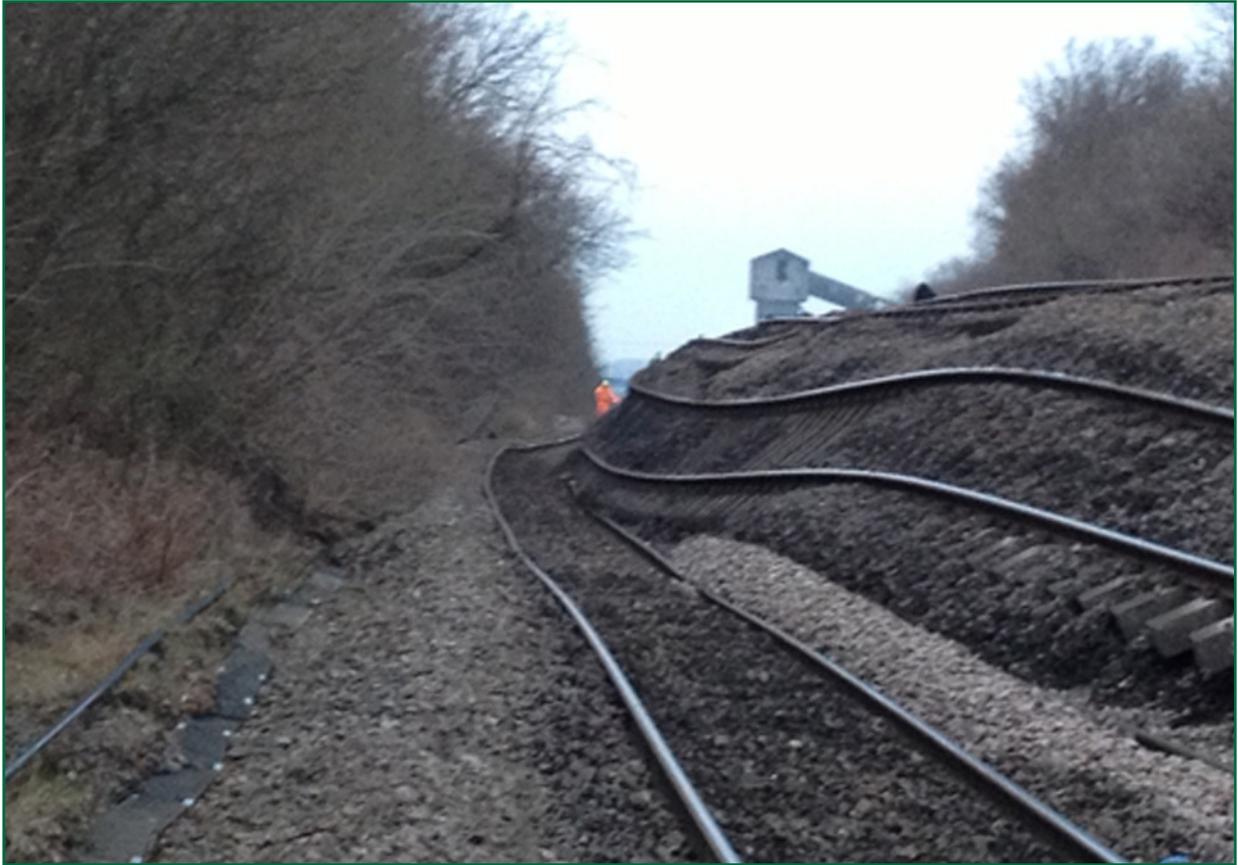
Figure 30: Hatfield Colliery: track deformation (image courtesy of Network Rail)

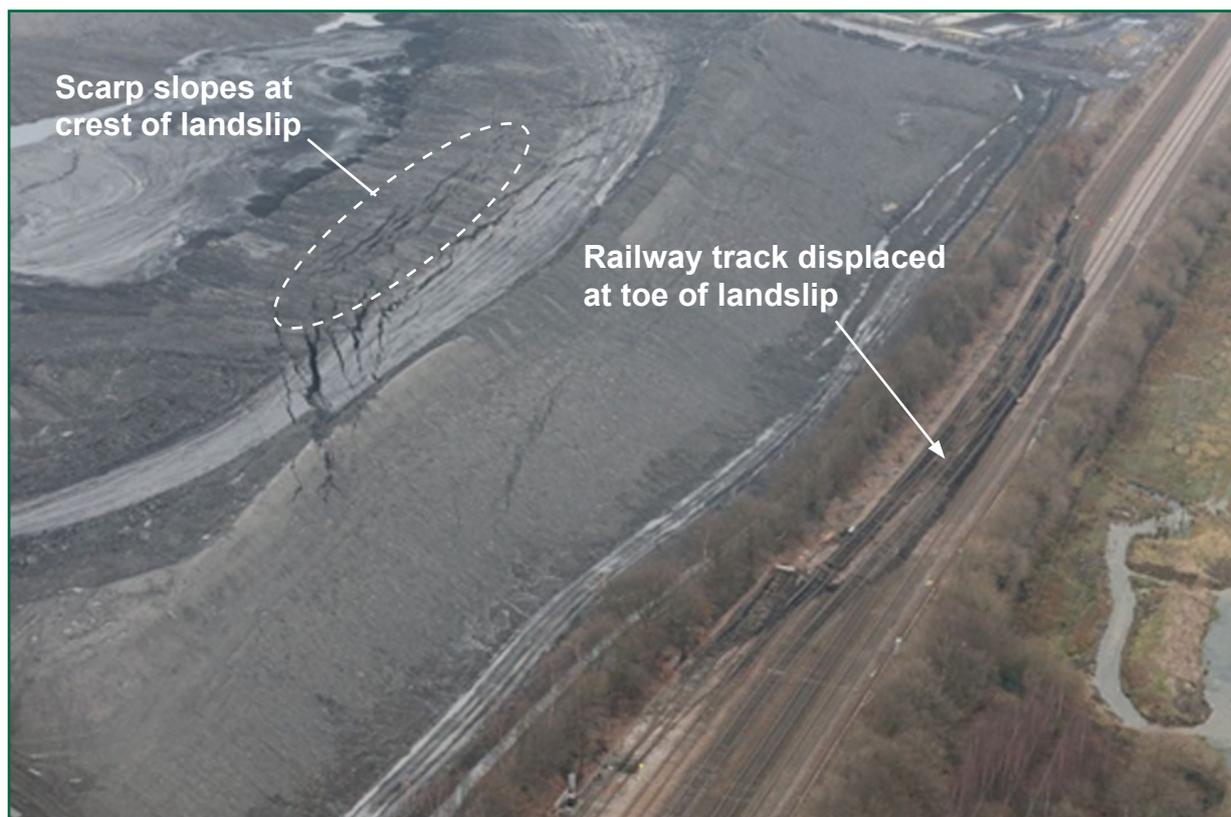
- 78 Aerial photographs taken by Network Rail show that the track deformation was a consequence of a large landslip caused by a spoil tip located outside the railway boundary and within Hatfield Colliery (figures 31 and 32). The precise reason(s) why the landslip occurred remain to be determined and, in addition to the ground loading imposed by the spoil tip, may involve factors such as unexpected weakness in the natural ground. RAIB has not investigated these reason(s) because this was not expected to lead to additional RAIB safety recommendations.

Figure 31: Hatfield Colliery: aerial view (image courtesy of Network Rail)

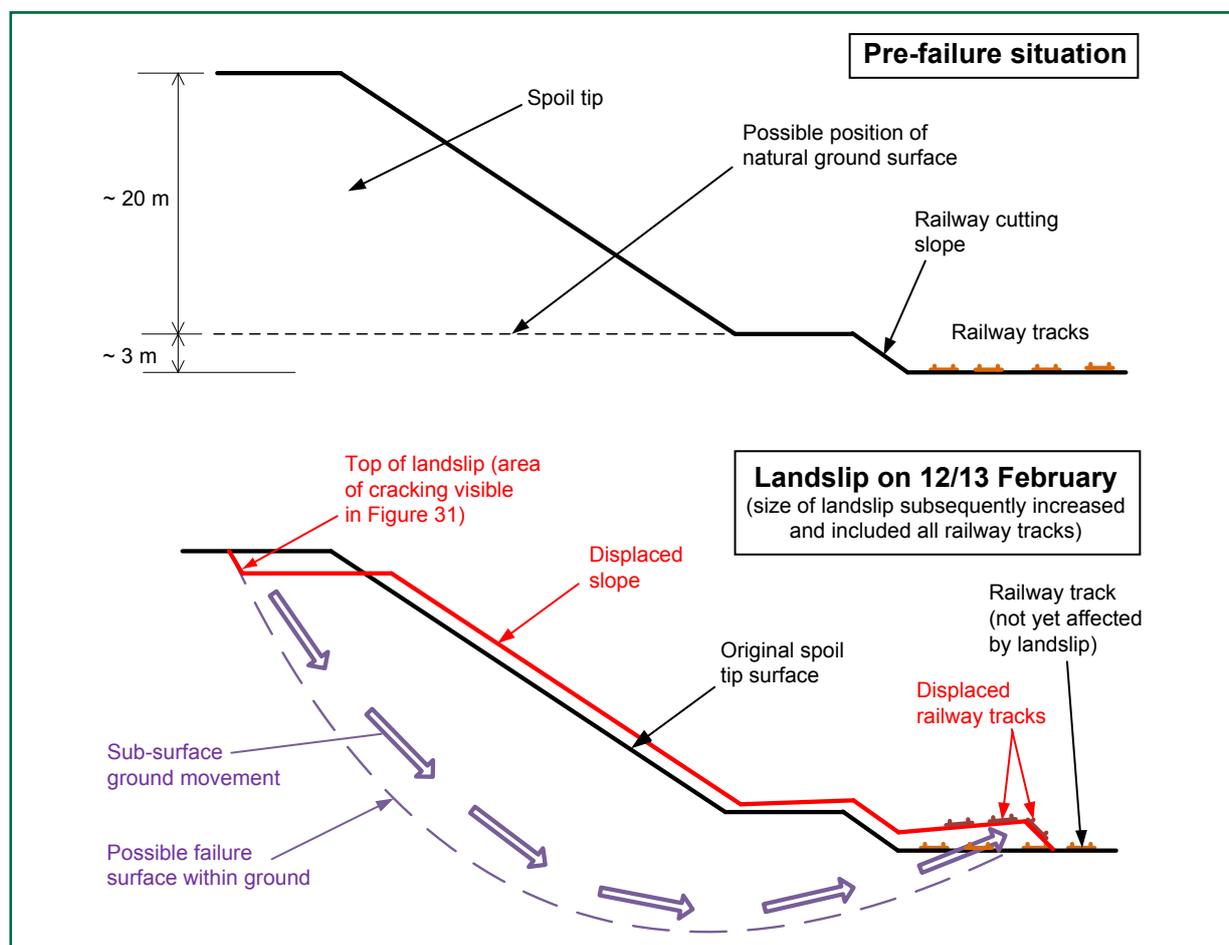
- 79 In the area of the landslip, the railway is running in a cutting up to three metres deep with a side slope of typically 1 in 1.4. When the landslip occurred, photographs seen by RAIB, coupled with desk study information provided by Network Rail, suggest that the nearest toe of the spoil tip was about 9 metres from the top of the cutting and the spoil tip rose about 20 metres above the toe with a side slope of around 1 in 1.5.

Figure 32: Hatfield Colliery: landslide geometry (cross-section)
