Rail Accident Report

**Tram running with doors open on London
Tramlink, Croydon
13 April 2013**

Report 05/2014
March 2014

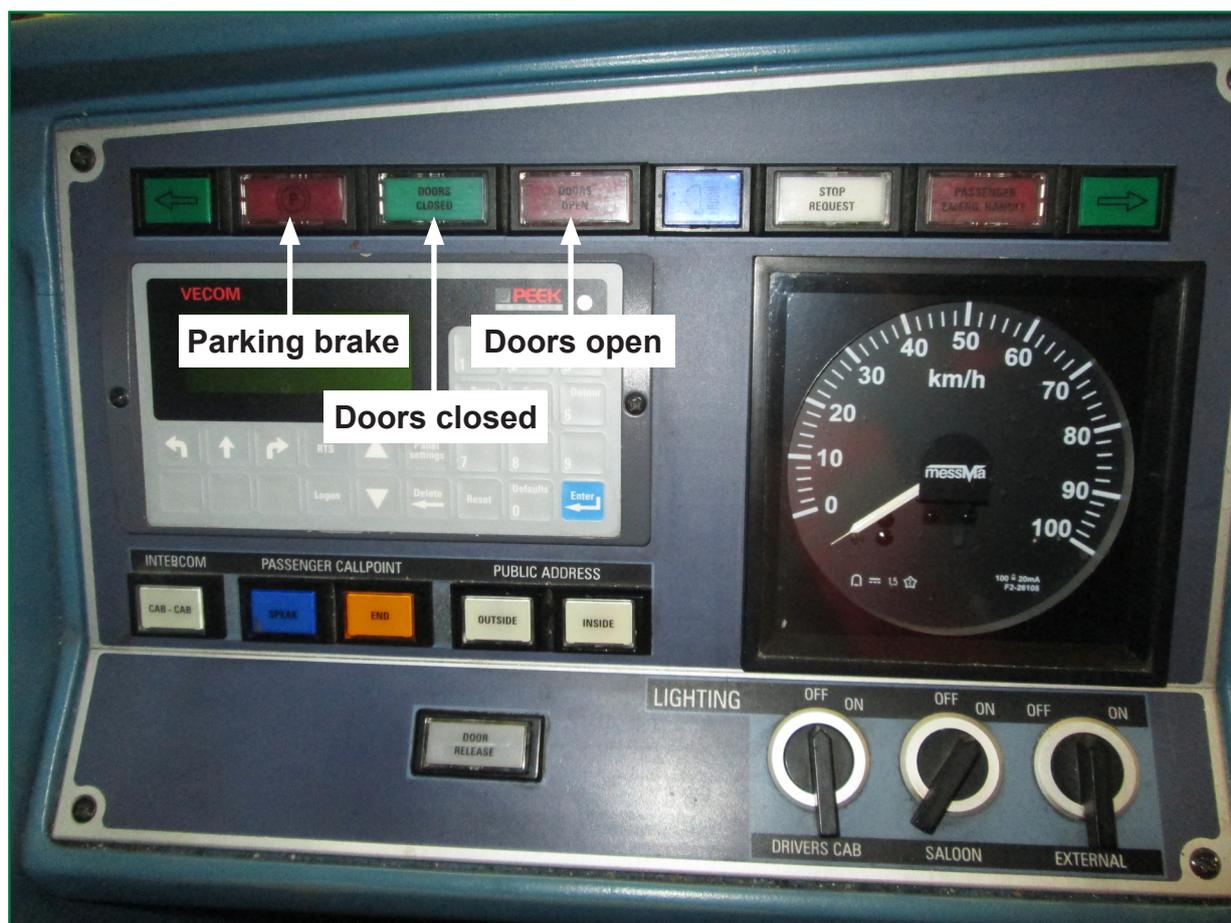
Figure 4: Driver's cab panel showing door indicator lights for closed (green) and open (red)

- 52 There was poor indication in the driving cab as to whether the doors were closed.
- 53 The main means for drivers to check that the doors are closed is by observing that a red 'doors open' indicator light on the driver's display panel has extinguished and a corresponding green 'doors closed' light has illuminated (figure 4). The driver did not recall seeing that the red light was illuminated before departure (which would have told him that the doors were open). During testing, the RAIB found the red indicator light was not prominent and was similar in appearance to a red parking brake indicator light on the same panel. The parking brake indicator would also be lit at tram stops. This may have led to the driver not noticing the indicator before departing.

- 54 The tram also has exterior wing mirrors, but these do not provide a good view of the doors and, according to TOL's driver training modules, are primarily intended to be used for observing road traffic and to check that passengers are clear of the tram before departing from tram stops. Neither the driver training modules nor the Office of Rail Regulation's (ORR) 'Guidance on Tramways'⁶ (referred to as Railway Safety Publication 2) explicitly mention using the mirrors to check whether doors are closed.

- 3 *The intention of this recommendation is for improvements to be made to the driver's cab displays and labelling to minimise the chance of the driver not noticing that the doors are open and of misunderstanding the operation of override switches.*

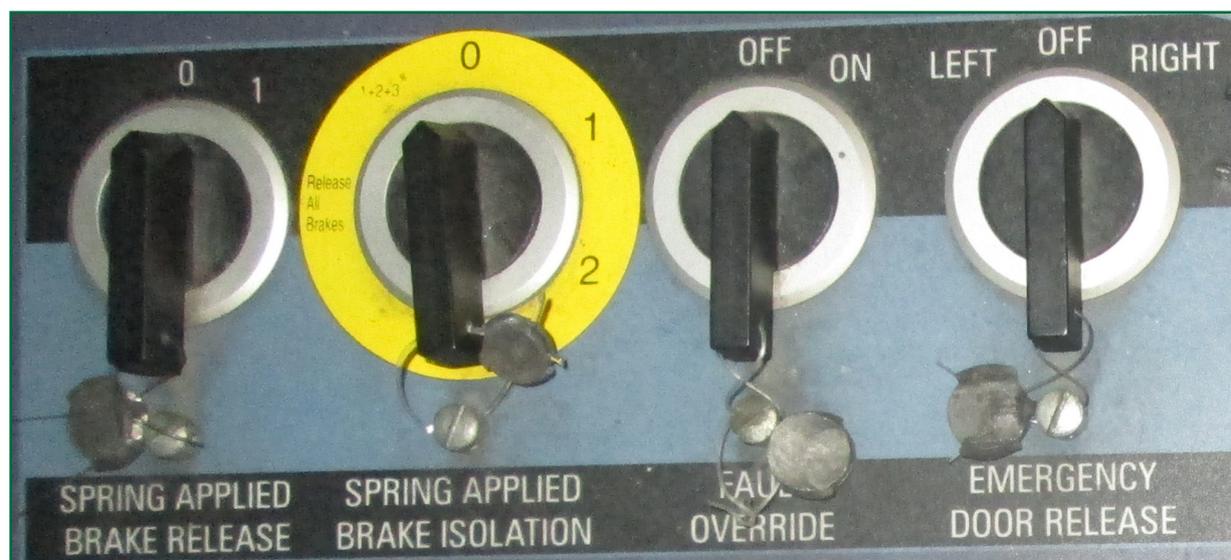
Figure 5: Fault override and brake isolation switches

Design of controls and displays**60 The safety interlock which prevents the tram from moving with the doors open had been overridden by the driver's inadvertent operation of the fault override switch.**

- 61 The emergency release switches were all protected by lead seals (figure 5). The seals are intended purely as a means of identifying when a switch has been used; TOL's procedures state that a driver is not permitted to operate any emergency release switch without authorisation from the controller. In practice, the driver found that the seal on the spring applied brake isolation switch was very difficult to break. In contrast, he operated the fault override switch without breaking the seal at all, because the wire of the seal was able to stretch enough to allow the switch to move to its 'on' position (as observed in the post-incident inspection of the driving cab). When the driver operated the fault override switch, he had just, with difficulty, broken the seal on the switch for the brake isolation a few seconds previously. Because the fault override switch could be operated without the resistance from breaking its seal, the driver might not have noticed that he had operated the wrong switch if he had been operating them through feel alone.

- 63 The fault override and brake isolation switches are located next to each other and are similar in design (figure 5). It was originally a deliberate design decision to group these switches as they all had safety implications. However, this could lead to the switches being confused with each other, especially if the driver was attempting to operate them without looking (paragraph 58).

- 109 Bombardier Transportation subsequently developed a modification to the fault override switch, protecting it with a key-operated cover incorporating the green plastic seal, in order to prevent inadvertent operation (figure 9). This modification has been installed across London Tramlink's CR4000 fleet. It was supported by a briefing to controllers and drivers (on 5 and 9 August 2013 respectively) and a new procedure involving walking through the tram to physically check that all the doors are closed before operating the fault override.

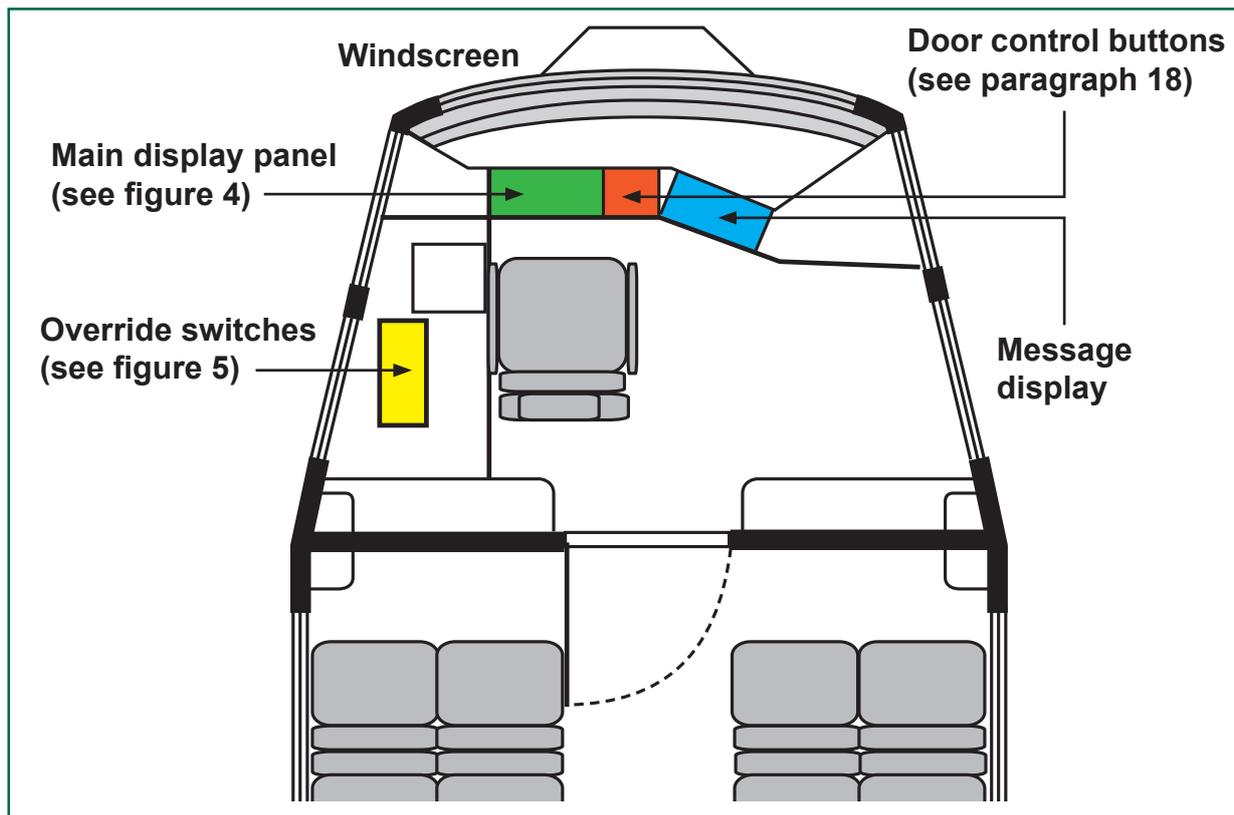
Figure 6: Bombardier CR4000 cab layout (plan view)

- 65 Tramtrack Croydon Ltd, who originally procured the CR4000 trams, had limited influence on the design of the tram, as it was essentially acquiring an off-the-shelf model that had been developed for other customers. Nevertheless, some relevant design changes were made, with early discussions during the procurement process focused on specific aspects of labelling (eg the change from 'system override' to 'fault override' mentioned above). The Operations Manager at the time of the procurement expressed concerns over some basic ergonomics elements of the driver's interfaces, such as the lack of an integrated approach to the cab layout.

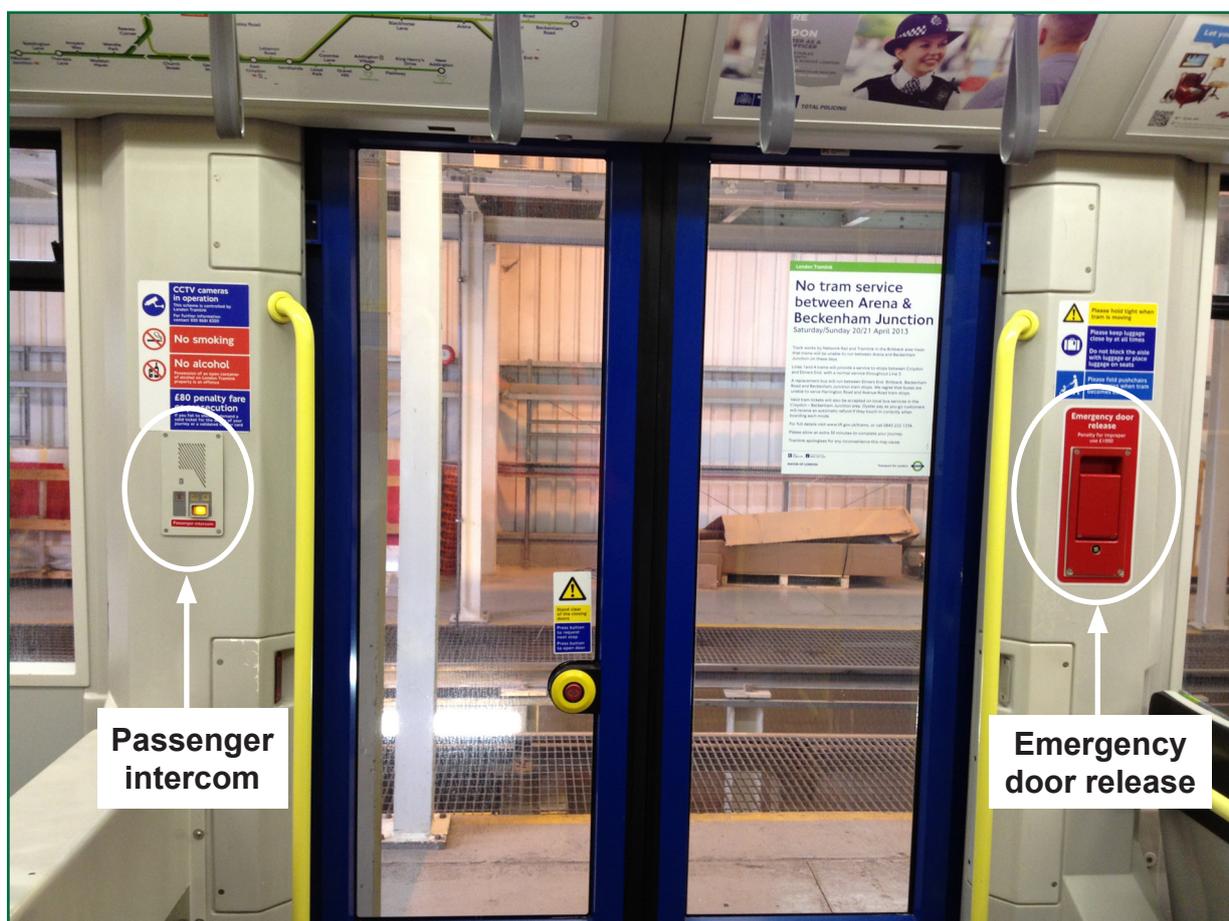
Figure 7: Passenger intercom and emergency door release

- 70 **Passengers did not succeed in alerting the driver to the fact that the doors were open. This was a causal factor.**
- 71 Some passengers had tried to communicate with the driver through the internal cab door and window (which, as is ordinarily the case, were closed during the journey), but their message was misunderstood (paragraph 30).
- 72 There are intercoms on the tram for passengers to speak with the driver, but these are not clearly signed or labelled (figure 7). For instance, the intercom is labelled 'Passenger intercom', which does not clearly signal that the device can be used to contact the driver. There is no other passenger emergency alarm on the CR4000 tram. Although the handle labelled 'Emergency door release' has the effect of bringing the tram to a stop before releasing the doors, this aspect of its functionality is not mentioned on the associated label.

- 6 *The intention of this recommendation is to improve the design of passenger controls and displays (emergency alarms, intercoms etc.), through shape, colour, symbols and/or signage, so as to make their operation more obvious and intuitive to the user in the event of an emergency.*

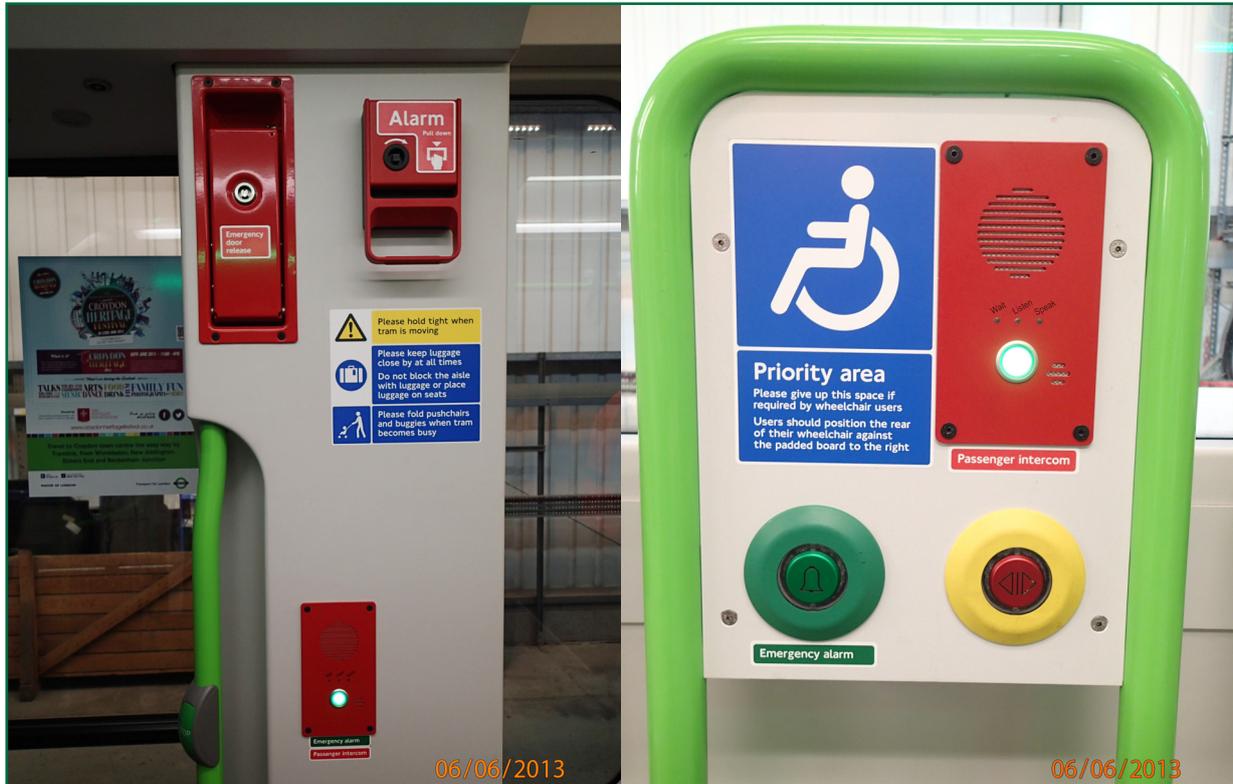
Figure 8: Passenger interfaces on Stadler Variobahn tram

- 74 The RAIB has examined other types of tram used in Britain for comparison, and found that there is little consistency between trams, with similarly unclear designs observed elsewhere. For instance, the Stadler Variobahn, also used on London Tramlink, presents more options to the passenger in the form of 'passenger alarm', 'passenger intercom', 'alarm', and 'emergency door release' (figure 8).
