Rail Accident Investigation Branch

# Rail Accident Report

**Fatal accident at Athelney level crossing, near  
Taunton, Somerset  
21 March 2013**

Report 04/2014  
February 2014

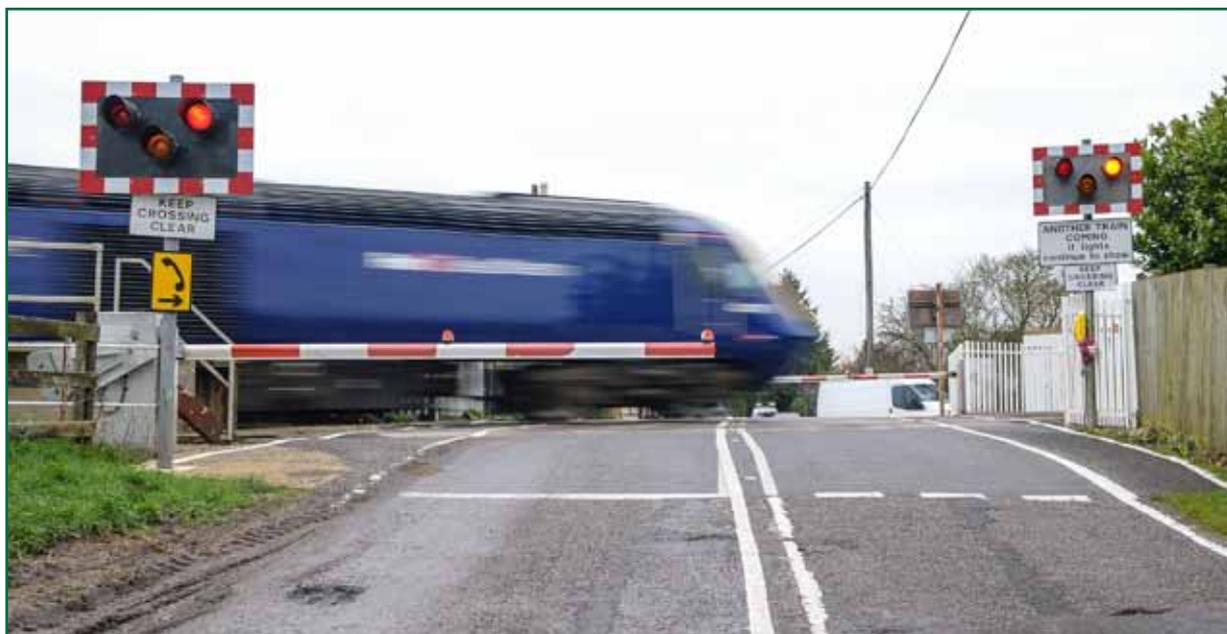
- 7 At about 06:23 hrs on Thursday 21 March 2013, a car drove around the barriers of Athelney *automatic half barrier crossing* (AHBC) and into the path of an approaching train (figure 1).

Figure 1: View of Athelney level crossing (courtesy British Transport Police)

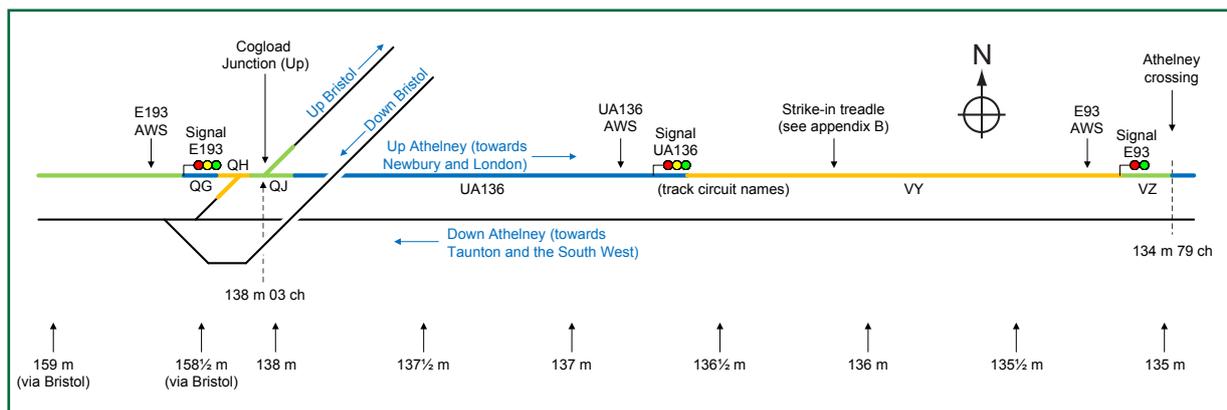
- 16 Athelney level crossing was commissioned in 1986 and is supervised from Exeter signal box. The maximum permissible speed for trains on both the Up and Down Athelney lines is 100 mph (161 km/h).
- 17 For trains running on the Up Athelney line, a signal (E93) is located 277 metres on the approach to the crossing. This is a *controlled signal* with an *automatic working* facility and is normally switched into automatic mode. It is the last signal before the boundary with the area controlled by Westbury signal box. The previous automatic signal (UA136) is located 2,808 metres on the approach to E93 signal (figure 3).

Figure 3: Track layout, showing signals and track circuit names on the Up Athelney line

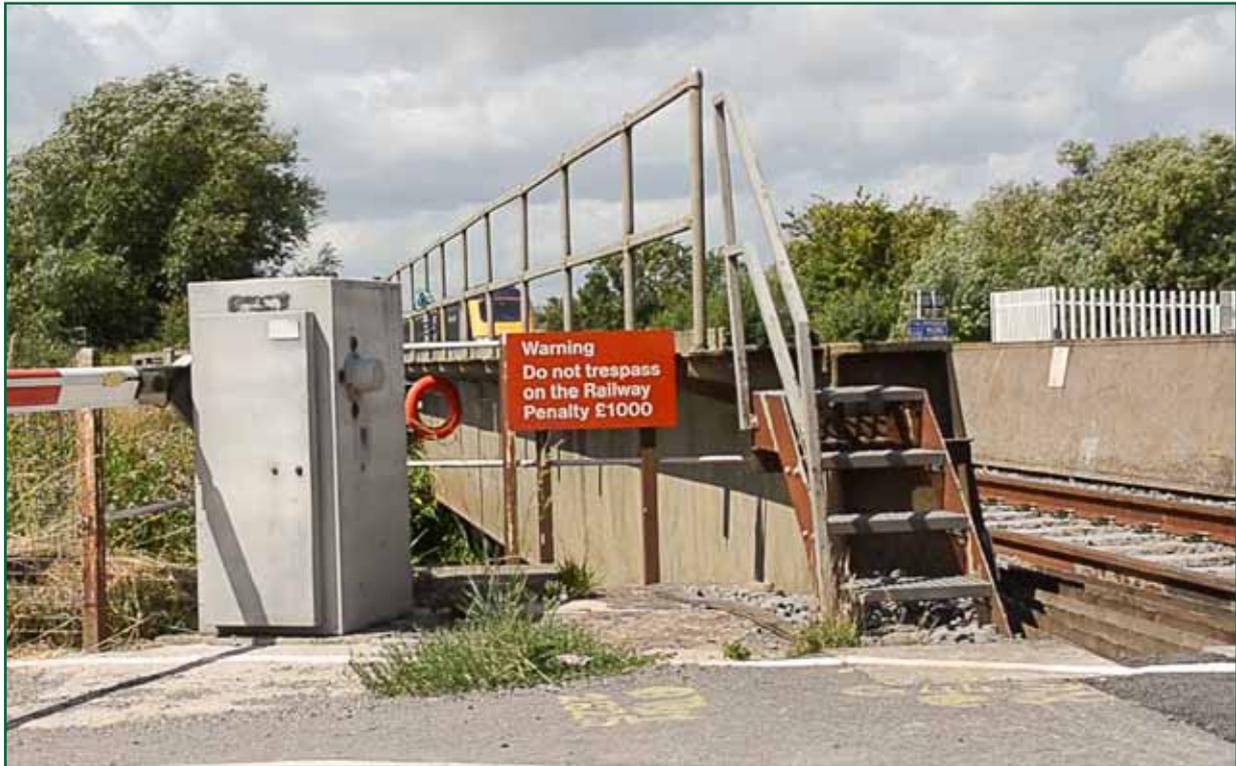
Figure 5: Motorist's eye view of a passenger train approaching Athelney on the Up Athelney line

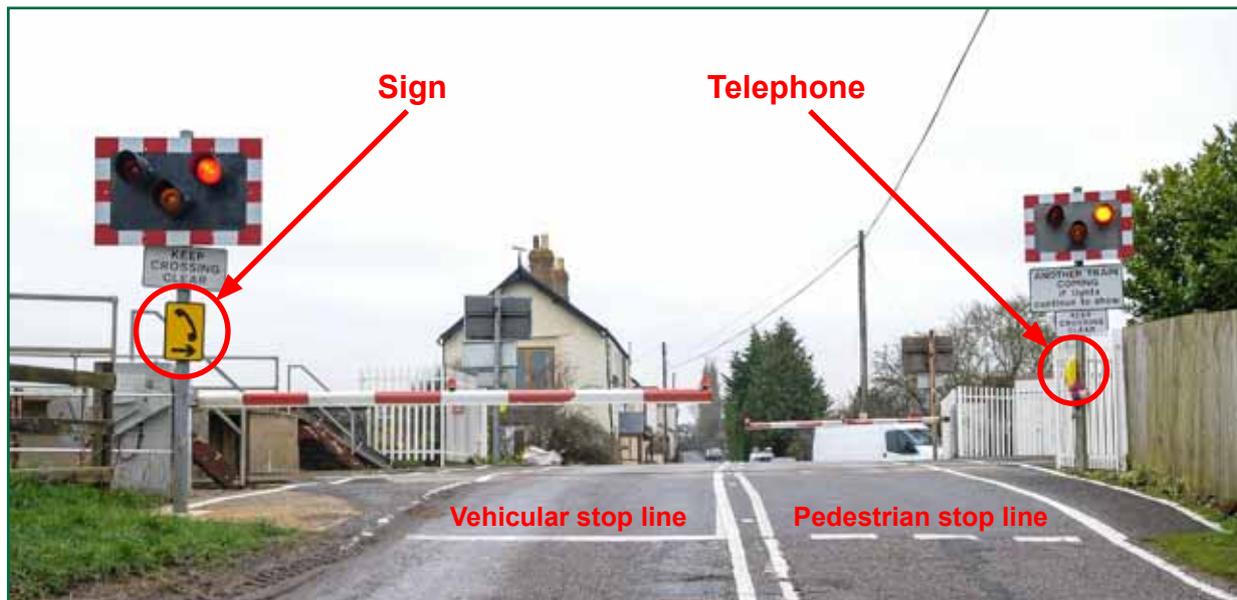
- 61 Whatever the motorist's understanding, he did not use the telephone provided at the level crossing to contact the signaller. This may have been because he was not aware of the existence or purpose of the telephone.

Figure 6: Level crossing telephone and signage at Athelney AHBC (courtesy British Transport Police)

- 62 The location of the telephone at Athelney level crossing is indicated by a yellow sign with a telephone symbol on the near side of the carriageway, with an arrow pointing to the telephone mounted on the offside road traffic light signal post (figure 6). Such telephones are described by Network Rail as 'public emergency telephones'; they are also intended for use by the drivers of large or slow vehicles. There is no signage to advise a motorist detained at closed level crossing barriers that they could use the telephone to contact the signaller.

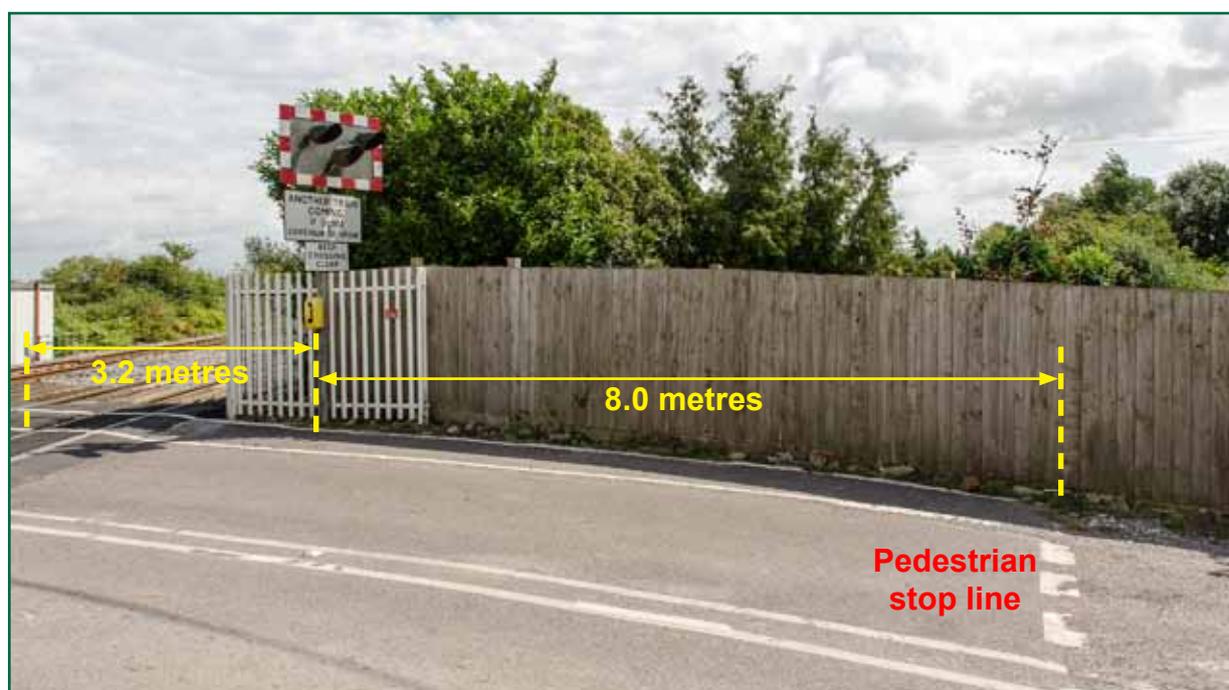
- 75 **The road markings are not consistent with Network Rail's *ground plan* for Athelney level crossing or the ORR's level crossing guidance.**
- 76 The telephone at Athelney level crossing is eight metres beyond the pedestrian 'stop' line (figure 7). Highway Code Rule 34 for pedestrians states 'You MUST NOT cross or pass a stop line when the red lights show'.

Figure 7: Location of the telephone at Athelney level crossing
