Rail Accident Investigation Branch

Rail Accident Report

Partial failure of a structure inside Balcombe Tunnel, West Sussex 23 September 2011

Report 13/2013
August 2013

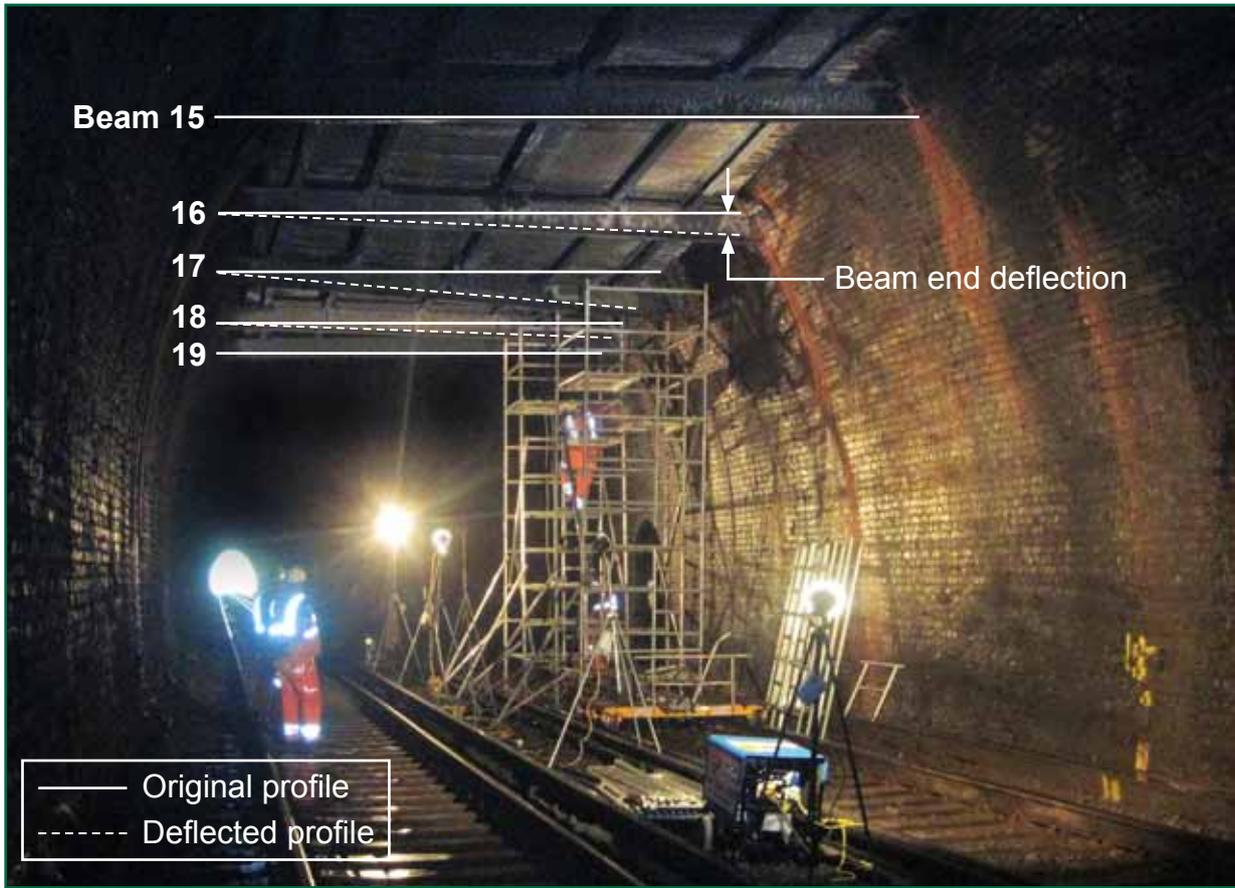
- 33 An initial inspection on 23 September 2011 by on-call staff identified that three transverse beams near the south end of tray 5 (beams 16, 17 and 18 near chainage 36) had become detached from the tunnel lining above the up line.
- 34 Network Rail structures engineers, supported by staff from Amey, undertook a more detailed post-incident inspection later the same day and found that all 12 studs connecting the three beams to the tunnel lining above the up line were missing. The loss of support had caused this part of the structure to sag (figures 9 and 10).

Figure 9: View of deflected structure on 23 September 2011 (photograph courtesy of ORR)

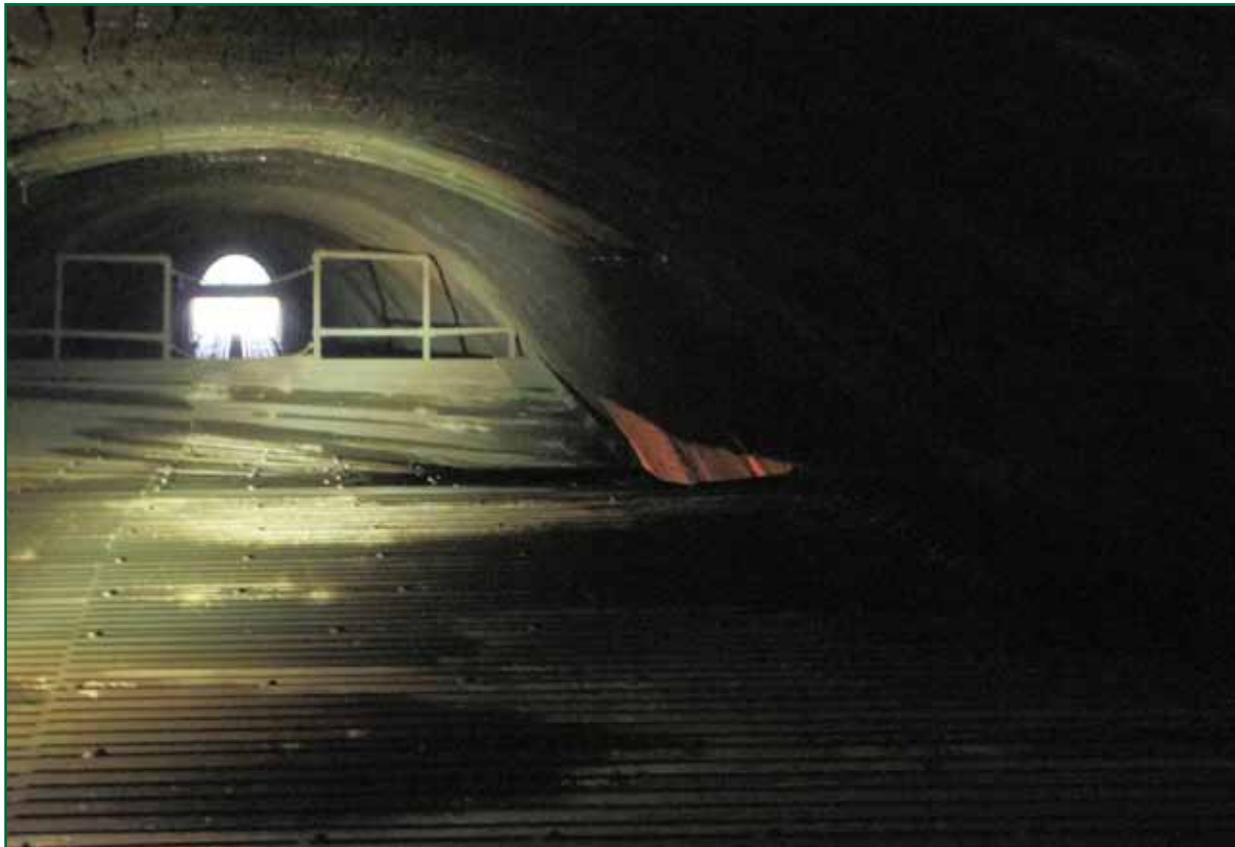
Figure 10: View of deflected structure from above, looking towards the south end of the tunnel, showing the twisted deck on the right-hand side (photograph courtesy of Amey)

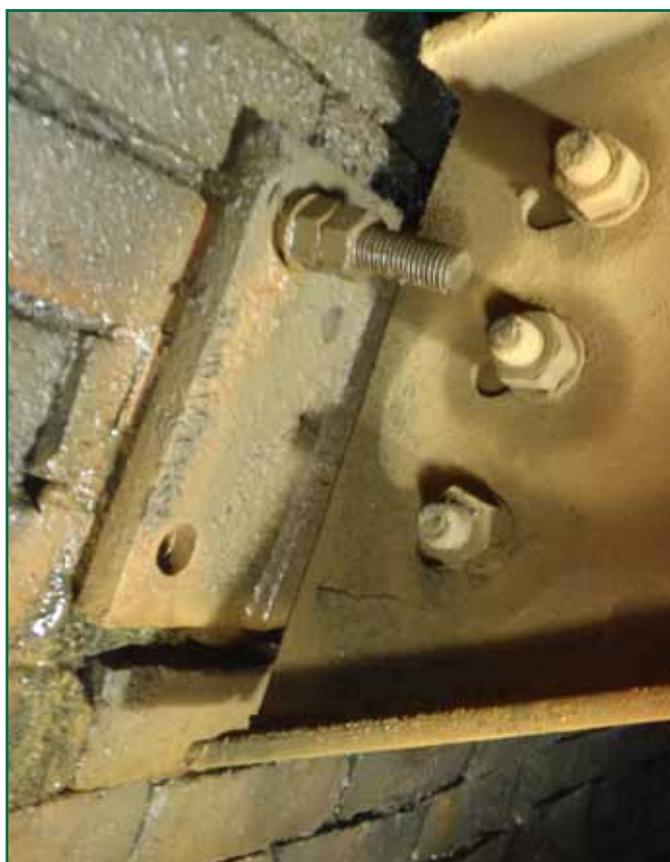
*Figure 11: Bracket with lower stud found missing
(photograph courtesy of Amey)*

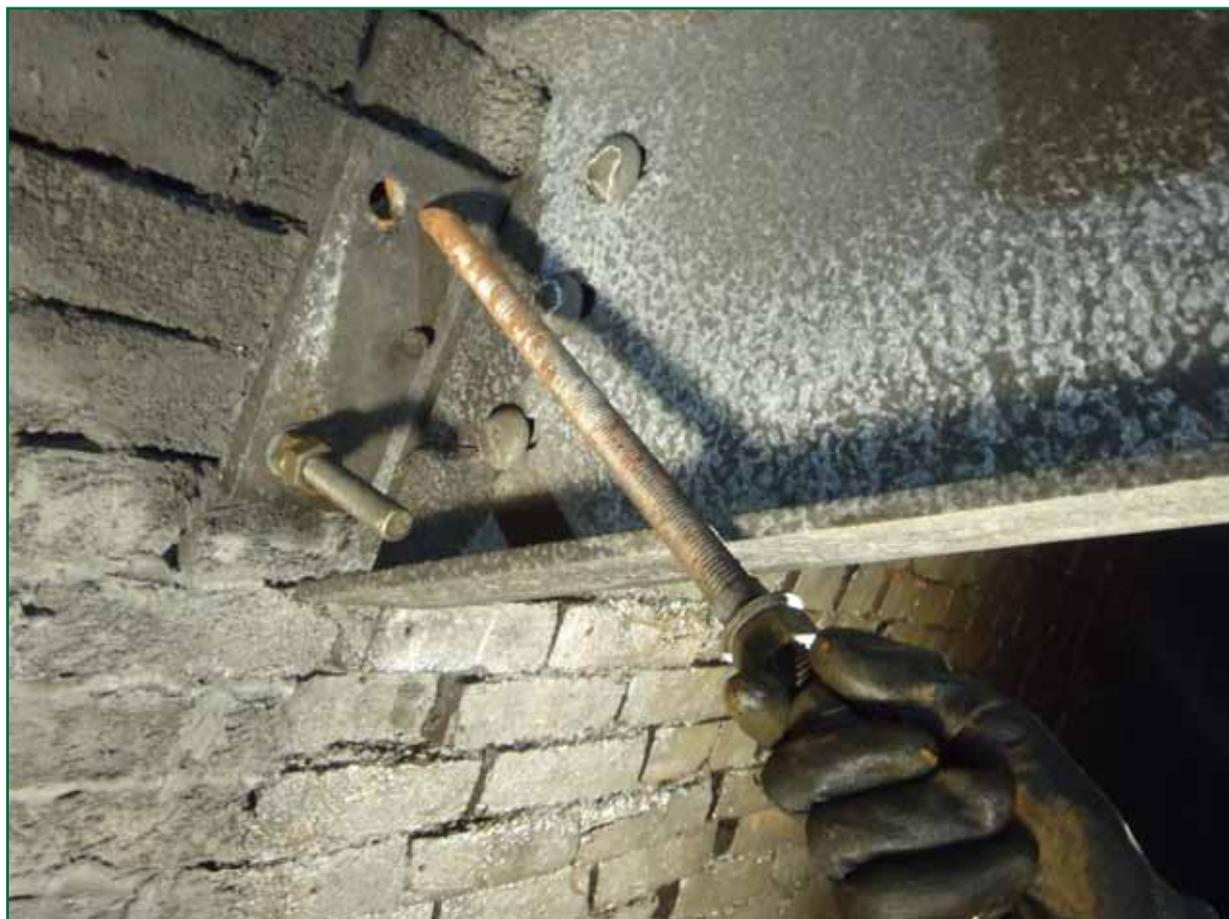
- 36 The post-incident inspection included a physical check of all similar studs within the tunnel with the exception of 13 beam-ends (52 studs). These were located within an exclusion zone, established by Network Rail, to keep staff away from the deflected structure while temporary brackets were installed, or in areas obstructed by equipment. This inspection identified that, in addition to the studs that were missing at the end of the deflected beams, a further six studs were missing (figure 11) and five studs were loose (ie could be removed by hand, figure 12). Within the tunnel, a total of 29 studs had one or more nuts loose (table 1).

Figure 12: Loose stud outside incident area removed by hand during inspection on 23 September 2011 (photograph courtesy of Amey)

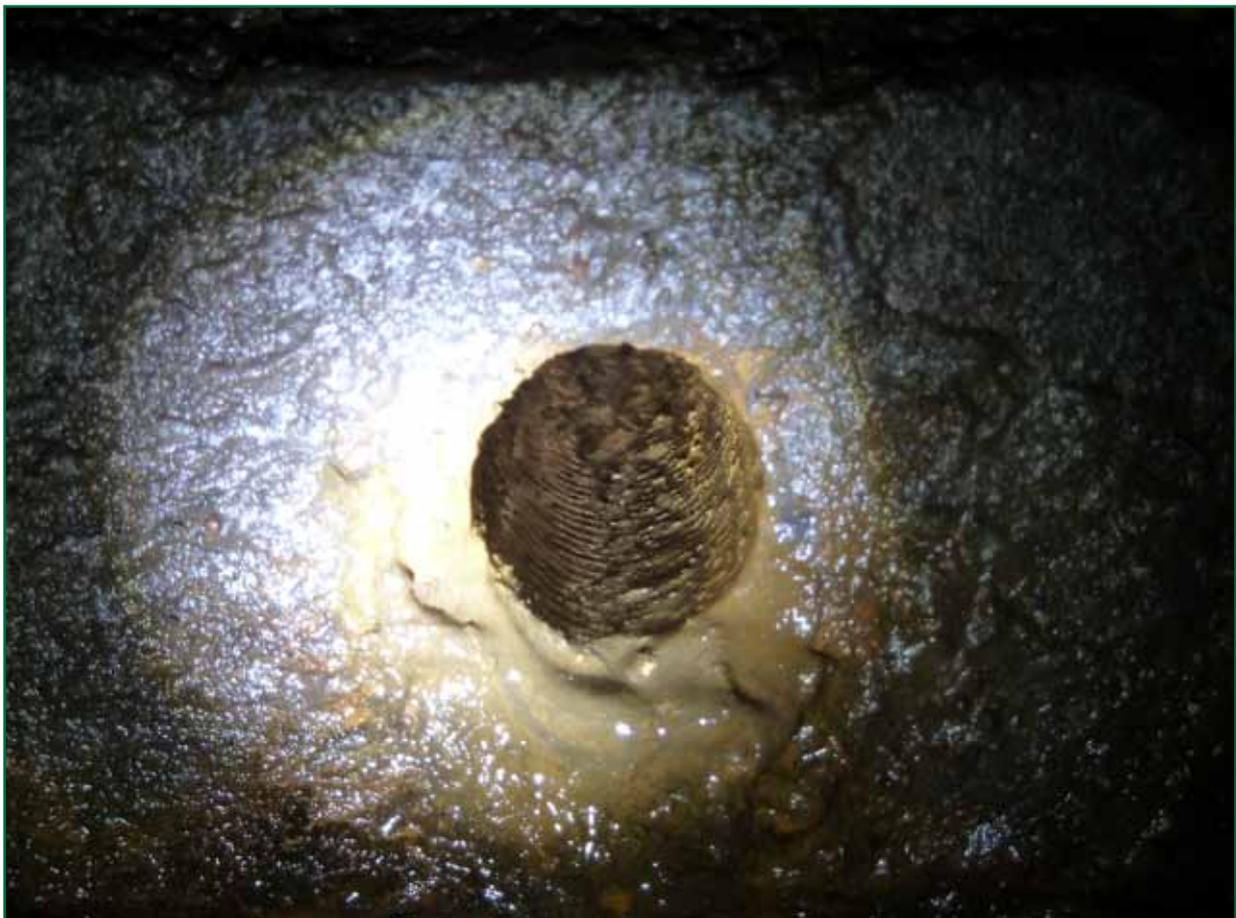
- 43 Examination of the holes in the brickwork from which the studs had fallen showed an imprint of the threaded bar at some locations (figure 13). Some holes exhibited signs of wear and had deformed (figure 14), indicating that the stud had oscillated upwards and downwards, rather than simply rotated (unscrewed) out of the hole.

Figure 13: Hole in brickwork from which studs had fallen, showing thread pattern imprint

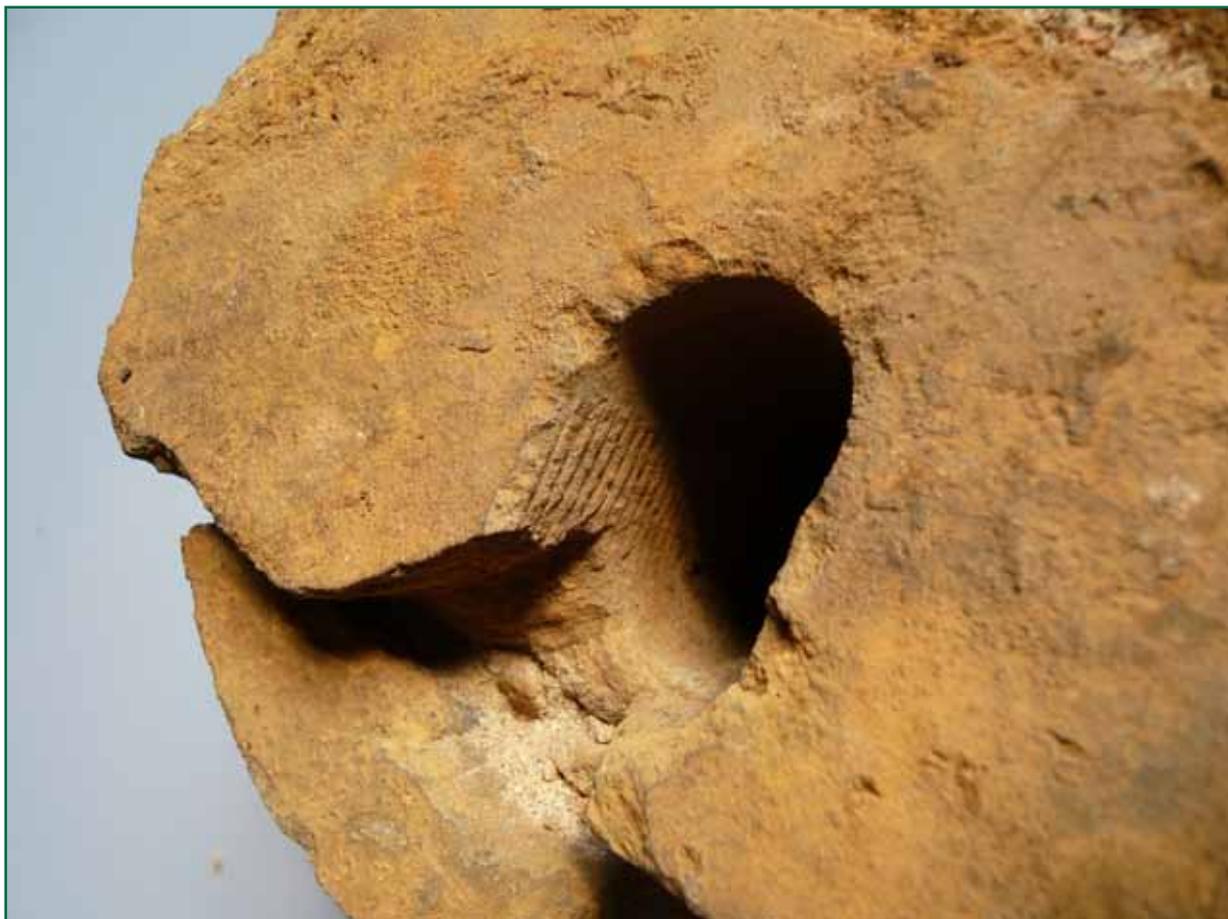
Figure 14: Deformed hole in brickwork core removed from tunnel lining

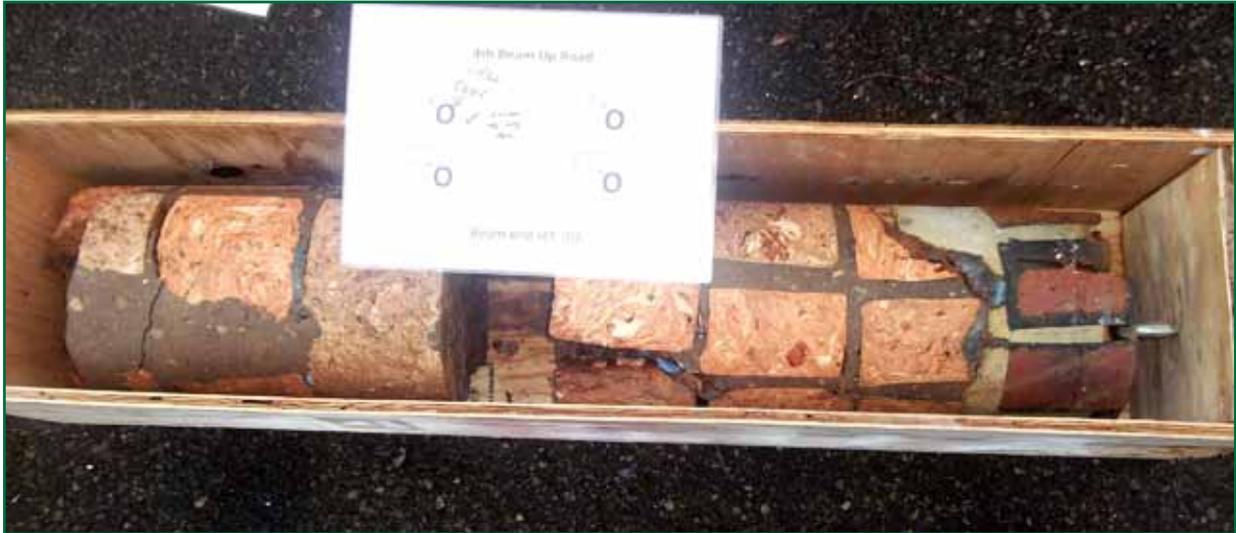
Figure 15: Core taken from tunnel lining during investigation, showing engineering brickwork (right). Core split into two sections during removal (photograph courtesy of Network Rail).

- 47 The cores confirmed that the inner one or two rings of brick (ie those closest to the railway) were constructed of engineering brick, whereas the outer rings were constructed of 'common' brick made of poorly mixed clay. A blue-coloured gel was injected into one hole to keep the sample intact and to highlight cracks in the brickwork (typically gaps between bricks which are normally filled with mortar) through which resin could be lost. Detailed observations for each core are included in appendix D.

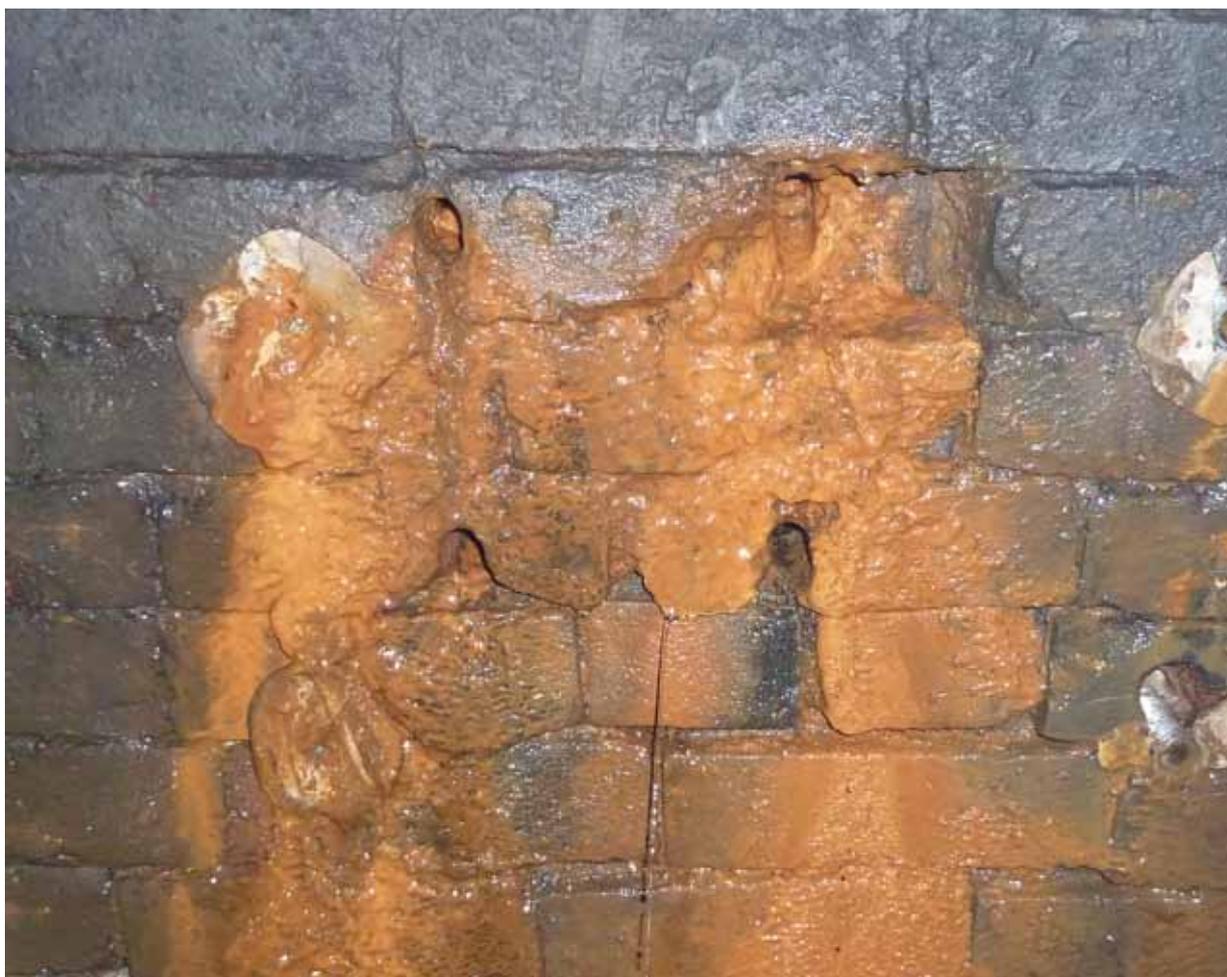
- 50 Some parts of the tunnel are extremely wet. The RAIB observed water running from holes from which studs were missing at chainage 36 (figure 16).

Figure 16: Former position of transverse beam 16 (up side) - note running water

- 51 The water percolating through the brickwork and into the tunnel was analysed by Ceram and found to be slightly alkaline (with a pH value of 7.9).
- 52 Polyester resin can soften in some circumstances if water is present. A London Underground Ltd (LUL) civil engineering technical advice note, issued in April 2009, gives this as a reason for LUL prohibiting use of polyester resin in damp or wet environments. LUL's action followed the publication of an academic paper⁸ in 1997 which casts doubt on the long term performance of polyester resins in submerged conditions. This issue occurs because of a loss of bond strength at the resin and host material interface, and softening of the resin.

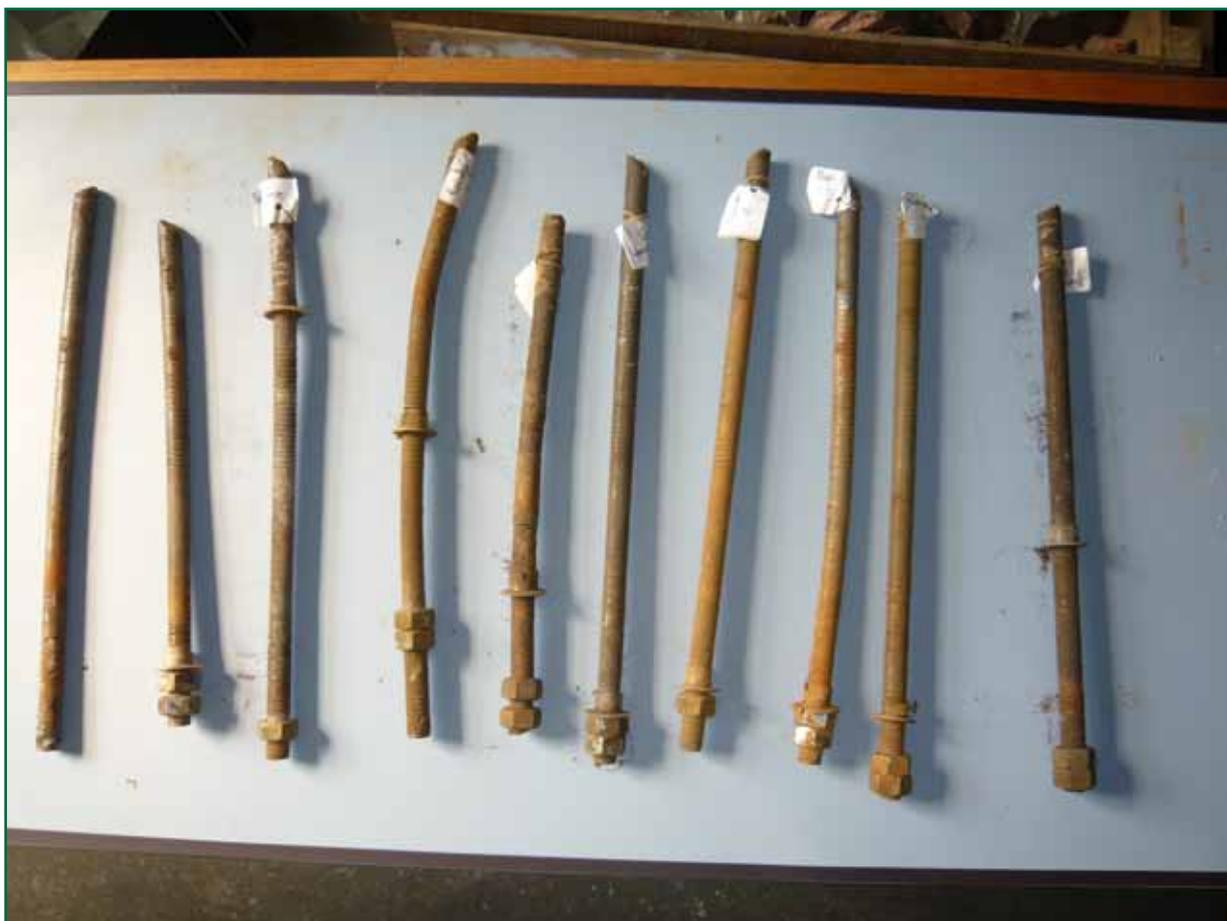
- 60 The length of studs found (figure 17) varied from about 440 mm to about 520 mm, while the depth of the holes, established by a post-incident endoscope survey, ranged from 380 mm to 500 mm. With a fixed quantity of resin, shorter bars or longer holes would encourage the formation of a resin plug at the end of the hole, and gaps in the brickwork would cause loss. Both these features had the potential to reduce the amount of resin at the intended location around the stud. The extent of supervision and quality control of the site work is unclear due to the lack of records. Witness evidence indicates that Railtrack staff were not on site during installation.

Figure 17: Selection of missing studs found in the tunnel - note variation in length

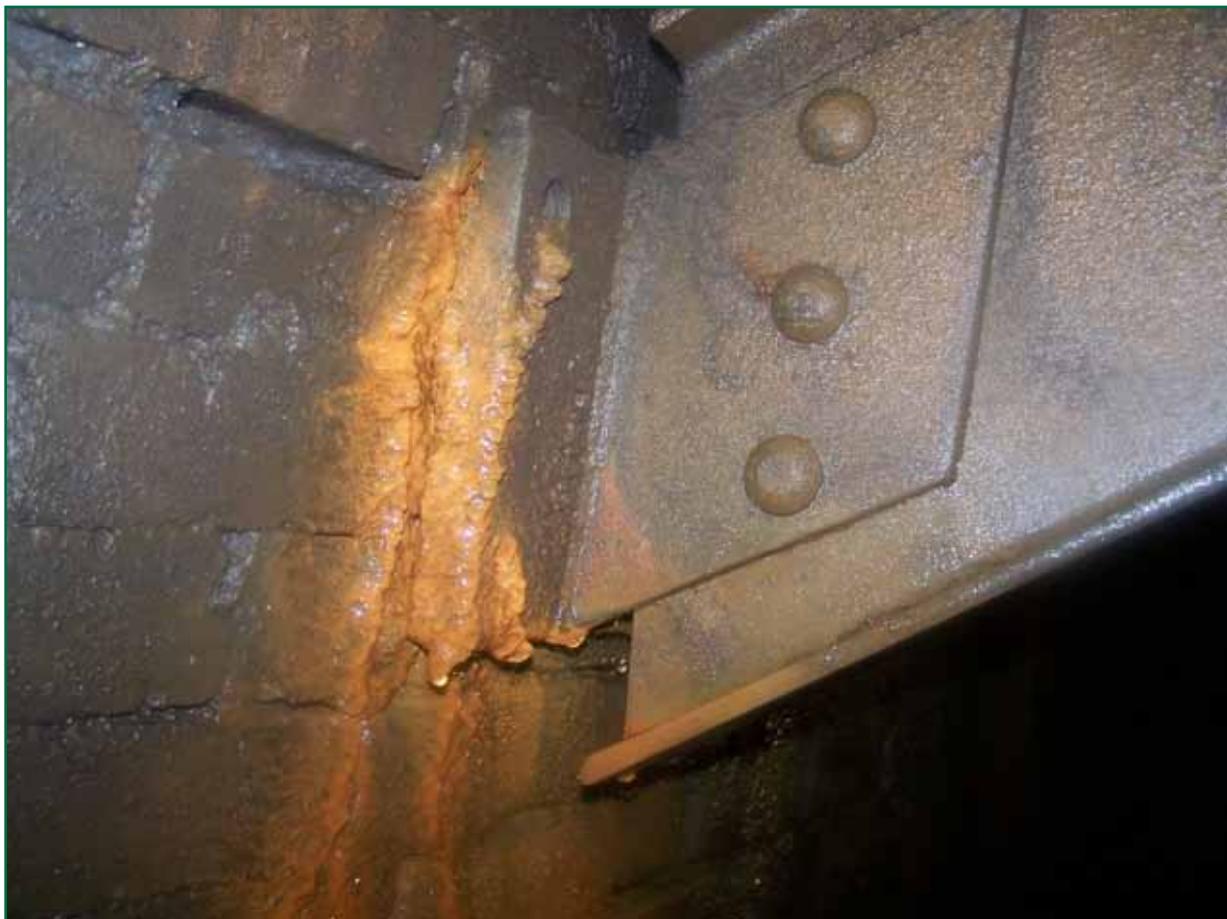
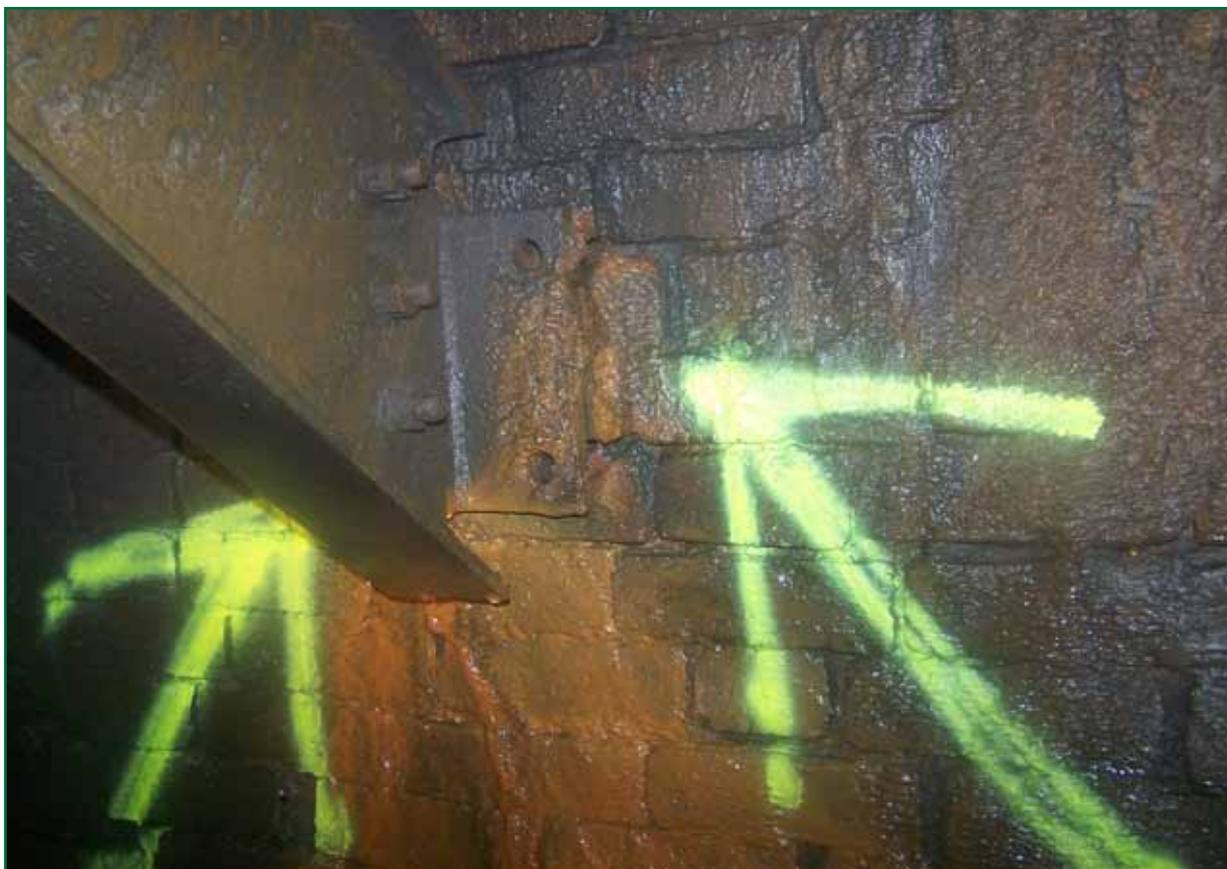
69 The October 2008 examination was part of a *detailed examination* which was not completed on site until January 2009. However, in November 2008, Atkins’ tunnel engineer sent an email to Network Rail’s South East Territory Structures Management Engineer Tunnels (SME1) providing further information on the missing studs as an interim measure. He attached photographs of the unsupported beam end to the email (figures 18 and 19) and stated:

‘This is the specific platform beam bearing where all the bolts are inexplicably missing/sheared at the support that we discussed, discovered following limited access to this area at the latest detailed examination possession.’

‘I have sprayed the wall adjacent to highlight the defect... However, early placement of a full set of bolts at the support here must [be] the safest future solution.’

70 Although the email stated that the missing studs were located at tunnel chainage 36, the transverse beam affected was beam 5 of tray 5 above the down line. This beam is located at tunnel chainage 34, and will be referred to at this location hereafter. Some tunnel chainage marker plates were missing or wrongly spaced within the tunnel, making it difficult for examiners to accurately record the location of defects.

Figures 18 and 19: Missing studs at chainage 34 in November 2008 (photographs courtesy of Network Rail)

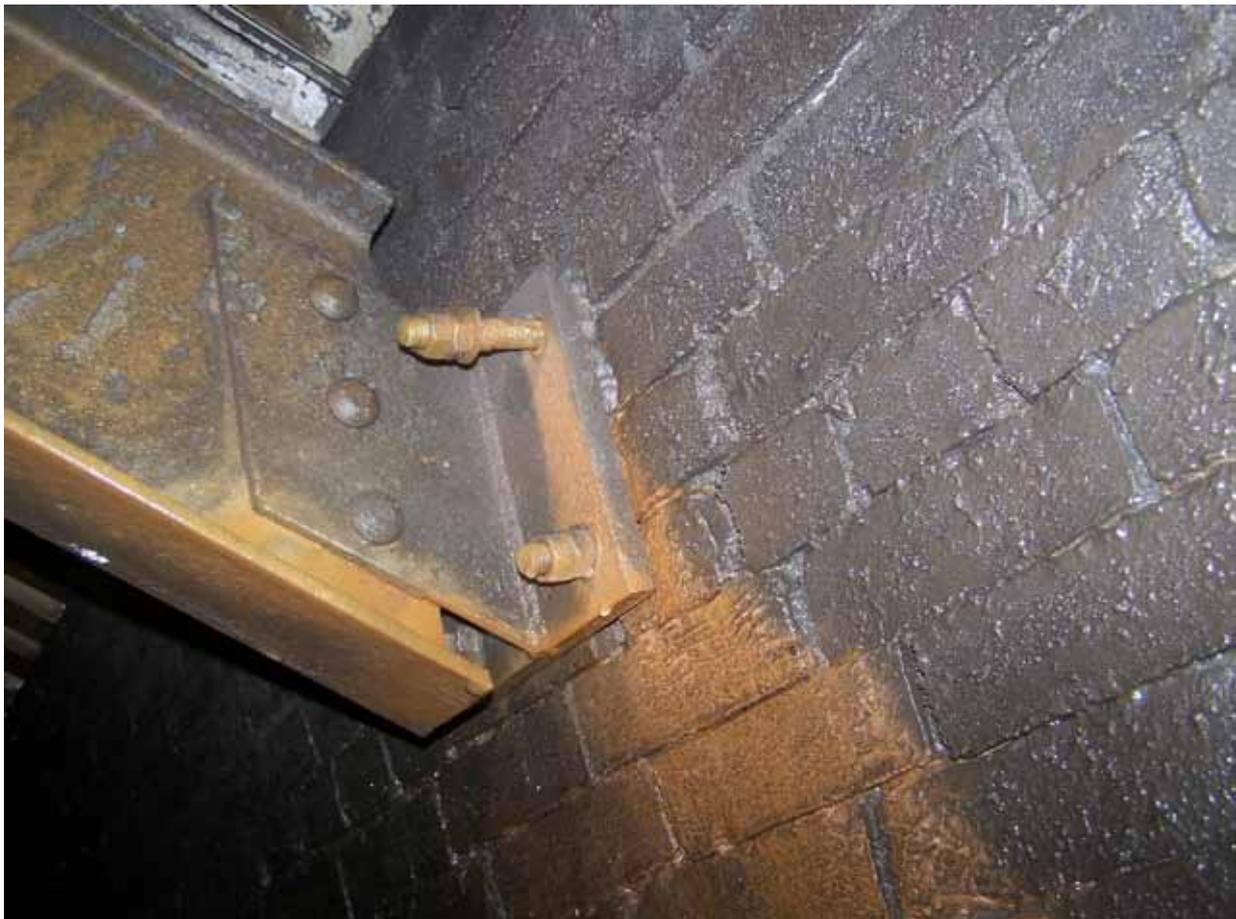
73 In his emails sent in March 2009, Atkins’ tunnel engineer also advised SME1 to assume that 50 studs needed replacing or re-drilling (25 on each side throughout the tunnel) and enclosed a photograph of a typical loose stud (figure 20).

Figure 20: Loose stud sent to SME1 in March 2009 (photograph courtesy of Network Rail)

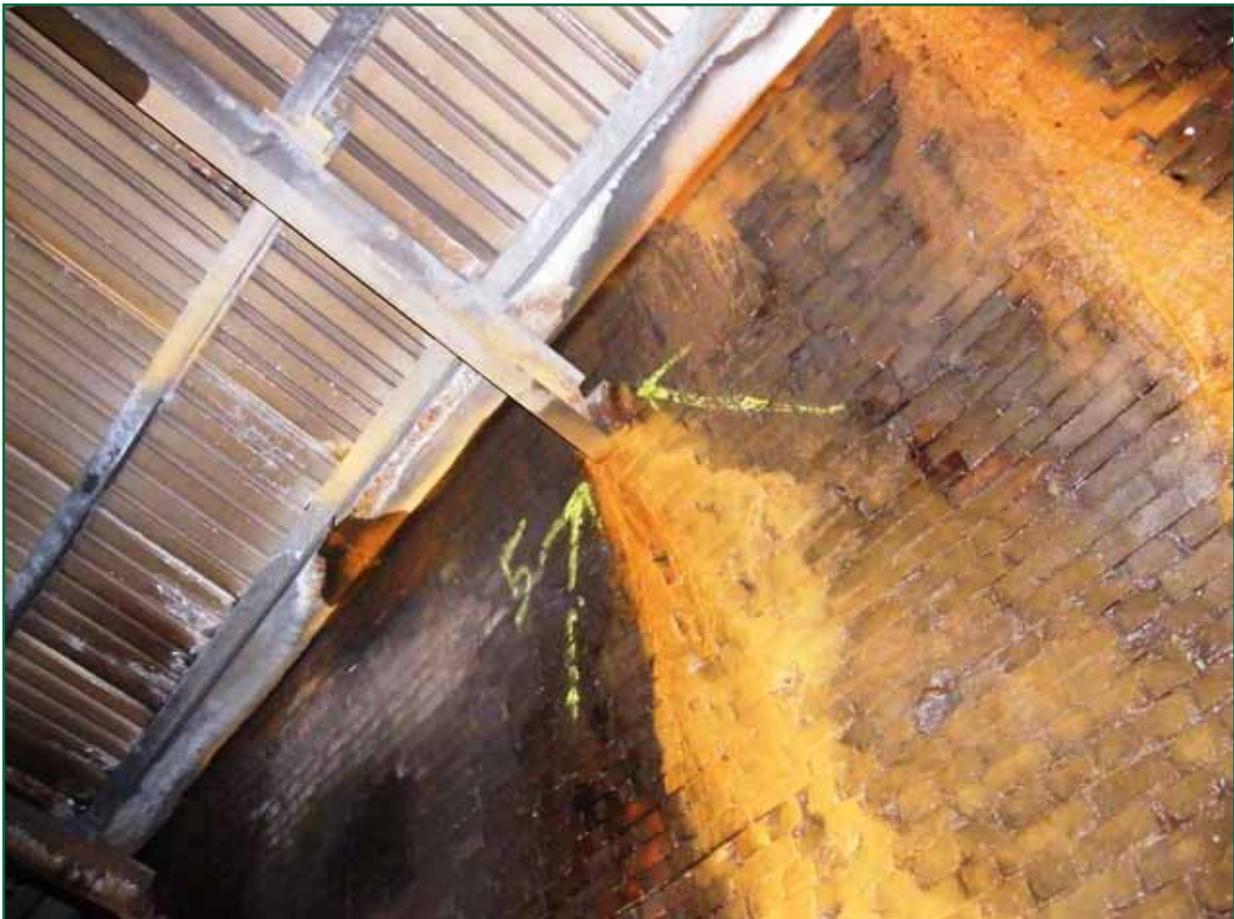
- 98 SME1 forwarded the email to SME2 because by June 2011, following an internal reorganisation, he was no longer responsible for Balcombe tunnel. However, as he was now a structures manager (paragraph 80), he provided advice and guidance on tunnel issues to other staff as required. In his email to SME2, SME1 stated "the beam fixing should be resolved but can be planned". This would have suggested to SME2 that the work was not of an urgent nature. This may explain why SME2 had taken no action to address the defect at chainage 34 before the incident on 23 September 2011.

Figure 21: Missing studs at chainage 34 (June 2011) (photograph courtesy of Amey)

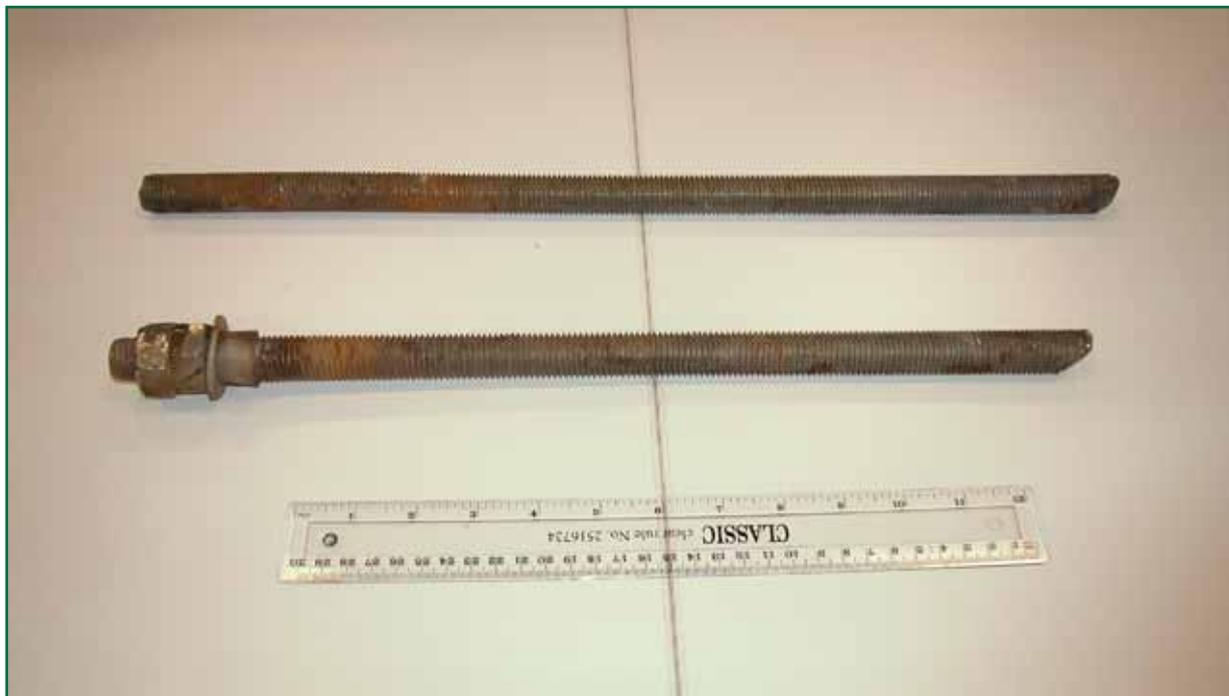
103 Amey's record of the briefing received from Network Rail states "Studding bar reportedly fell off sheeting and struck train" and "P Way walkthrough confirms that studding bar has come away from drainage sheeting." Amey's examiner was not informed that two (rather than one) studs had been found, or from where in the tunnel, and they were not made available for him to inspect (figure 22).

Figure 22: Studs recovered in March 2011 (courtesy of Network Rail)

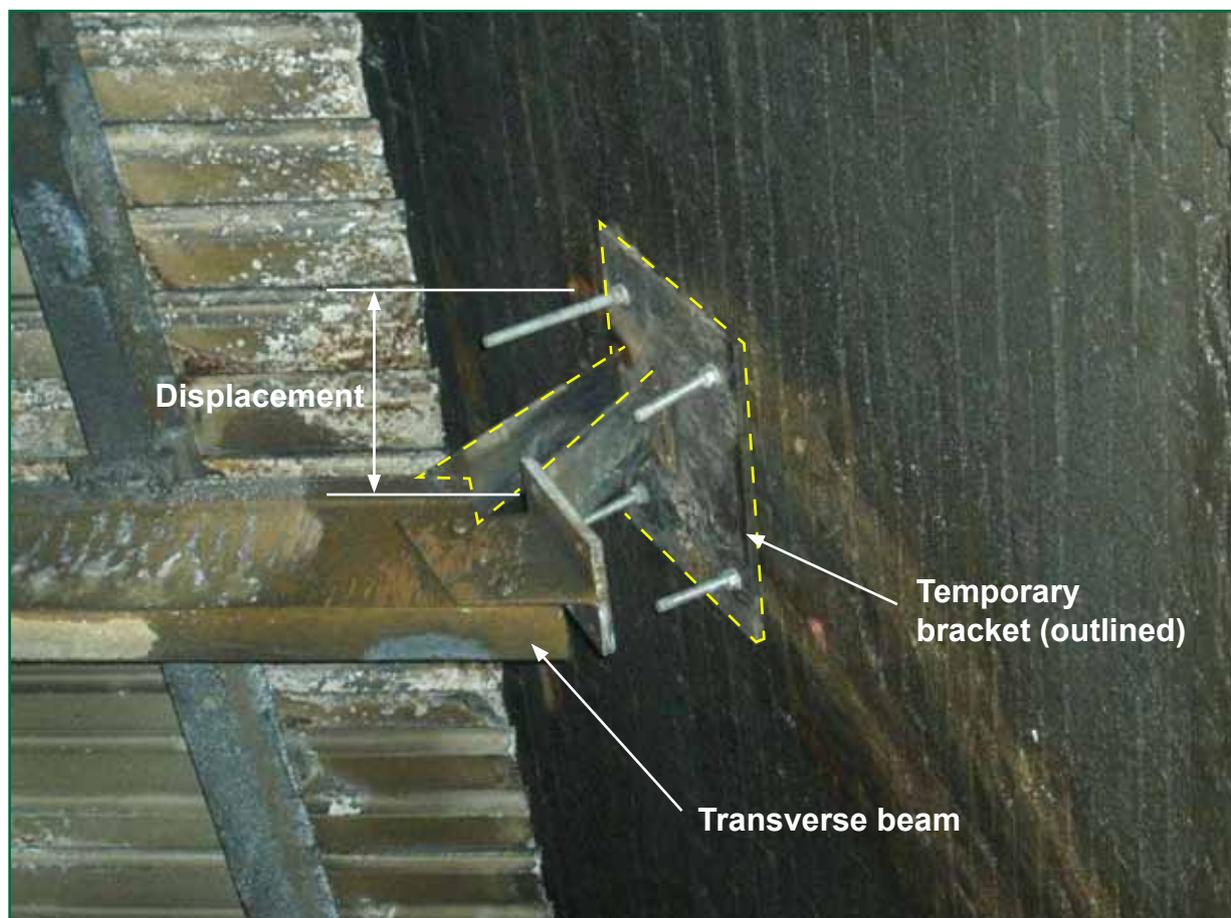
Figure 23: Temporary bracket supporting end of detached transverse beam 16

137 Network Rail arranged for temporary brackets to be fabricated and installed to support the three detached beam-ends in their deflected positions (figure 23) before the tunnel was reopened to traffic on 24 September 2011.

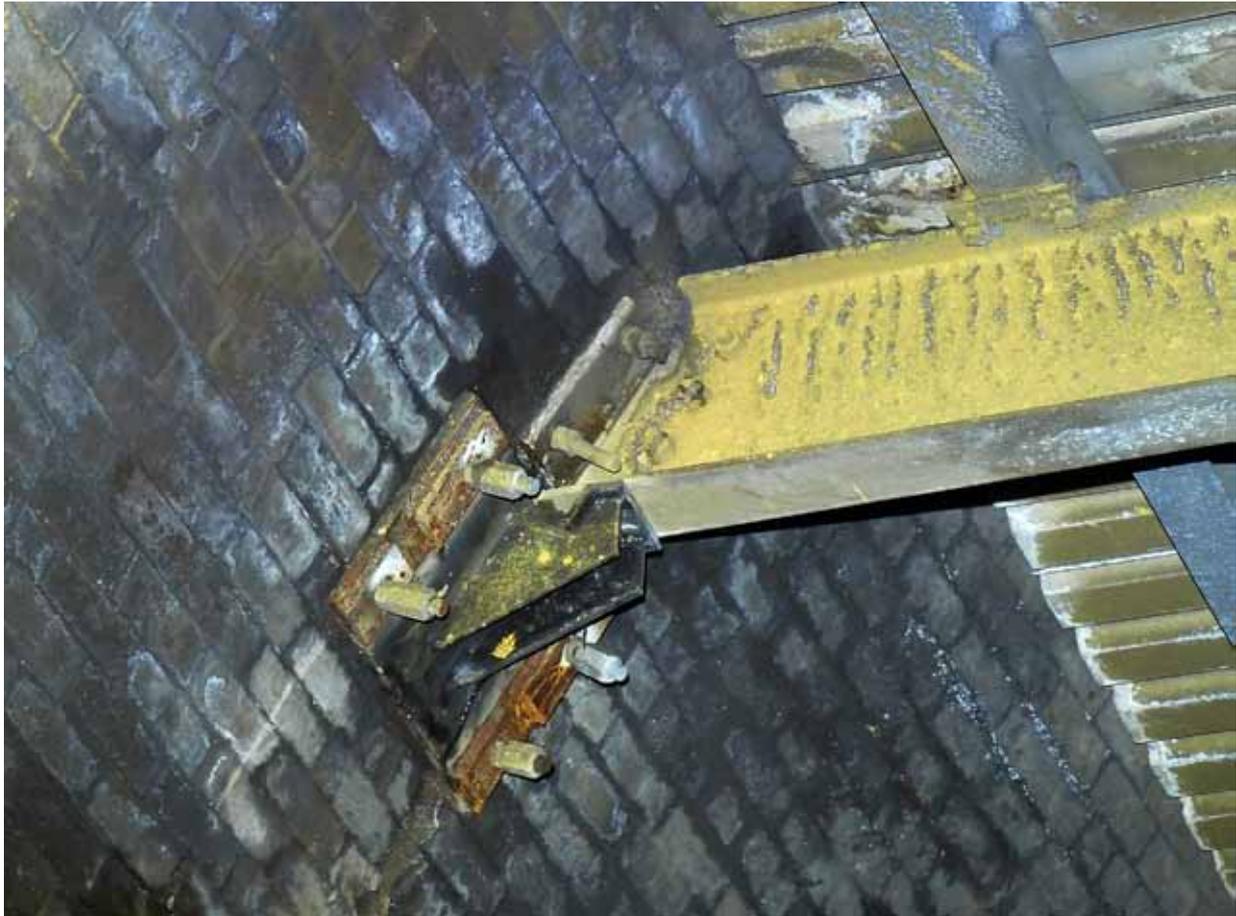
Figure 24: Transverse beam end after fitting of additional support bracket post-incident

138 The five southernmost beams of tray 5, including the three deflected beams, were subsequently removed, which resulted in the tray being shortened by 20 metres. Further work undertaken in the tunnel included the provision of brackets to provide additional support to the transverse beams remaining in the tunnel (figure 24).
