Rail Accident Investigation Branch

# Rail Accident Report

## **Collision of a road-rail vehicle with a buffer stop at Bradford Interchange station 25 March 2012**

Report 09/2013  
July 2013

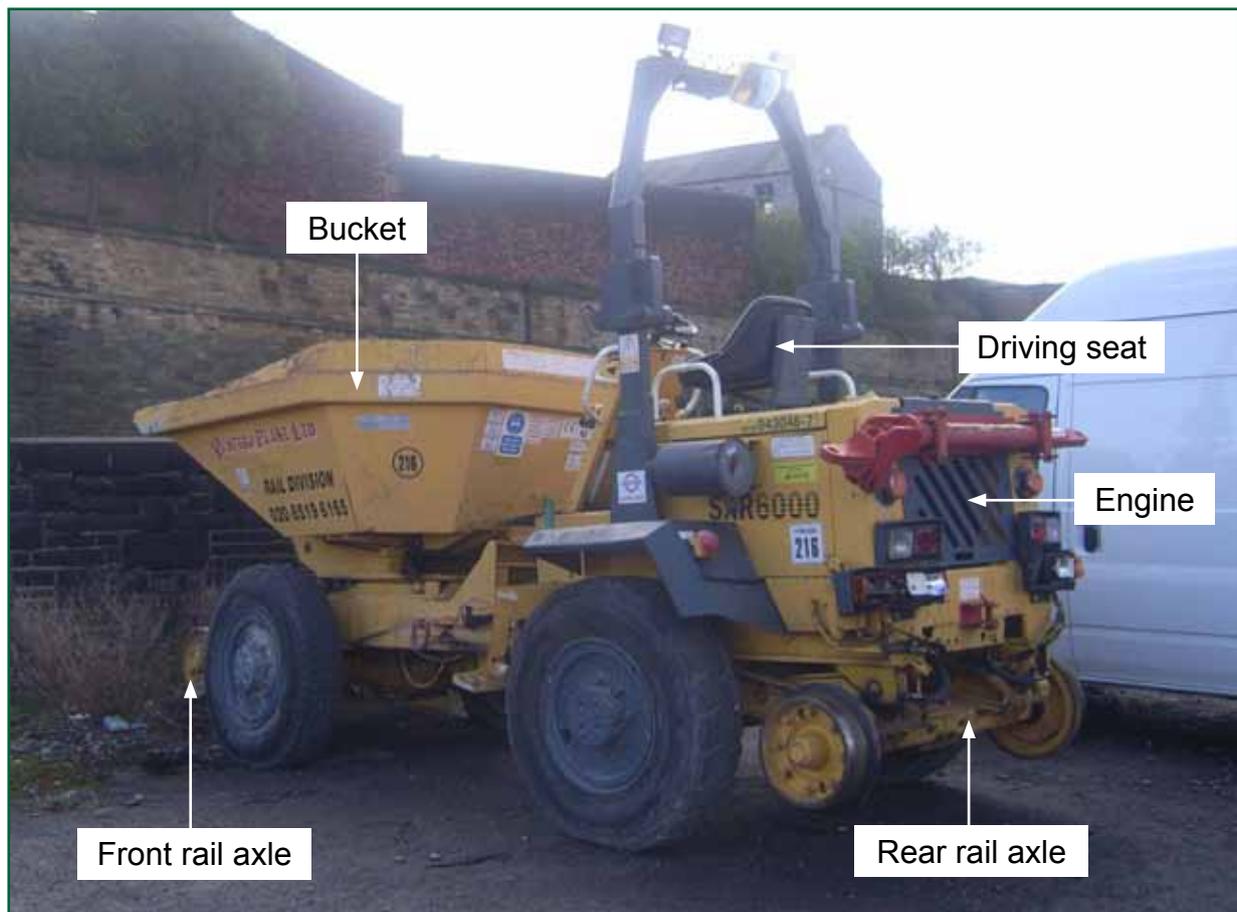
Figure 2: Dumper 216

- 13 The vehicle involved in the accident was a 'Barford' dumper, number 216 (Network Rail No. 99709 943048-7), owned by Quattro Plant Limited (figure 2). This was a road-rail vehicle (RRV) capable of operating on both ordinary terrain and railway track.

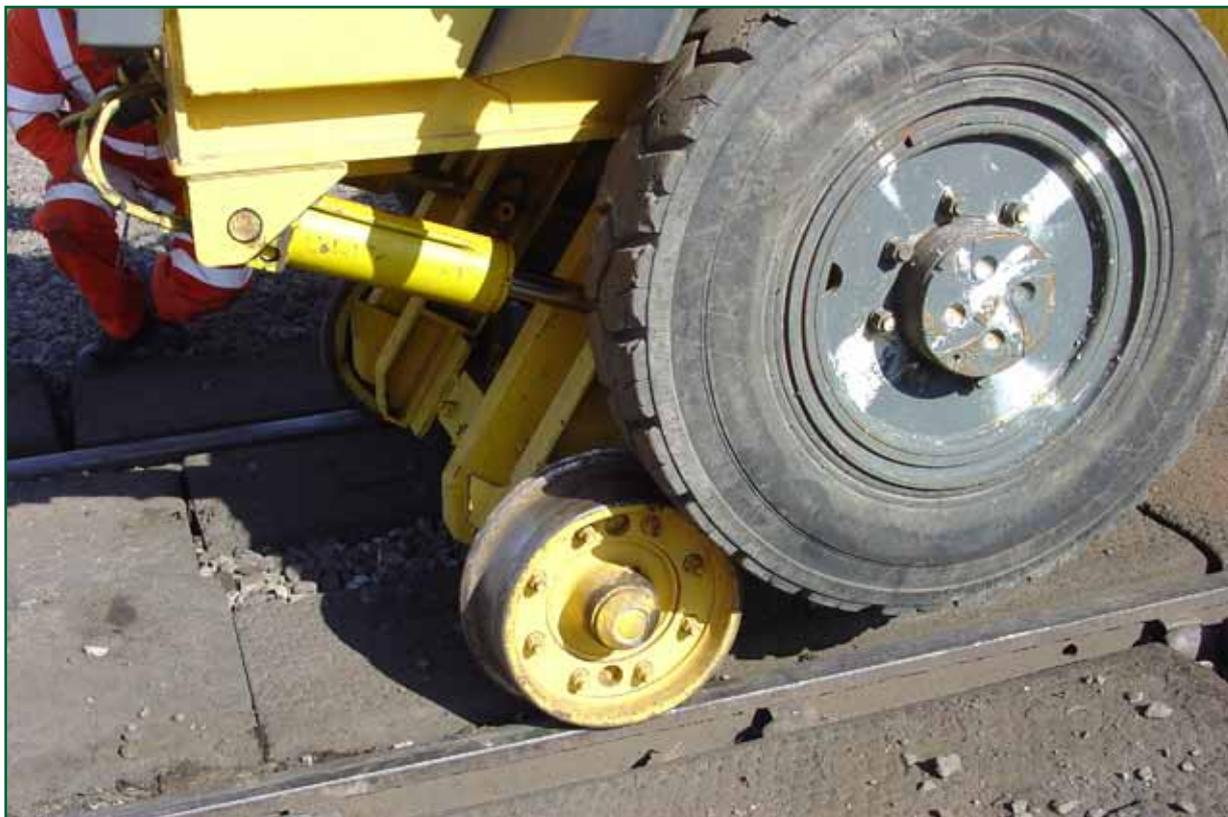
Figure 3: Rear rail axle in fully lowered position

- 14 Dumper 216 (and its sister machine 217) were acquired by Quattro in April 2005. These were the only two Barford dumpers that Quattro owned that, at the time of the accident, were certified for use on both Network Rail and London Underground infrastructures. Before they were acquired by Quattro they had both been converted for use on rail and were known as 'Type 9B high ride' RRVs. The rail modification consisted of the addition of two rail wheels at each end mounted on moveable axles which were pivoted on the chassis, and raised and lowered by hydraulic actuators (figure 3).

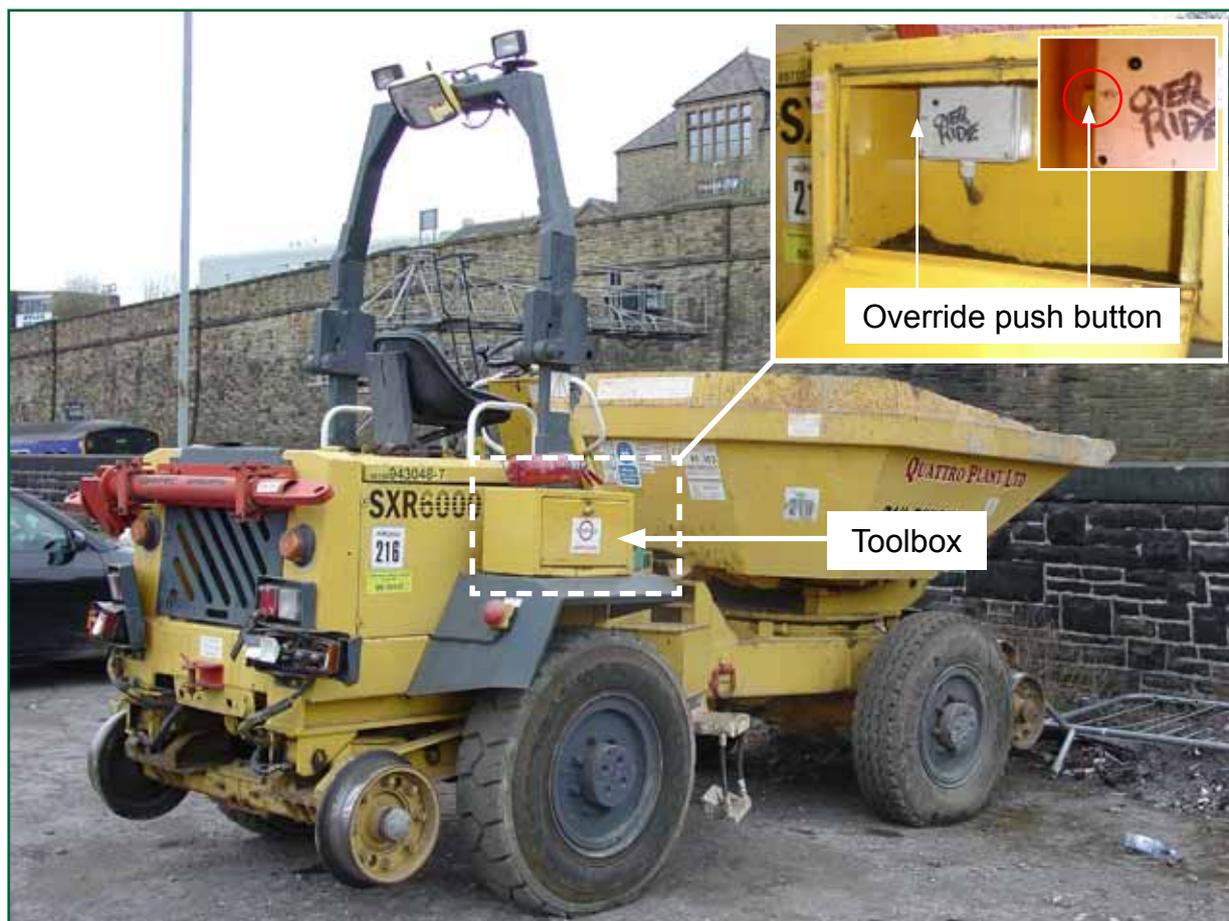
Figure 7: Location of interlock circuit box and override button

- 60 The override button on dumper 216 was positioned on the side of the interlocking circuit box which was located in the toolbox (figure 7). This was out of reach of the driver and therefore required that another person be present to operate it. This was intended to prevent inadvertent or improper use by the operator which could compromise the safe use of the machine. The button was intended to be used by fitters for recovery purposes.

Figure 6: Rail axle movement sequence when off-tracking

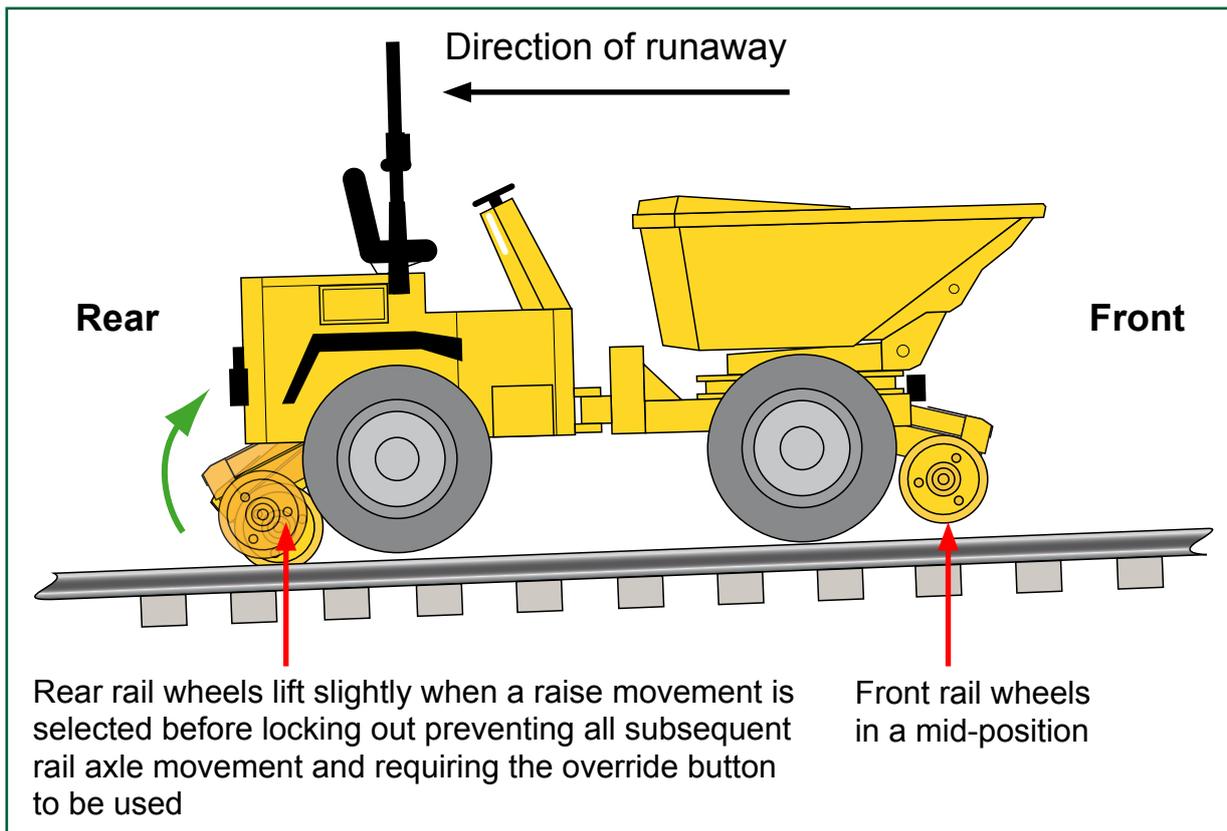
Figure 8: Effect of selecting an out-of-sequence movement of the rail axles when off-tracking dumper 216

- 65 Following this slight movement, further movement of both axles was prevented by the lockout (paragraph 58). To recover from this condition, it was necessary to press and hold the override button within the toolbox. If the override button was held pressed during any out-of-sequence movement of the rail axles, and then released, the lockout was restored and further rail axle movement was again prevented (ie the machine could lock out when neither rail axle was fully braked).

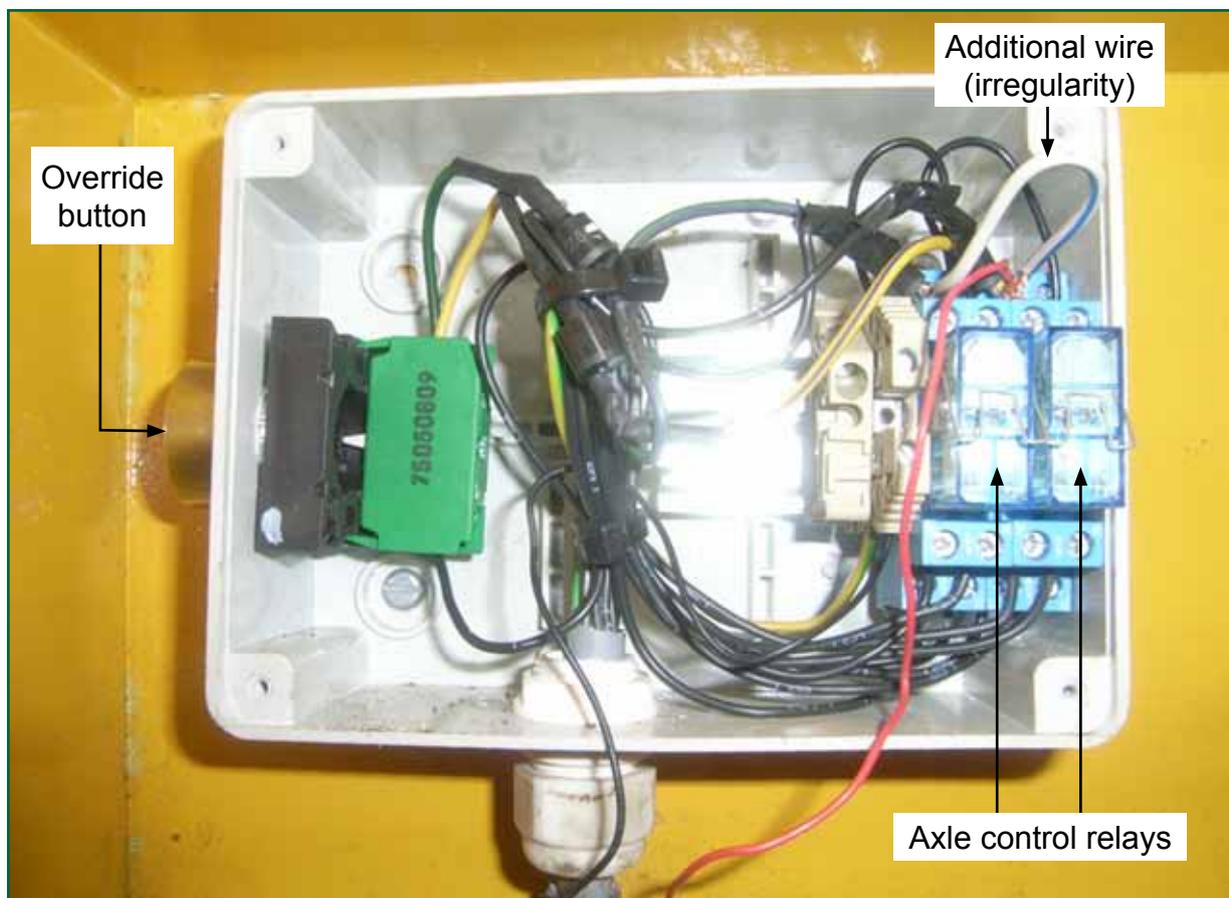
Figure 9: A view inside the axle interlocking circuit box on dumper 216

- 66 An examination of the dumper's interlocking electrical circuit found that there was a wire connected between terminals of the two electrical relays controlling the movement of the front and rear rail axles (figure 9). This wire was not shown on the electrical circuit diagram (paragraph 61h and figures 11 and 12).

- 67 The wire provided a parallel electrical feed to the coils of both relays controlling rail axle movements and was responsible for the performance of the rail axles as described in paragraph 64.

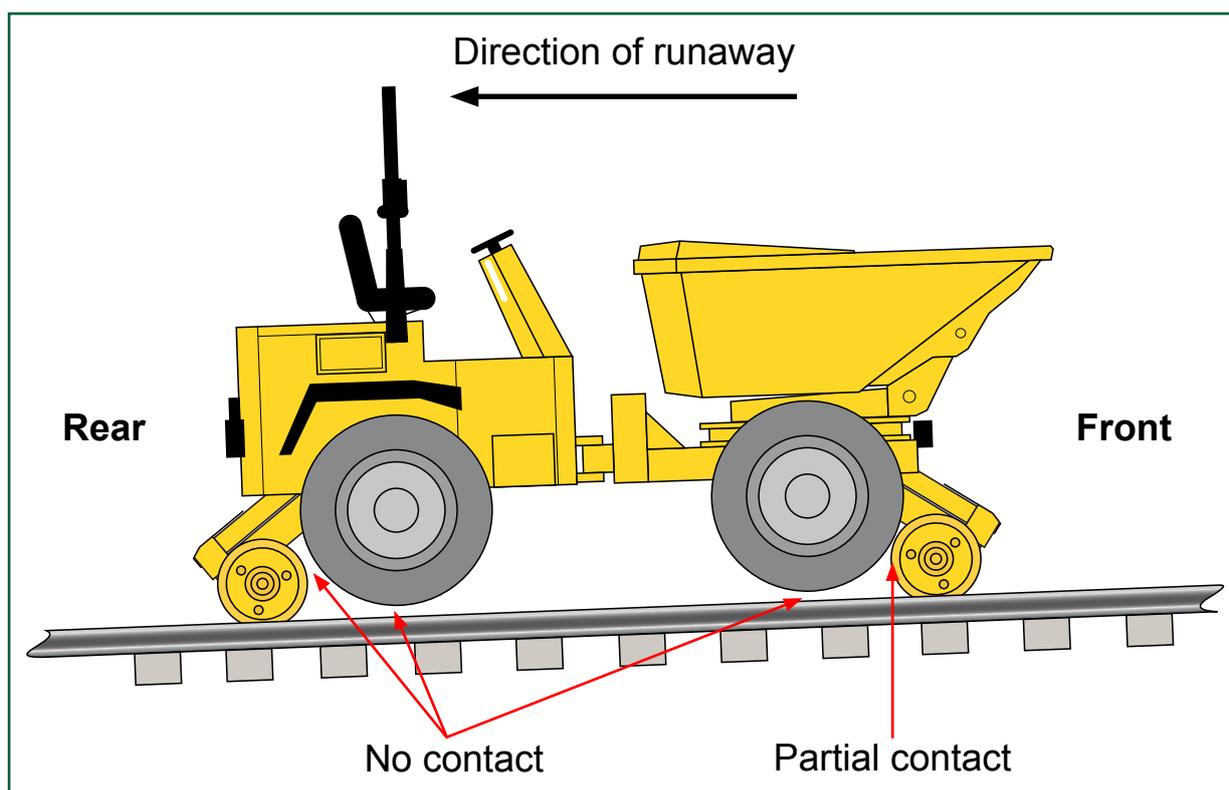
Figure 10: Positions of the road and rail wheels following the accident

- 73 The dumper was examined on site after the accident and before it was moved. All the road wheel tyres were found to be lifted clear of the rails. At the rear end of the dumper there was no contact between the road wheel tyres and the rail wheels (figure 10). Therefore the rear rail wheels were not braked during the runaway. Contact between the front tyres and the front rail wheels was less than the full squash condition that occurs when the rail axle is in its fully lowered position. There were scrubbing marks on the front tyres indicating that there had been slipping contact with the rail wheels. This suggested that there had been partial braking of the front rail wheels.

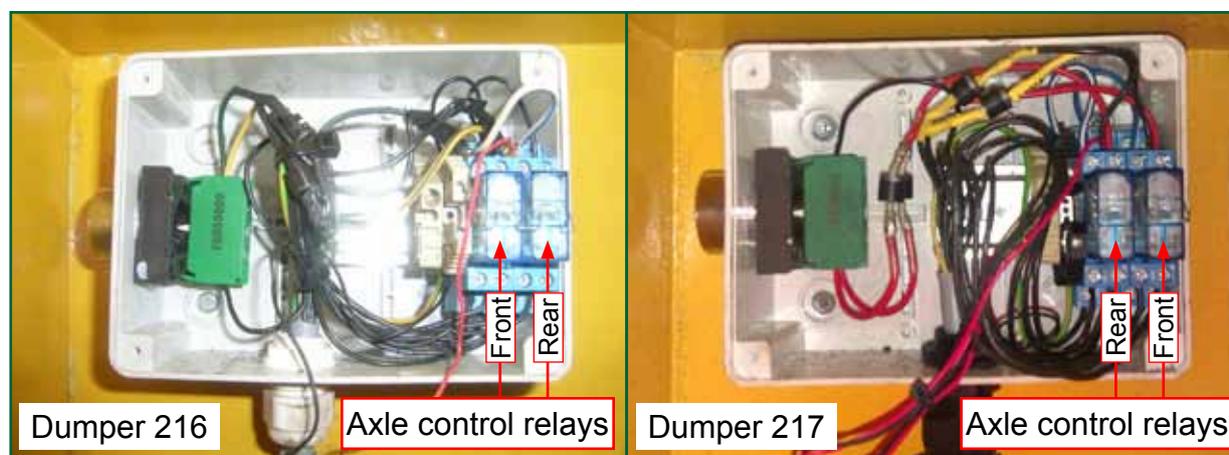
Figure 14: Views inside dumper 216 and 217 interlocking electrical circuit boxes

- 109 During the examination of the dumpers, the RAIB observed that the wiring of the interlocking circuit on dumper 216 was substandard (figure 14). Many of the connections between components were insulated by tape rather than heat-shrink insulation and the legs of components were connected directly to screw terminals. Even though the dumpers were of the same type, with a common design of interlocking circuit, the layout of the control relays was different, as were the rail axle control switches (paragraph 122). These differences are very unlikely to be as a result of tampering and are further indications that the installation of a safety critical system was not adequately controlled.

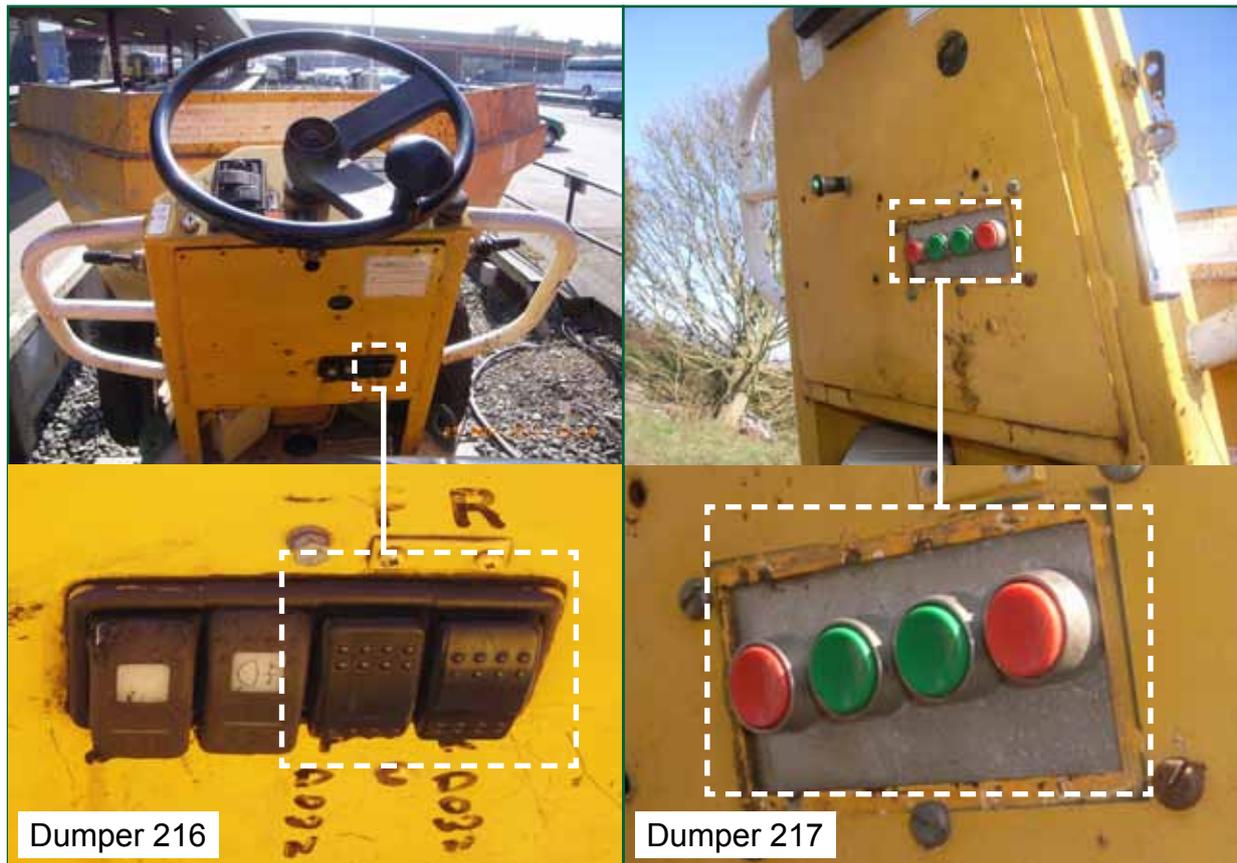
Figure 16: Rail axle control switches on dumpers 216 and 217

- 120 When off-tracking the operator pressed the front rail axle 'raise' rocker switch in error (paragraph 31) although this was the correct end to operate first when off-tracking. The design and positioning of the switches are considered likely to have contributed to his error in selecting the 'wrong' switch, particularly as he was wearing gloves. The switches were situated low down on the vertical panel beneath the steering wheel making them difficult to see (figure 16).

- 122 There were two rail axle switches on dumper 216 and these were three-position rocker types. Dumper 217, which the operator had recent experience of driving (paragraph 42), had four separate coloured push buttons (figure 16).

- 123 It is possible that the poor positioning and labelling of the control switches contributed to the accident.

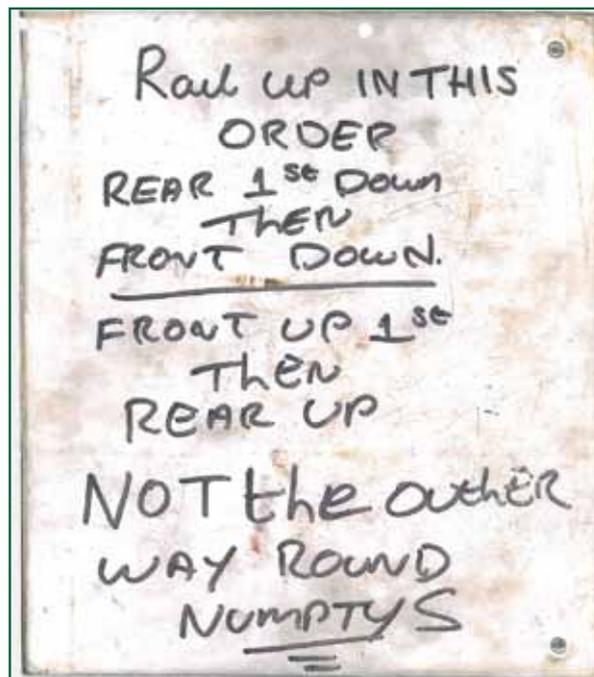
Figure 17: Note written on the back cover of the dumper's file kept within the toolbox

- 134 The dumper was dispatched to site with a wiring irregularity in a safety system.
- 135 There was a note on the back cover of the file in the toolbox of dumper 216. This was hand written in marker pen (figure 17). It informed operators and fitters of the correct sequence of operation of the switches to lower and raise the rail axles.

- 136 The presence of this note suggests that the dumper had probably previously locked out due to the wiring irregularity. There was no equivalent note on, or in, the file for dumper 217.
