Rail Accident Report

Collision between a train and a lorry and trailer on Llanboidy automatic half barrier level crossing 19 December 2011

Collision between a train and a lorry and trailer on Llanboidy automatic half barrier level crossing, 19 December 2011

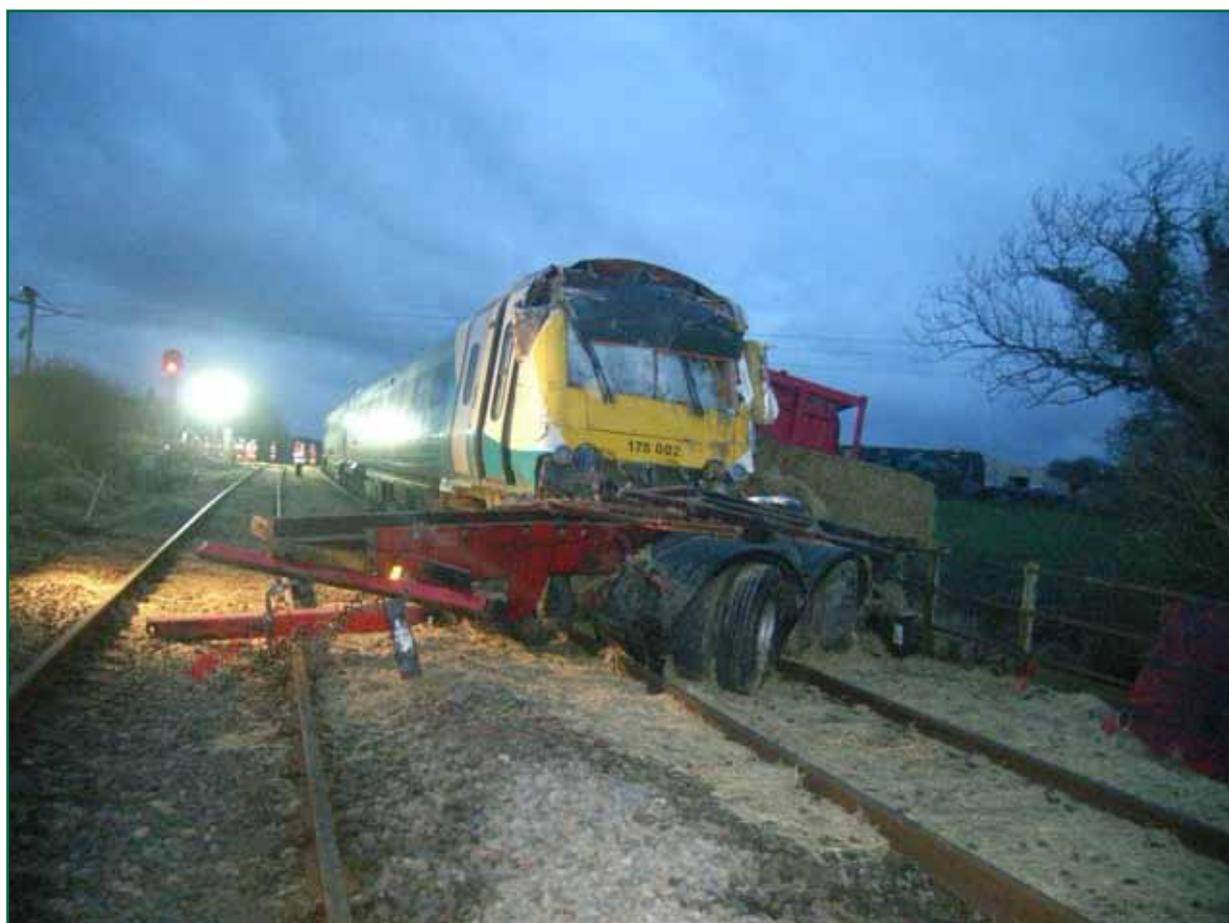
- 4 The impact between the train and the lorry caused the lorry to be separated from its trailer and pushed 78 metres along the track (figure 1). The lorry driver left his cab prior to the collision and was beside the trailer when the impact occurred. He was struck a glancing blow by the trailer and was slightly injured.

Figure 1: The train and lorry where they came to rest after the accident (most of the straw has been removed)

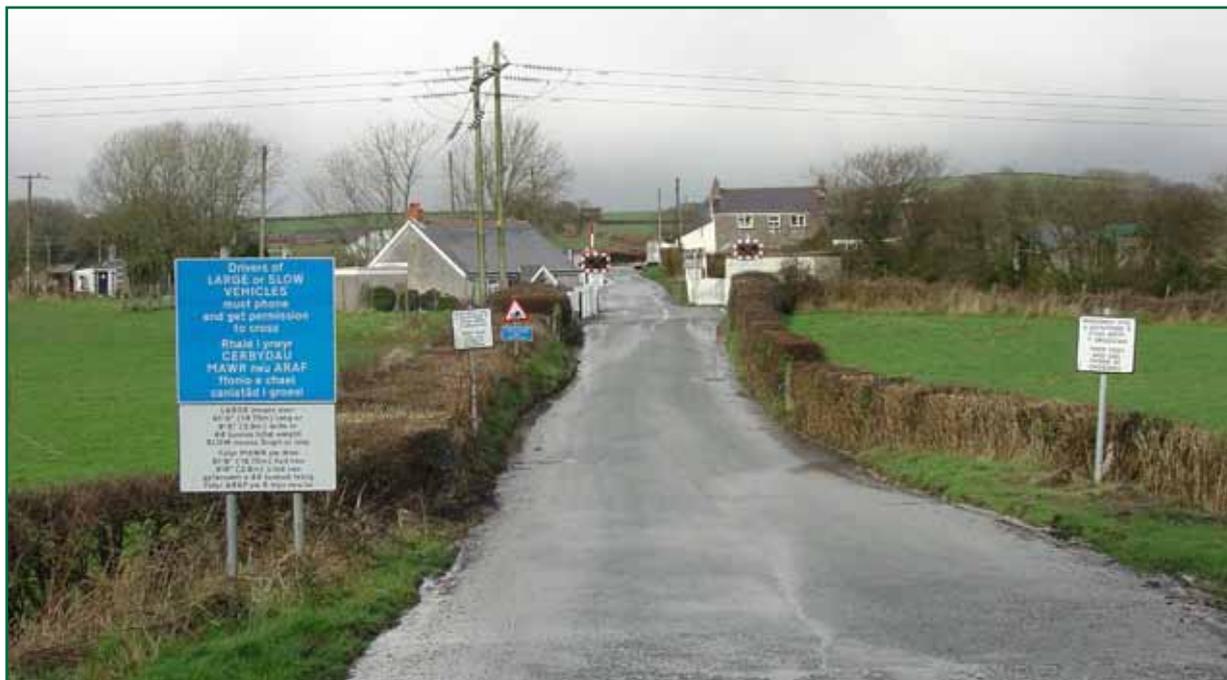
Figure 3: South approach to Llanboidy AHB crossing

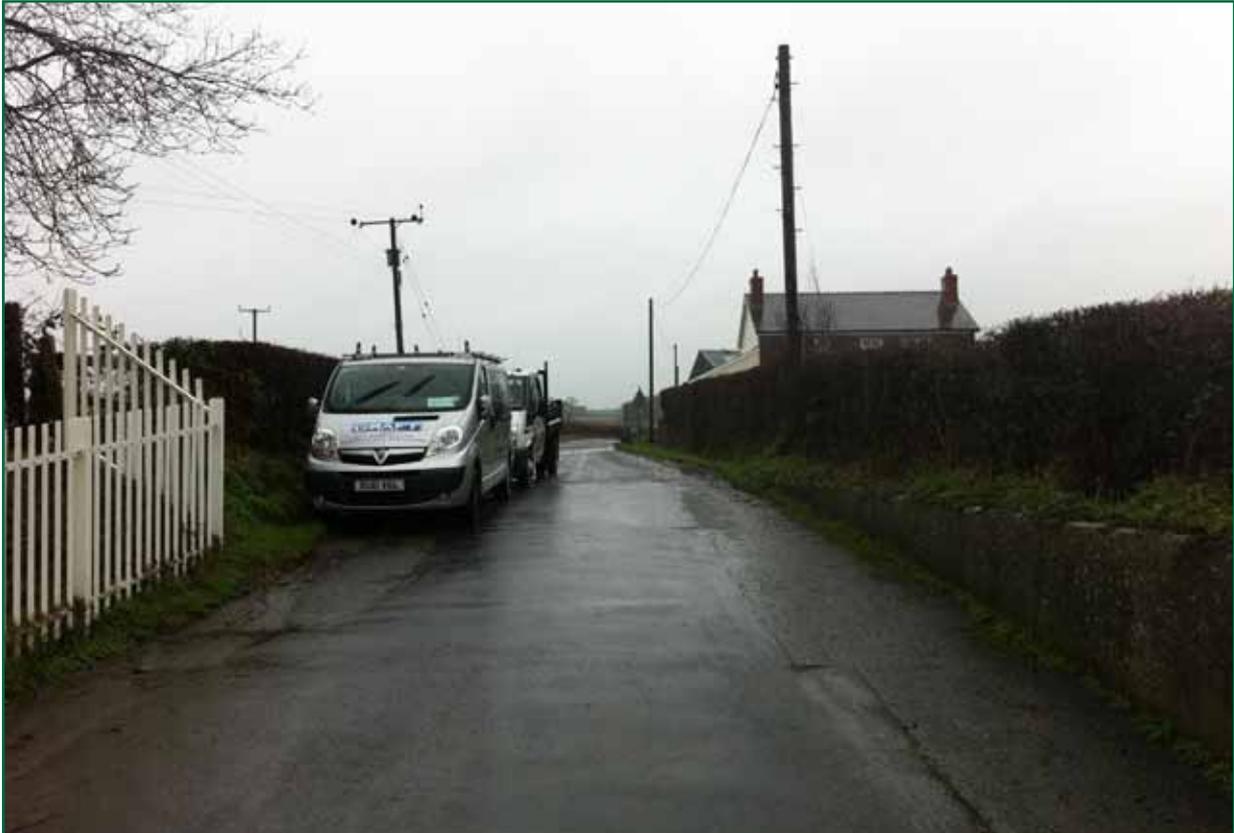
Figure 4: Road on the north side of Llanboidy AHB crossing showing parked vehicles (courtesy of BTP)

40 The contractors working on the line side parked their vehicles close to the crossing, partly obstructing the road on the exit from the crossing.

- 41 The road exit from the crossing at the north side narrows from 5 m at the crossing to 3.8 m, which is the width of the road on this side of the crossing. The narrowing of the road is all on the left-hand side, so that vehicles travelling northwards must move to the right-hand side as they leave the crossing. The position of the parked vans on the left forced vehicles to move to the right earlier than they would otherwise have done, bringing them closer to the half barrier on the exit side of the crossing (paragraph 33).

- 4 *The purpose of this recommendation is to prevent parked staff vehicles causing traffic to block back onto a level crossing, in particular vehicles of maximum legal dimensions.*

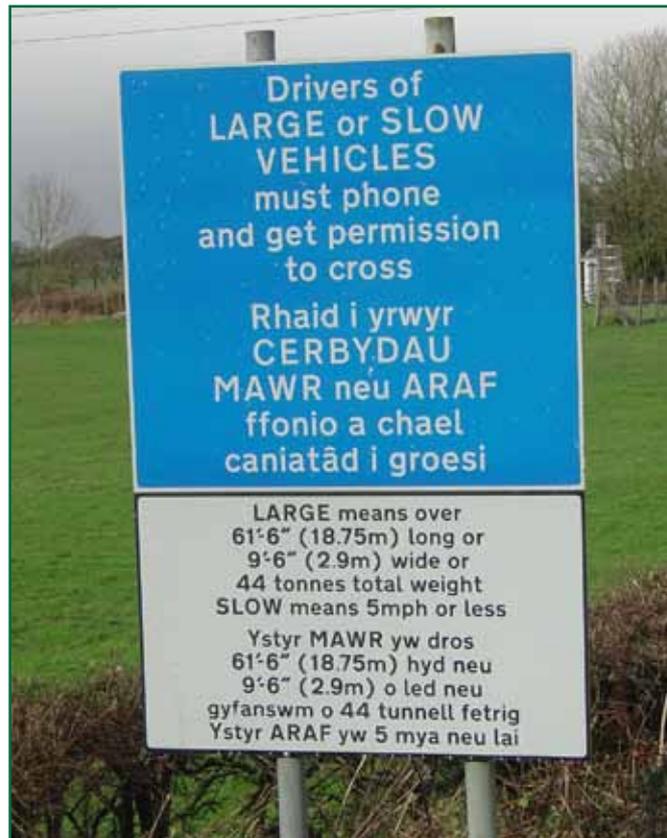
- 18 **The lorry driver did not telephone the signaller to get permission to cross the line, which he was required to do as indicated on the road signs on the approach to the crossing. Had he phoned, the signaller would have refused permission to cross because of the approaching train. This was a causal factor.**

- 20 The road signs on the approach to the crossing are standard signs defined in the Traffic Signs Manual⁷ and are the same as those provided at all AHBs in Great Britain (with the exception of the Welsh translation). They include one which states '*Drivers of LARGE or SLOW VEHICLES must phone and get permission to cross*'. Beneath the sign the terms 'large' and 'slow' are defined: '*LARGE means over 61'-6" (18.75m) long or 9'-6" (2.9m) wide or 44 tonnes total weight SLOW means 5 mph or less*' (figure 5). The length of the lorry was recorded in the Vehicle and Operator Services Agency (VOSA) vehicles database as 11.61 m and this dimension was broadly consistent with measurements made after the accident (the damage to the lorry made it impossible to measure its length accurately). The length of the trailer was recorded in the VOSA database as 9.81 m from coupling pin to the end of the trailer. However, the trailer was fitted with drop down flaps at the front and rear which extended its length and were in use at the time of the accident. The manufacturer's drawing of the trailer showed that it was 11.07 m long with the flaps extended. The combined length of lorry and trailer, when coupled together, was calculated as 21.48 m at the time of the accident. As this was longer than the length defined as 'large' on the sign (over 18.75 m), the driver should therefore have phoned for permission to cross the line.

Figure 5: Sign reminding drivers of large or slow vehicles to call signaller

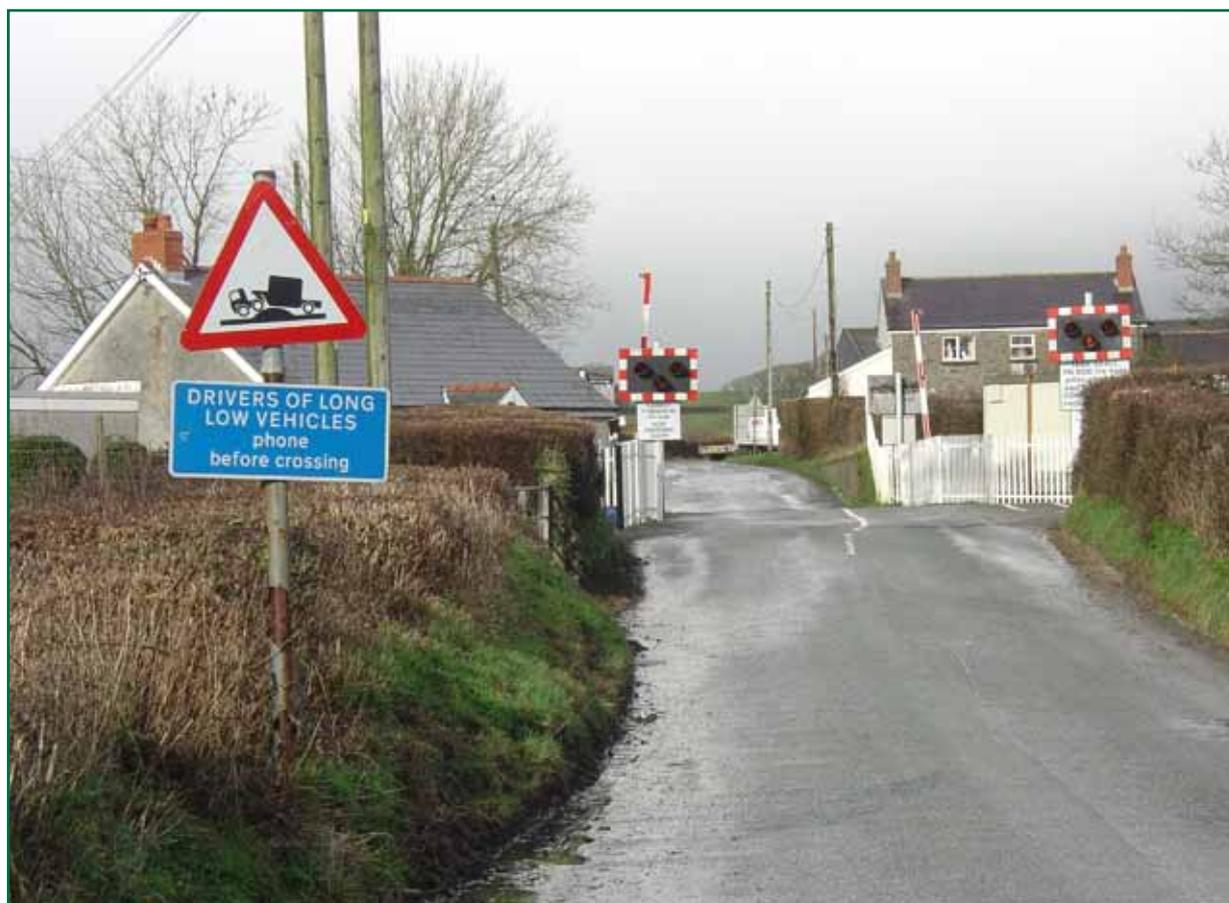
Figure 6: Uneven road warning sign on approach to crossing

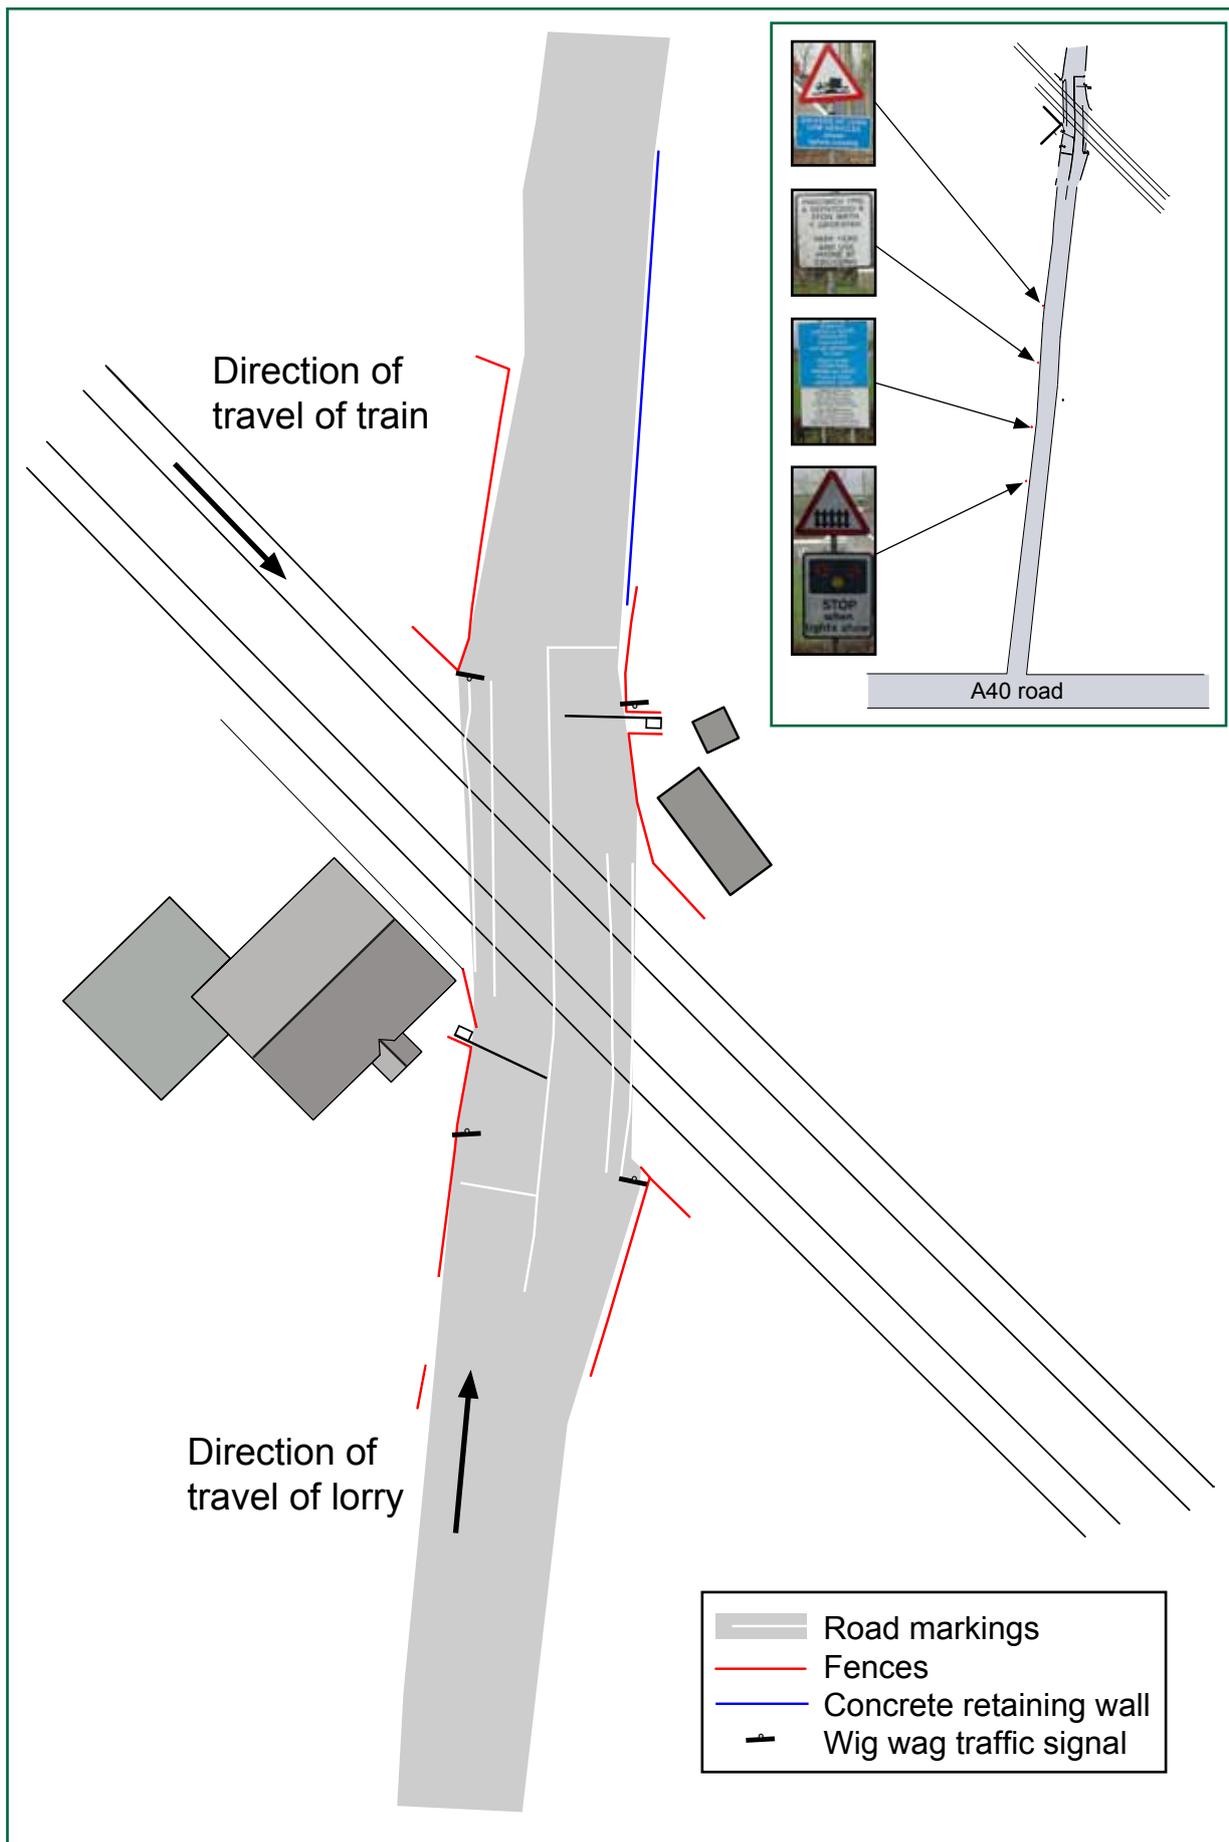
- 27 The centreline of the road over the crossing was at an angle of 6 degrees to the left of the line of the road approaches. The effect of this misalignment was to make the half barriers jut out into the path of a vehicle taking a straight line over the crossing (figure 7). The misalignment first arose when the crossing was converted from manually controlled gates to an AOCR. The road over the crossing was widened to comply with the minimum width of 5 m for an AOCR crossing specified in the Department of Transport publication '*Railway Construction and Operation Requirements – Level Crossings*'. Physical constraints meant that the road was widened on opposite sides of the road on each side of the crossing (on each side of the crossing the road was widened on its right-hand side). This caused the widened road over the crossing not to be parallel with the rest of the road.

Figure 7: Plan of the crossing (to scale)

- 1 *The purpose of this recommendation is to make the crossing, as viewed by a road user, more closely parallel to the rest of the road and hence provide a clear exit if the user is on the crossing when the barriers start to lower.*

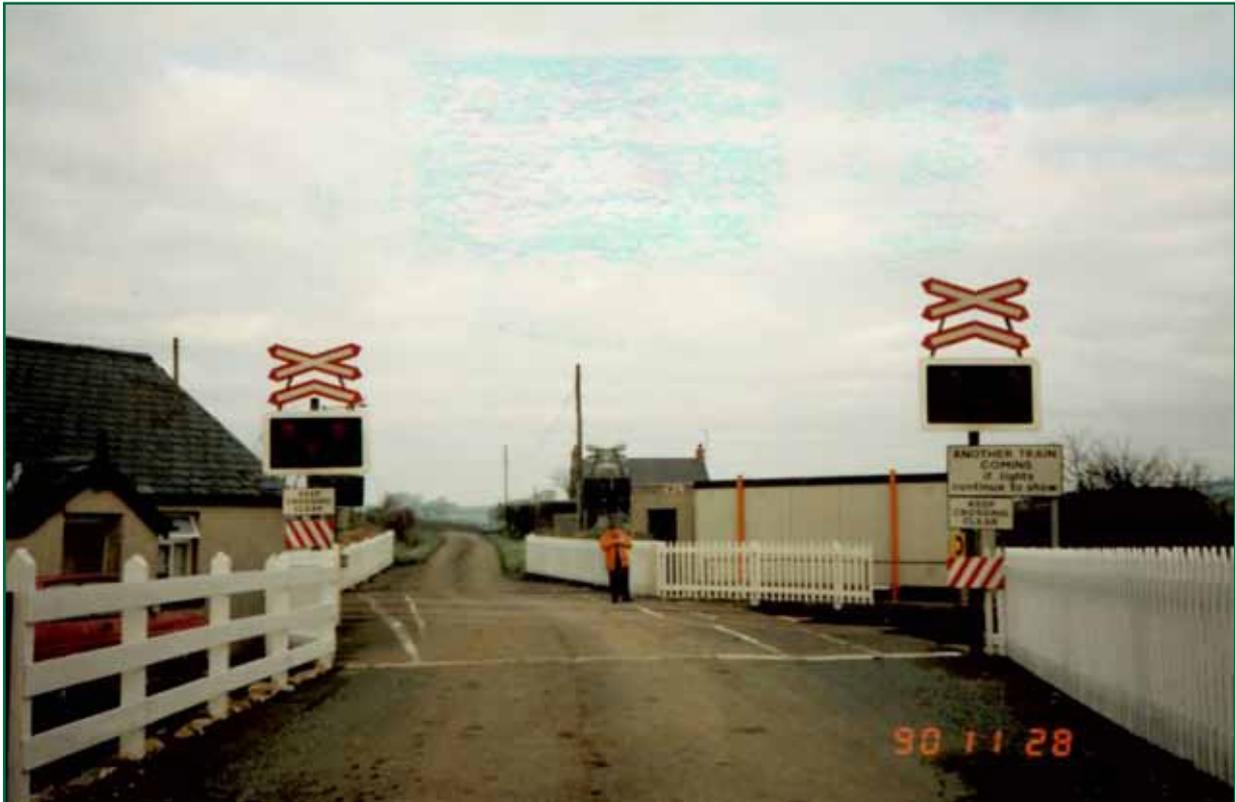
- 28 The Department of Transport Railway Inspectorate (RI) wrote to British Rail (BR - the infrastructure owner at the time) in April 1987 asking them to narrow the roadway over the crossing to 4 m and realign the edge markings as the road appeared skewed. This was done, though the date was not recorded. Figure 8 shows the crossing in November 1990 with the realigned edge markings.

Figure 8: Llanboidy crossing as an AOCR in 1990 (photo courtesy of Network Rail)

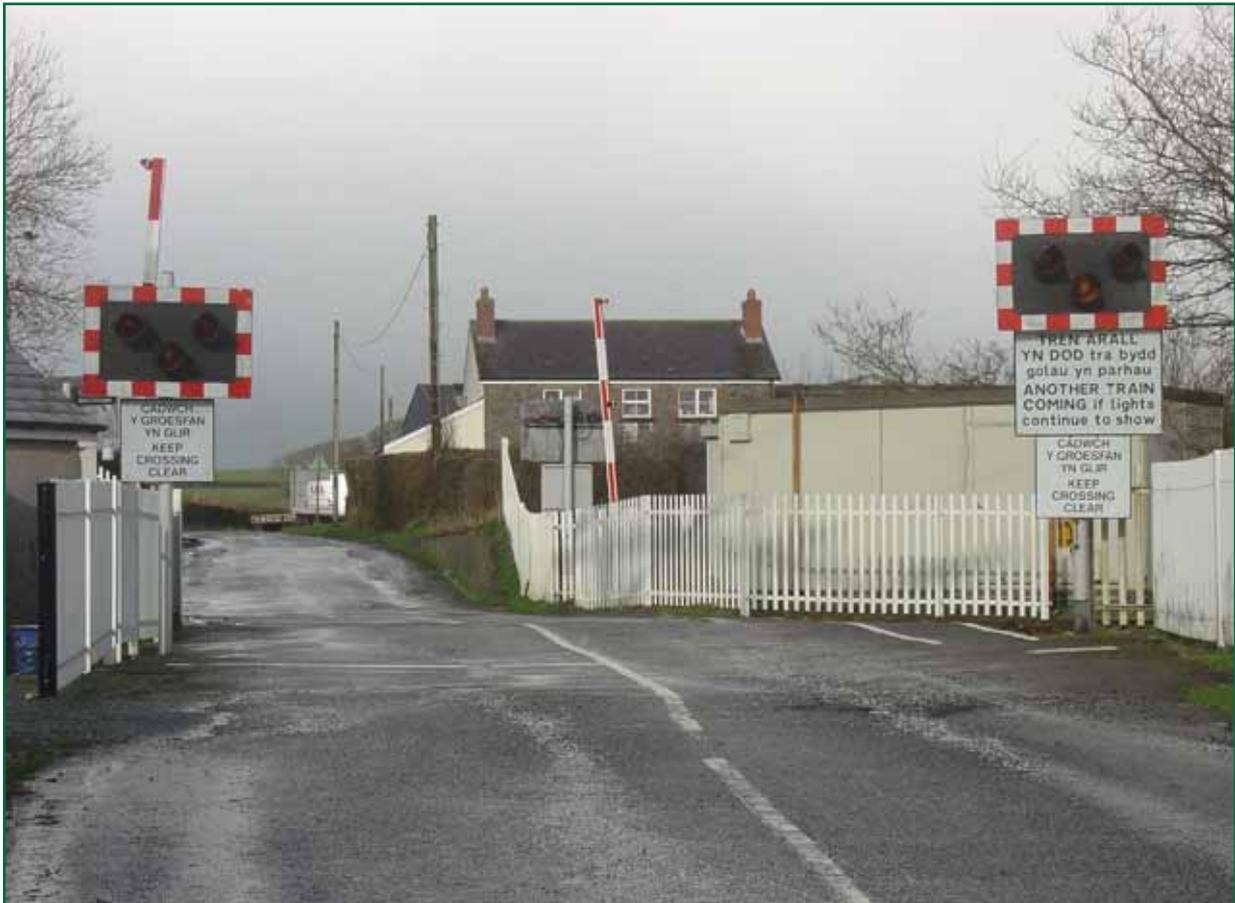
Figure 9: Wig wag signals at the south side of the crossing

- 34 The position of the wig wag light signals was shown on the crossing ground plan dated 25 June 1993 associated with the level crossing order¹⁰. The position was also specified in the Department of Transport's *Railway Construction and Operation Requirements – Level Crossings*; the same requirement is included in the current ORR guidance document *Railway Safety Publication 7 'Level crossings: A guide for managers, designers and operators'*. The position is defined as the distance between the nearest red light lens and the edge of the carriageway. This distance is defined as not less than 810 mm and not more than 1500 mm, meaning that the light unit backboard is clear of the carriageway. The position of the nearside wig wag unit on the south side of Llanboidy crossing did not comply with this requirement. The light unit was positioned at the edge of the carriageway and projected out into the carriageway by 1072 mm, meaning that the red lamp was 700 mm into the road rather than a minimum of 810 mm back from it (figure 9).

- 35 The combined effect of the wig wag signal being positioned too far out into the carriageway, the misalignment of the road over the crossing with the rest of the road and the position of parked vehicles on the far side (paragraph 40) would have been to encourage a lorry driver to take a line towards the right-hand side of the road. This line was obstructed by the half barrier on the far side lowering for the passage of the train.

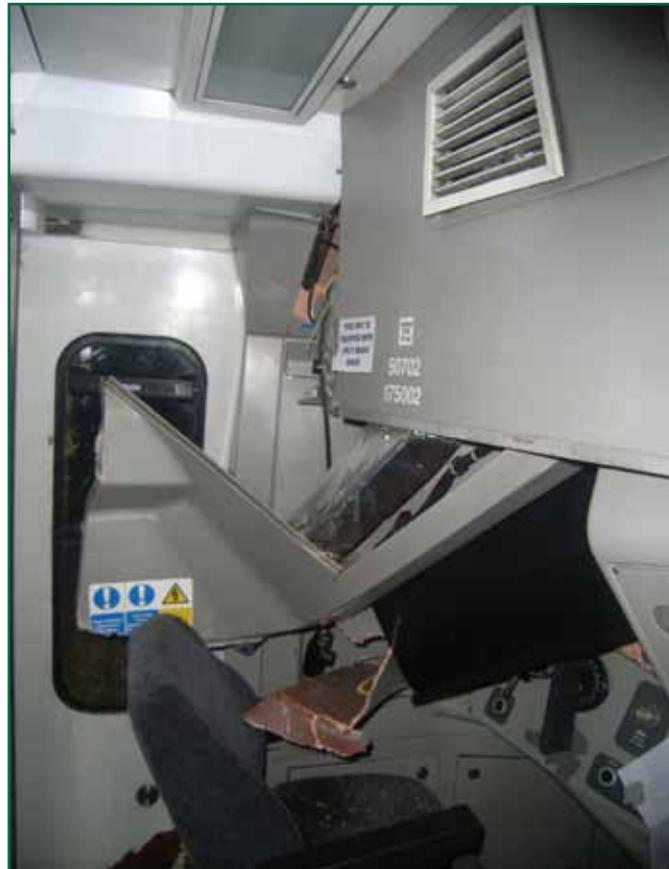
56 In the collision, the steel structure remained undamaged as the collision forces were not high enough to deform it. However the GRP skins became detached from the steel structure as they were hit by the lorry's load which pushed the skins towards the inside of the cab. Parts of the inner GRP skin intruded into the area around the driver's seat and compromised his survival space. It is likely that he would have sustained injury, had he not left the cab before the collision (figure 10). It should be noted that GM/RT2100 Issue 5 and the TSI, by reference to European Standard EN15227 '*Railway Applications – crashworthiness requirements for railway vehicle bodies*', now includes a specific definition of, and requirement for, a driver's survival space. This requires that deformation of the structure does not cause any vehicle equipment or parts to encroach into the designated survival space during the specified collision scenarios. RAIB calculations accounting for deformation of the obstacle showed that the collision scenario at Llanboidy was less severe than any of the EN 15227 scenarios for level crossing collision at a comparable speed.

Figure 10: Driver's seat showing position of GRP panels after collision

- 5 *The purpose of this recommendation is to find a means of mitigating the risk to the driver from detachment of the cab GRP structure during a collision.*
