Rail Accident Investigation Branch

# Rail Accident Report

## Fatal accident at Piccadilly Gardens, Manchester, 5 June 2011

Report 08/2012  
May 2012

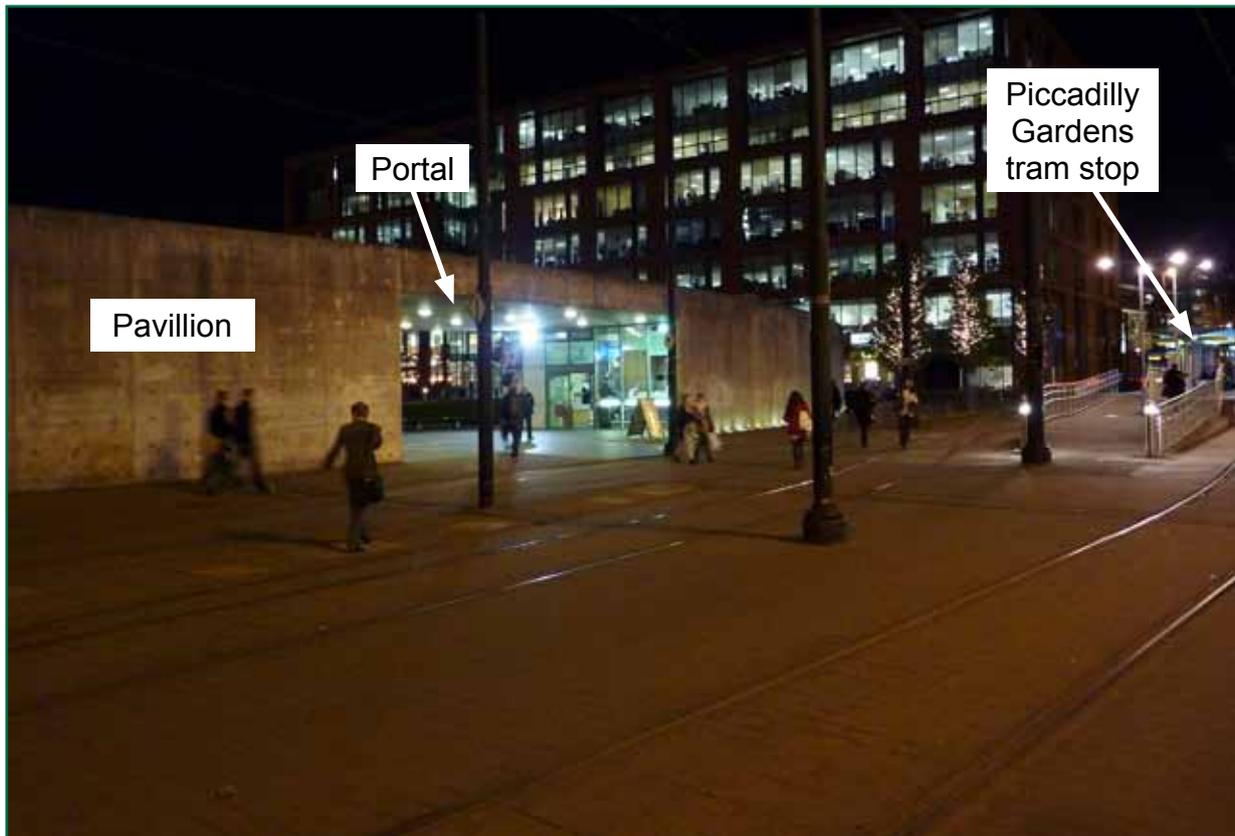
Figure 2: The Pavillion showing the portal entrance leading to/from Piccadilly Gardens

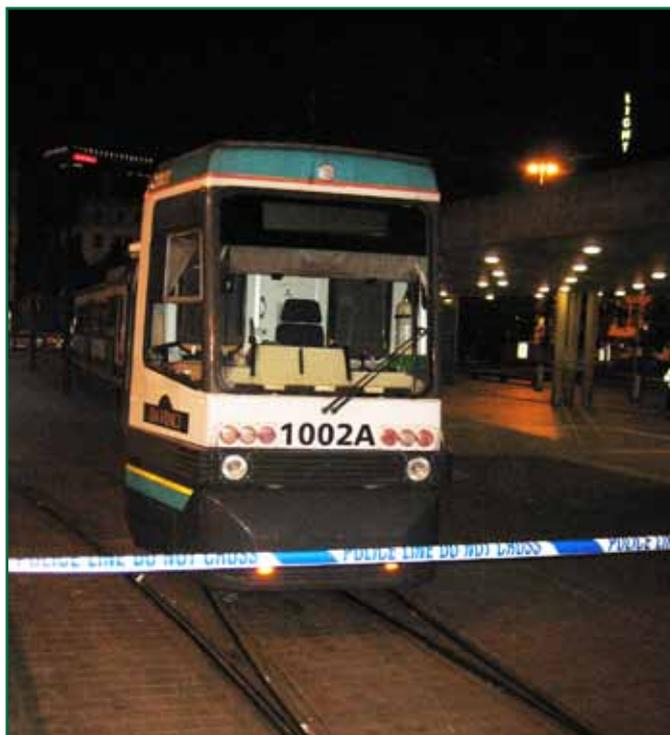
- 11 The tram involved in the accident was a T68 type, number 1002 (figure 3). This was one of the fleet of 32 T68 trams, built by Ansaldo, Italy, first introduced in 1992. It was travelling from Bury to Piccadilly Gardens tram stop.

Figure 3: The 'A'-end of tram 1002 at the accident site

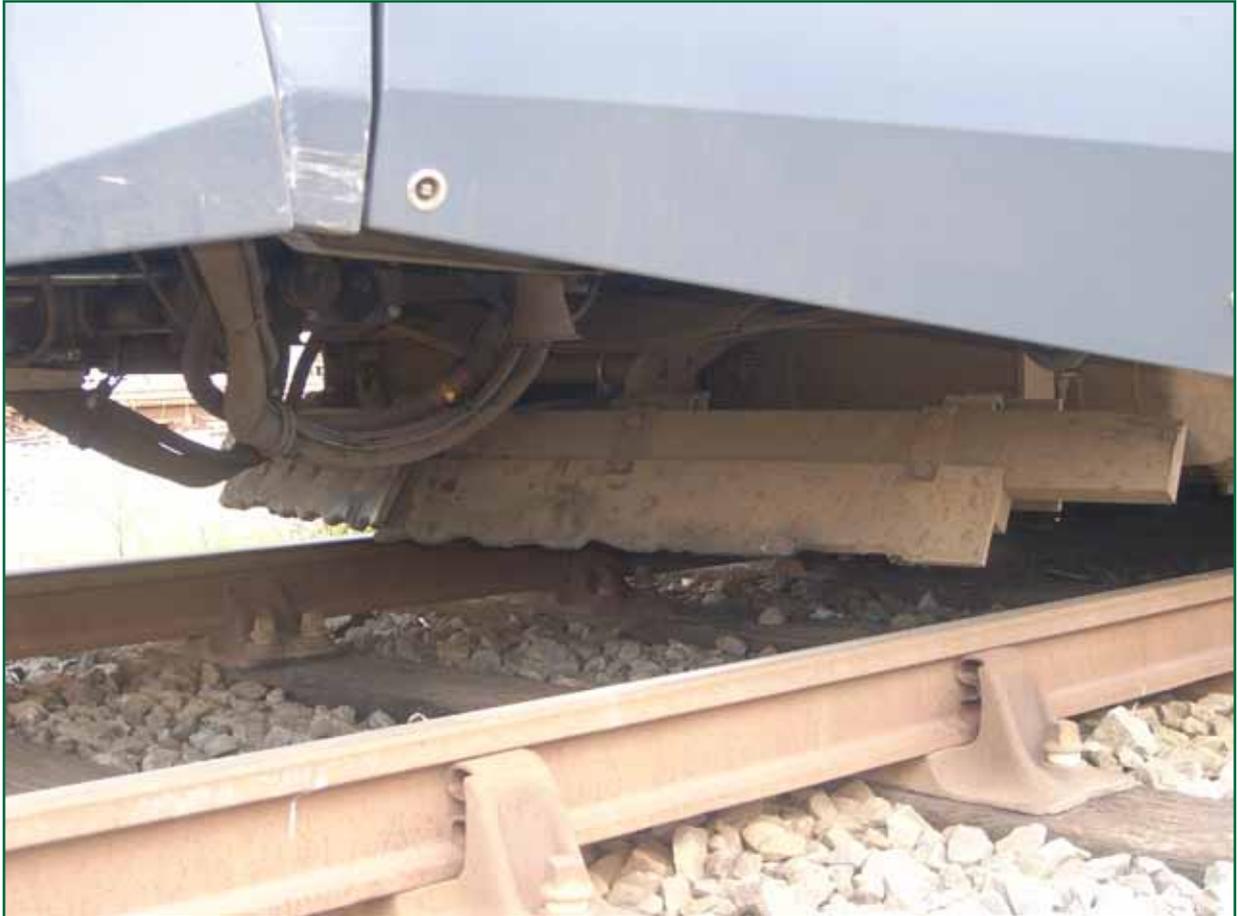
- 16 Tram number 1002 was fitted with a skirt around its ends and sides, together with a guard in front of the leading wheels (figure 4). The purpose of this guard, also known as an object deflector or under-run protector, is to prevent both people and objects from being run over by the tram's wheels. Figure 4 shows the tram in the depot; in Parker Street the paved surface is level with the tops of the rails.

- 17 The under-run protector on the leading end of the tram was mounted on the bogie frame (the metal frame equipped with the wheelsets), 1.4 metres back from the front of the tram. It consisted of two wooden sections fixed to metal support brackets and it spanned the full width of the bogie. On the leading end of tram 1002, the clearance between the lower edge of the wooden section and the road surface was 115 mm. Metrolink's design and maintenance instructions specify that this clearance should be 115 mm, with a tolerance of +/- 5 mm. Some clearance (ground clearance) is necessary between the underside of the protector and the paved highway to prevent contact between the protector and the rails and road surface when the tram meets changes in vertical curvature in the track.

- 18 On the lower edges of the wooden sections were 10 mm thick rubber strips. The rubber strips projected below the wooden sections giving a clearance of 80 mm between their lower edges and the road surface when on level track.

Figure 4: The under-run protector on the 'A'-end of tram 1002 (not at accident site); the notches in the rubber edge are caused by occasional contact with rail heads

- 76 The chest injury sustained by the pedestrian after he came into contact with the under-run protector was rated by the AIS severity scale as 'life threatening'. The injury graphs suggest that this would almost certainly be the case irrespective of age.

- 77 For the under-run protector to make contact with the chest, the protector had to be able to pass over the arm and shoulder.

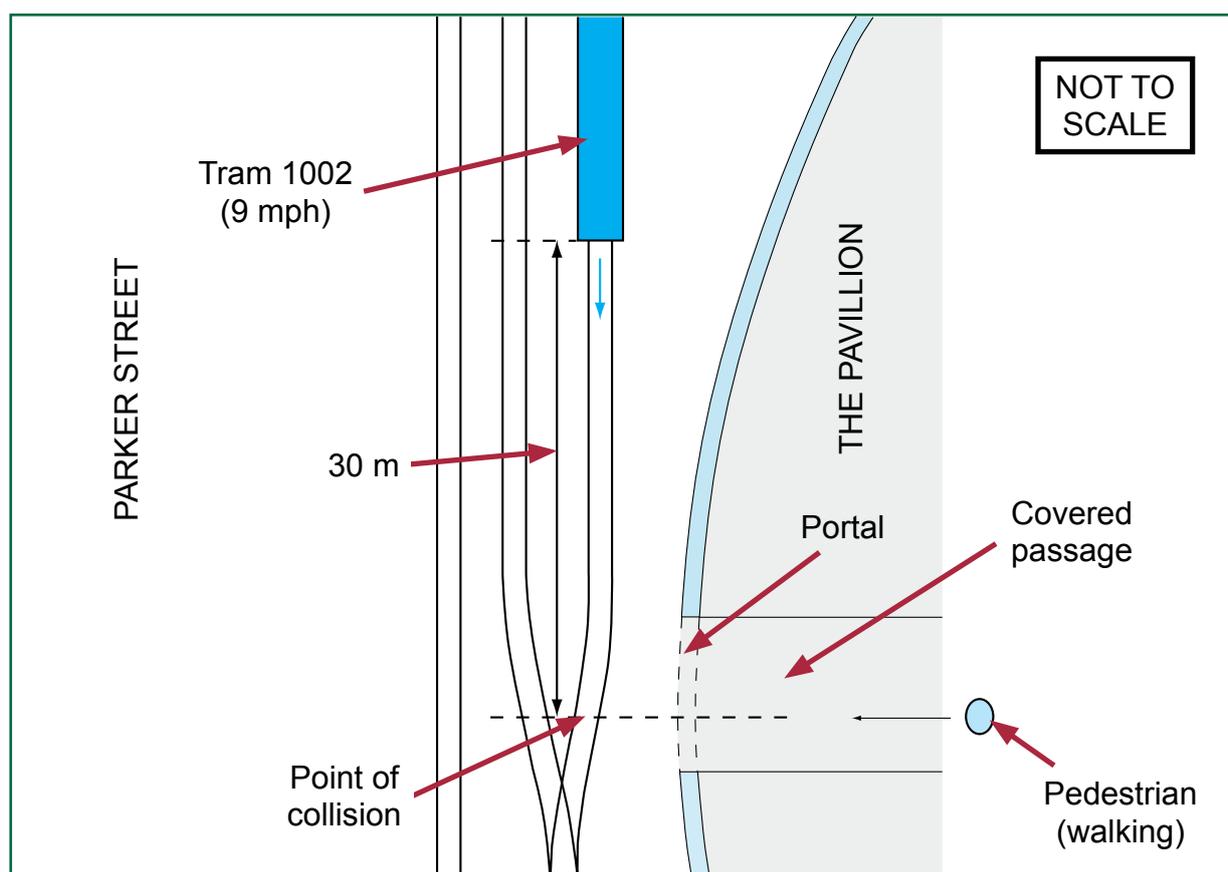
- 28 The pedestrian walked into the covered passage of the Pavillion 8 to 9 seconds prior to the accident. He was within the central half of the passage's width. At this time the tram had turned into Parker Street and was about 30 metres from the point of collision (figure 5).

Figure 5: Positions of tram and pedestrian 8 to 9 seconds before the accident

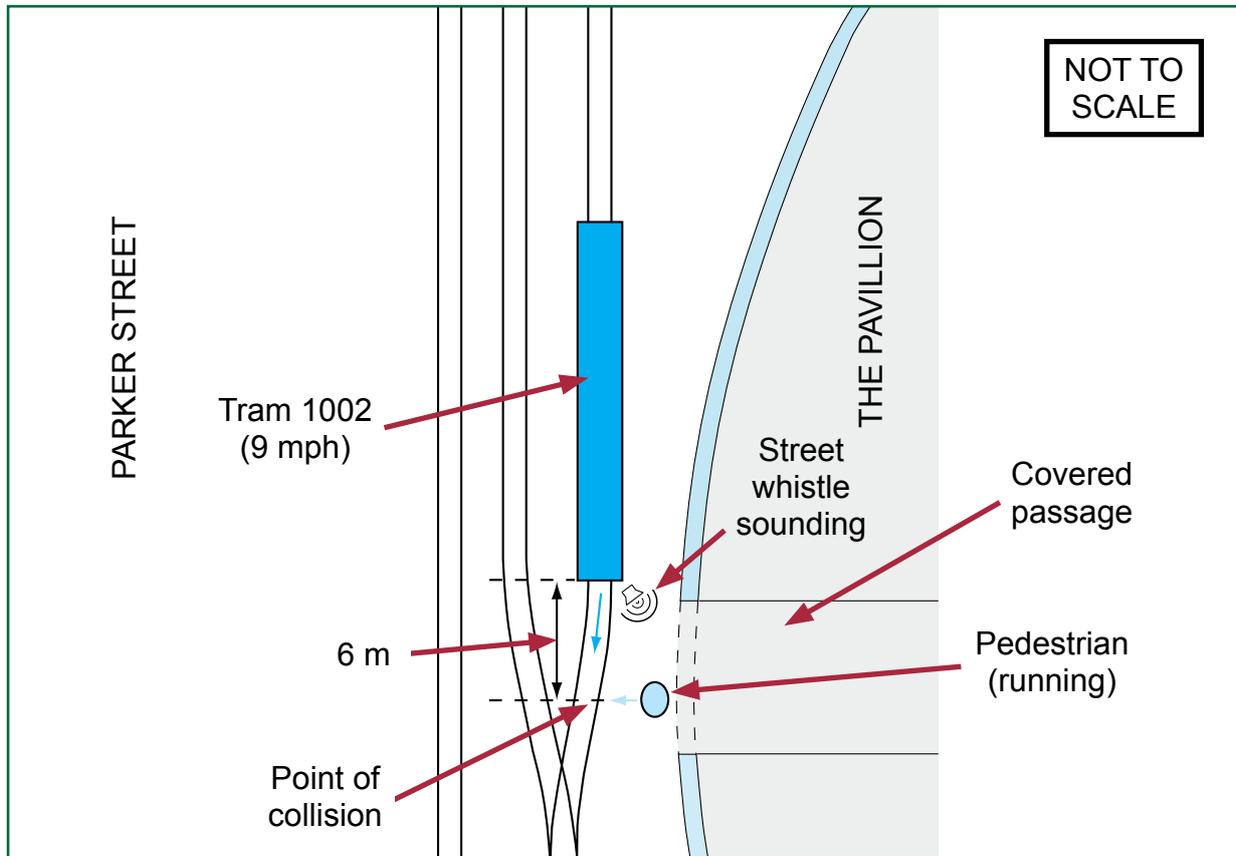
- 30 The data recorder shows that the driver sounded his street whistle between 1.5 and 2 seconds before the collision, when the tram was approximately 6 metres away (figure 6).

Figure 6: Positions of tram and pedestrian 1.5 to 2 seconds before the accident

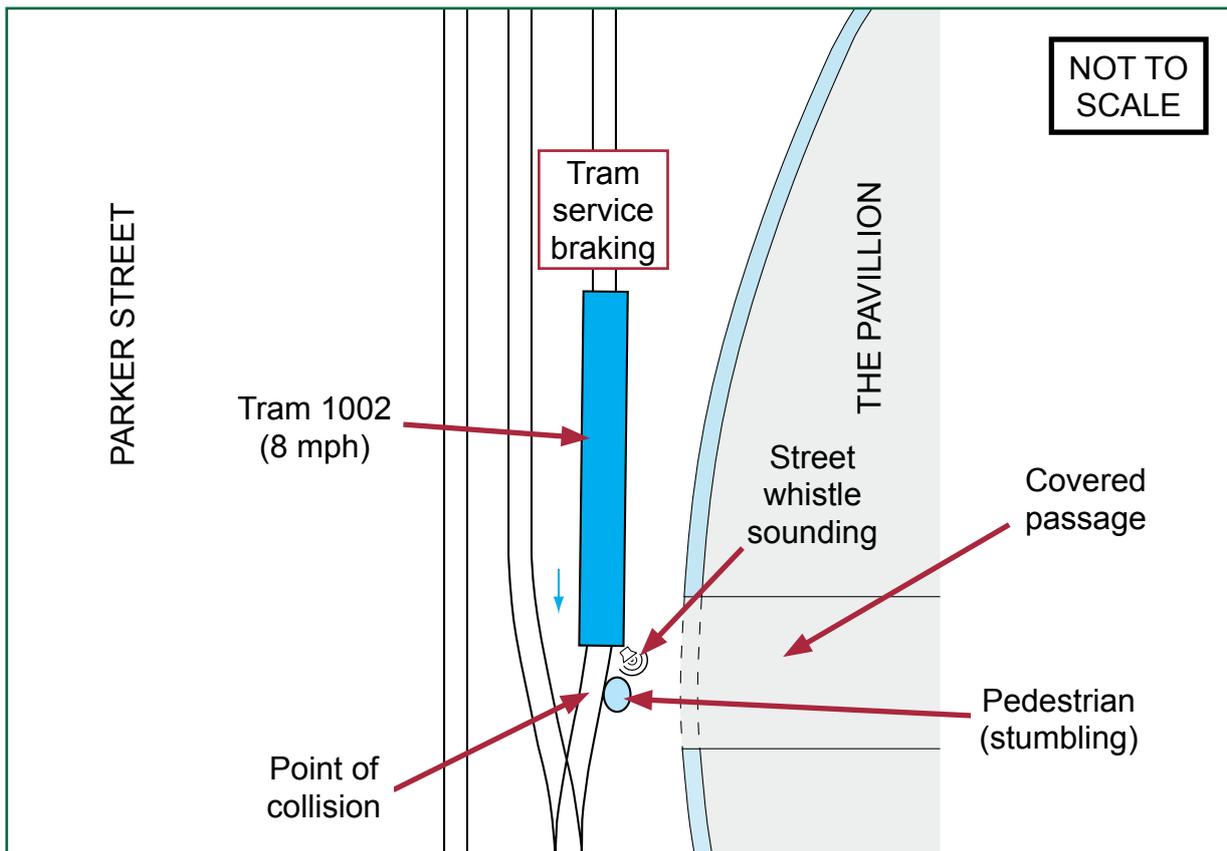
- 32 The CCTV footage shows the pedestrian attempting to stop immediately before crossing in front of the tram then stumbling (figure 7). The tram at this time was continuing to brake and sound its street whistle. The data recorder indicates that the speed of the tram was 8 mph (13 km/h) when the pedestrian was struck.

Figure 7: Positions of tram and pedestrian approximately 1 second before the accident

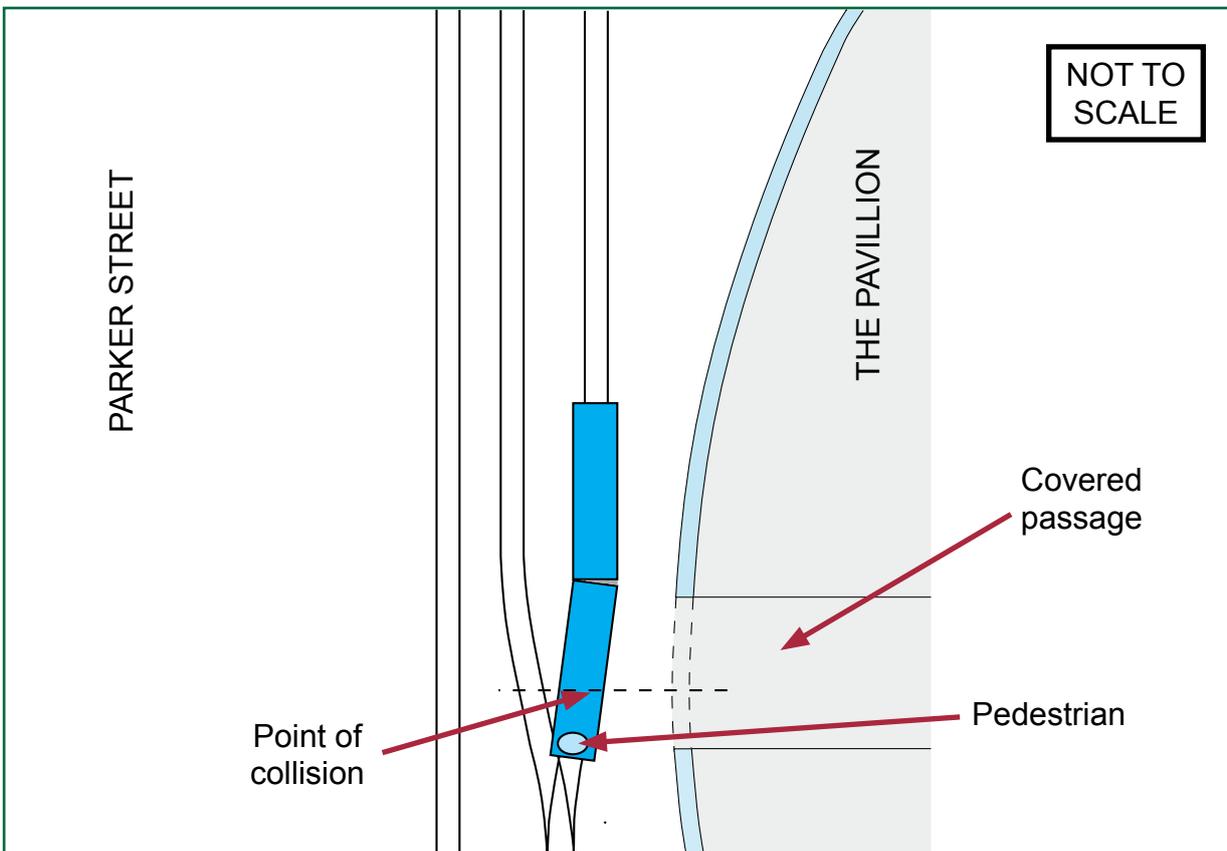
- 33 The driver stopped sounding the tram whistle and applied the hazard brake (figure 8). This was within 2 seconds after the collision and when the tram was travelling at 7 mph (11 km/h).

Figure 8: Positions of tram and pedestrian following the accident

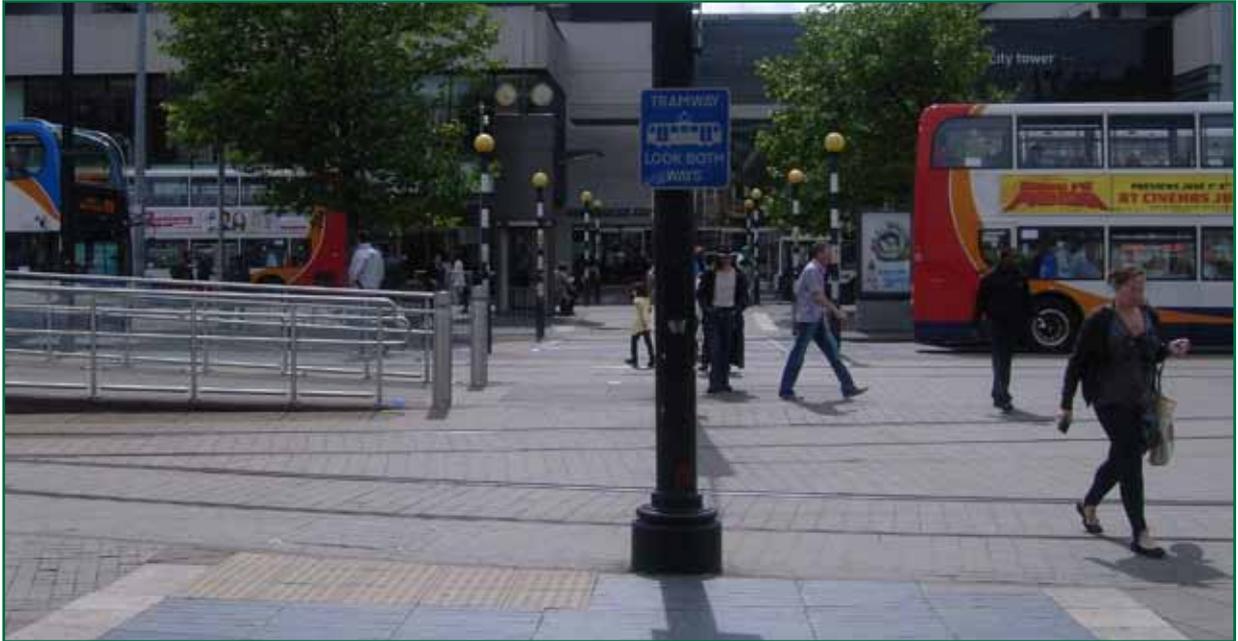
Figure 9: The approach to the tram lines from the covered passage

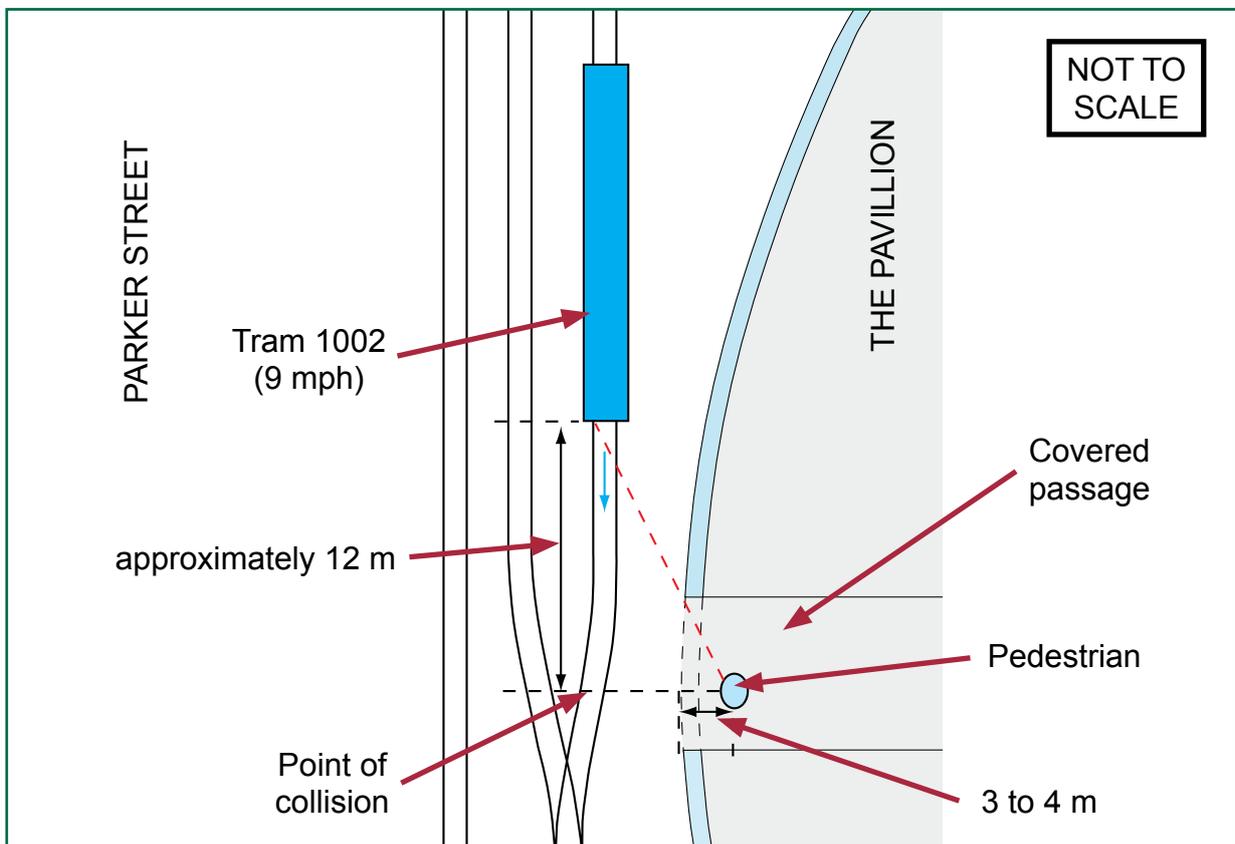
- 53 From analysis of the positions of the tram and the pedestrian, based upon the CCTV footage, the tram would have been visible to the pedestrian when he was 6 to 7 metres from the nearest running rail. At this point the pedestrian was 3 to 4 metres from leaving the covered passage and corresponds to a time when the tram was approximately 12 metres from the crossing. For the running pedestrian, based upon his approximate speed measured from the CCTV footage, this was about 3 seconds before reaching the tram lines (figure 10).

Figure 10: Relative positions of tram 1002 and pedestrian when the tram was visible
