Rail Accident Investigation Branch

Rail Accident Report

**Partial failure of Bridge 94, near Bromsgrove,
6 April 2011**

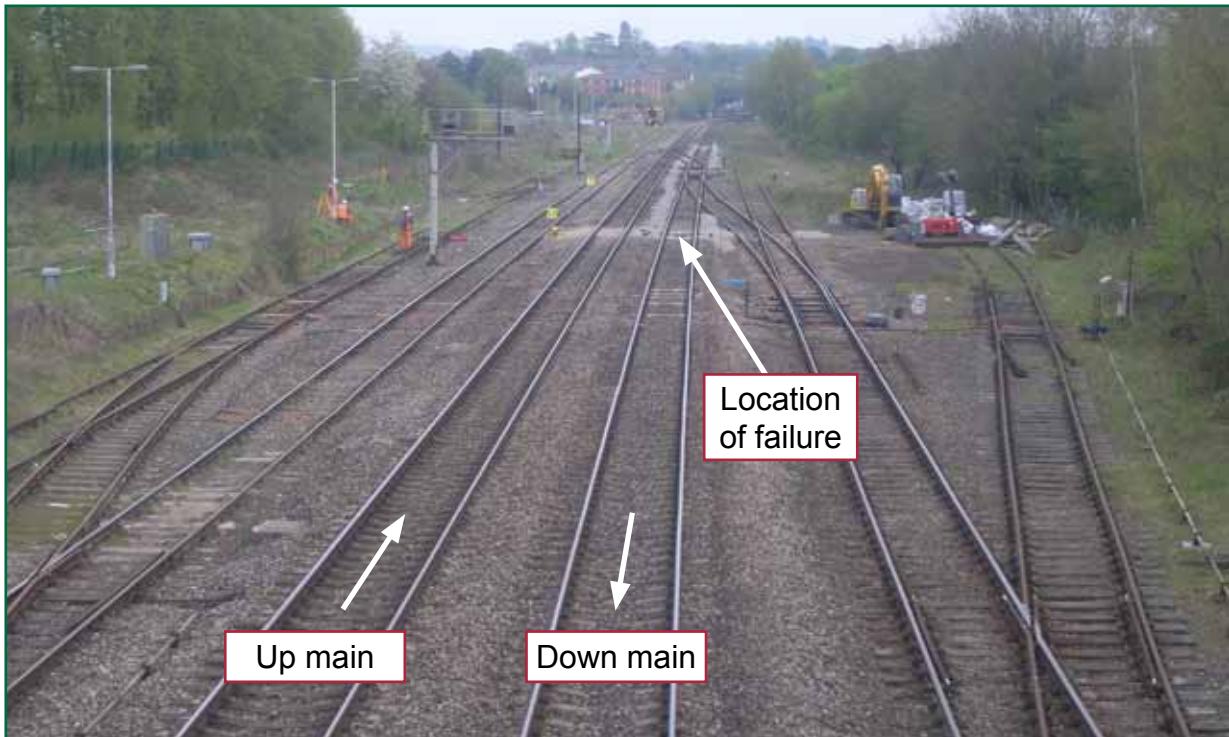
Figure 3: Site overview following the incident looking north-east towards Bromsgrove station

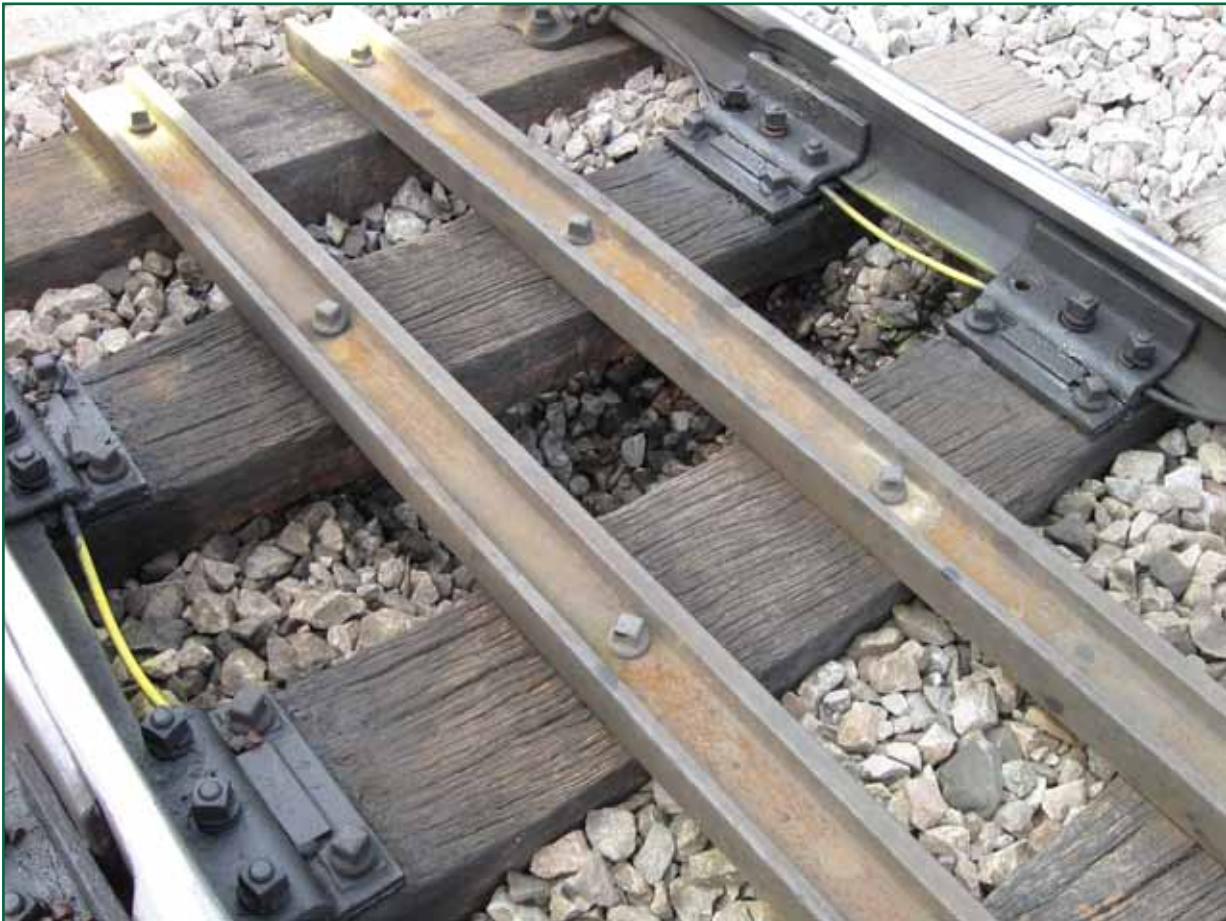
- 29 The next basic visual track inspection took place on Tuesday 29 March 2011. Patroller A, who on this occasion was being mentored by the ATSM, observed a lack of ballast in the four-foot (ie the space between the running rails) beneath the same adjustment switch. He made a record on his patroller's report. The ATSM instructed the patroller to replenish the ballast, which he did. Despite having visited this site many times, neither member of staff was aware that there was a bridge beneath the track at this location.

- 30 On Tuesday 5 April 2011, during the following week's inspection, a different patroller (Patroller B) found that ballast was missing beneath the adjustment switch. He contacted the ATSM who instructed him to top up the ballast again. The ATSM also arranged to make a special inspection himself the following morning.

- 31 On Wednesday 6 April 2011, the ATSM observed that the void had reappeared, but saw no evidence of track movement when trains passed over the site. He examined the site, looking for manhole covers which might indicate the presence of a cross-track drainage pipe. He located the upstream headwall of Bridge 94 in the undergrowth on the east side of the railway (figure 5), and became concerned that the structure could be collapsing. He stayed on site to monitor the situation during the day, and arranged for a further inspection by Patroller B that evening. As there was no evidence of rail movement, he did not consider that a speed restriction was necessary at this time.

- 32 At 19:00 hrs that evening, Patroller B attended site with a colleague specifically to inspect the defect. They measured a depression 350 mm deep below bottom of sleeper level (figure 6) and one member of staff entered the structure and observed ballast in the watercourse (figure 7). Patroller B was concerned and contacted the Gloucester ATME and requested his attendance. The ATME was not on-call, but agreed to attend site and advised Patroller B to inform Network Rail's fault control and request a structures examiner.

Figure 6: Ballast loss beneath sleepers at adjustment switch (photograph courtesy of Network Rail)

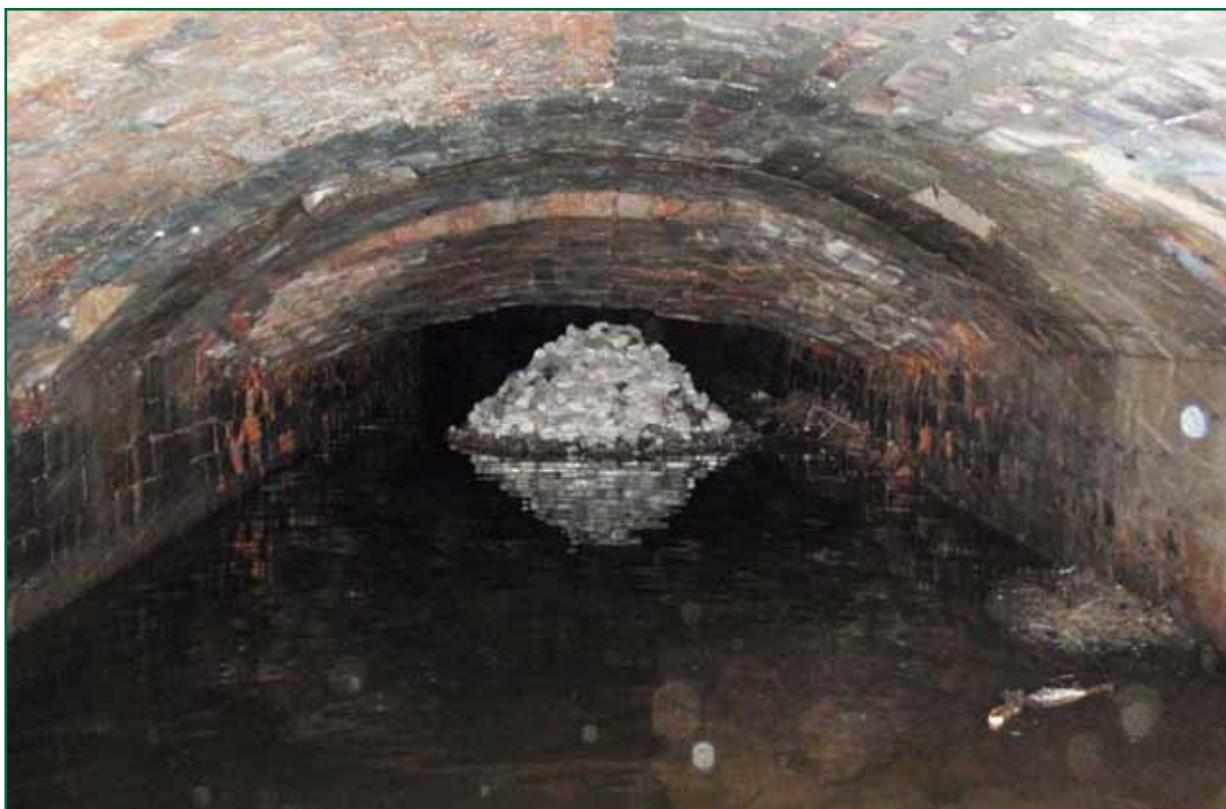
Figure 7: View from within structure showing distortion of arch beneath down main line and ballast lost into watercourse (photograph courtesy of Amey)

- 34 When the ATME was informed of ballast in the watercourse, he entered the structure and observed ballast falling into the water as a train passed above. He lowered the speed limit on the down main line again to 20 mph (32 km/h) for all trains pending the arrival of the structures examiner. Initially, this required signallers to caution all trains from Blackwell because of the steep gradient¹ immediately north of Bromsgrove station which could have made it more difficult for drivers to slow their trains sufficiently for the speed restriction at Bridge 94.

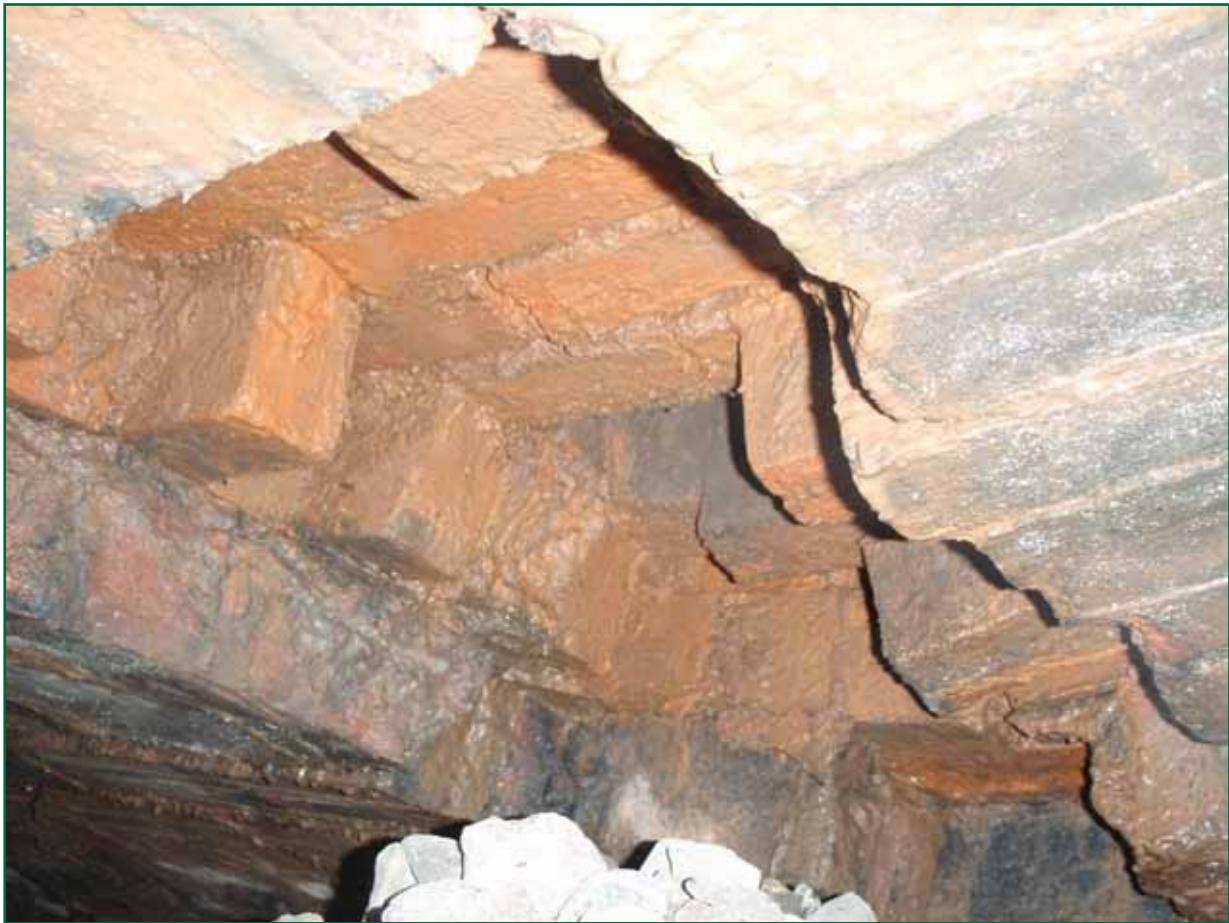
- 36 At 22:00 hrs, the ATME and structures examiner took part in a telephone conference with Network Rail structures engineers and operations staff. The structures examiner advised that a 600 mm square section of brick arch had failed. The conference supported the ATME's decision to block the down main line.

- 39 At 05:47 hrs, the examiner advised that the damage appeared more widespread from below and was likely to affect the up main and down goods lines. He reported that the lower two of the three rings of brickwork forming the arch structure had separated from the upper ring (figure 8), that surrounding brickwork exhibited significant deformation to the arch profile suggesting possible widespread failure, and that the north abutment was leaning away from the watercourse (figure 9). A hole in the roof was allowing ballast to drop through.

Figure 8: Loss of brickwork at location of failure (photograph courtesy of Amey)

- The loss of shape and reduction in the compressive force allowed a section of the brickwork to fall out (figure 8).
- 55 At the time that the partial failure was discovered, the structure was substantially weakened and complete failure was probably imminent.

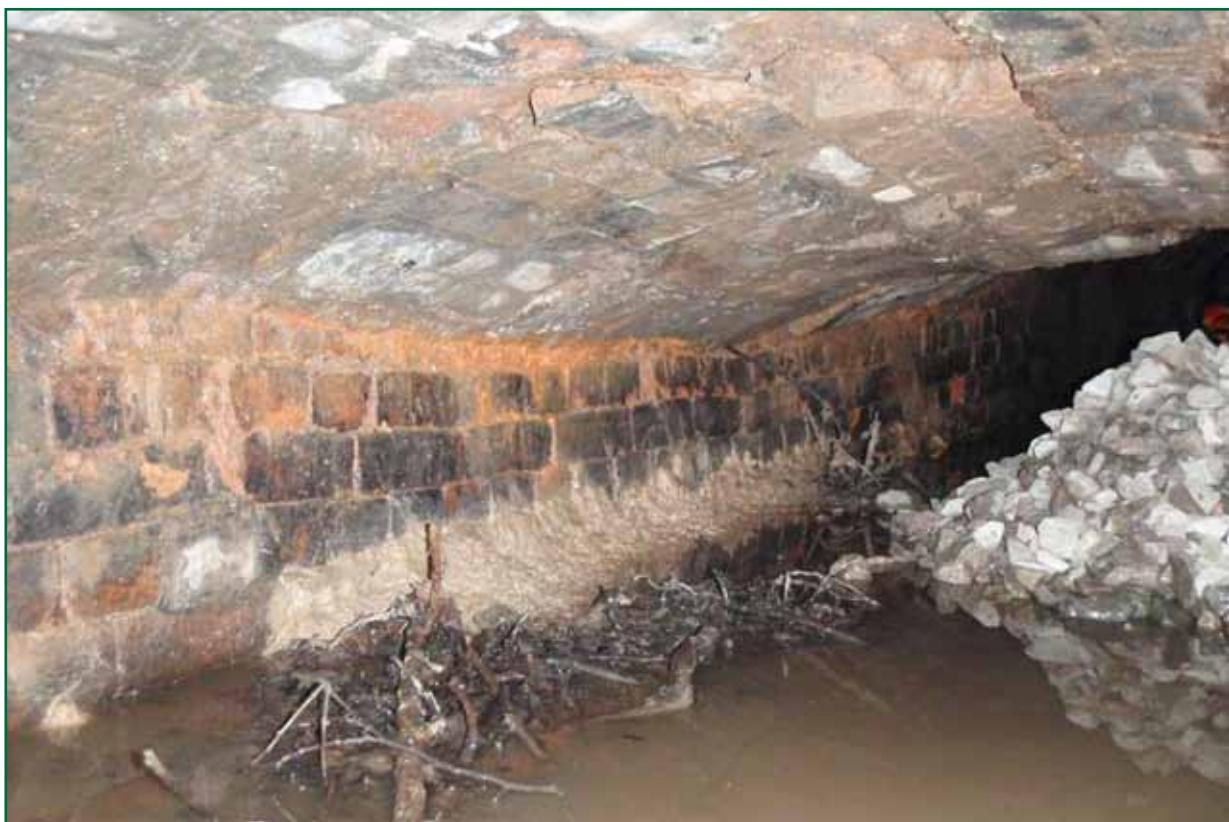
Figure 9: Deformation to roof of deck E and leaning north abutment looking upstream (photograph courtesy of Amey)

- Repeated impact loading from trains passing over the adjustment switch.
 - A lack of resistance from fill material behind the north abutment, which, when combined with a horizontal force that increased as the arch shape deteriorated, allowed the abutment to rotate outwards. As the arch widened and flattened, it is probable that it experienced a *snap-through-buckle* causing a sudden jump in deflection and dissipation of much of the horizontal (compressive) force.

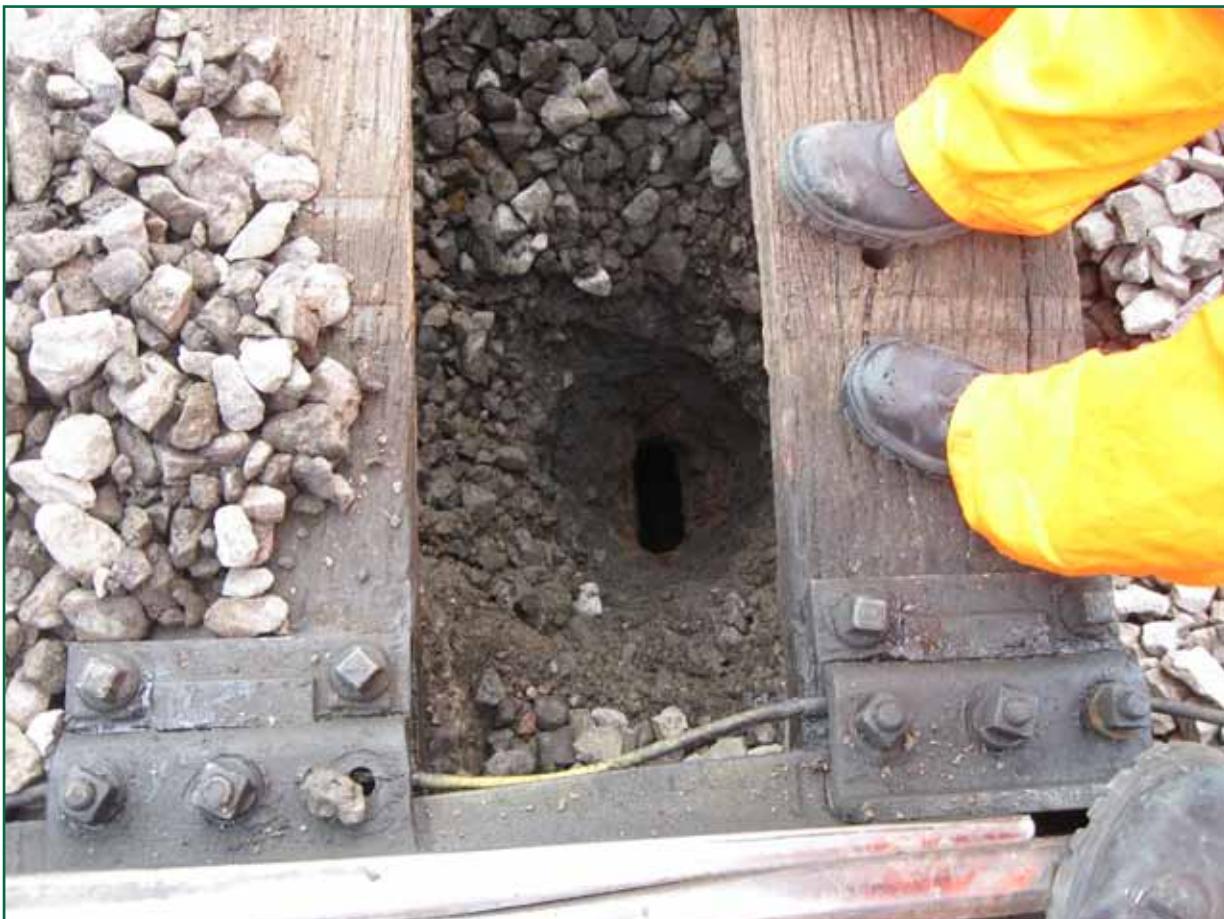
Figure 10: View into structure from track level following partial clearance of ballast (photograph courtesy of Network Rail)

- 40 Work commenced immediately to excavate the structure from above to confirm the exact location of the affected arch and adjacent unaffected decks relative to each track (figure 10). Following a review of the damage, the up goods loop was reopened to traffic at 08:28 hrs. The down loop was found to be only marginally affected, and a decision was taken to temporarily reinforce the track by screwing additional lengths of rail to sleepers. This allowed the down loop to reopen for passenger traffic at 16:50 hrs, with a 20 mph (32 km/h) emergency speed limit in place.

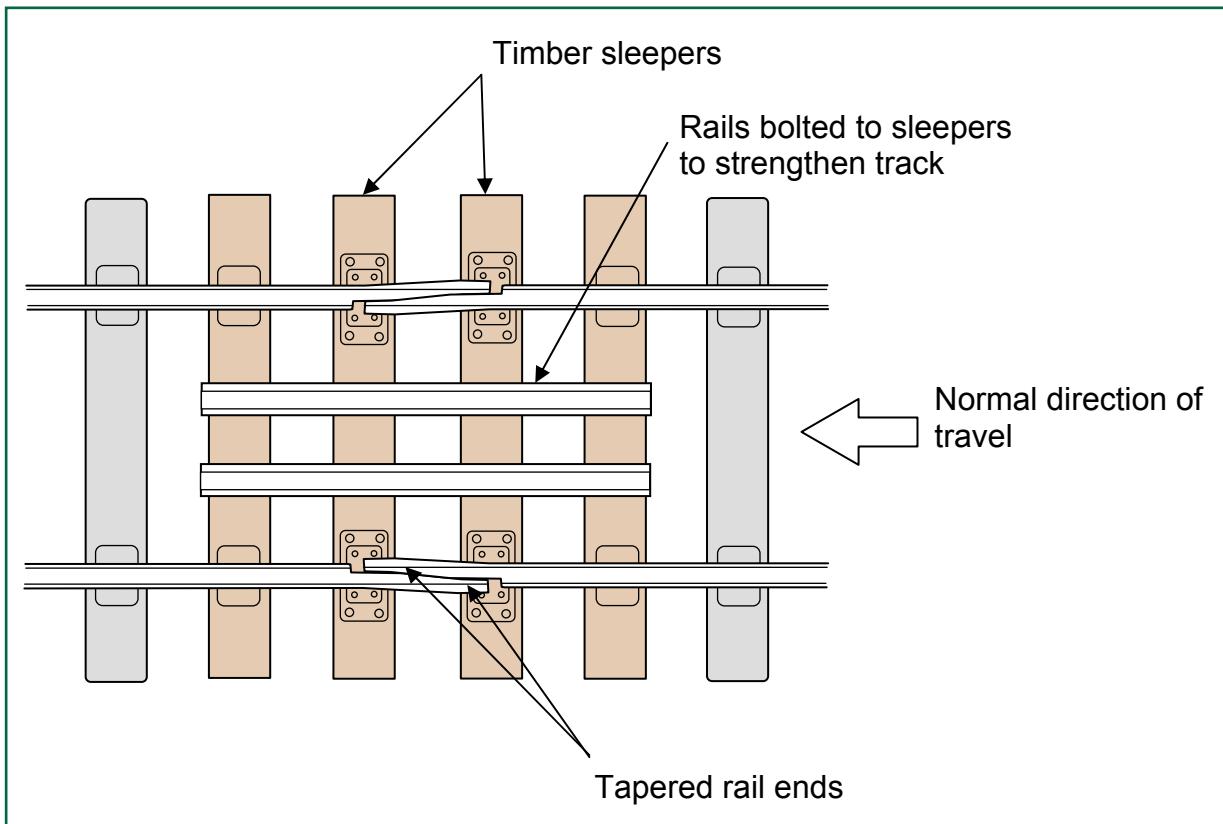
- 46 The roof of the structure was damaged by impact loading originating from train wheels passing over an adjustment switch which had been installed above, creating a minor, but recurring dip in the track. This was a causal factor.

Figure 11: Diagram of an adjustment switch

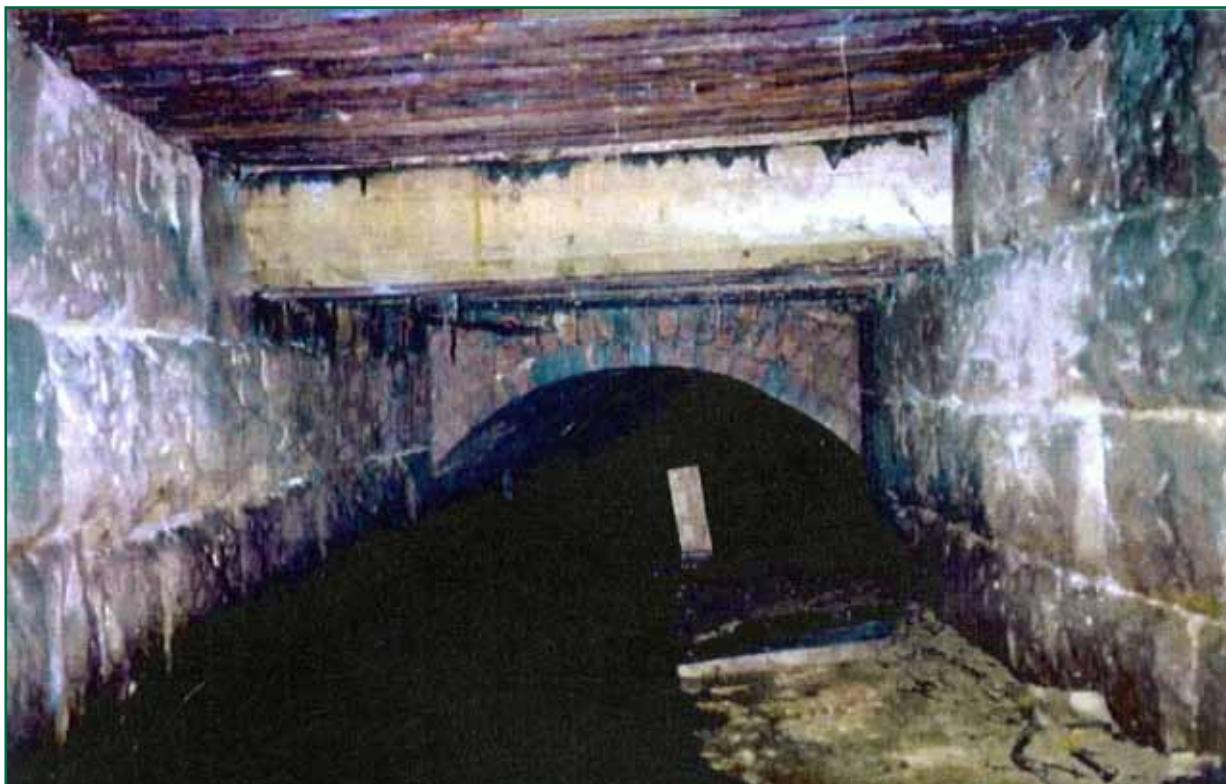
- 85 Bridge 94 was inspected in November 2001 by staff trained and equipped to enter confined spaces (figure 12). Railtrack received the inspection report, which included photographs of the structure, in January 2002. The corresponding assessment report was delivered in August 2003, and confirmed that the structure was in 'fair condition' and sufficiently strong to carry the loads imposed by rail traffic. Deck E was found to have an acceptable arch shape, but the report recorded a 5 mm wide longitudinal crack from abutment to abutment and damp staining indicating that the waterproofing had broken down.

Figure 12: Internal photograph (November 2001) showing decks C, D and E (photograph courtesy of Network Rail)

- 86 The assessment report confirmed that the structure was sufficiently strong to carry the imposed loads from rail traffic, but recommended re-waterproofing the deck, monitoring and repointing of 5 mm cracks in the brick arch sections, replacing small areas of damaged brickwork and removing obstructions to water flow.
- 87 A Network Rail structures assessment engineer (SAE) reviewed the assessment report, and visited site in November 2004 to resolve anomalies he had observed on a drawing. He subsequently hand-amended the general arrangement drawing to put the tracks in the correct order.
