# Rail Accident Report

## **Boiler incident on the Kirklees Light Railway 3 July 2011**

# Boiler incident on the Kirklees Light Railway

## 3 July 2011

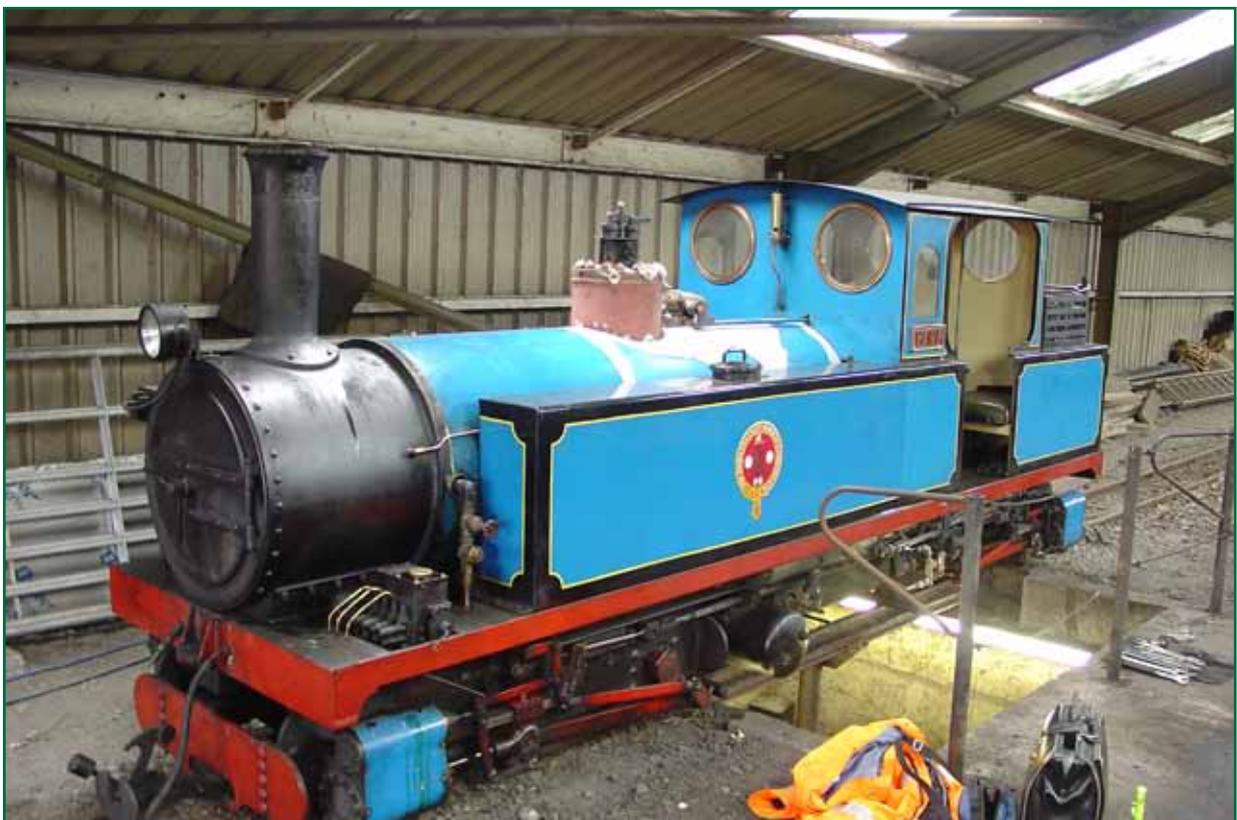
Figure 2: Locomotive 'Hawk' which was involved in the incident

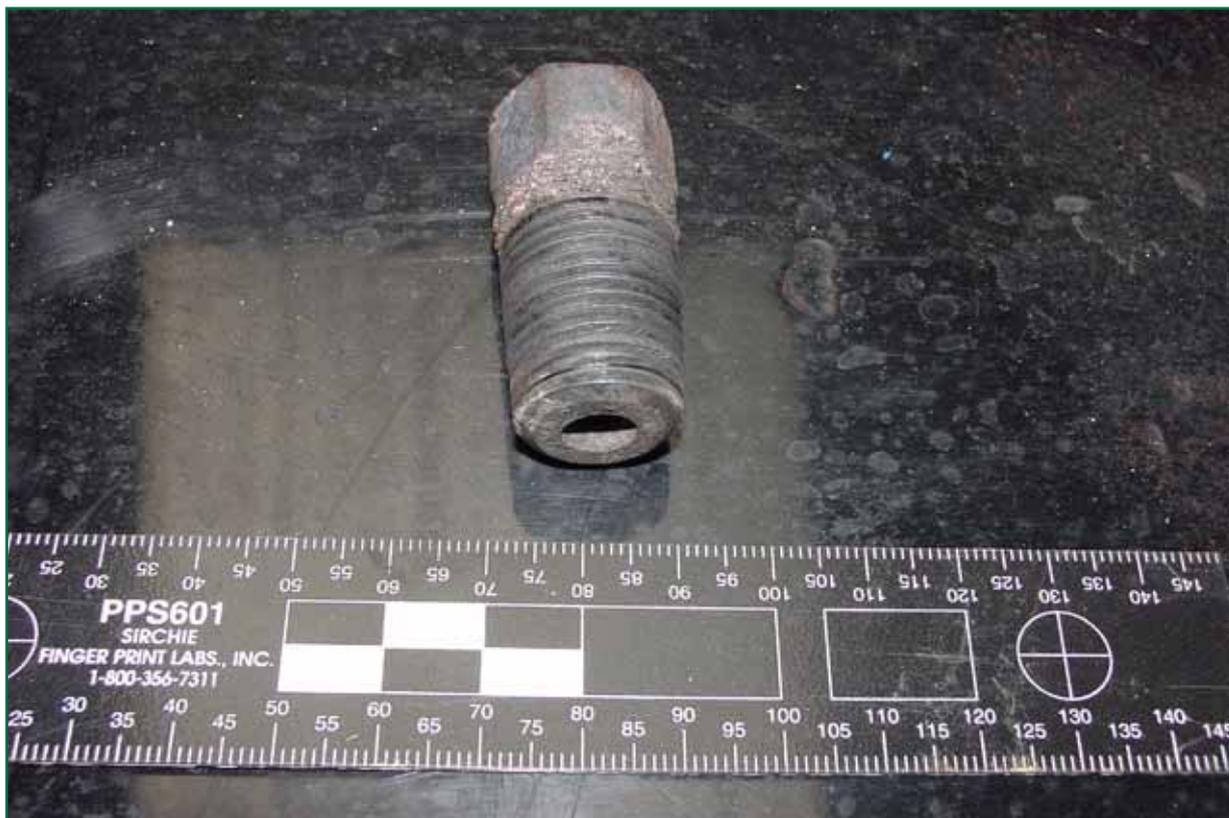
- 33 The locomotive was removed from the train and taken to an inspection pit where the responsible officer examined it for leaks. None were found, but the *fusible plug* (paragraph 39) in the top of the firebox had melted. The responsible officer reported that the front tanks were full and the rear tank still had a significant volume of water in it. He checked the water supply system on the locomotive and found that a valve between the *clack valve* and the boiler (figure 3) on the large injector feed pipe was only open 1 ½ turns. The operations manager stated that this valve should have been fully open (12 turns).

- 39 A threaded boss in the inner firebox *crownsheet* was fitted with a fusible plug. A fusible plug is a hollow threaded steel plug containing a core of a low melting point metal, such as lead<sup>1</sup>. Its purpose is to provide a warning of overheating of the firebox crownsheet by the melting of the core of the plug and consequent release of steam into the firebox. It does not prevent the firebox overheating, but is intended to give a warning so that action can be taken by the crew to prevent further damage. The appropriate action is to drop the fire. Figure 6 shows the fusible plug that was removed from the locomotive after the incident. The location of the plug in the firebox crownsheet is indicated in figure 7. The fusible plug was manufactured by the KLR to its own design and was installed in April 2010.

Figure 6: Fusible plug removed from 'Hawk'

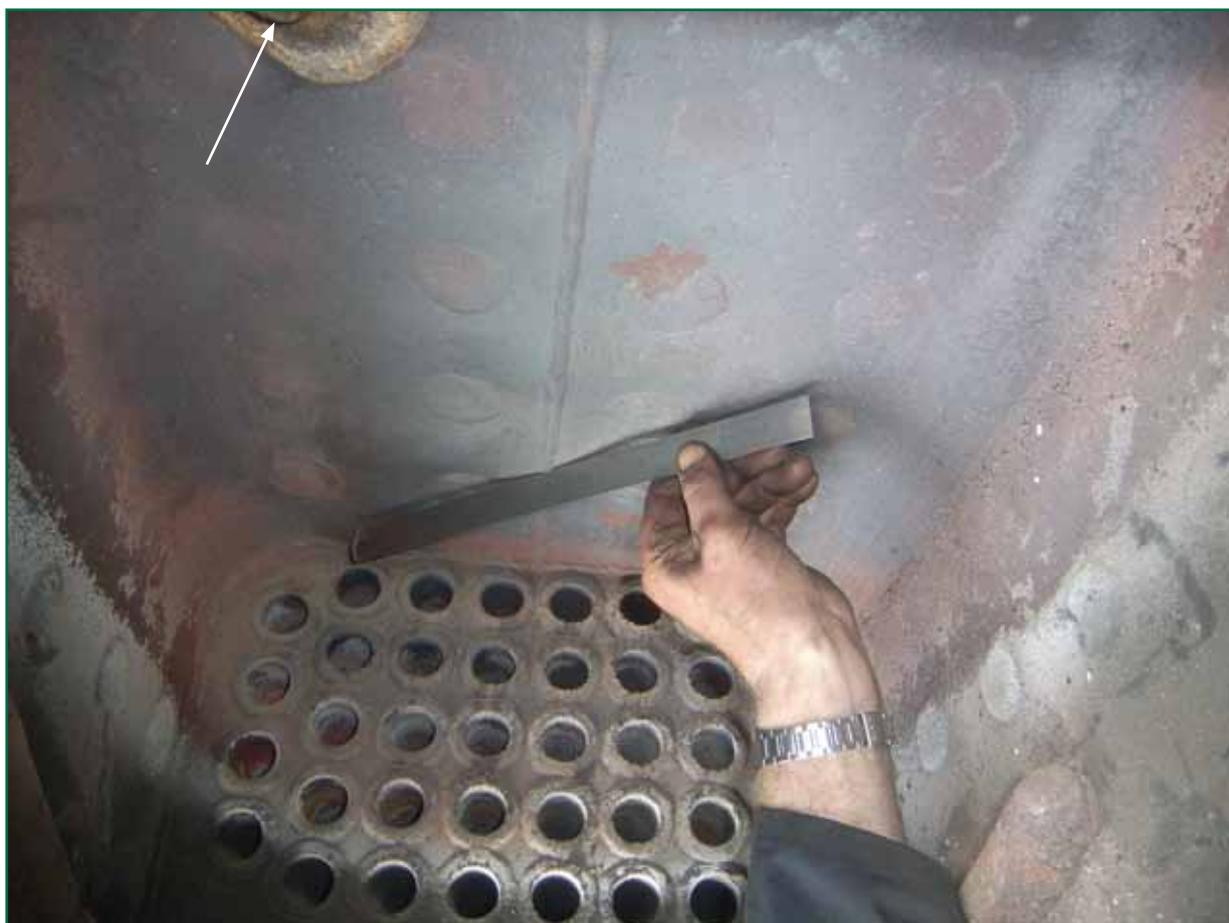
- 6 By the time the fire was dropped the boiler water level was below the top of the firebox, and the steam pressure had fallen from its normal operating pressure of 160 – 170 psi (11 – 11.7 bar) to around 100 psi (6.9 bar). The firebox was exposed to the heat of the fire without water behind it and suffered extensive damage as a result. Had the heat-softened metal in the top of the firebox ruptured there would have been a risk of serious injury to the train crew.

#### Staff involved

Figure 7: Interior of firebox showing scorch marks and quilting of the crown (location of fusible plug arrowed)

**50 The water level in the boiler was allowed to fall so low that the fusible plug melted and the firebox crown sheet was damaged. This was a causal factor in this incident.**
