# RAIB Bulletin 02/2012

## Derailment at Clarborough tunnel, near Retford, Nottinghamshire, 27 April 2012

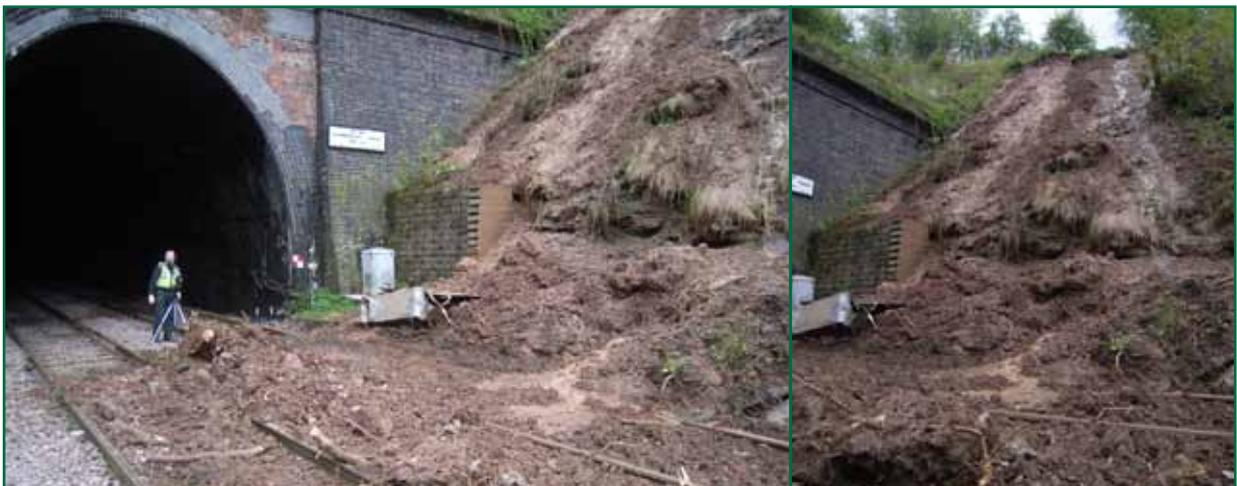
- 1 At approximately 11:55 hrs on Friday 27 April 2012, train 2R15, the 11:25 hrs service from Lincoln to Adwick, operated by Northern Rail, ran into a landslip (figure 1). This occurred as the train exited Clarborough tunnel, near Retford, Nottinghamshire on the Gainsborough to Sheffield line. The train, a class 142 diesel multiple unit, derailed (figure 2). There were 17 passengers and two crew on board; the driver and one passenger were taken to hospital with minor injuries. The train suffered damage to its coupler and underframe equipment; several bodyside panels also came loose during the impact.

Figure 1: The landslip outside Clarborough Tunnel

- 8 The cause of the landslip and subsequent derailment was the poor condition of the crest drain, on neighbouring land, and its ineffectiveness in dealing with water flow from the surrounding catchment area following the recent wet weather.
- 9 The RAIB has made recommendations relating to the management of drainage flows from neighbouring land and off-track drainage following previous investigations.

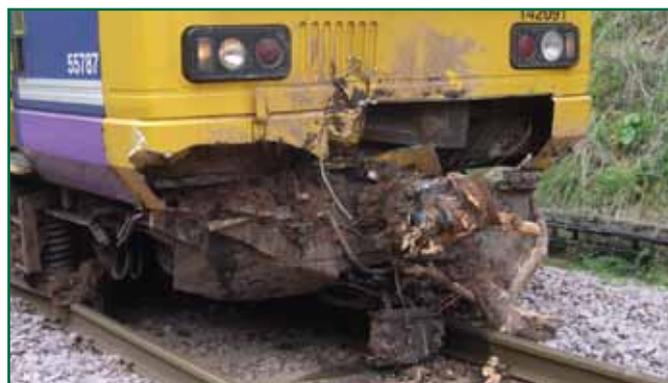
Figure 2: The derailed train 2R15

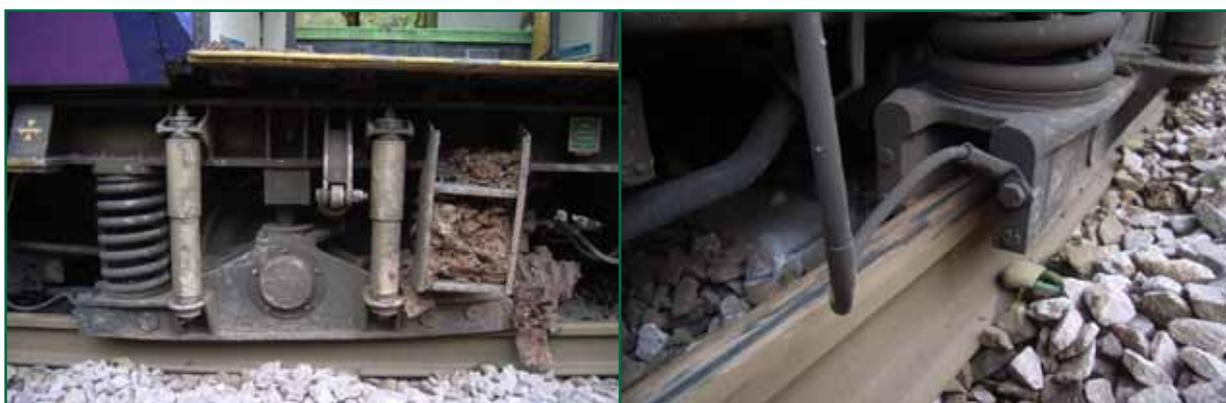
- 2 Train 2R15 left Gainsborough Lea Road station at 11:51 hrs. The journey was uneventful until, when within Clarborough tunnel and travelling at 59 mph (95 km/h), the driver spotted an obstruction on the track ahead. The driver shut off power and applied the emergency brake. The train struck a large mound of earth and also hit a track-side cabinet and tree root ball that had been pushed onto the track by the landslip. The train's speed had reduced to 45 mph (72 km/h) by the time of the impact. The leading axle derailed to the cess (left in accordance with the direction of travel) and the train travelled a further 100 metres before coming to rest.
- 3 The degree of lateral derailment was limited by the axle box engaging with the right-hand rail and preventing the train deviating further towards the cess (figure 3).

Figure 3: Detail of the axlebox on derailed train 2R15 engaging with the rail

- 22 The RAIB has observed in several previous derailments that features of the bogie, underframe equipment and running gear have, following a derailment, engaged with the running rails and limited the degree of lateral deviation. The RAIB has made recommendations to RSSB<sup>2,3,4</sup> to consider the practicability of including design elements to limit the degree of deviation. However, RSSB concluded that it is inappropriate to recommend changes to the relevant standards, and the ORR accepted this position. The basis for RSSB's conclusion is not fully detailed in the related RSSB report.
- 23 The RAIB observes that in this derailment a feature of the running gear has again provided this function. The RAIB believes there is a case for the industry to revisit its previous study and to carry out a more detailed assessment.

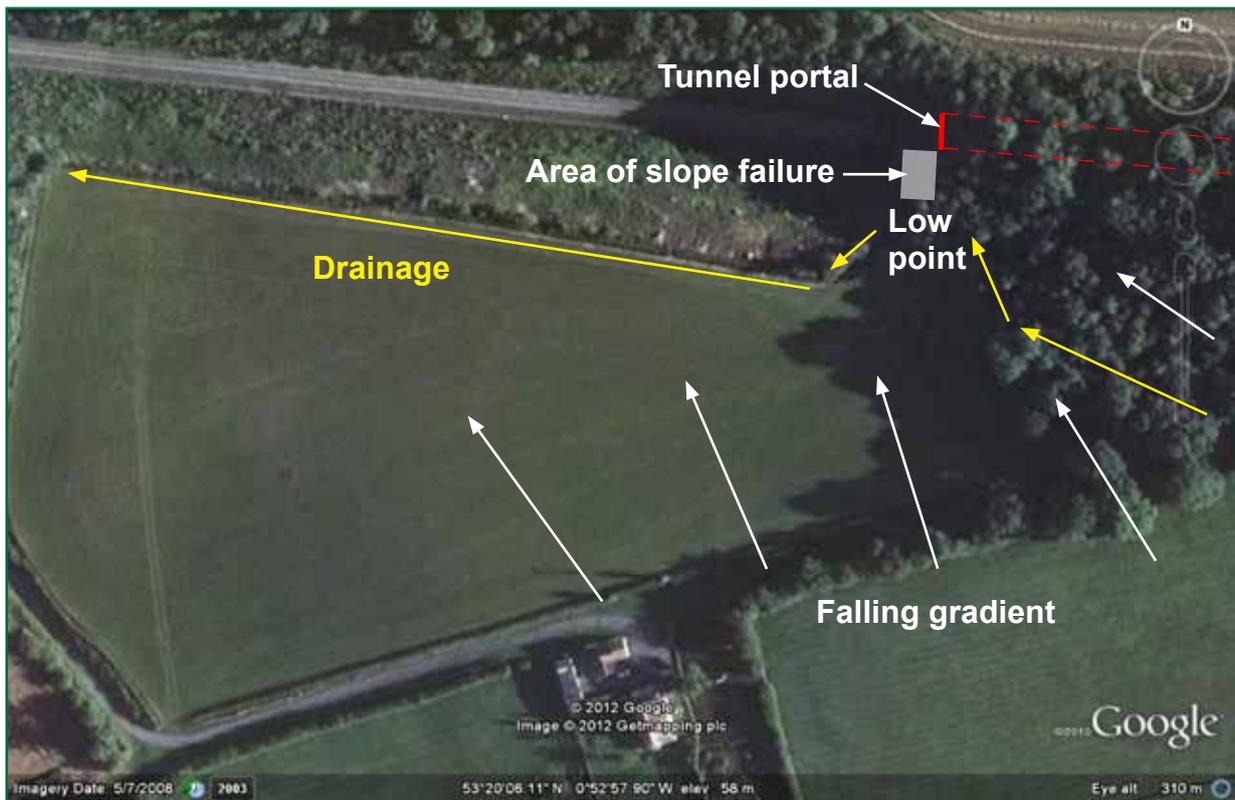
Figure 4: The catchment area above the slope (courtesy of Google Earth)

- 6 There had been a significant amount of rain over the weeks prior to the accident and very heavy rainfall during the days immediately prior. Inspection of the crest drain shortly after the incident revealed that the section that runs immediately above the slope was ineffective. There was a local low point in the drain immediately above the site of the landslip where water had collected; the drain 'down-stream' of this was dry.
- 7 The water collecting at this low point had saturated the ground and filtered through the bank causing the soil at the top of the bank to be washed down onto the track. Several hours after the landslip occurred, water was still flowing through the ground and could be seen emerging on the cutting face to form distinct streams flowing down the face to track level.

- 18 The crest drain at the location of the earthworks failure had not been considered for improvement works under the crest drain initiative because it had neither been identified as a high priority, nor had there been any reports of problems with it. Also, the drainage survey had not been completed for this location.

- 20 This accident reiterates the importance of correctly identifying and managing the risk from drainage of land outside of the railway's boundary.
- 21 Where the risk is not being effectively managed by the railway's neighbour, the infrastructure manager will need to:

- identify drainage that is critical to the stability of the slope; and
- assess the adequacy of existing drainage;

such that suitable arrangements can be established with neighbours to cover:

- the inspection and maintenance of drainage; and
- the identification and implementation of any necessary improvements.

Where such arrangements cannot be established infrastructure managers need to consider implementing measures on their own land to manage the risk.
