# Rail Accident Report

## Passenger accident at Brentwood station 28 January 2011

Report 19/2011  
November 2011

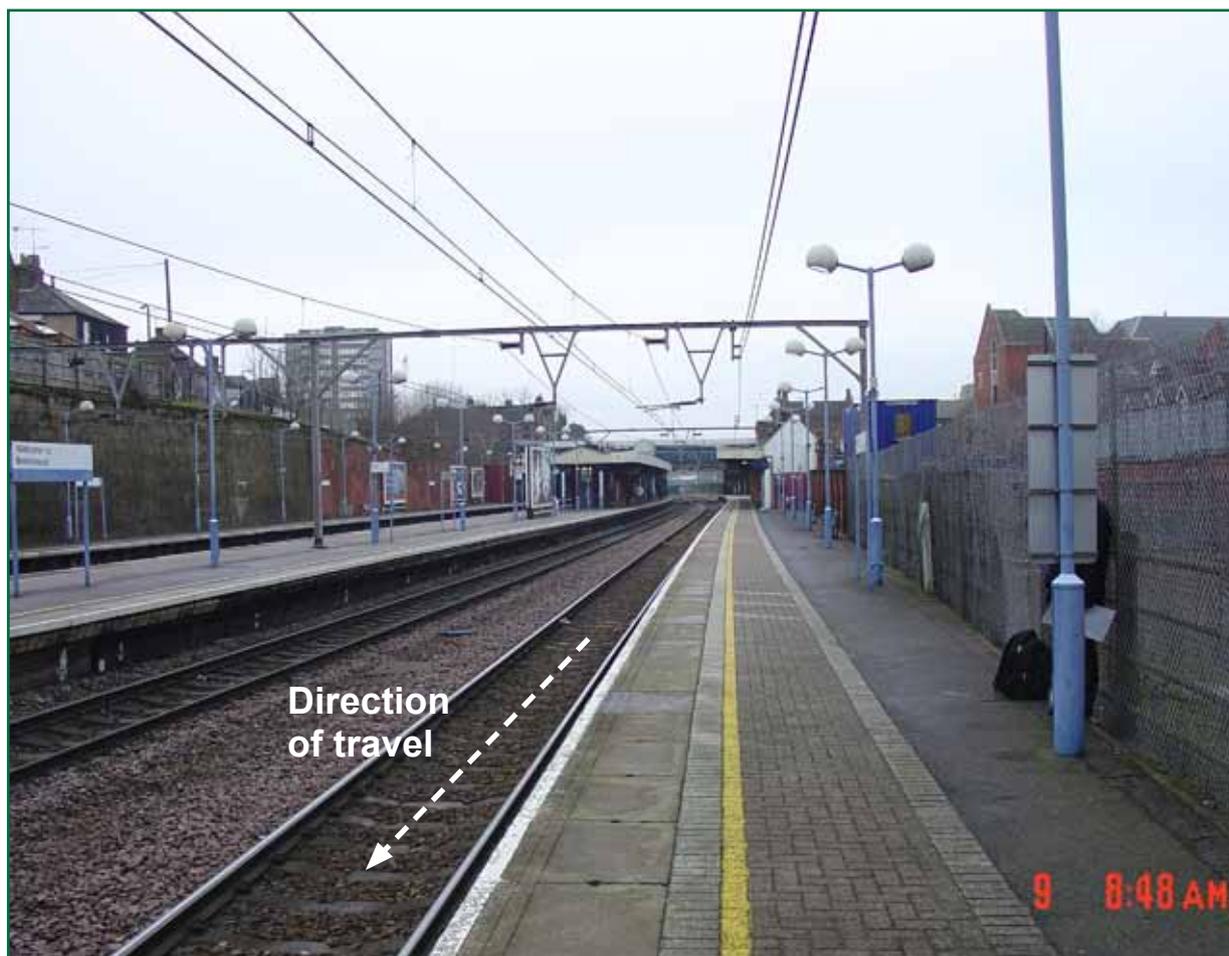
Figure 3: Brentwood platform 4. Photograph depicting curvature of platform.

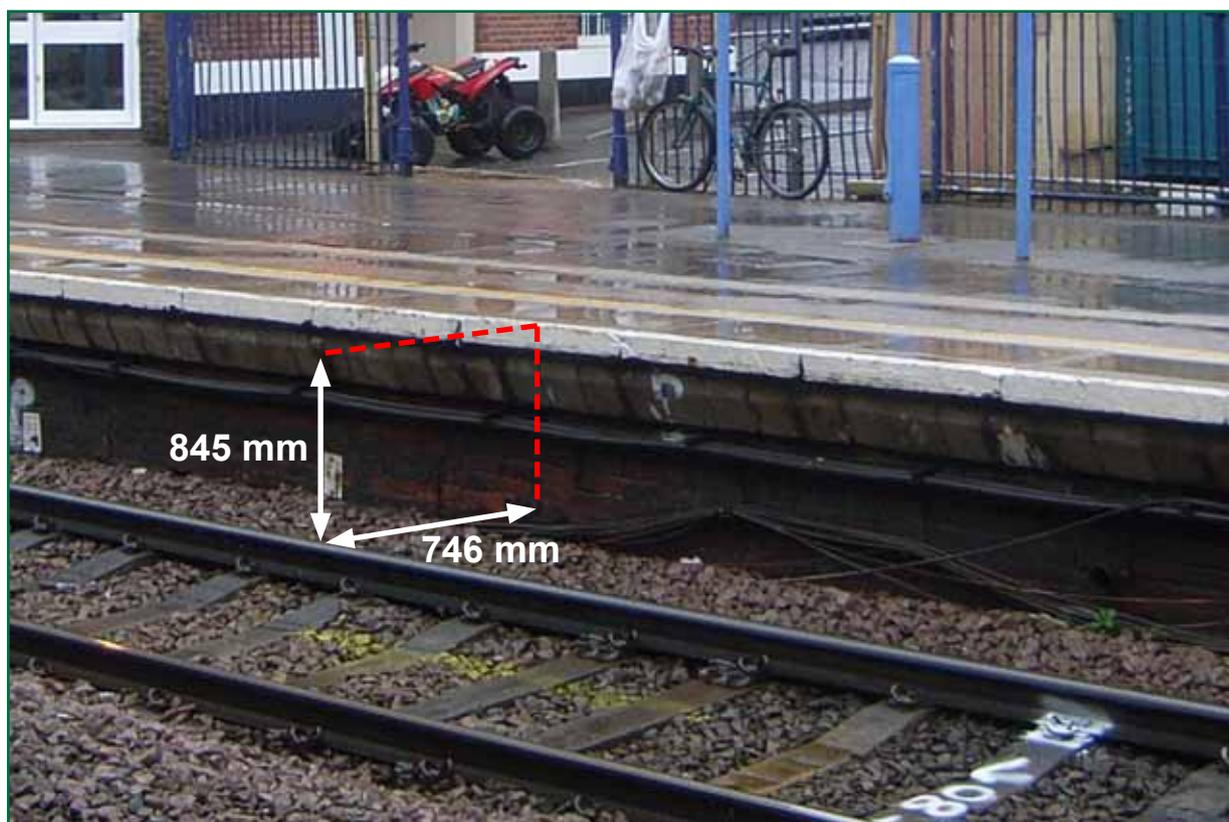
Figure 4: Platform-track dimensions at location of accident on platform 4 Brentwood station.

- 13 The track through platform four at the location of the accident had a *cant* of approximately 77 mm to allow trains that do not stop at the station to pass through at speeds up to 75 mph (120 km/h). The platform curve radius at the location of the accident was approximately 1,428 metres.

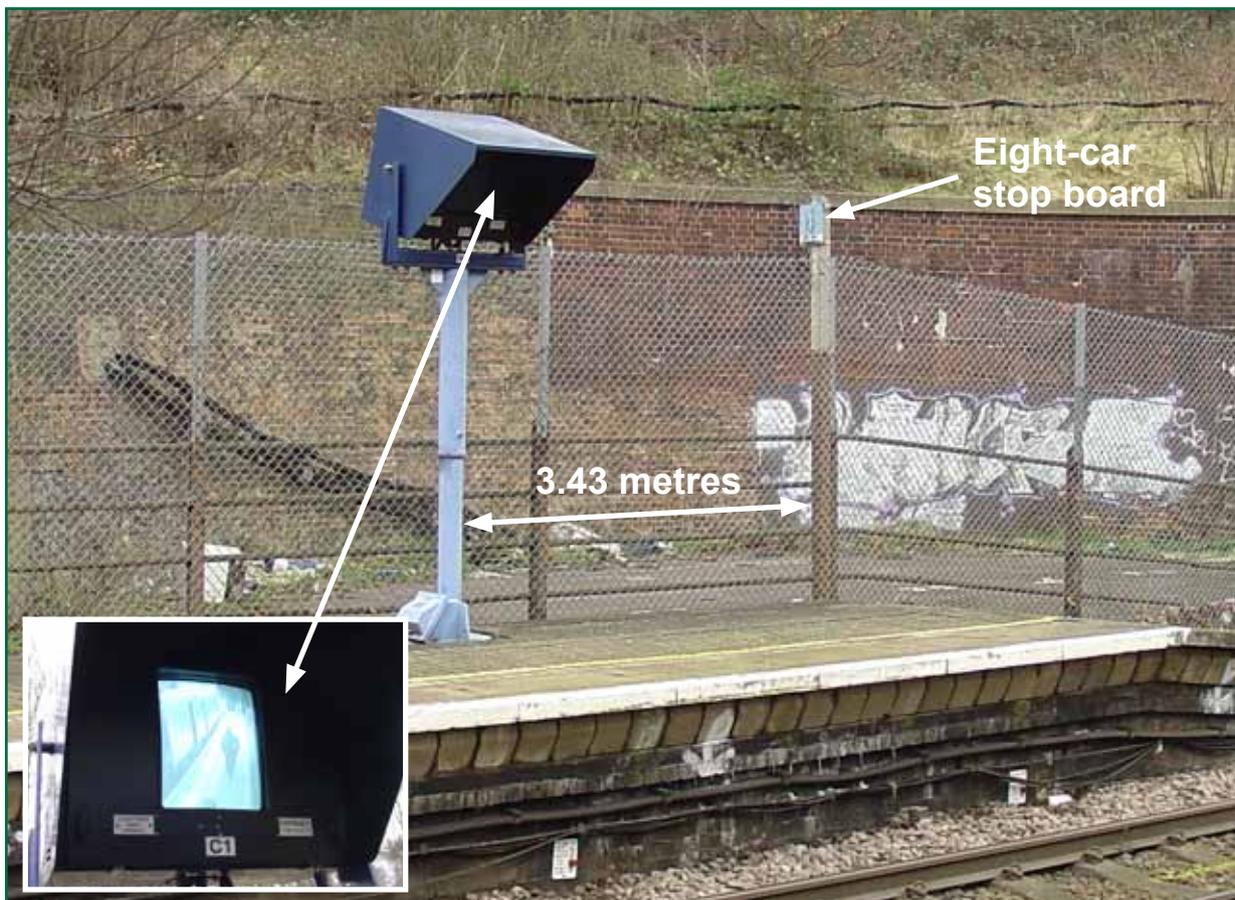
- 14 The platforms at Brentwood station are unstaffed, as are other stations on the route. The trains that form the Metro<sup>1</sup> service are operated by a train driver alone and no train *guard* is provided: this is known as *Driver Only Operation* (DOO). Two *greyscale* Cathode Ray Tube (CRT) monitors linked to a single CCTV camera are provided to assist train drivers in operating their trains safely at the platform. One monitor is provided for the drivers of four-car<sup>2</sup> trains and one is provided for the drivers of eight-car trains. This is necessary because four-car and eight-car trains are required to stop at different points at the platform. A *stop board* (for eight-car trains) was provided 3.43 metres beyond the centre of the eight-car DOO monitor.

Figure 5: Brentwood platform four. Eight-car DOO monitor and stop-board. Inset: Image displayed on CCTV monitor.

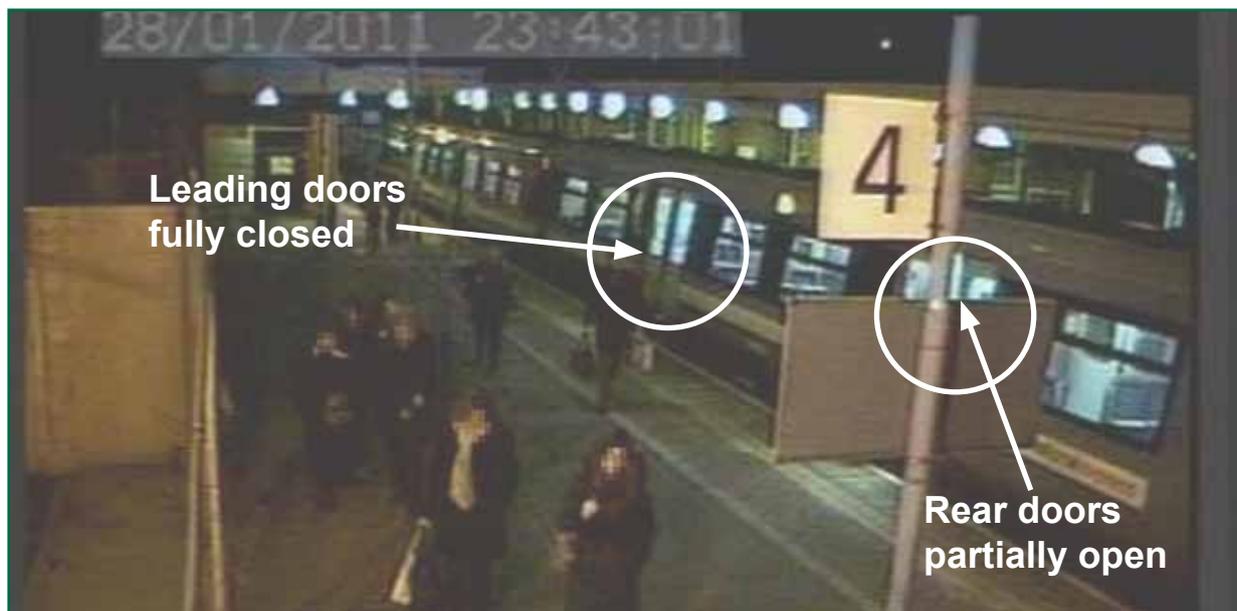
- 45 A witness to the accident recalled that the passenger moved towards the rear set of passenger doors on the last carriage as he was walking along the platform having alighted from the fourth or fifth vehicle from the front of the train. The train doors were beginning to close and the door closing audible warning was sounding. The same witness thought it likely that the person would not get off the train in time. Moments later, he saw the passenger in the doorway. She appeared to get momentarily caught by the closing doors by at least one of the bags she was carrying on her back or shoulder. An image from the platform CCTV shows the rear doors of the eighth (rearmost) carriage partially open, while the leading doors on the same carriage are closed (figure 7). This is consistent with witness evidence that the injured passenger's bag(s) obstructed the closing of the doors.

Figure 7: CCTV still showing accident door at the rear of the train partially open (and partially obscured by a station information sign) and leading door closed.

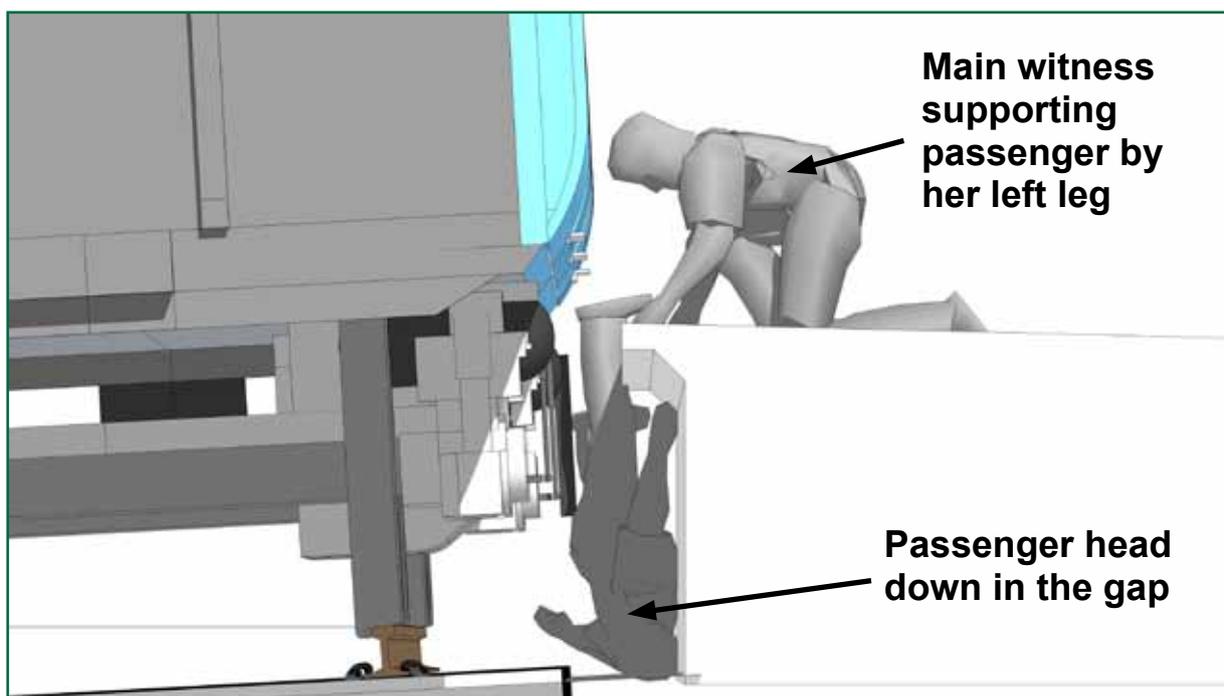
- 46 The witness saw the passenger pull herself free of the closing doors and fall to her right towards the gap between the platform edge and train bodyside (not between the train step and platform edge). He ran forward and was able to hold onto her leg as she fell into the gap. Analysis<sup>9</sup> by the RAIB indicates that she was almost completely head-down in the gap (figure 8). As the train began to depart the witness supported the passenger by holding her left leg until the rear of the train had passed by.
- 47 The passenger received minor injuries as the train passed by. The main injury, a severe graze to the back of the upper right leg, was consistent with her right leg having been struck by the steps that provide access to the rear driving cab of the train (figure 9).

Figure 8: Positions of witness and passenger looking towards the back of the train.

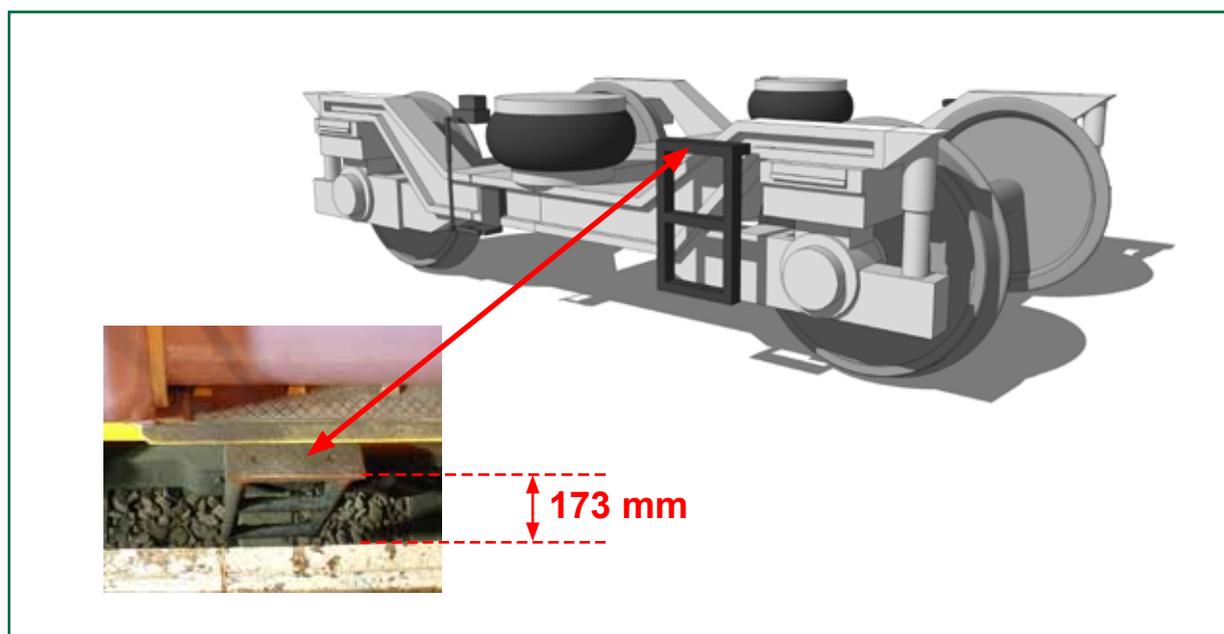
Figure 9: Class 315 bogie from driving cab vehicle. The inset photograph shows the tread plate fixed to the top of the cab access steps and the 173 mm gap that existed between the edges of the cab access step tread plate and the platform edge.

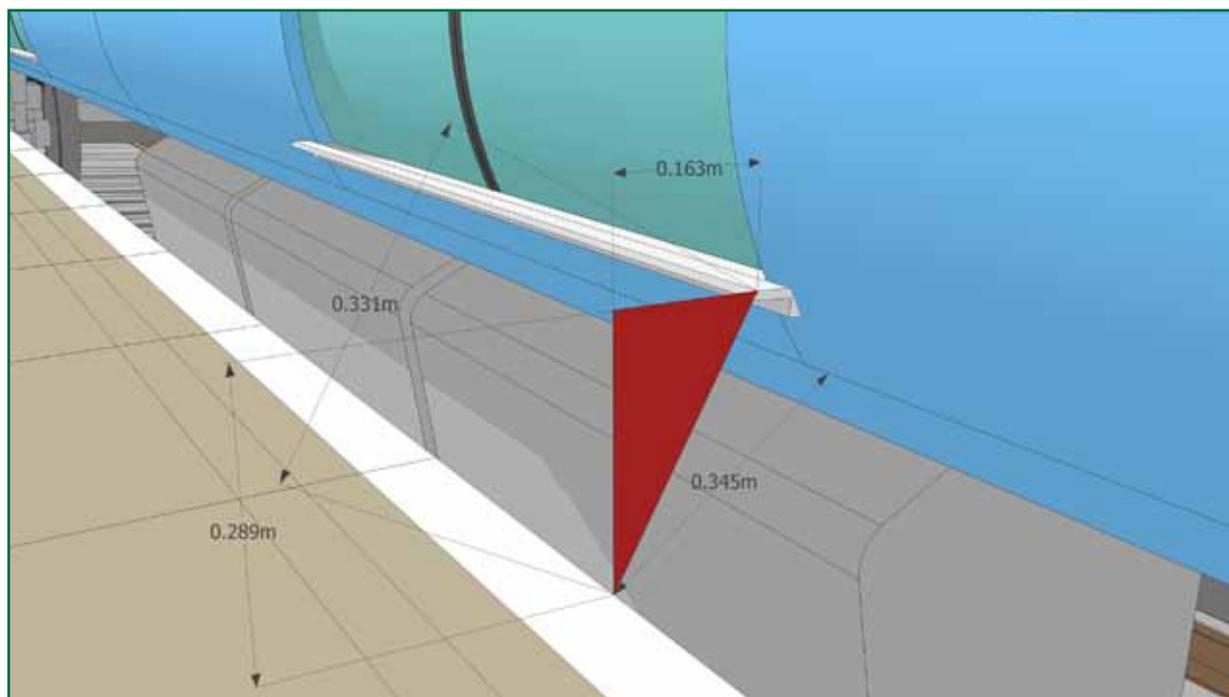
- 59 The RAIB has considered whether the gap between the bodyside of the train and the edge of the platform would still have been large enough for the passenger to have fallen into if Brentwood platform four was fully compliant with the requirements of the current railway group standard, GI/RT7016. The diagonal gap between the bodyside of the train and the edge of the platform at the site of the accident was approximately 345 mm (including the effect of the 77 mm cant at the location). To align with the values in standard GI/RT7016 the platform height would need to be increased by 45 mm and the track would need to be positioned 1 mm closer to the platform edge. If these changes were made the diagonal gap between the bodyside of the train and the edge of the platform would be reduced to approximately 320 mm (ie a reduction of 25 mm). It is unlikely that a reduction of 25 mm in the diagonal dimension of the gap between the bodyside of the train and the edge of the platform would have prevented the passenger from falling between the train and the platform (figures 10 and 11).

- 60 The train did not stop with the driving cab alongside the CCTV monitor. The significance of this is discussed later. The RAIB has established that if the train driver had stopped the train alongside the CCTV monitor on the night of the accident, the diagonal dimension between the bodyside of the train and the edge of the platform would have been 9 mm greater (ie 354 mm) due to slight variances in platform height, track lateral position and carriage suspension movement.

Figure 10: Platform-train interface dimensions as measured at Brentwood platform four.

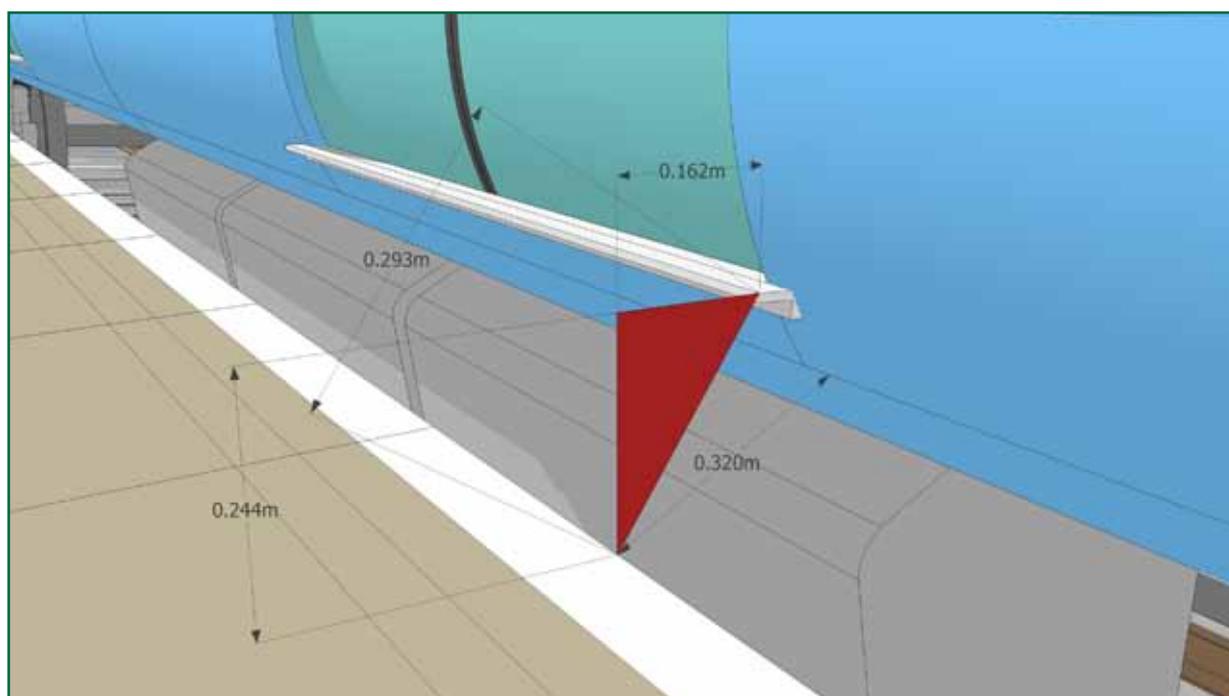
Figure 11: Dimensions if Brentwood platform four was compliant with modern standards.

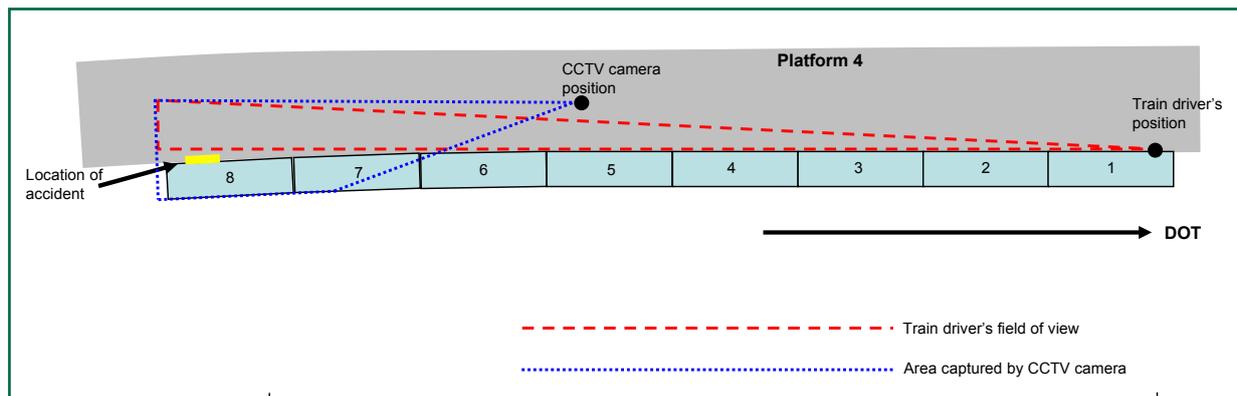
Figure 12: Train drivers' view of an eight-car train and area captured by DOO CCTV system.

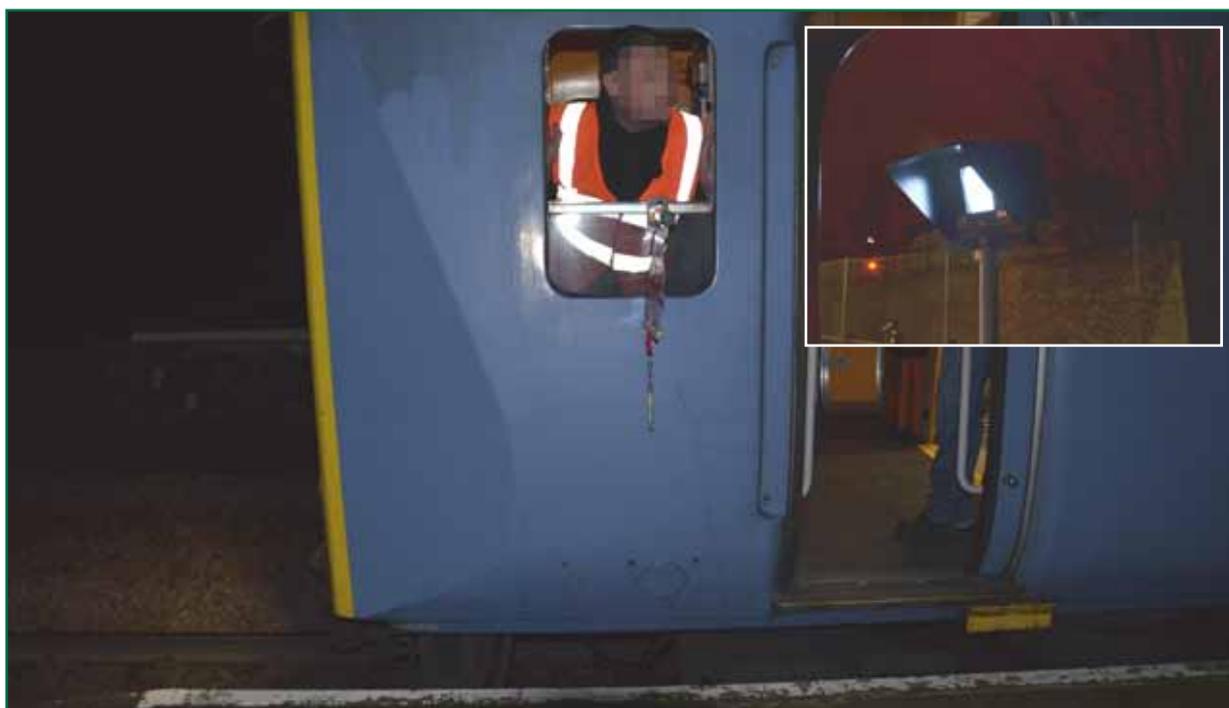
Figure 13: View of DOO CCTV monitor from train drivers stopping position on the night of the accident.

- 85 The driver of train 2W10 stated that as the train started to depart from Brentwood station he carried out the train safety check. Once the train had moved forward 20 cm (taking under two seconds from the application of power<sup>17</sup>) the sun shroud on the right-hand side of the DOO monitor partially obscured the monitor's image and, crucially, it obscured the area of the image where the accident was occurring.

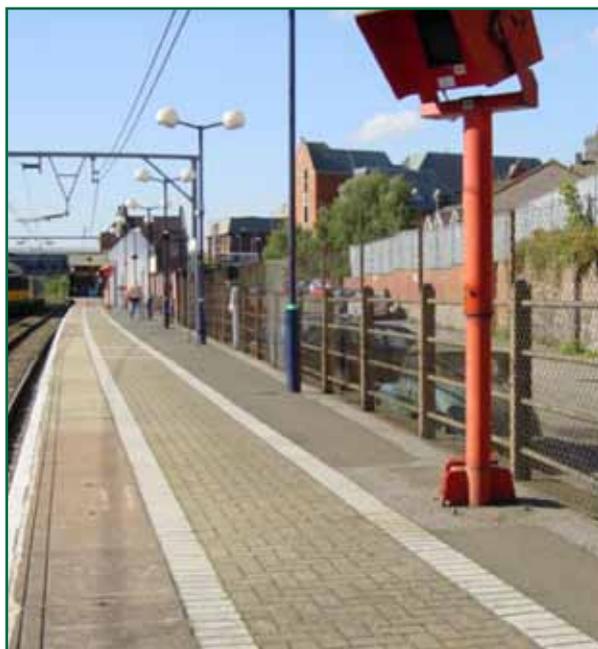
88 In 2003, Network Rail authorised the renewal of the DOO CCTV system on platform four at Brentwood station as part of an ongoing national renewal programme. The work was carried out by a Network Rail approved subcontractor. The existing 15 inch greyscale monitors were replaced with 20 inch greyscale monitors. The monitor housings and posts were also replaced. These monitors have, respectively, screens measuring approximately 38 and 50 cm on the diagonal. Photographic evidence from October 2004 indicated that the eight-car DOO monitor head was now parallel to the platform edge (figure 15), having been rotated from the position shown in figure 14.

Figure 14: Eight-car monitor position in October 2001. The head of the DOO monitor is rotated to the left and not at an angle to the platform edge (photograph courtesy of Network Rail)

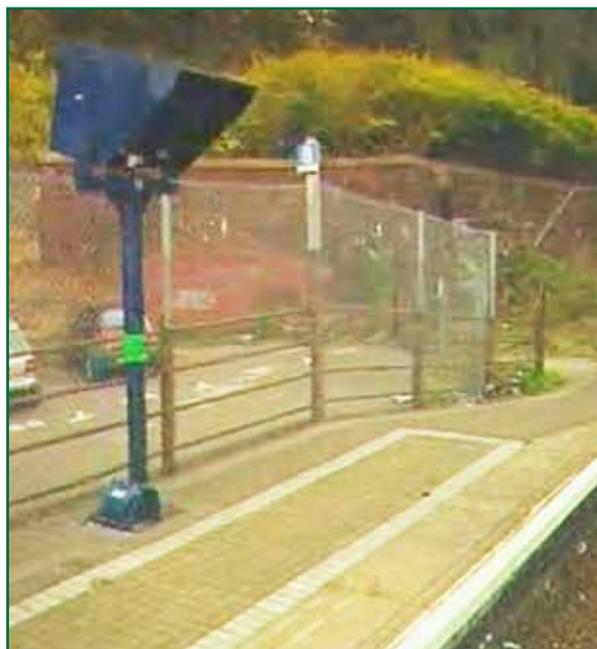
Figure 15: Eight-car monitor position in 2004. The head of the DOO monitor is now parallel to the platform edge (photograph courtesy of Network Rail)

- 89 In its original position, it appears that the eight-car DOO monitor was angled to enable drivers stopping at the eight-car stop board to see the monitor from that position. A shroud with deep side covers was provided to shade the monitor image from sun glare. When the monitor and housing were renewed in 2003, narrower, angled side covers were provided. The RAIB has not been able to establish why the eight-car DOO monitor head angle was altered during the 2003 renewal work.
- 90 In June 2003 the RSSB published Railway Group Standard, GE/RT8060. This standard mandates the minimum engineering requirements for the dispatch of trains from platforms. Among the requirements of GE/RT8060 is a need to ensure that station-mounted monitors are compatible with train operations and that a train driver is able to see the required monitor image for +/- 1 metre from the train stop location.
