Rail Accident Report

Runaway and derailment of wagons at Ashburys 4 May 2010

Runaway and derailment of wagons at Ashburys, 4 May 2010

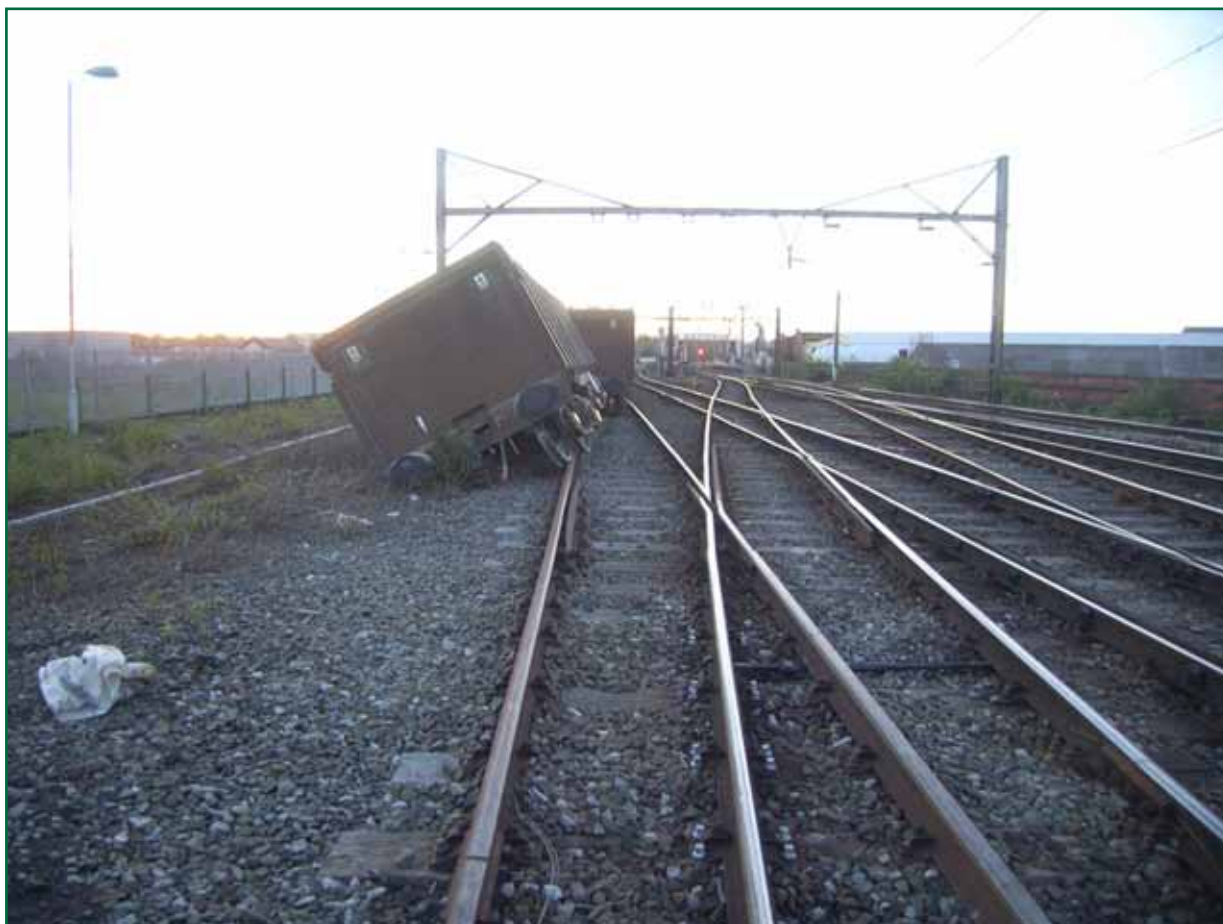
- 27 Nobody was injured in the derailment.
- 28 The leading wagon, VTG 3507, was completely derailed and partially overturned. All wheels of the leading bogie of wagon VTG 3493 were derailed but the trailing bogie remained on the track. The derailed wagons were close to, but not fouling, the down goods line, which was closed to traffic as a precaution.
- 29 There was no damage to signalling cables or *overhead electrification equipment* (OLE). Delays were caused to empty passenger trains to and from the nearby Ardwick train care depot due to the closure of the down goods line.

Figure 4: The derailed wagons, looking towards Ashburys station. The track closest to the camera is the connection between the down Ashburys line from Philips Park South Junction and the up main line

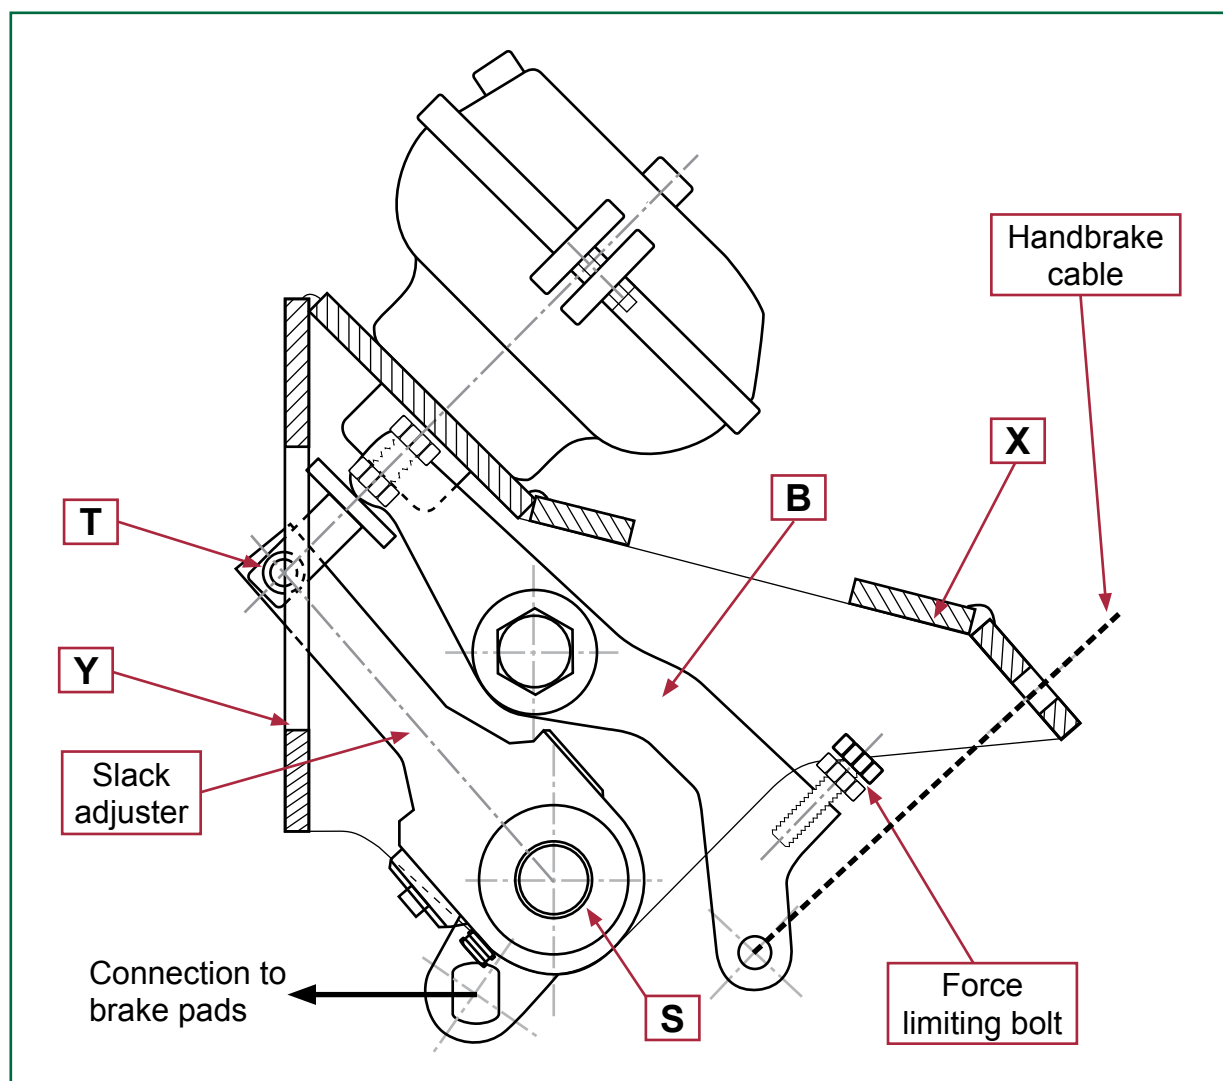
41 The handbrake had been applied on three of the five wagons; all three were disc braked. The handbrakes on two of the three wagons were restricted in their application by a force limiting bolt in the mechanism being wrongly adjusted. The handbrake on the third vehicle was found to be not fully effective when tested at site after the derailment. Figure 5 shows the arrangement of the brake unit. The brakes were applied by rotating the shaft ('S' in figure 5) in an anti-clockwise direction. This was achieved by applying a force to the top of the slack adjuster 'T'. This can be done either by the air brake actuator or by the handbrake arm 'B'. If the force limiting bolt contacts the brake unit at 'X' before the brakes have been fully applied, the handbrake force will be limited.

Figure 5: Diagram showing brake unit

- 42 Similarly, the slack adjuster body may strike the edge of its slot at point 'Y' before the full brake force has been applied. This would restrict the service brake as well as the handbrake but will only occur if the slack adjuster is not working correctly. When tested after the incident some of the slack adjusters were found to not be working correctly and had contacted the edge of the slot.

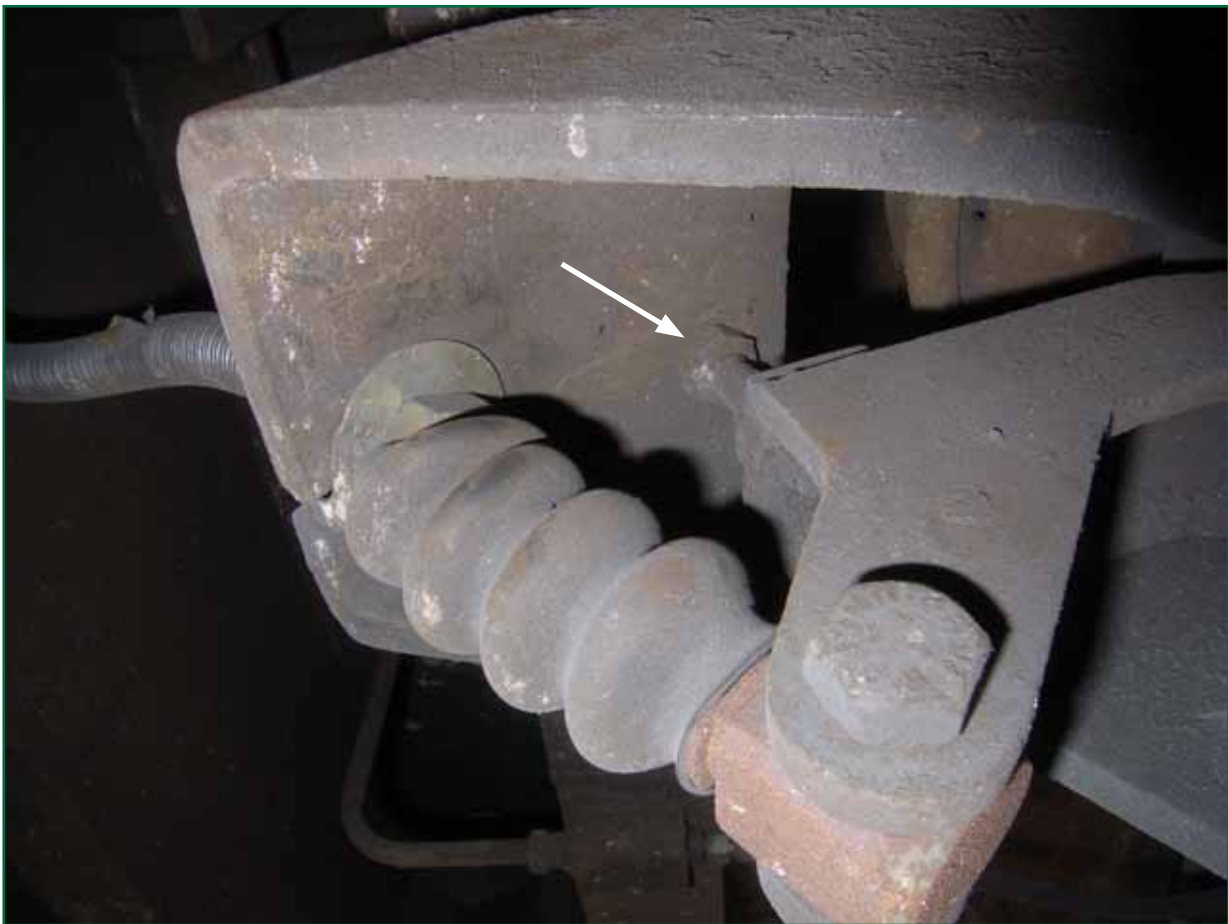
45 The lack of consideration of the force limiting bolt in the maintenance plan for the wagons was a contributory factor.

- 48 The adjustment of this bolt was not included in the VTG master maintenance plan and so was not included in any maintenance plan for these vehicles. When examined by the RAIB at Peak Forest, these bolts were found to be contacting the brake unit housing during the application of the handbrake and therefore restricting the brake force on three of the disc braked wagons (figure 6).

Figure 6: Handbrake cable and attachment to arm. Stop bolt (arrowed) in contact with bracket

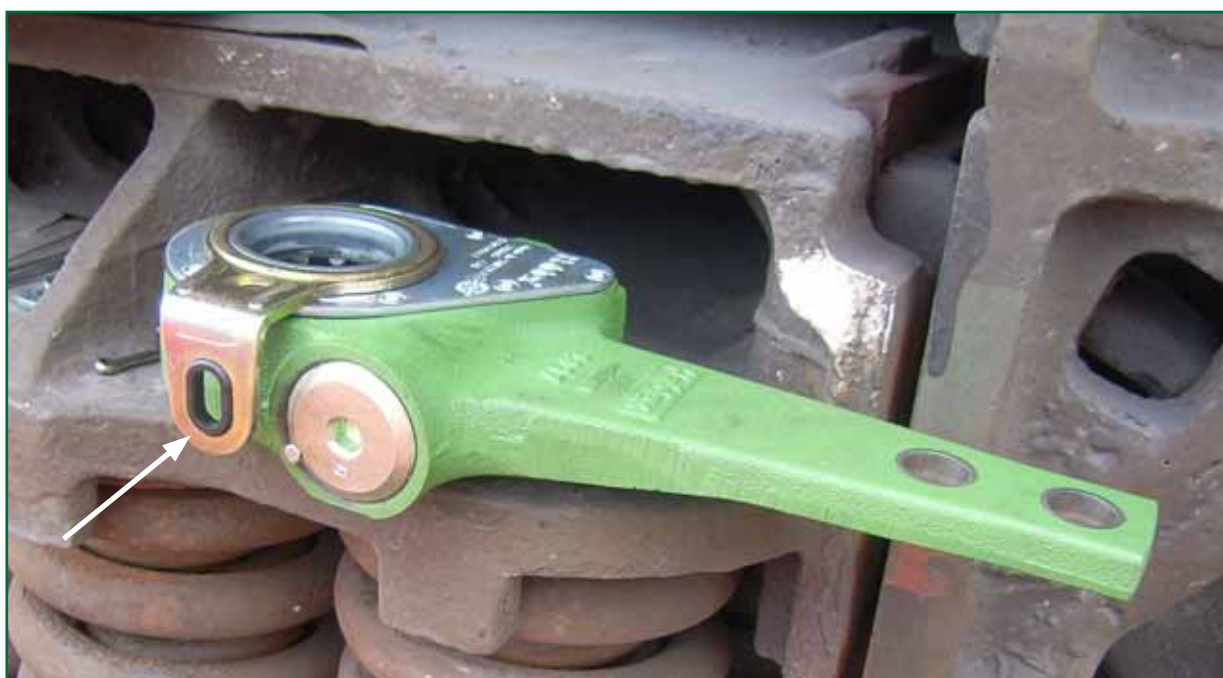
Figure 7: New AA1 slack adjuster showing anchor bracket (arrowed)

- 53 Haldex identified an issue with wear of the anchor bracket in the early 1990s following reports of slack adjusters not working on road vehicles and introduced a plastic grommet to improve the fixing to the anchor bolt (figure 7). All AA1 units supplied after this date included the plastic grommet. At this time the bogies of the JNA wagons were in use on tank wagons. The RAIB has been unable to locate a copy of the maintenance plan for these wagons to confirm whether the importance of securing the anchor bracket was identified.

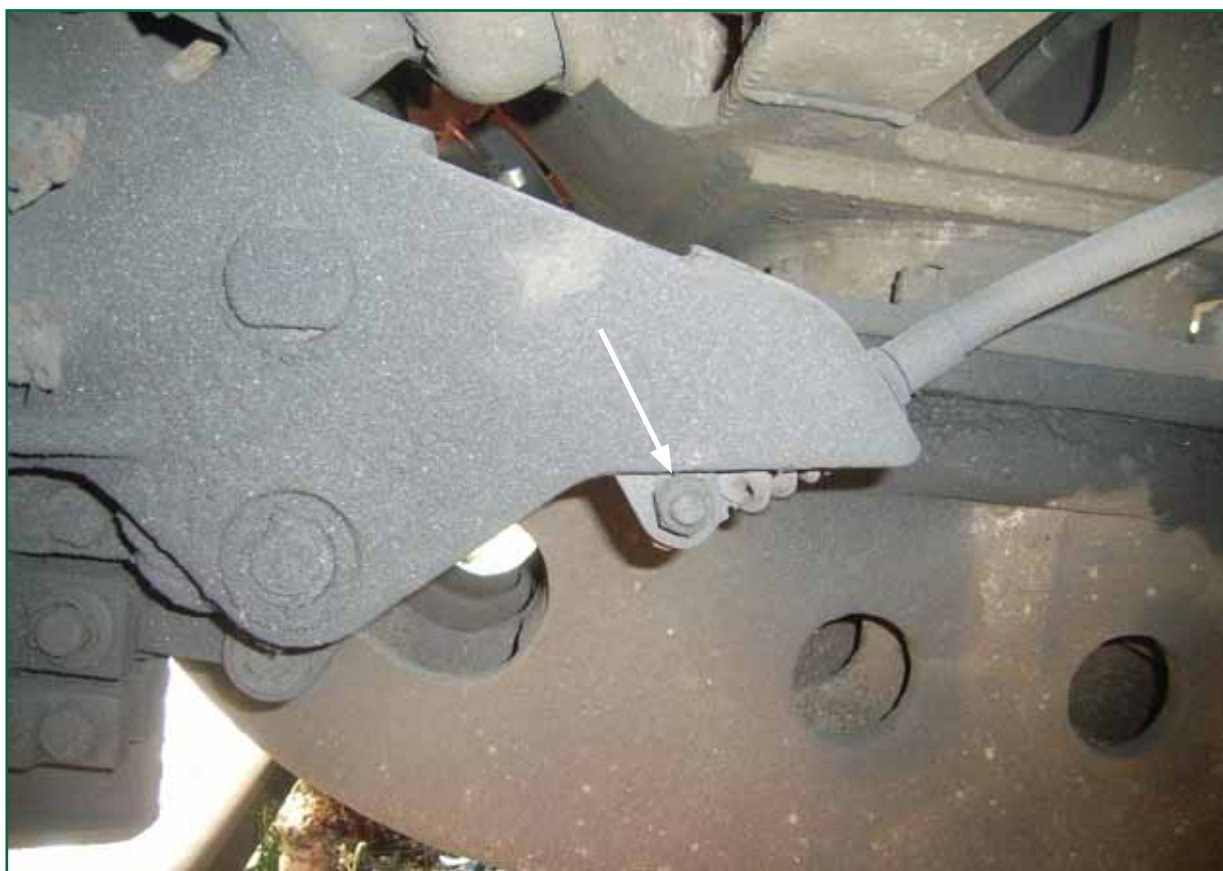
- 54 If the anchor bracket is loose on its anchor point, the effect is to increase the clearance between the brake pads and the disc. If this clearance becomes too great, the slack adjuster arm or another part of the brake operating mechanism can reach the end of its travel before the brakes have been fully applied (figure 8).

Figure 8: Brake unit on wagon VTG 3510 showing (arrowed) handbrake cable bolt fouling brake unit housing

- 55 When examined by the RAIB at Peak Forest, the slack adjuster arm on wagon VTG 3510 was contacting part of the bogie frame limiting the travel of the air brake and the handbrake cable bolt was contacting the brake unit housing preventing the handbrake from being fully applied (figure 8). The slack adjuster grommet was missing from the slack adjusters on wagons VTG 3478 and VTG 3507 and the anchor bolts were worn (figures 9 and 10).

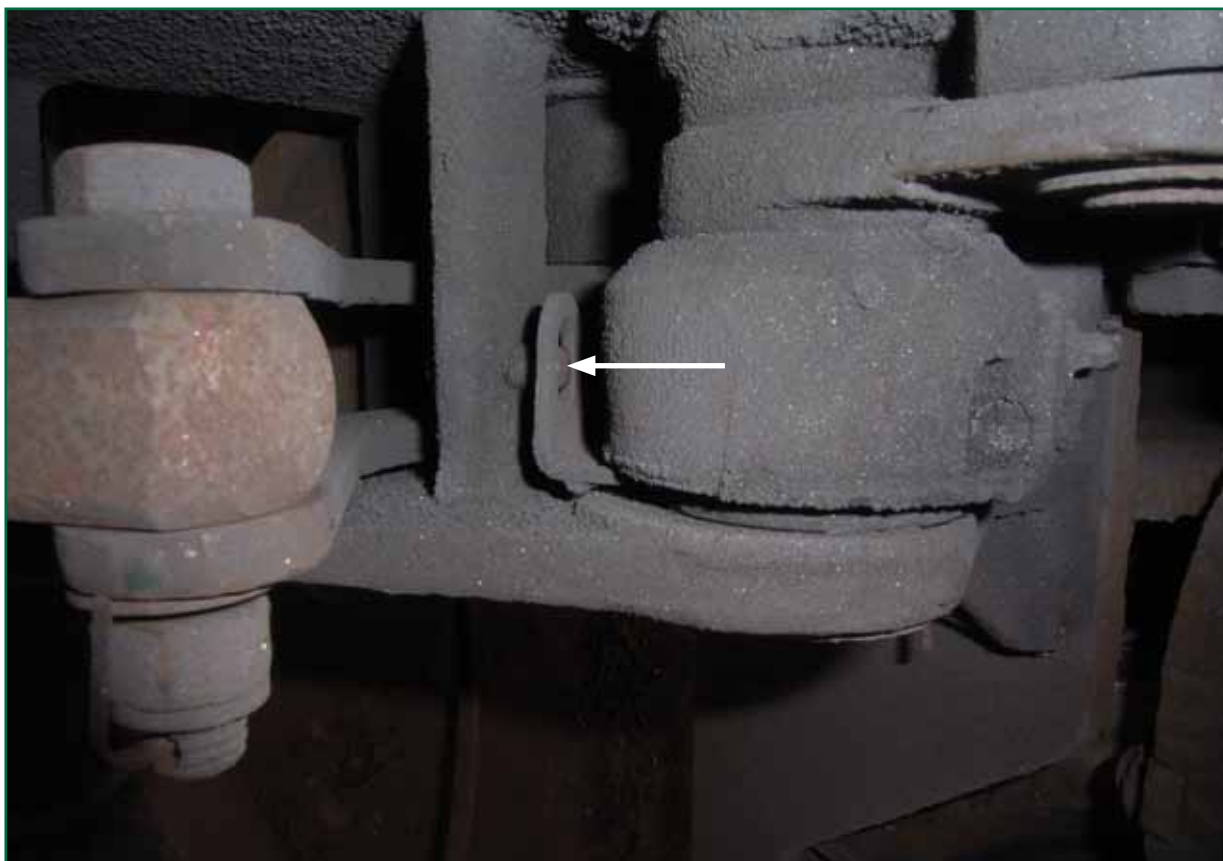
Figure 9: View of brake unit from below showing (arrowed) slack adjuster anchor bolt on VTG 3478

Operators of wagons fitted with SAB/Haldex AA1 type slack adjusters should, in conjunction with the maintainers and owners as appropriate, ensure that the maintenance plans are reviewed to confirm that they incorporate the manufacturer's current recommendations on their inspection and maintenance. Network Rail PWRA should issue a *private owners circular letter* to this effect to PWRA members.

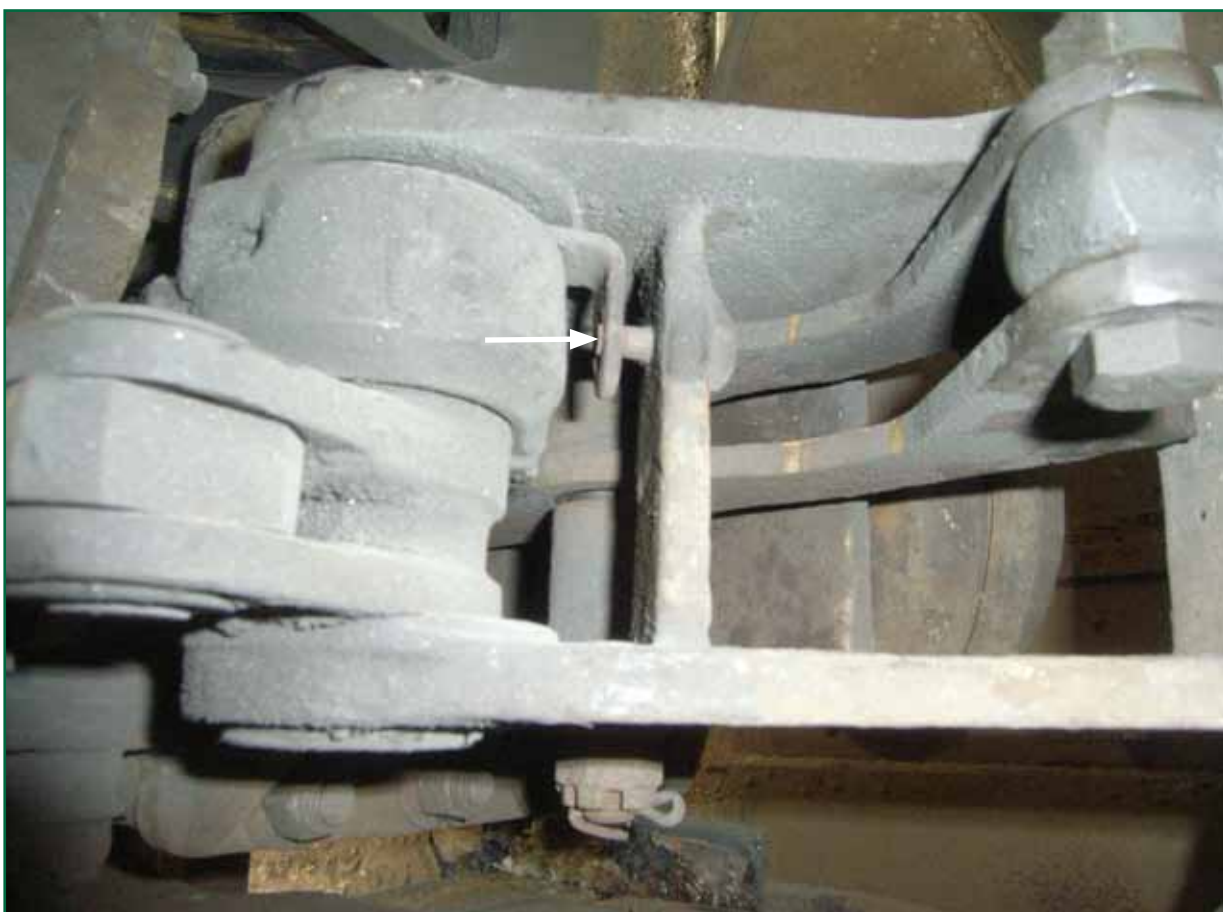
Figure 10: View of brake unit on VTG 3507 from below showing worn anchor bolt (arrowed)
