Rail Accident Investigation Branch

Rail Accident Report

Passenger train struck by object at Washwood Heath 6 March 2010

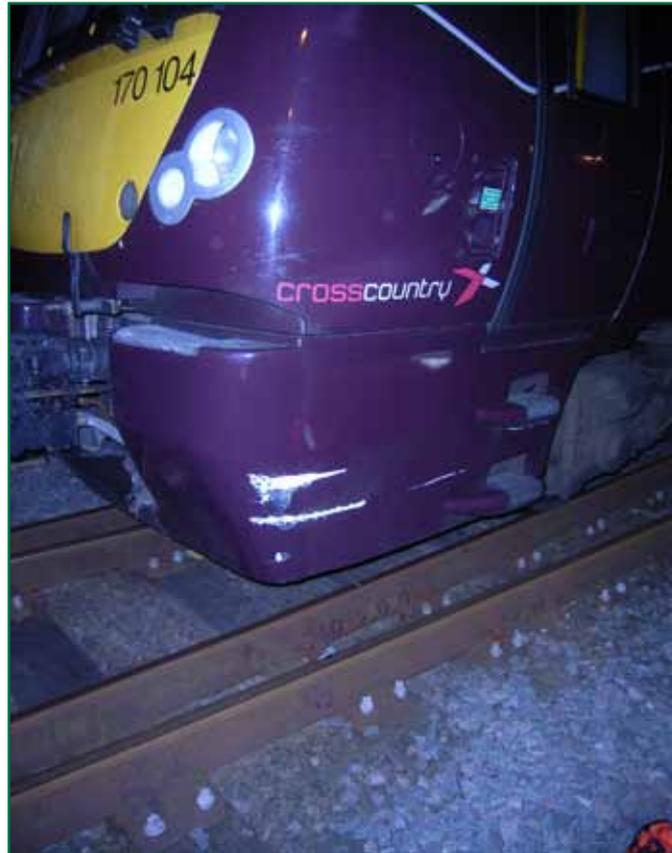
Figure 3: Damage to the front of the train

- 27 The plastic fairing on the front of the train was broken and gouged in four places and loosened from its mountings (figure 3). The *bogie* sideframe was dented above the *axle box* and the *yaw damper* was gouged at one end (figure 4). The train was returned to Birmingham New Street station and taken out of service.
- 28 The rail end was damaged by the impact (figure 5).

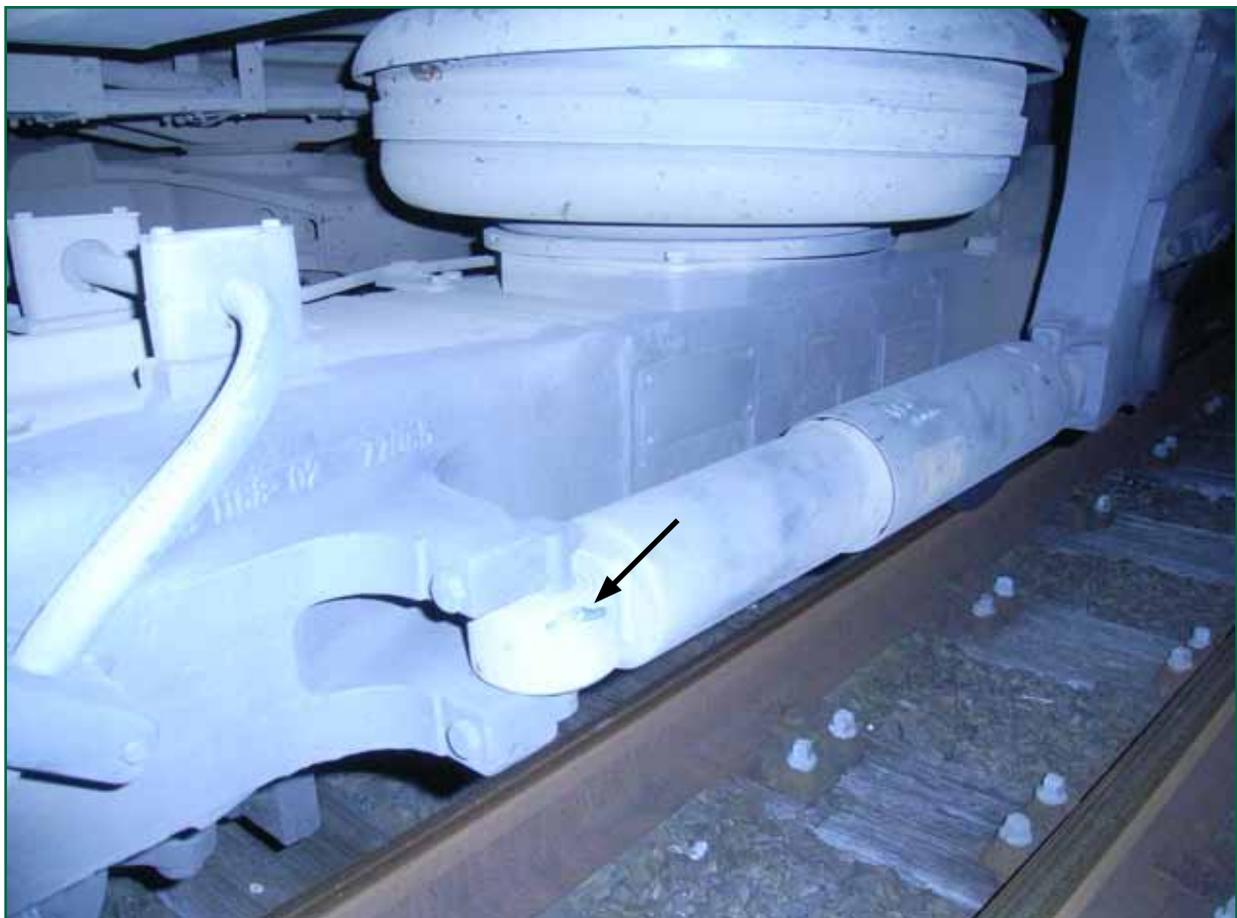
Figure 4: Damage to the leading bogie of the train

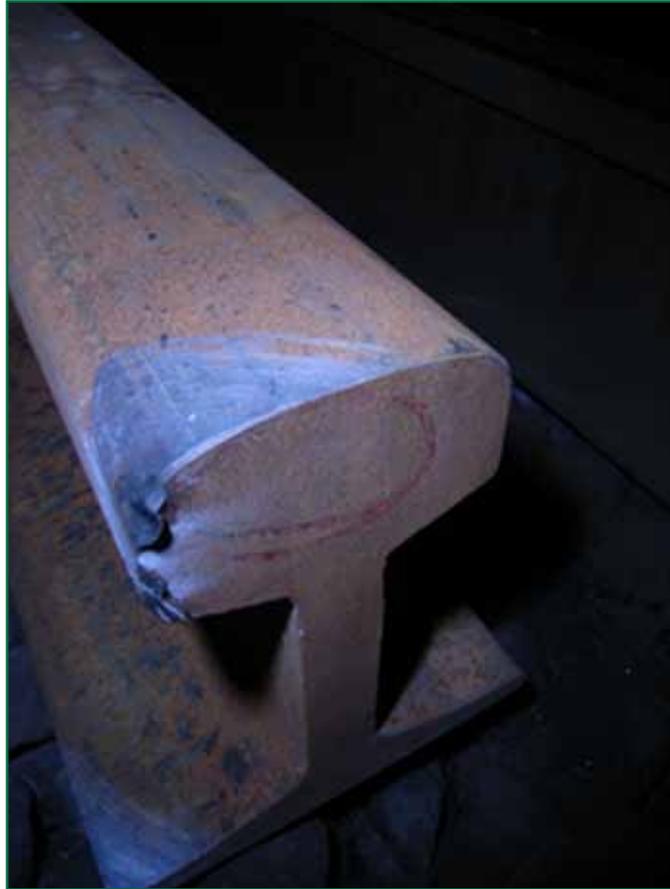
Figure 5: Damaged rail end
