Rail Accident Investigation Branch

Rail Accident Report

Failure of Bridge RDG1 48 (River Crane) between Whitton and Feltham 14 November 2009

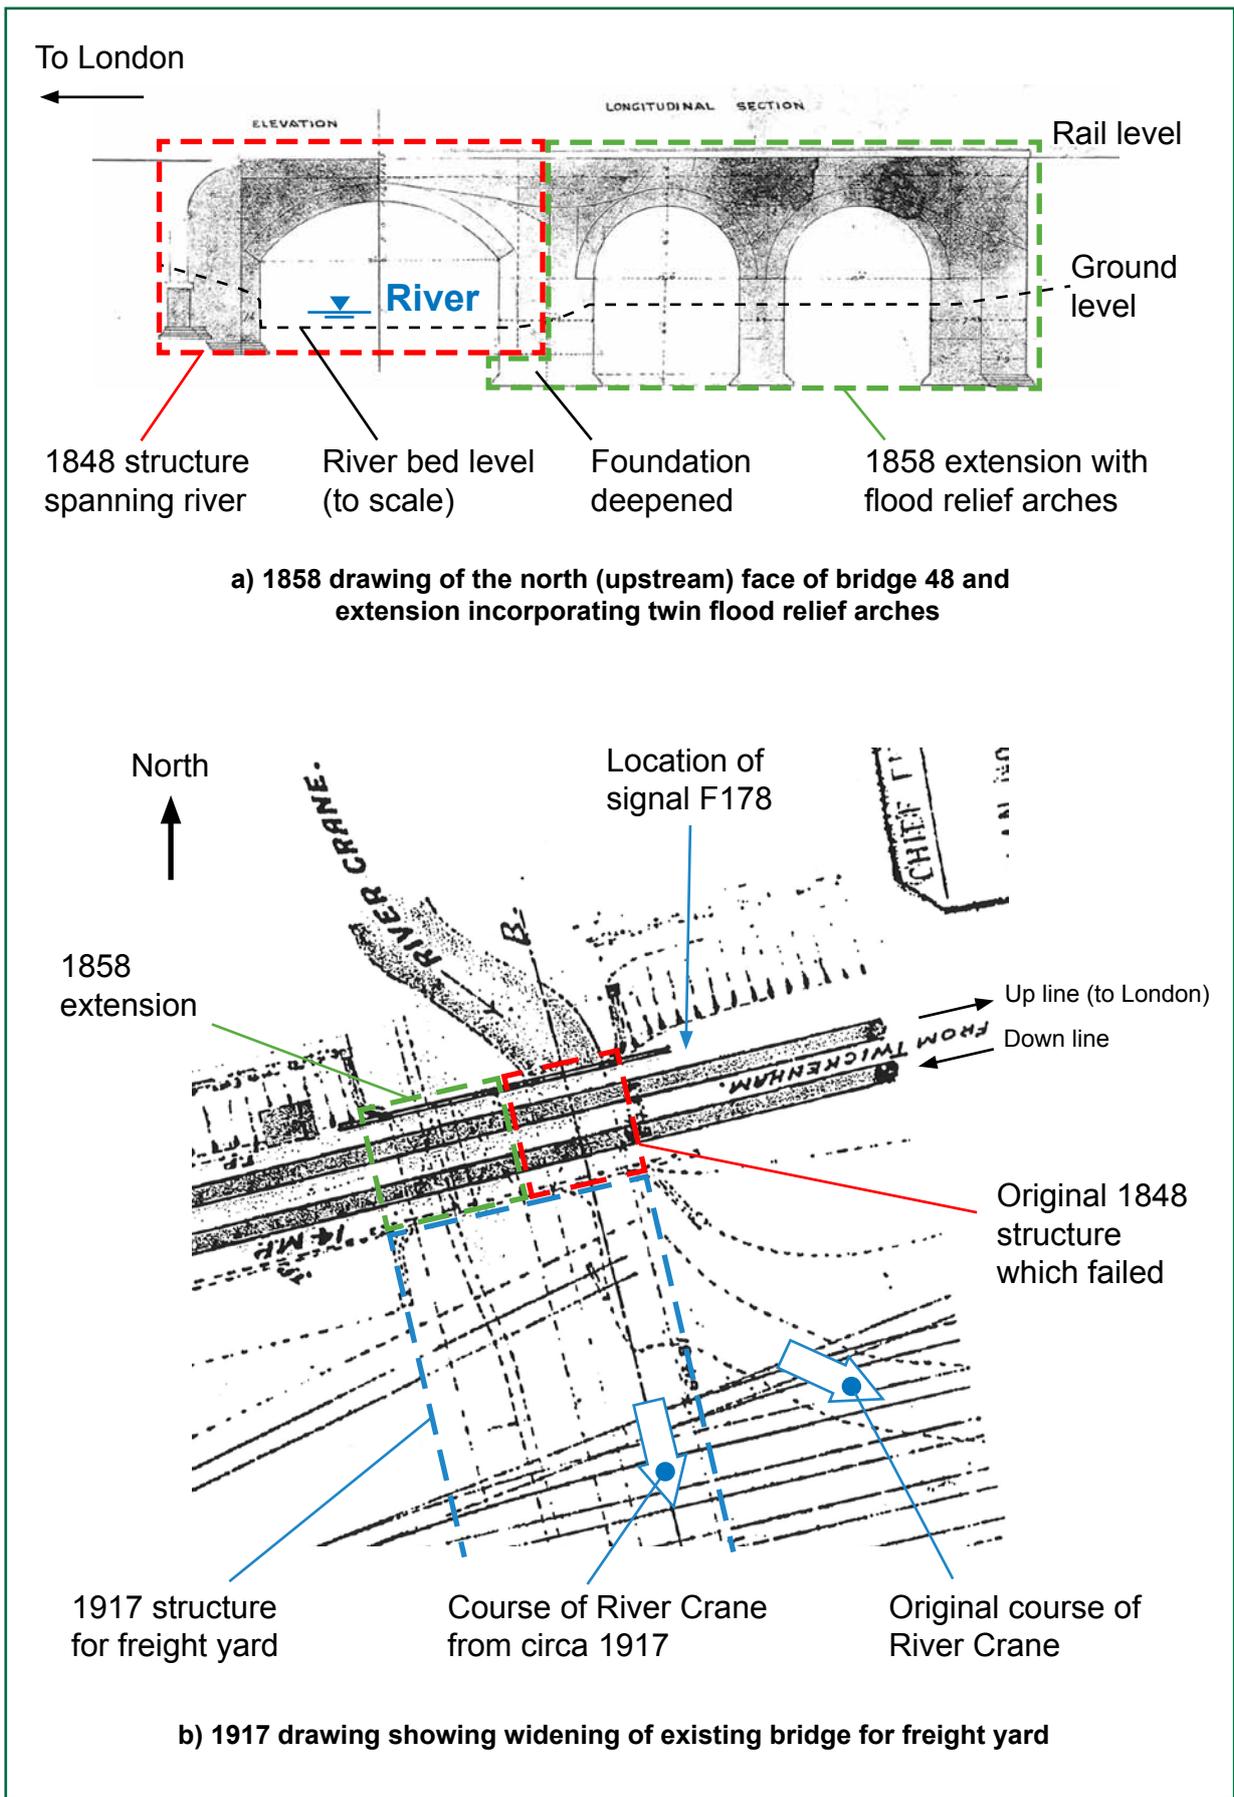
Figure 3: Extracts from historical drawings showing bridge 48 and later extensions

- 22 The River Crane approaches the bridge from the north at a 10° angle, placing the east abutment on the outside of the bend (figure 3). The shape of the river channel directs the river flow towards this abutment, regardless of whether any obstruction is present.

- 72 **The east abutment of the bridge was located on the outside of a bend in the river where the flow of water was directed at it. It was constructed with shallow foundations which were not renewed when the structure was extended in 1858, and it was founded on erodible material. These features, taken together, increased its vulnerability to scour and this was a causal factor.**

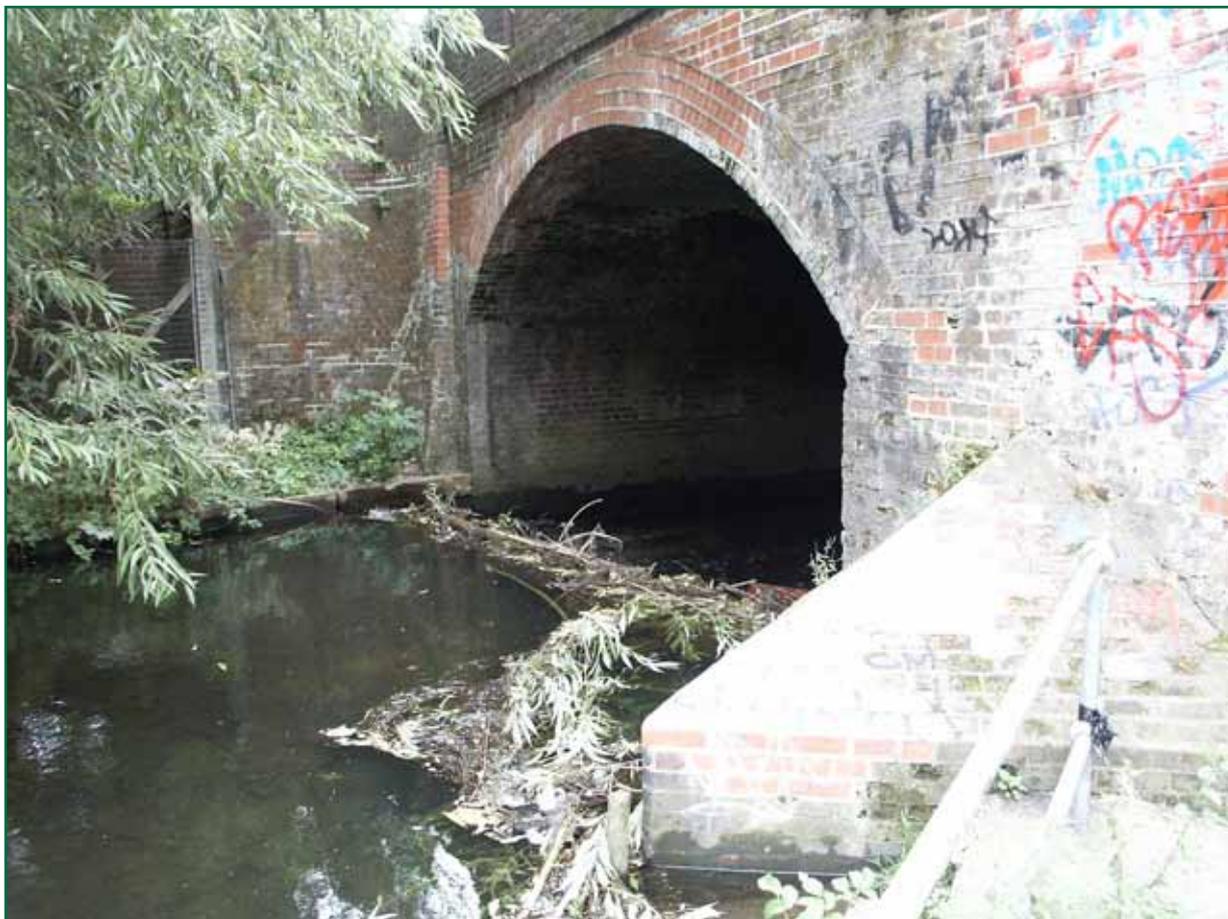
Figure 4: Branch across upstream face of bridge 48 on 20 August 2009 (photograph: N Banks)

- 23 On 20 August 2009, a member of the public took a photograph of a recently cut willow branch positioned across the upstream face of bridge 48. The branch was sufficiently long to span the full width of the watercourse, constricting the flow (figure 4).

44 An obstruction in the watercourse channelled the flow towards the east abutment, increasing its velocity and making it more likely that scour would occur, particularly during periods when the river flow was raised. The presence of an obstruction across the upstream face of the bridge prior to its failure was a causal factor.

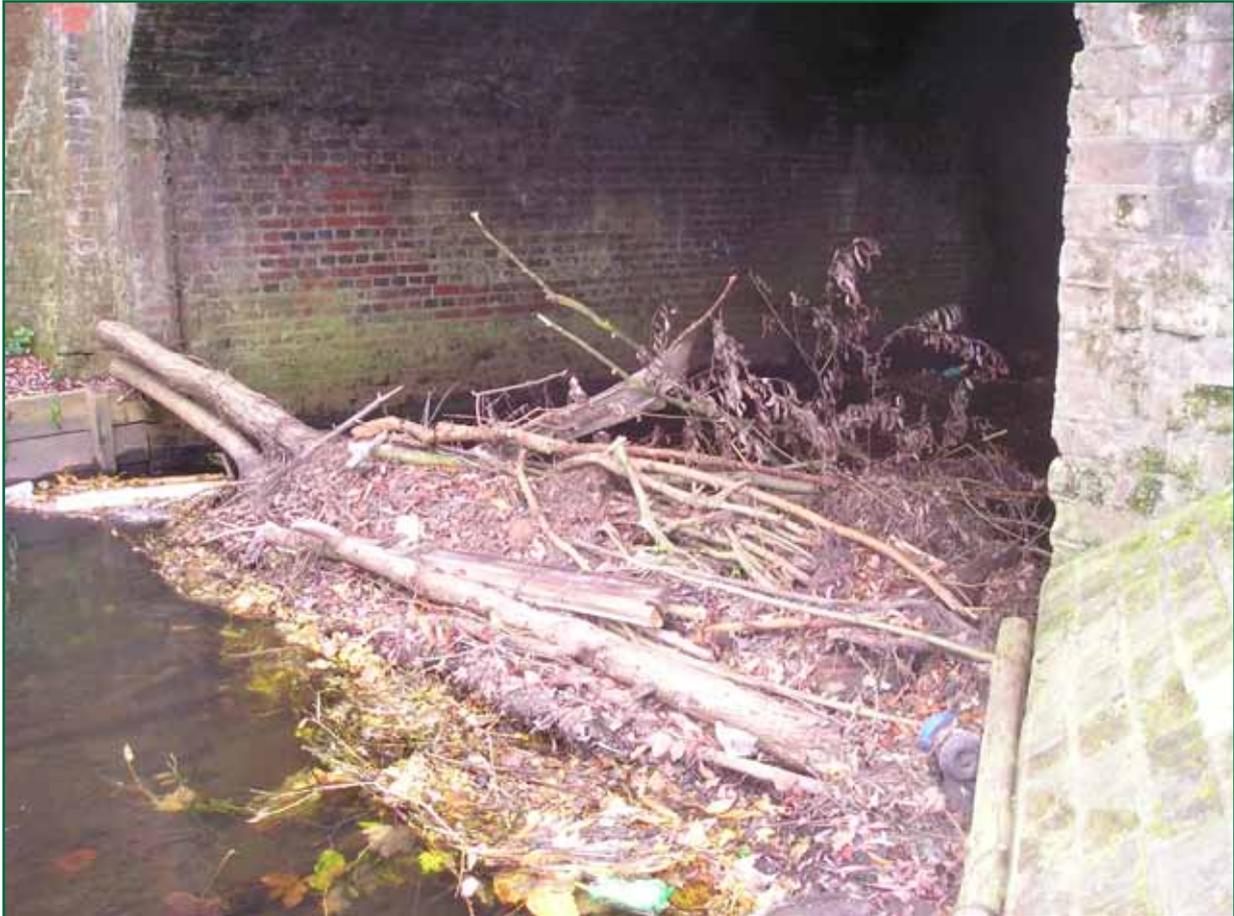
Figure 5: Obstruction across upstream face of bridge 48 on 28 October 2009 (photograph: Environment Agency)

- 26 On 28 October 2009, an Asset Inspector employed by the Environment Agency (EA) observed a large obstruction at the upstream face of bridge 48 (figure 5) formed of logs, branches and other detritus. This constricted the flow and directed it towards the east abutment. The inspector did not report the obstruction to Network Rail.

- 91 The EA's records show that obstructions were observed in the channel beneath bridge 48 in September 2008 and again during an internal inspection in December 2008. An EA Inspector also observed and photographed the large obstruction against the upstream face of the bridge by 28 October 2009, but he considered that the risk of flooding was low due to the size of the arch. The EA was considering removing the obstruction using its own resources and at its own expense, but no action had been taken prior to the failure occurring.

- 92 The EA did not notify Network Rail of any of the identified obstructions as the risk of upstream flooding was judged to be low and there was no visible damage to the structure. The scour risk was not recognised.

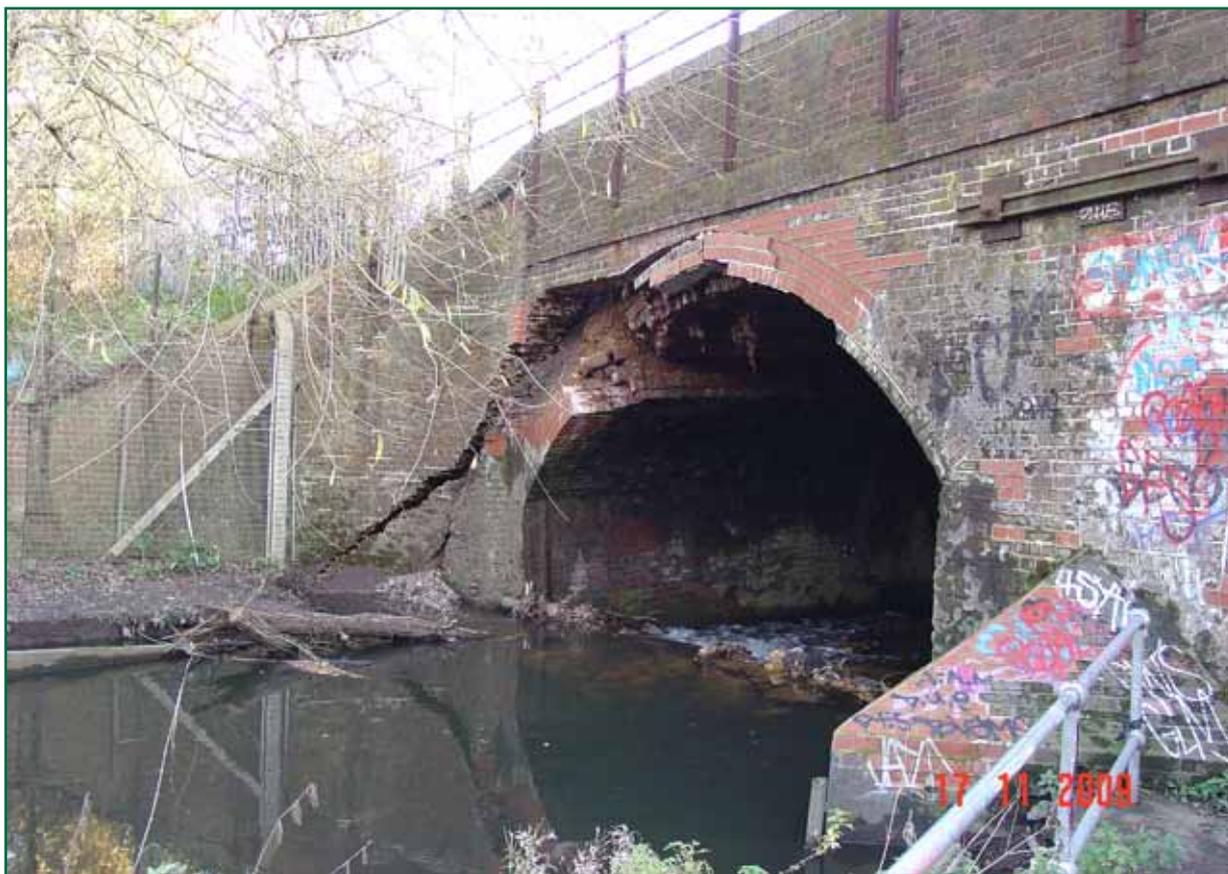
Figure 6: upstream face of bridge 48 following the incident showing failed arch

- 29 During the six minute period between train 2C74 and the following train 2S74 crossing the bridge, the unsupported section of the east abutment subsided. This movement caused dislocation of the arch at the upstream face and resulted in a loss of track support to the up line (figure 6).

- 96 Railway users were put at risk by the subsidence of the east abutment of bridge 48, which rotated to the left as a single section about a point approximately 5.5 metres from the upstream face, beneath the down line, and subsided by about 400 mm. The movement of the abutment in a single section confirms that it was structurally sound prior to becoming undermined, but the resulting *differential settlement* caused the brick arch to twist. This is a known failure mode for arch structures, and led to a complete dislocation of the arch ring at the upstream face (figure 6), compromising its structural integrity, and greatly reducing its capacity to support train movements. It is probable that the arch would have collapsed into the river within a short time if trains had continued to run.

- 97 Train services between Feltham and Whitton were suspended for eight days following the incident while a temporary track diversion was installed. This remained in use until the tracks were restored to their original alignment in May 2010. During the intervening period, the river span of bridge 48, dating from 1848, was rebuilt as a reinforced concrete structure spanning 16.5 metres between piled foundations, with scour protection for the east abutment.

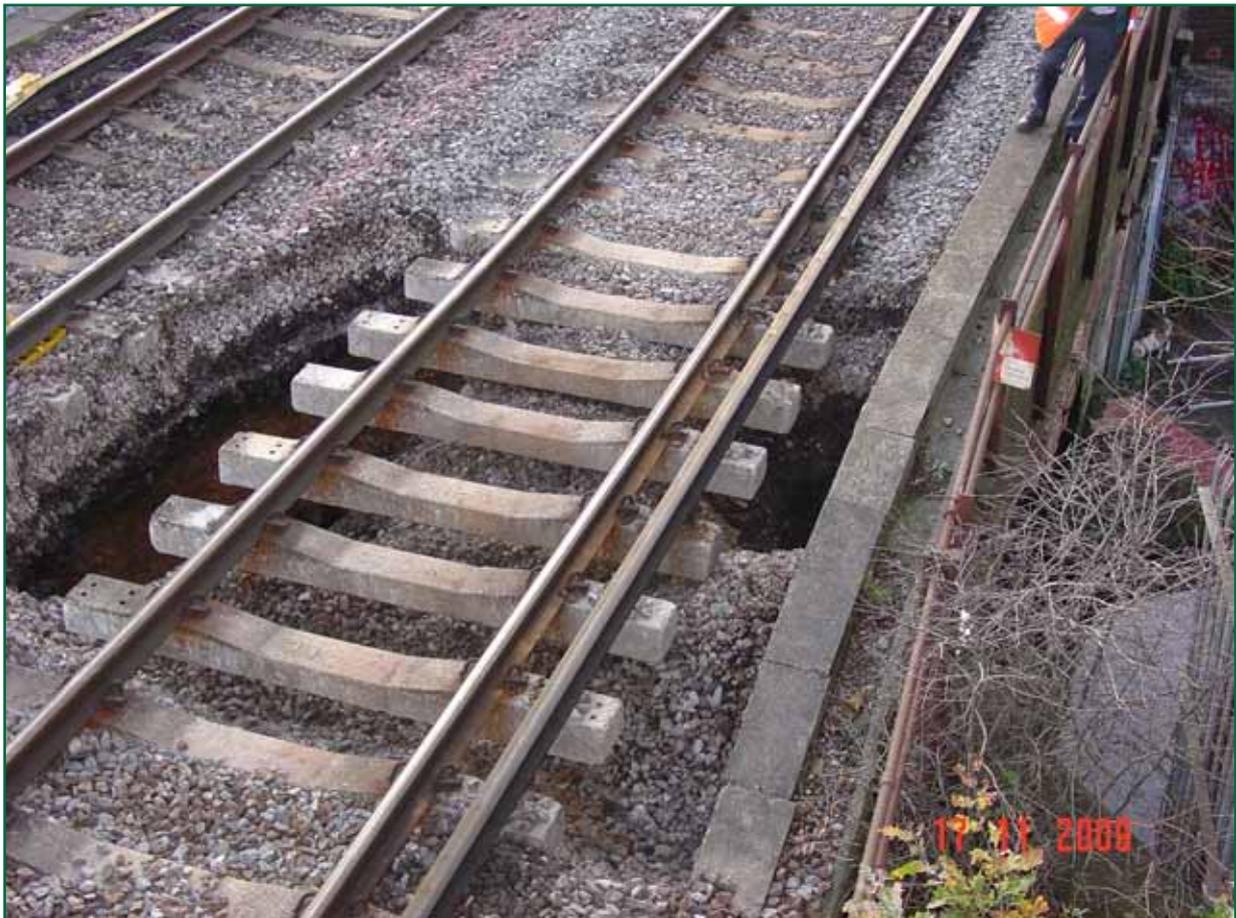
Figure 7: Overview of track showing loss of support to up line

- 36 The on-call supervisor attended site, accompanied by six men with equipment to lift the track and consolidate the ballast. He arranged for the signaller to block the line while he examined the track, but was unable to find a dip at the reported location. He subsequently widened his search in both directions.
- 37 At 00:14 hrs on Sunday 15 November, the on-call supervisor contacted the signaller and instructed him to limit the speed of the next train, 5S80, an ECS movement standing at signal F178, to 5 mph (8 km/h) so that he could watch it pass. As it crossed bridge 48, he observed the rails dipping by an estimated 150 mm. On inspection, he found ballast missing around and beneath six sleepers and a hole between the up and down lines through which he could see the river (figures 7 and 8).

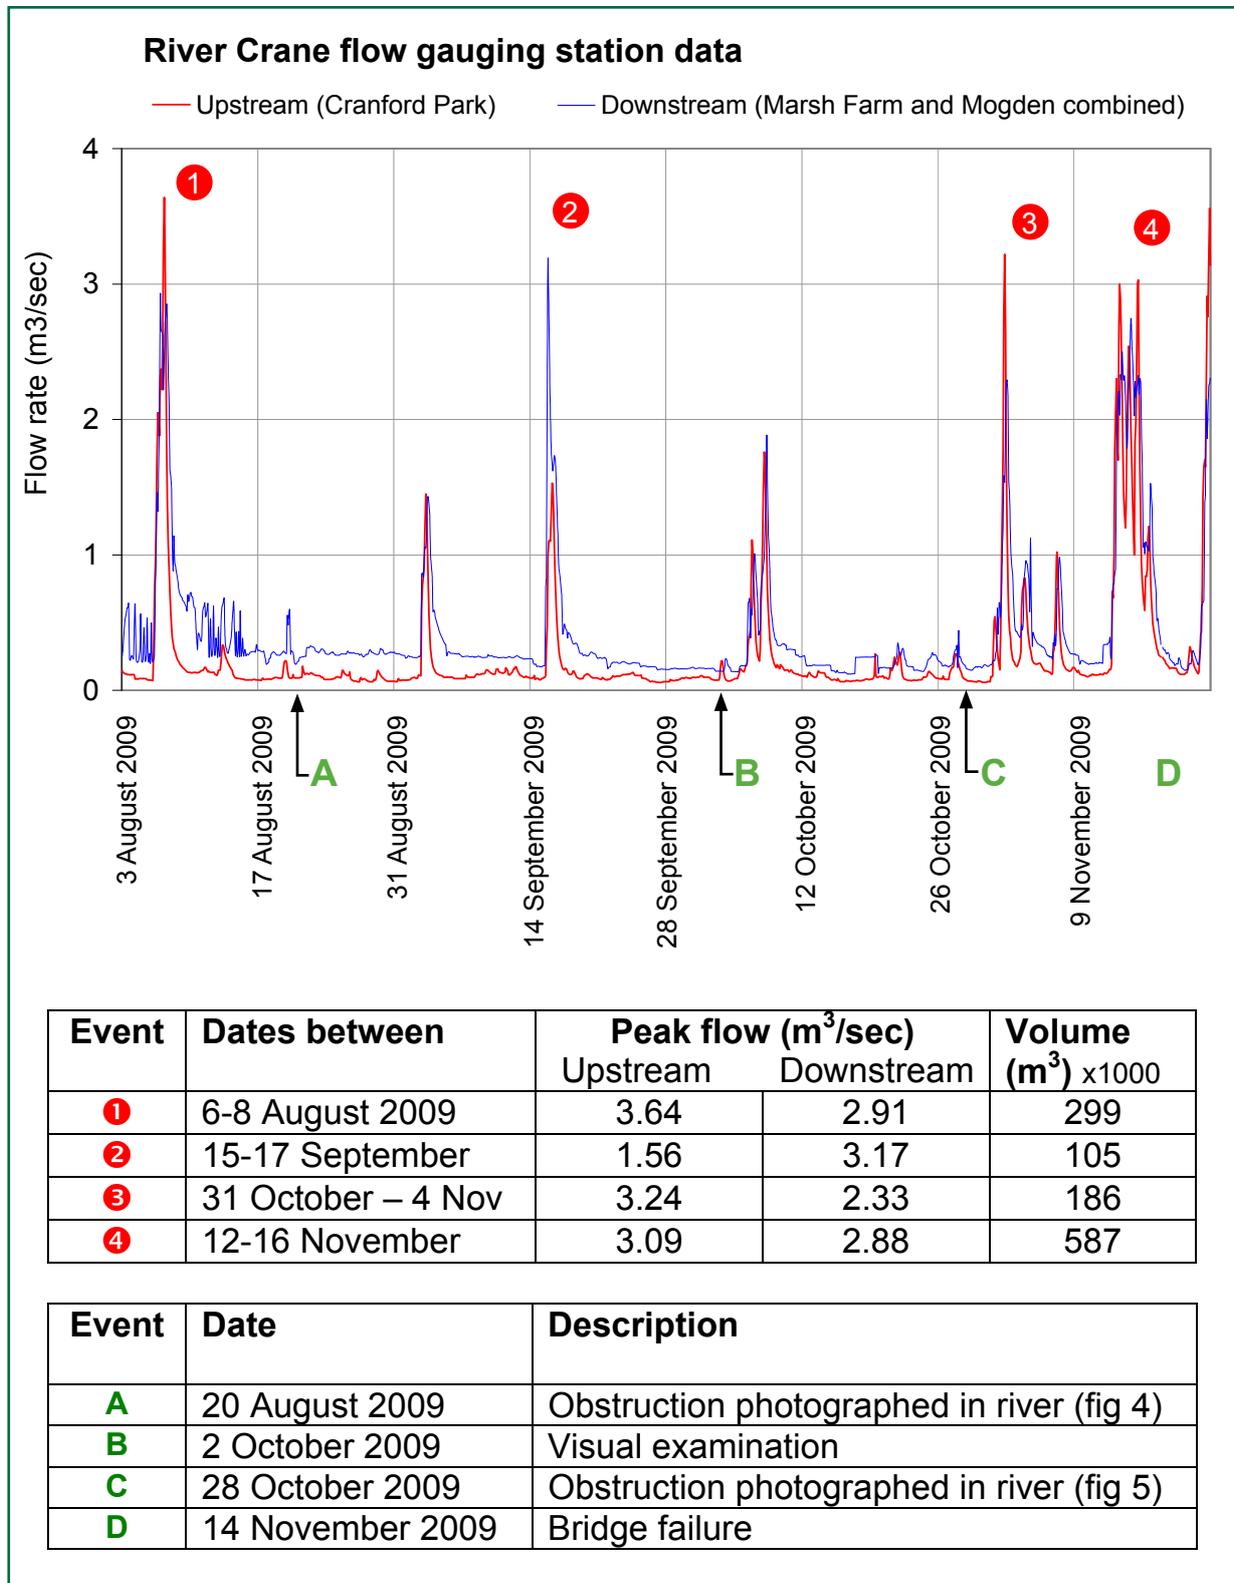
Figure 9: Flow data

48 Data for the River Crane upstream and downstream of bridge 48, recorded at *gauging stations* operated by the EA, indicates that the flow significantly increased on four occasions between August and November 2009. Flow levels were raised during the 48 hours prior to the incident (figure 9).

- 49 The data indicates that the flow rate, measured upstream of the bridge, averaged 0.21 m³/sec during the three months prior to the incident. Flow peaked at 3.02 m³/sec in the 48 hours prior to the incident (ie 14 times greater than the average flow). Although the increase in flow was significant, it was not exceptional and the depth of water, measured at the gauging stations, was not sufficient to trigger a flood alert.
