Rail Accident Investigation Branch

Rail Accident Report

Fatal accident at Halkirk level crossing, Caithness 29 September 2009

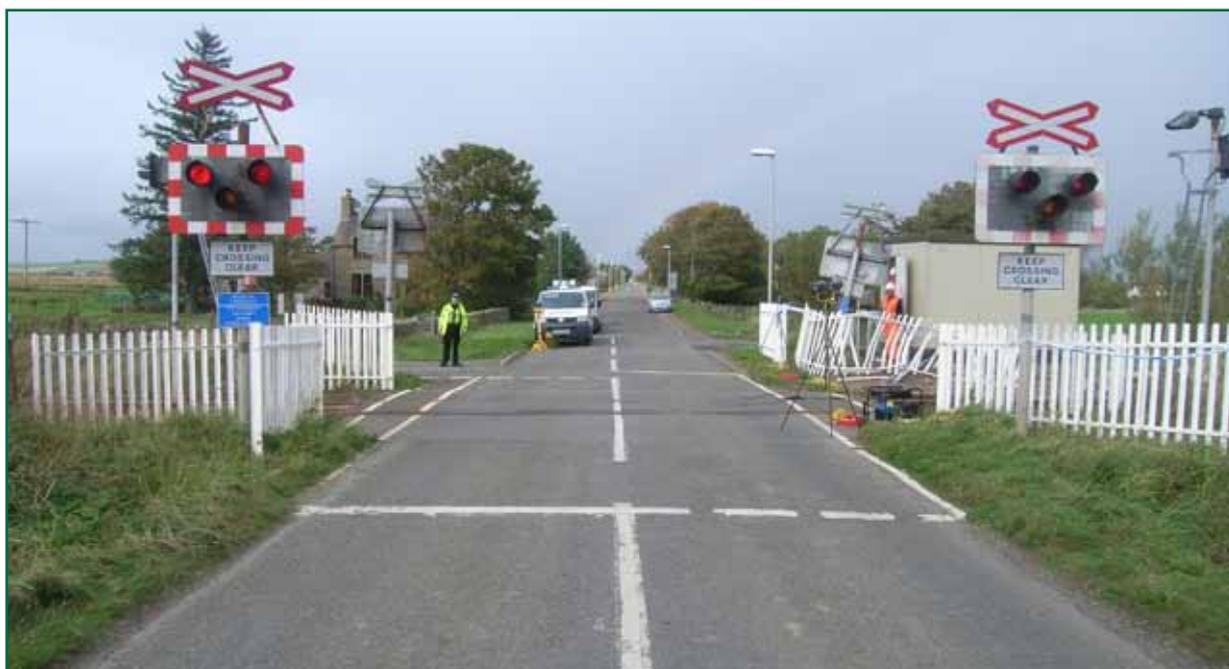
Figure 3: Halkirk level crossing from the south

- 33 The train hit the rear of the car leaving vertical indentations caused by the train's gangway on the nearside rear passenger door and roof. The impact caused the car to rotate in an anti-clockwise direction when viewed from above and be pushed into steel picket fencing and the post supporting the road traffic light signals at the north-east corner of the crossing (figure 3).

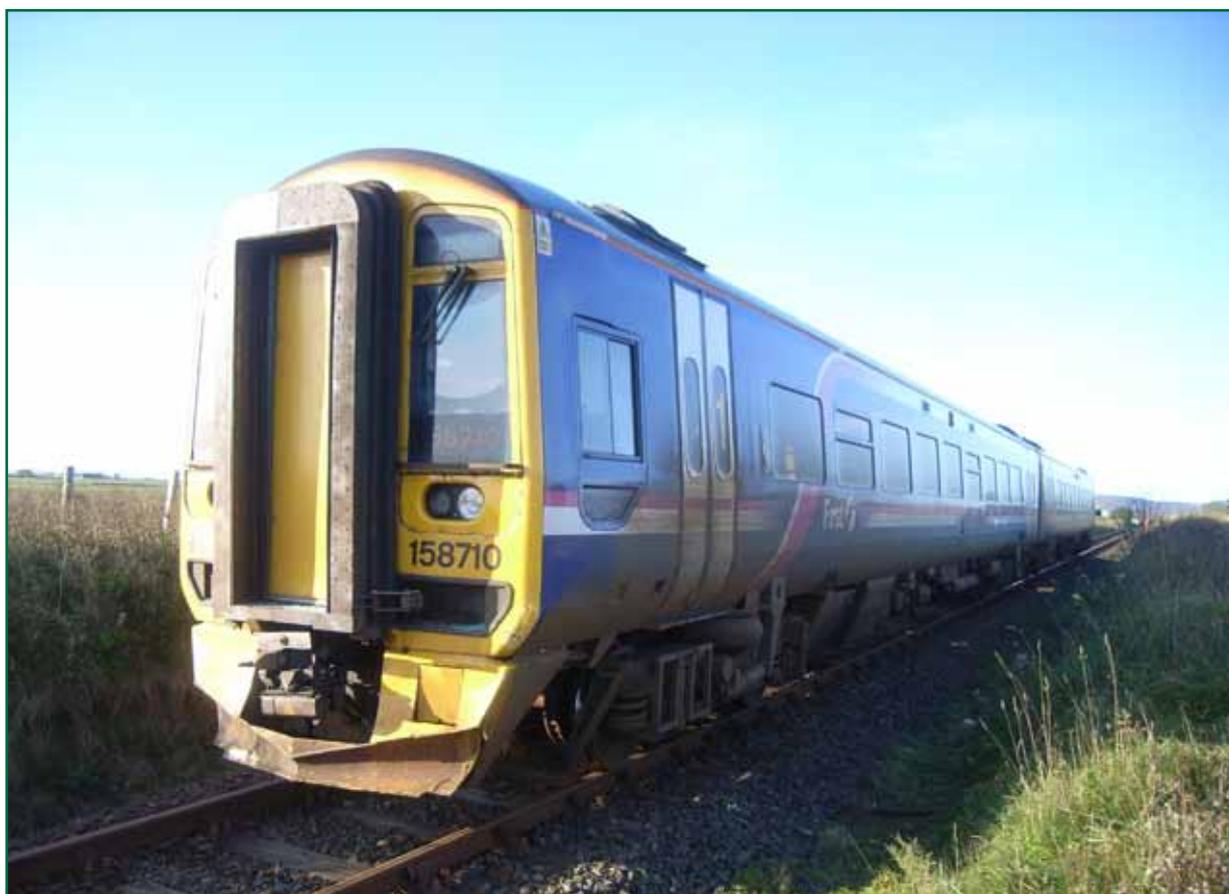
Figure 6: The train involved in the collision at Halkirk level crossing

- 37 The three occupants of the car were fatally injured and the car was severely damaged on its nearside.
- 38 The train sustained minor damage to its front end, particularly the coupling. There was also some bodywork damage, the most serious of which was the hole in the left-hand side of the leading coach caused by the second impact with the car (figure 6).
- 39 Level crossing equipment on the north side of the crossing was damaged by the impact of the car.

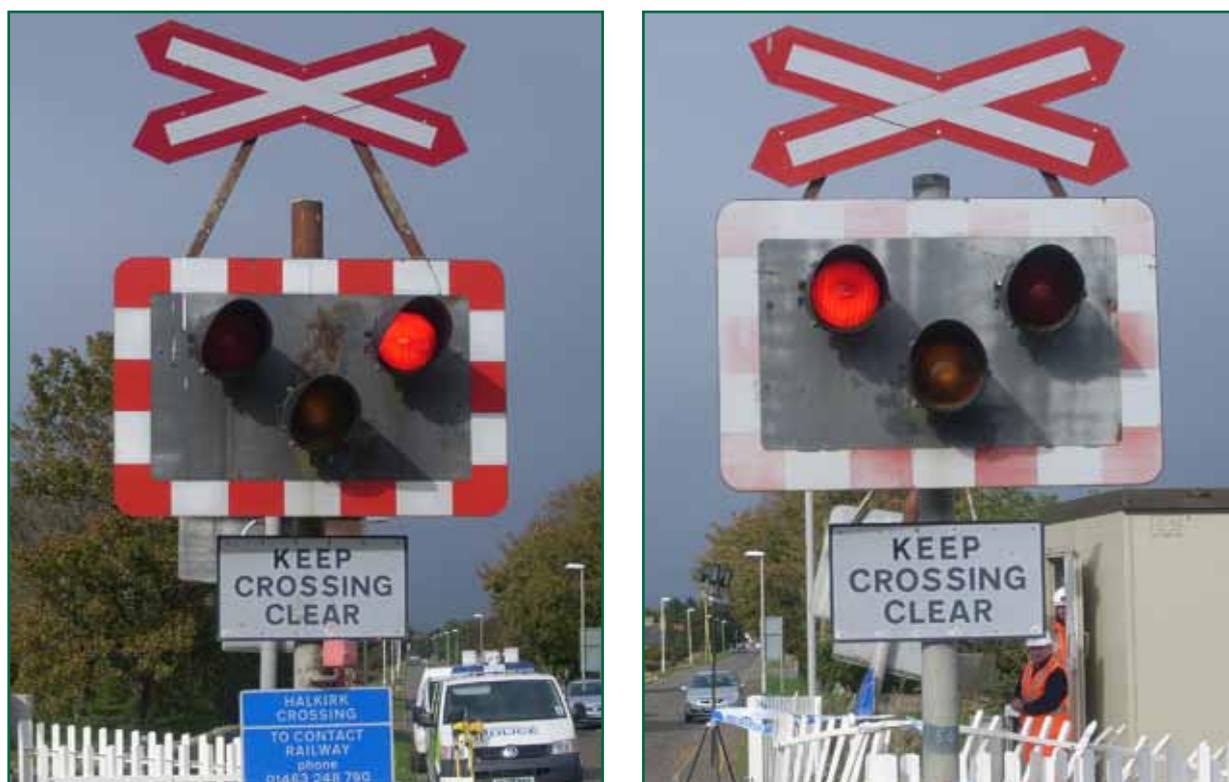
Figure 7: Condition of road traffic light signals, Halkirk crossing, south side

- 76 The matt black backboards and chequered surrounds (particularly the offside backboard) were faded and unable to prevent the reflection of sunlight (figure 7). The expert's view was that this would have been tolerable for a vehicle driver with normal eyesight.
- 77 The poor condition of the backboards, in combination with falling sunlight, reduced the conspicuity of the lights to any approaching road vehicle. Although unlikely to have significantly affected someone with standard eyesight, this was of particular significance to a road vehicle driver with sub-standard eyesight and a greater susceptibility to the effect of glare.

- 80 However, the optical tests found that the condition of the backboards was such as to reduce the amount of contrast between the lit red light units and the areas of the backboards, an effect that was more significant in the case of the right-hand backboard. This reduced the conspicuity of the lights.

- 81 Network Rail's routine inspection of 22 April 2009 (Appendix D, paragraph 27) noted that both the south side road traffic light signal chequered red and white borders were unsatisfactory: the nearside backboard was starting to rust and the off side backboard was faded. The defect was allocated a priority in accordance with Network Rail's procedures for the work to be completed within six months. A work arising form was completed on 24 April 2009 for action by the signal maintenance function. Remedial action was not taken before the next inspection, and the same defects were noted at the following inspections on 2 June and 21 July 2009. New work arising forms were completed duplicating the one that had been completed on 24 April 2009 and allocating the same priority for the work to be completed within six months.

- 82 The signal maintenance function did not take action in response to the work arising forms because they were waiting for the start of a project sponsored by Network Rail headquarters to upgrade the road traffic light signals at crossings identified as highest risk to LEDs. This project included converting most AOCLs.
- 83 The inspection checklists used by staff carrying out inspections of level crossings only required that a check was made 'that the road signals, and their associated hoods, are in acceptable condition'. The maintenance specification applicable to the crossing required a check of the backboard but emphasised that the check related to damage and the proper security of the road lights. There was no direct requirement to check that the colour of the backboard was providing the best contrast with each lit red light unit.

- 1 *The intention of this recommendation is that Network Rail should maintain the backboards fitted to road traffic light signals at level crossings so as to maximise the contrast between the lit red light unit and the backboard.*

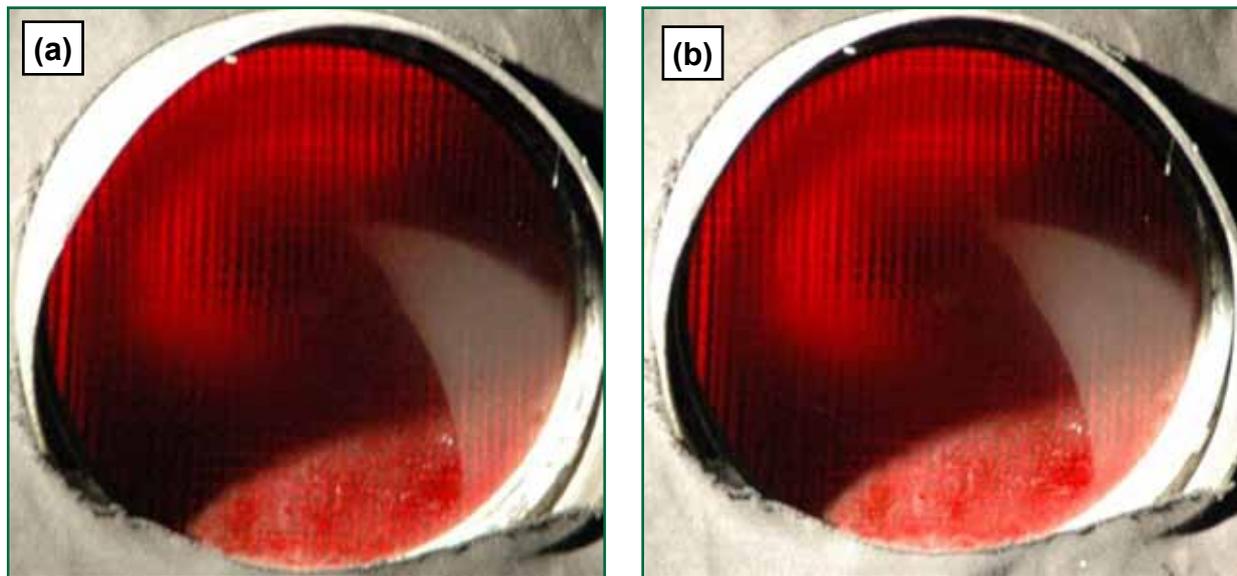
Figure 8: The effect of sunlight on the near side road traffic light signal red light units during tests from (a) 100 metres and (b) 50 metres

- 78 Figure 8 shows the effect of sunlight on the road traffic light signals, with the sun in the same position as it was at the time of the accident. This effect was investigated further with respect to the condition of the backboards and the amount of *contrast* between them and the lit red light units of the road traffic light signals. The difference long hoods would have made, had they been fitted, was also investigated.
- 79 The optical tests (paragraph 41) carried out found that only a small area of each lit red light unit would have been affected by sunlight at the angles associated with viewing the lights at the time of the accident (figure 8). These show a small crescent at the base of the lens and an arc shaped reflection from inside the hood. Therefore, the effect of sunlight swamping the red light units was not likely to have been a significant factor.

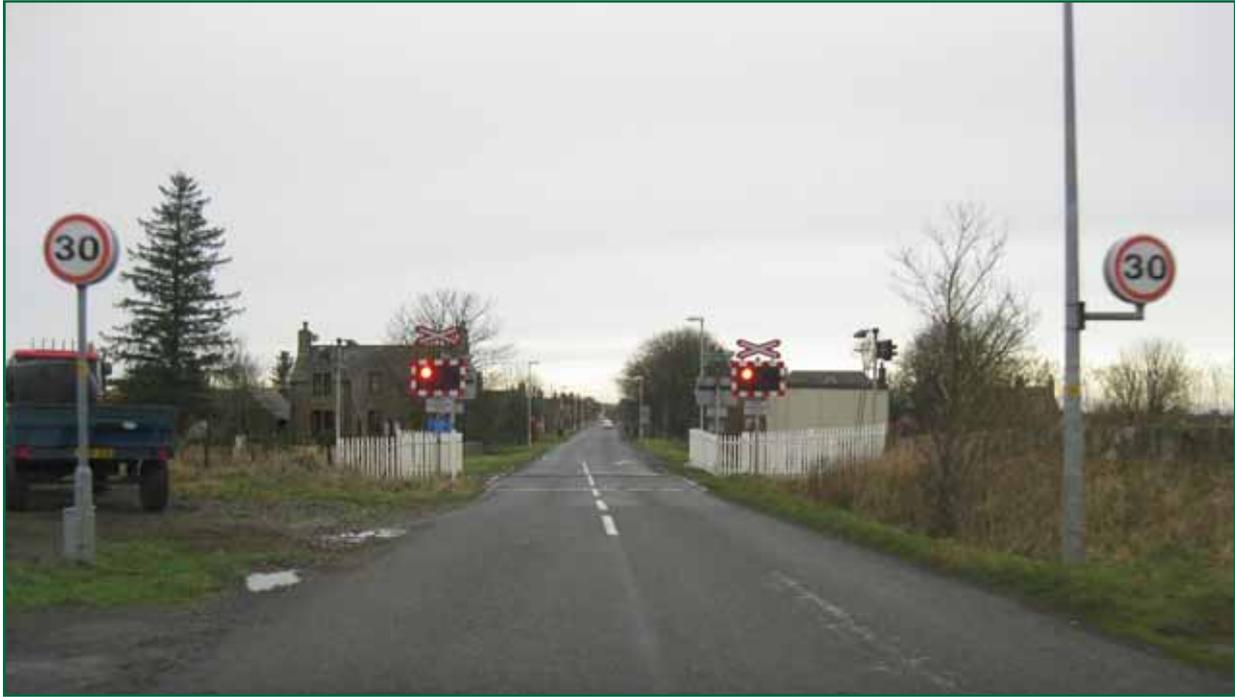
Figure 9: the 30 mph signs at Halkirk crossing (taken after the accident and the renewal of the road lights to the LED type)

- 88 The specialist human factors consultant commissioned by the RAIB advised that the commencement of the 30 mph (48 km/h) speed limit close to the crossing on the south side (figure 9) could be a distraction to motorists approaching the crossing. This proximity of the speed limit signs to the crossing might reduce the attention given to the crossing, or remove attention away from it completely. The signs might also draw a car driver's attention to the vehicle speedometer to check vehicle speed and away from maintaining vision out of the vehicle's windscreen. Other signs in the vicinity of a level crossing that are not related to that crossing could also be a potential distraction.

- 2 *The intention of this recommendation is that Network Rail should take into account the human factors issue of highway speed limit and other signs positioned close to level crossings while assessing the risk.*

Network Rail should consider amending the level crossing risk management toolkit to include the human factors issue and associated risk reduction measure relating to the potential distraction caused by highway speed limit signs and other signs positioned close to level crossings (paragraph 135c).
