RAIB Bulletin 11/2010

Derailment at Dingwall, Scotland 22 January 2010

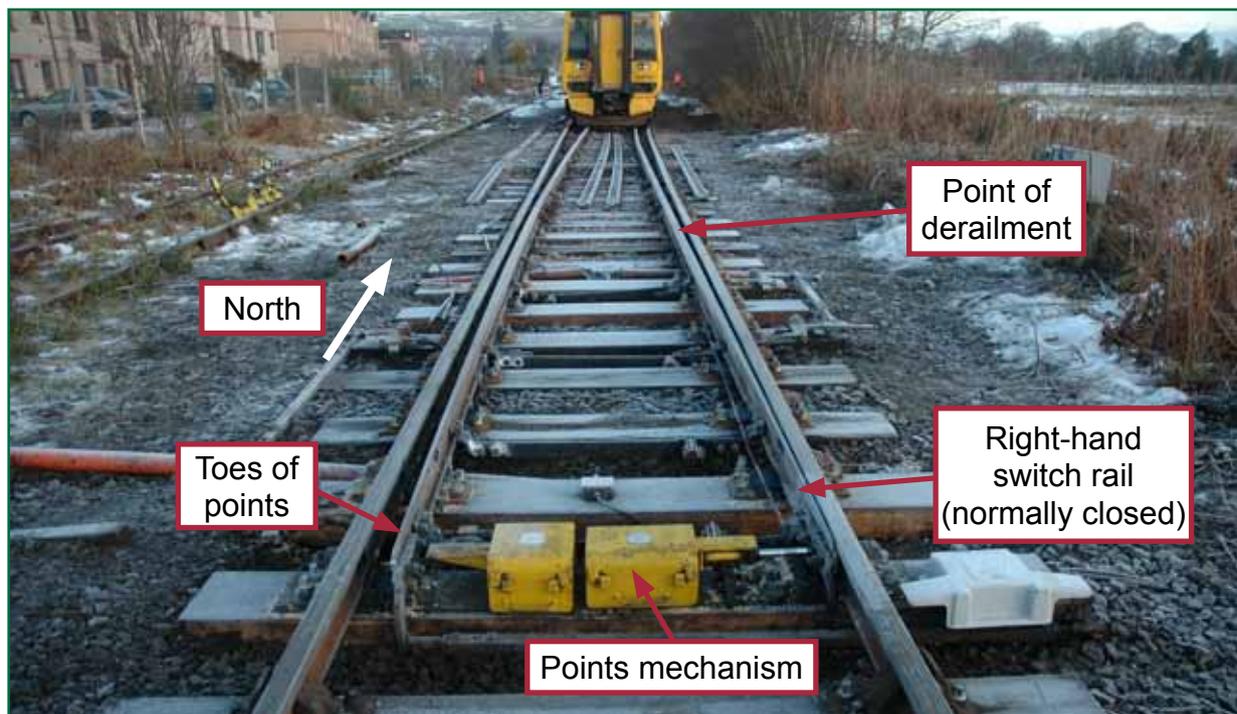
Figure 1: View showing the location of the derailment and the rear of the derailed train

- 2 All wheels of the train became derailed and the train came to a stand with the leading cab 69 metres north of the toes² of the points (figure 1). The driver informed the signaller at Inverness and the Fire and Rescue Service were called. The 75 passengers on board were taken to Dingwall station for their onward journeys. One person was taken to hospital with minor injuries.
- 3 The line was closed for three days while the infrastructure was repaired.

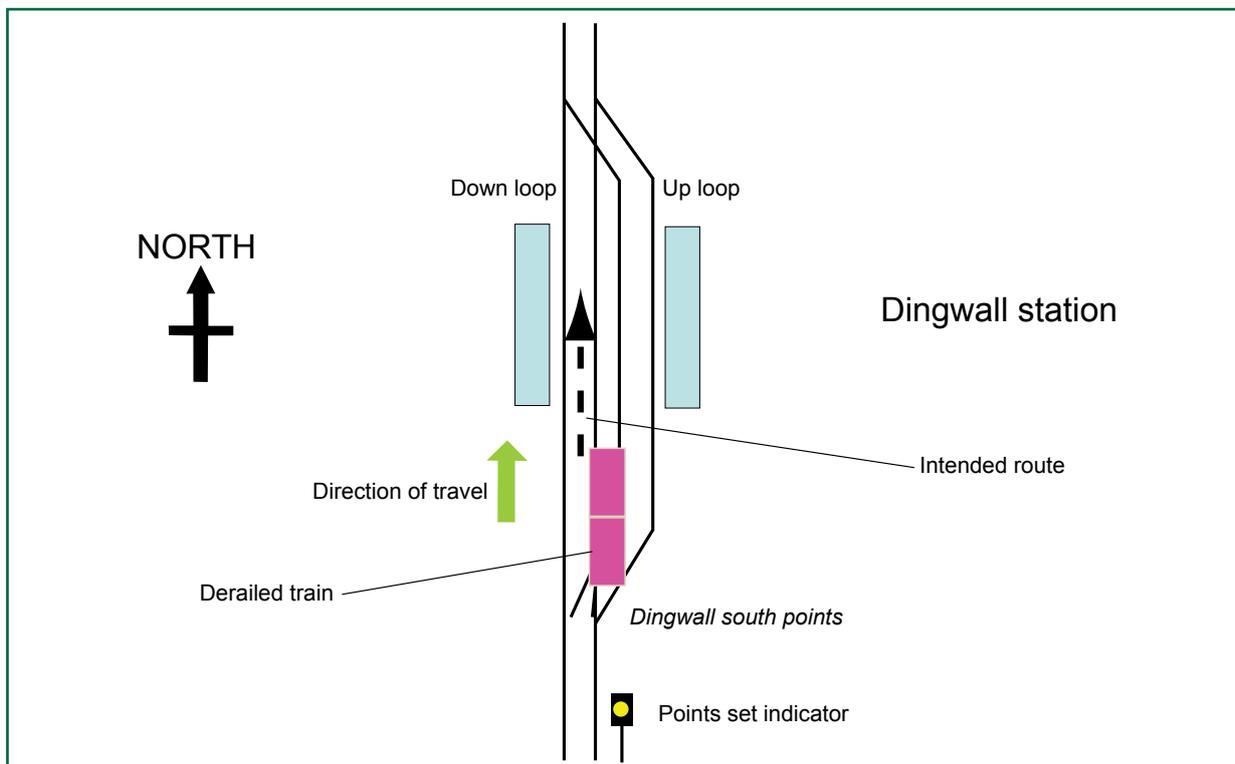
Figure 2: Layout at Dingwall showing the location of the derailed train

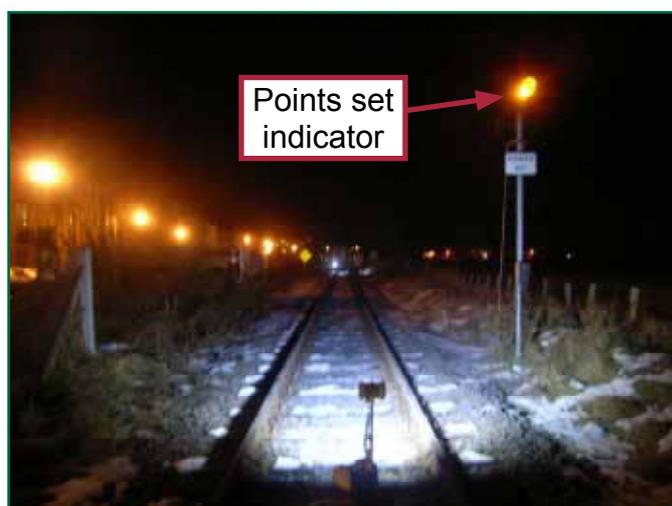
- 8 There is a 'points set indicator' (PSI) 50 metres to the south of the points (figures 2 and 3). The PSI is controlled by a points position detector unit. This permits the PSI to display a steady yellow lamp to approaching drivers if the points are in the correct position for the train. If the points are in an incorrect position the PSI cannot illuminate. The setting of the point detector ensures that the PSI lamp is illuminated when the right-hand switch rail is within 3.5 mm of its adjacent stock rail, i.e. the route is proven to direct northbound trains into the down loop.

Figure 3: View towards the north showing the illuminated points set indicator

- 46 Subsequently Network Rail undertook trials of a PSI that gives a positive illuminated signal to drivers when the points are not in the correct position. The trial is complete and the equipment was accepted for use earlier this year. Its implementation at all train operated points in Scotland began in July 2010 with full completion before August 2012. Plans are also in place for its introduction on other lines with train operated points.

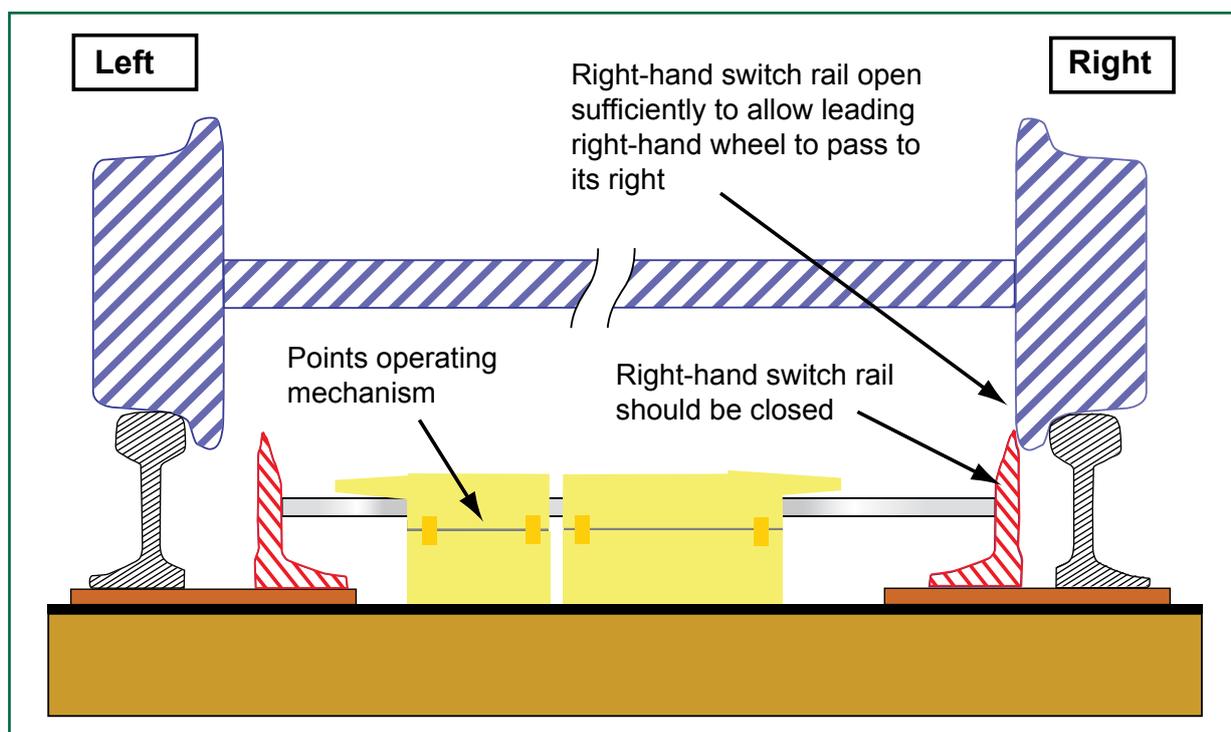
- 29 The RAIB attended the site and undertook examination and testing of the points with the support of Network Rail signalling technicians.
- 30 There was no evidence of the right-hand wheels having flange-climbed the right-hand switch rail or having made contact with the point toes. It is therefore deduced that the right-hand switch rail was wrongly positioned when the train approached. This permitted the right-hand wheels of the train to pass to the right of the switch rail, rather than to the left as intended (figure 4). As a consequence the right-hand wheels travelled towards the up loop and the left-hand wheels towards the down loop. After about 6 metres the divergence of the two rails on which the wheels were now travelling caused the wheels to drop off the rails. This scenario is known in the railway industry as 'splitting the points'.

- 31 For this to have happened the right-hand switch rail must have been open from its adjacent stock rail by at least approximately 30 mm to allow the leading wheel on the right-hand side to pass through the gap. Once the leading wheel had entered the gap, the wheels kept the switch rail open sufficiently to allow the other wheels through.
- 32 Since the evidence clearly indicates that the train split the points it can be concluded that the points had not returned to the correct position following the passage of the previous train at 17:03 hrs.

Figure 4: View of the toes of the points, looking north, showing leading wheelset splitting the points

- 33 After the accident it was discovered that the right-hand switch rail had moved to a more closed position against its stock rail. However damage incurred to the points had caused this switch rail to become twisted. This meant that the toe of the right-hand switch rail was away from its stock rail by 11 mm at rail head level. In this condition the PSI was still illuminated, consistent with the observations of the driver following the accident (paragraph 24).

- 35 There was no visible damage to the points actuator, and its pressure gauge indicated that the actuator's pressure was within its specified limits. Observations made when manually operating the points indicated that the switch rails did not return smoothly to their normal position. Tests undertaken by the RAIB found that this was due to high levels of friction between sliding surfaces, i.e. the rails were 'sticking'.

- 36 There were two areas of high friction. The first was between the undersides of the switch rails and the slide chairs. This was due to poor support of the switch rail toes because the newly installed bearer at this position was lower than the adjacent bearer.
- 37 The second area of high friction was between the detector slides (connected to the switch rails) and the newly installed detector unit. There were angular misalignments between these components leading to high forces resisting the actuator returning the points to their normal position.

- Network Rail should complete the implementation of the modified PSI that provides a positive indication to drivers when train operated points are not in the correct position (paragraph 46).
- When informed of incorrect operation of train operated points, even during trailing moves, signallers should notify Fault Control and inform subsequent drivers that the points may be incorrectly set. Once the modified PSI has been implemented, Network Rail should assess whether this additional requirement on signallers should remain in place.
- When changing equipment on these points, maintainers should ensure that before their reintroduction into operational service that:
 - i. the correct checks are undertaken and recorded (paragraphs 11 and 12), and
 - ii. the quality of installation, in particular support of switch rails, is such that points are working in a reliable manner.
