Rail Accident Investigation Branch

# Rail Accident Report

## Accident at Dalston Junction 30 March 2009

Report 30/2009  
November 2009

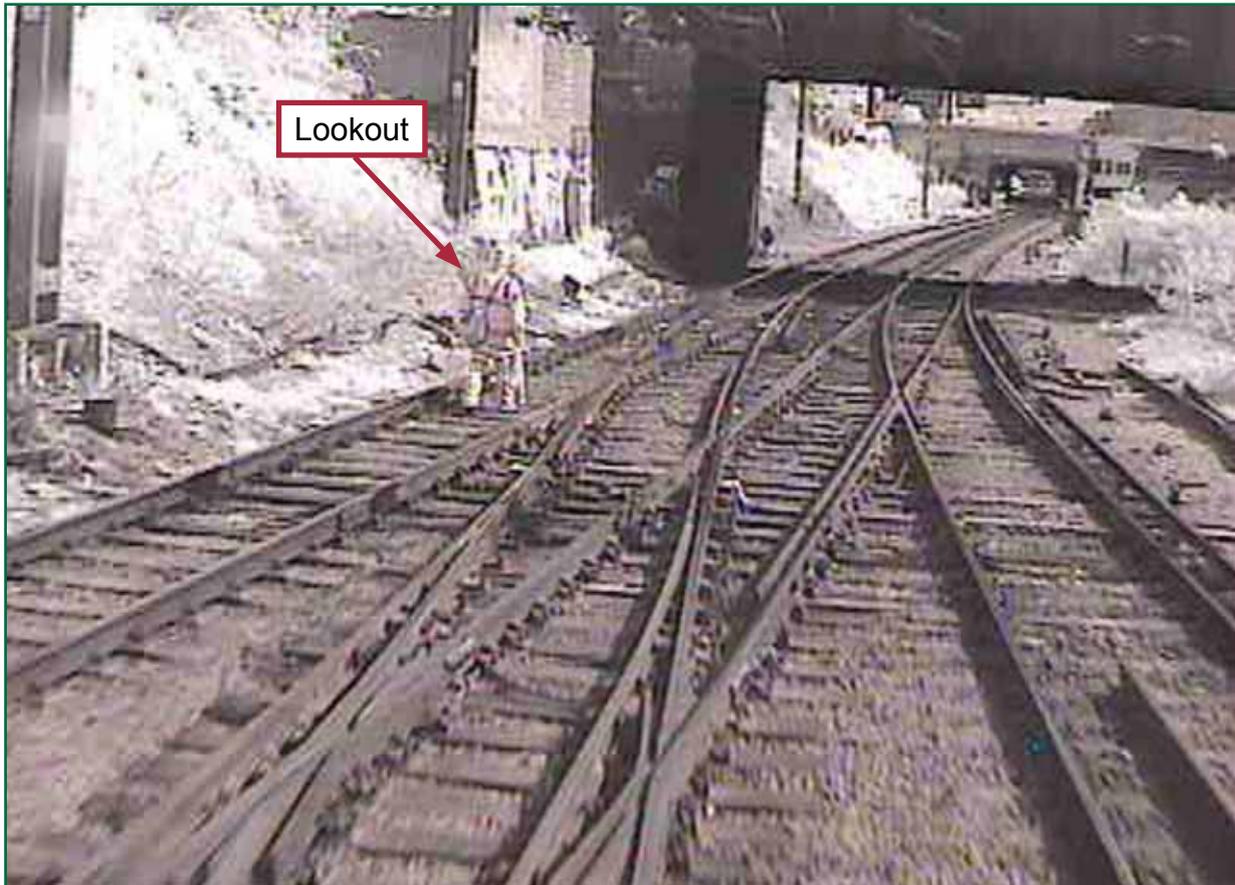
Figure 4: View from the train, about two seconds before the accident

- 36 The train's speed was reduced to 15 mph about 20 seconds before it reached the junction. The train driver observed the lookout walking ahead of the group, and sounded the horn again, 14 seconds before reaching the junction. The lookout probably acknowledged the warning and continued to walk along the four-foot (the area between the rails) of the down number one line towards the junction (Figure 4). The train driver sounded the horn again about three seconds before the train crossed the junction, but the lookout did not move clear and the left-hand front corner of the train cab struck him on the back of the head.

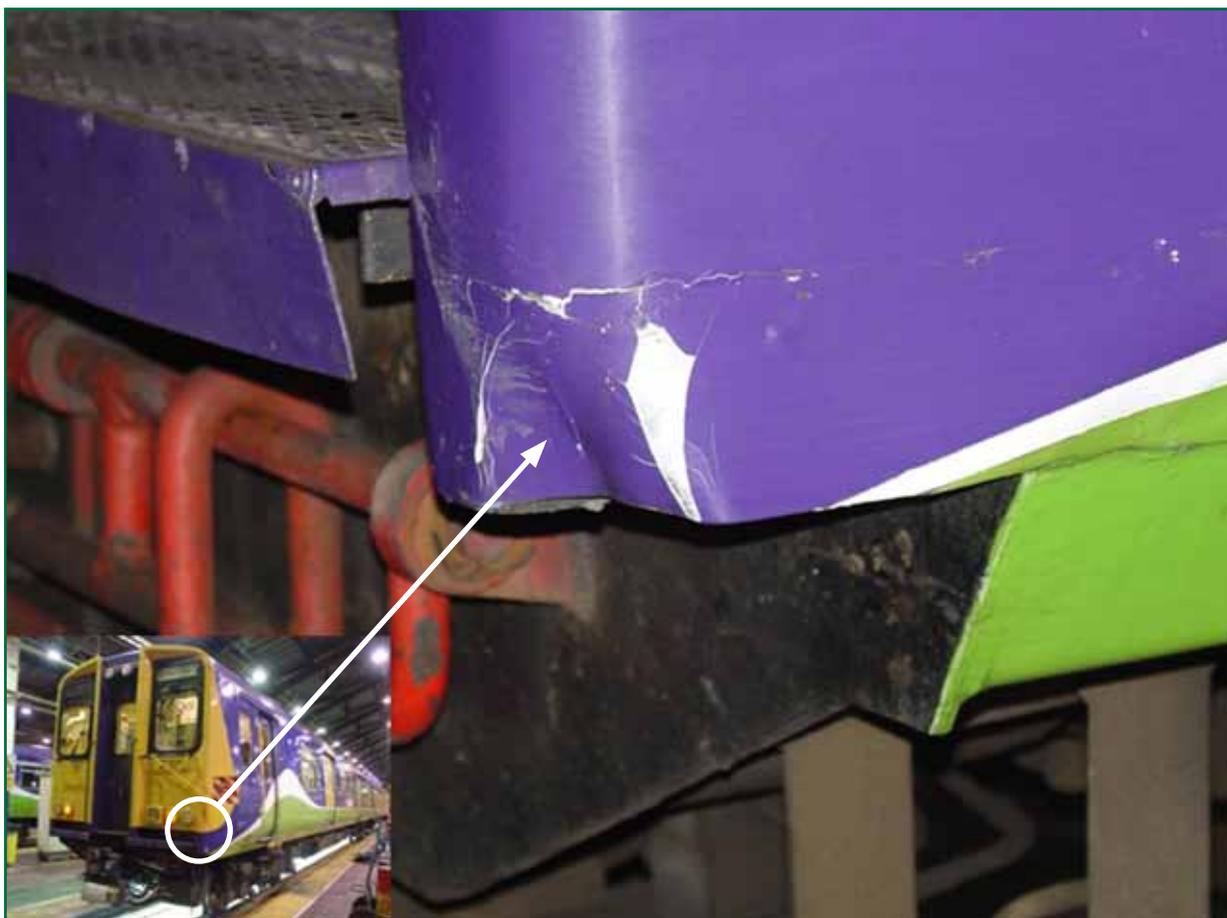
Figure 5: Damage to the front of unit 313119

- 38 The lookout was thrown to his left, and landed in the cess clear of the line. He was struck on the head, and sustained cuts and bruises. He appears to have since made a full recovery.
- 39 There was minor damage to the front of the train (Figure 5). No-one on the train was hurt.

- 142 The train struck the lookout on the back of his head and knocked him to the ground, but he suffered only minor cuts and bruises. He was wearing protective headgear. The damage to the front of the train (Figure 5) suggests that his safety helmet was important in preventing more serious injury to him.

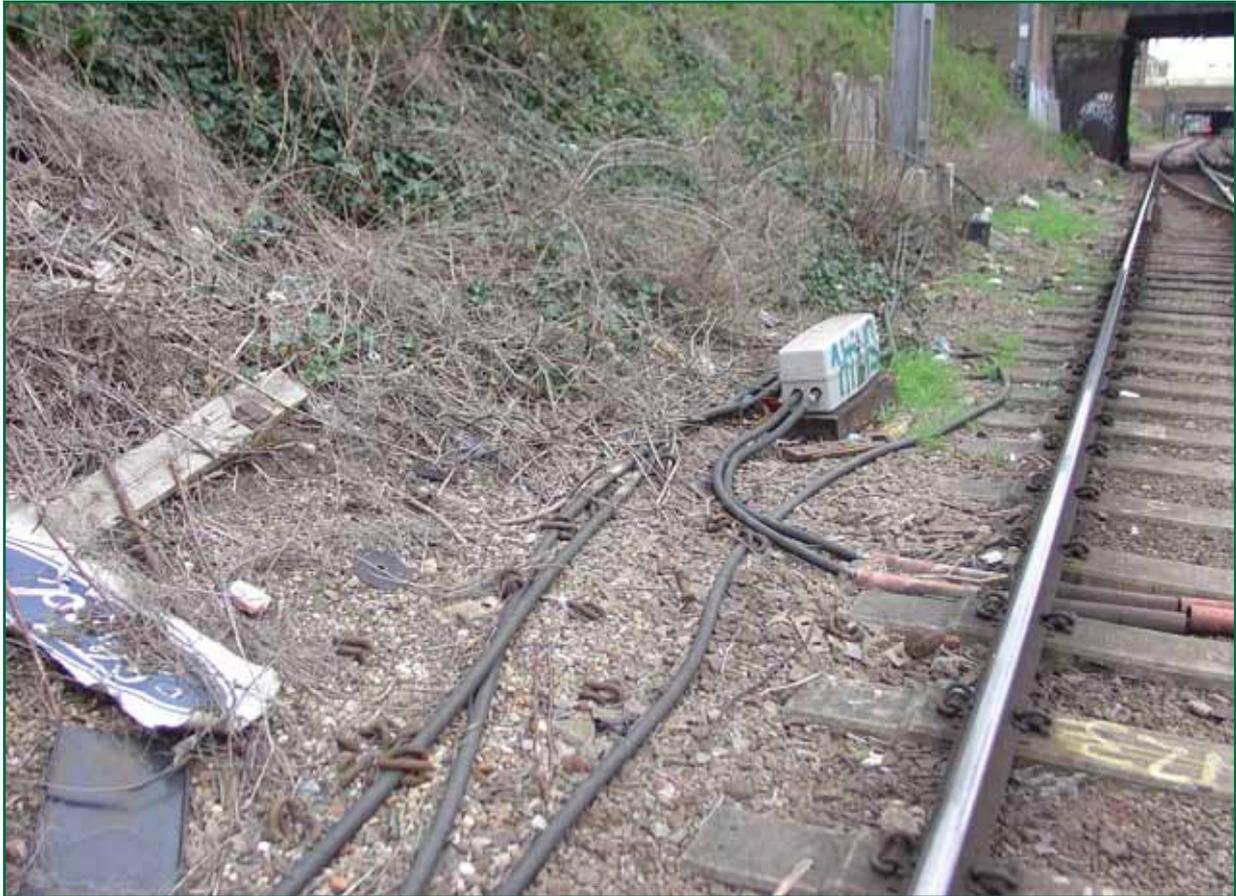
Figure 6: Down cess adjacent to the accident site

- 130 In this case, witness evidence indicates that the COSS had briefed the lookout that his position of safety was in the down cess. The lookout, and the group, intended to walk in the down cess and carry out most of the inspection from there. However, on this stretch of line the cess was in poor condition and the path along it was uneven, obstructed and in some areas non-existent (Figure 6), and so much of the time the group walked on the sleeper ends or in the four-foot of the down number one line. The accident occurred towards the end of the inspection, when this practice had become habitual. If the cess had been maintained in a usable condition, the lookout might not have chosen to walk in the four-foot of the down number one line.

131 The condition of the down cess, and the consequent need to walk on the down number one line, was a contributory factor in the accident. The Network Rail standard relating to the management of lineside vegetation, NR/L2/TRK/5201, requires that the cess area is maintained clear of trees, shrubs and brambles and 95% clear of other vegetation, by annual clearance. The whole of the North London Line is in an urban area and the deposit of litter and rubbish on the lineside is a continual problem. The contract for the project includes removal of rubbish, upgrading of access arrangements and provision of safe walking routes adjacent to bi-directionally signalled lines, which includes the area where the accident occurred, and so no recommendation is made on this issue.
