Rail Accident Investigation Branch

Rail Accident Report

Derailment at St Peter's Square, Manchester 29 June 2008

Report 25/2009
February 2011

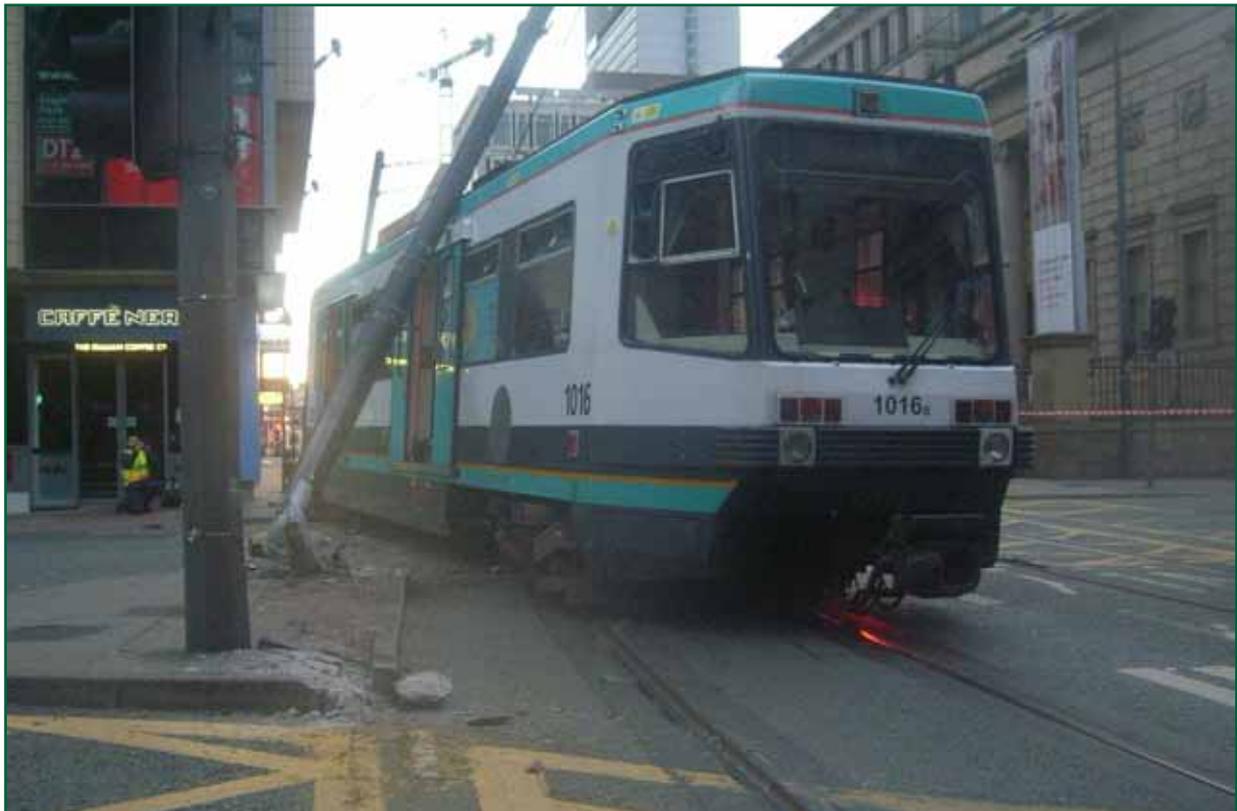
- 17 A Metrolink tram derailed at St Peter's Square, Manchester at 23:10 hrs on 29 June 2008 (Figure 1).
- 18 The 22:44 hrs service from Altrincham, consisting of trams 1008 and 1016, had just departed the St Peter's Square stop when the middle bogie of the rear unit (1016) derailed to the left. The tram travelled a further 90 metres before coming to rest across the junction with Princess Street, with the derailed bogie having partially mounted the pavement (Figure 2). No other bogie derailed.

Figure 2: Tram 1016 after the derailment

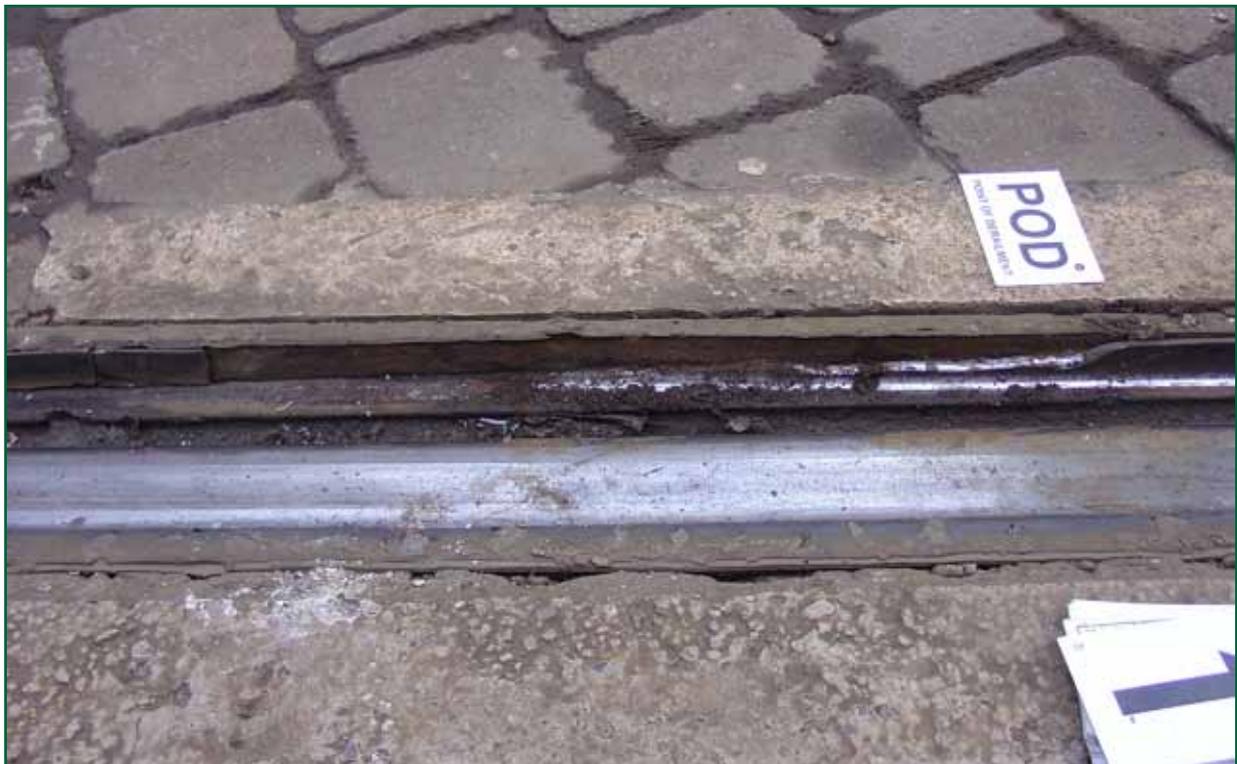
- 30 The leading right-hand wheel on the centre bogie of tram 1016 derailed by its flange riding to the left of the right-hand rail's keep. The wheel flange was allowed to climb behind the keep because a 400 mm section of keep had broken and detached (Figures 4 and 5). It is considered likely that the keep failed due to contact by a previous wheel on the double unit, because other wheelsets of this tram and previous trams had successfully negotiated the curve. The bogie ran for 33 metres with the left-hand wheel riding against the *gauge face* of the left-hand rail and the right-hand wheel running between the back of the right-hand rail's keep and the road surface; the mechanism is shown diagrammatically in Figure 6. The wheels continued on this path due to the *gauge spread* from the sidewear (paragraph 44); when the track gauge narrowed to the design value the left-hand wheel climbed over the left-hand rail, eventually leaving the rail head three metres later. The second wheelset of the middle bogie followed the first wheelset into derailment to the left (Figure 7).

Figure 4: The right-hand rail at the point of derailment where the keep had failed

Key Information

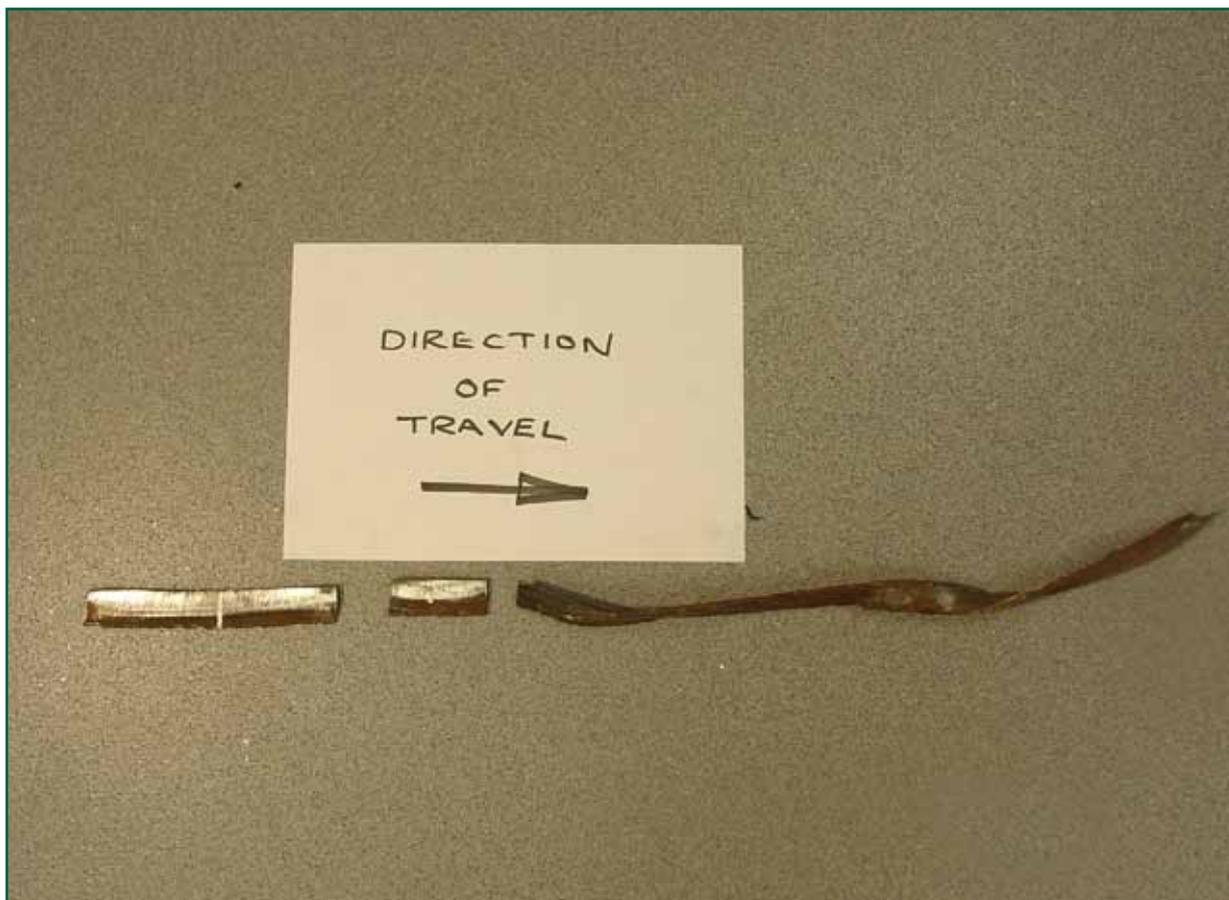
Figure 5: The failed section of the keep

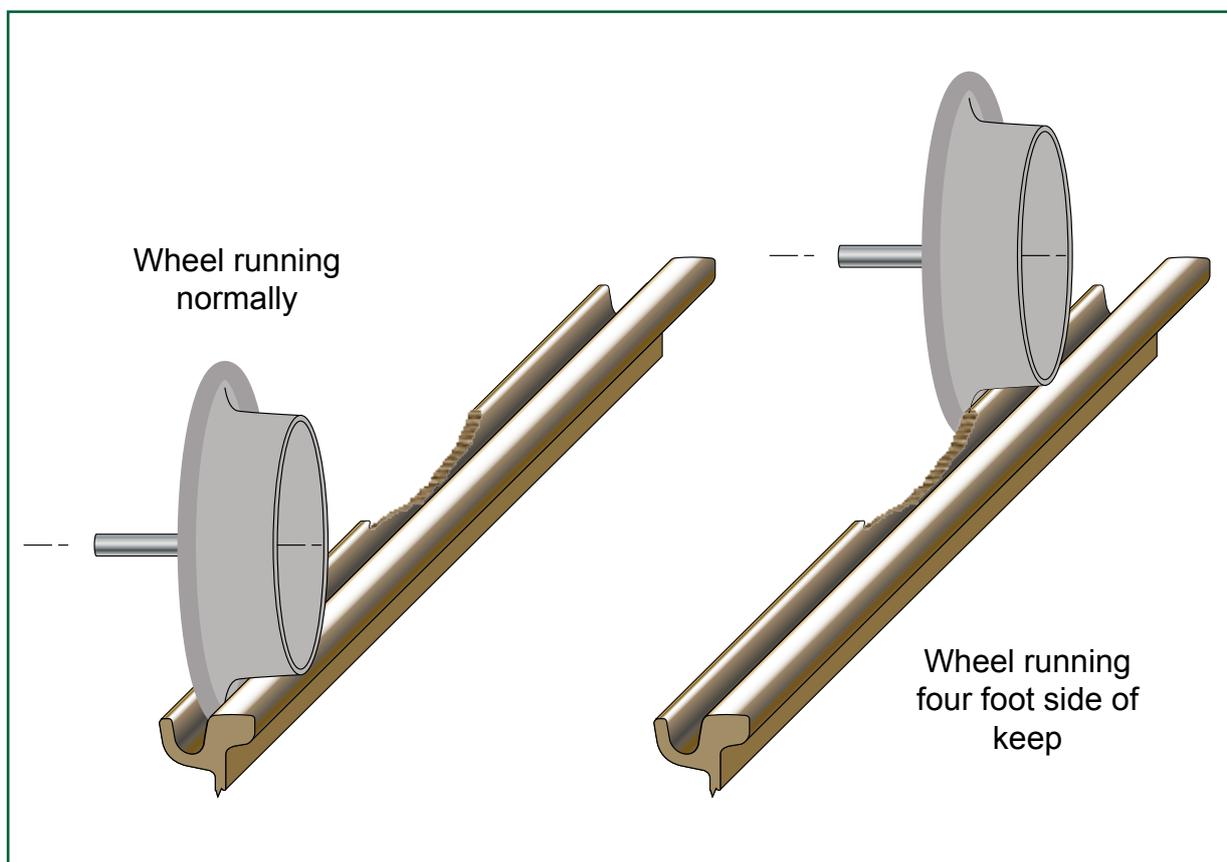
Figure 6: Image showing derailment mechanism

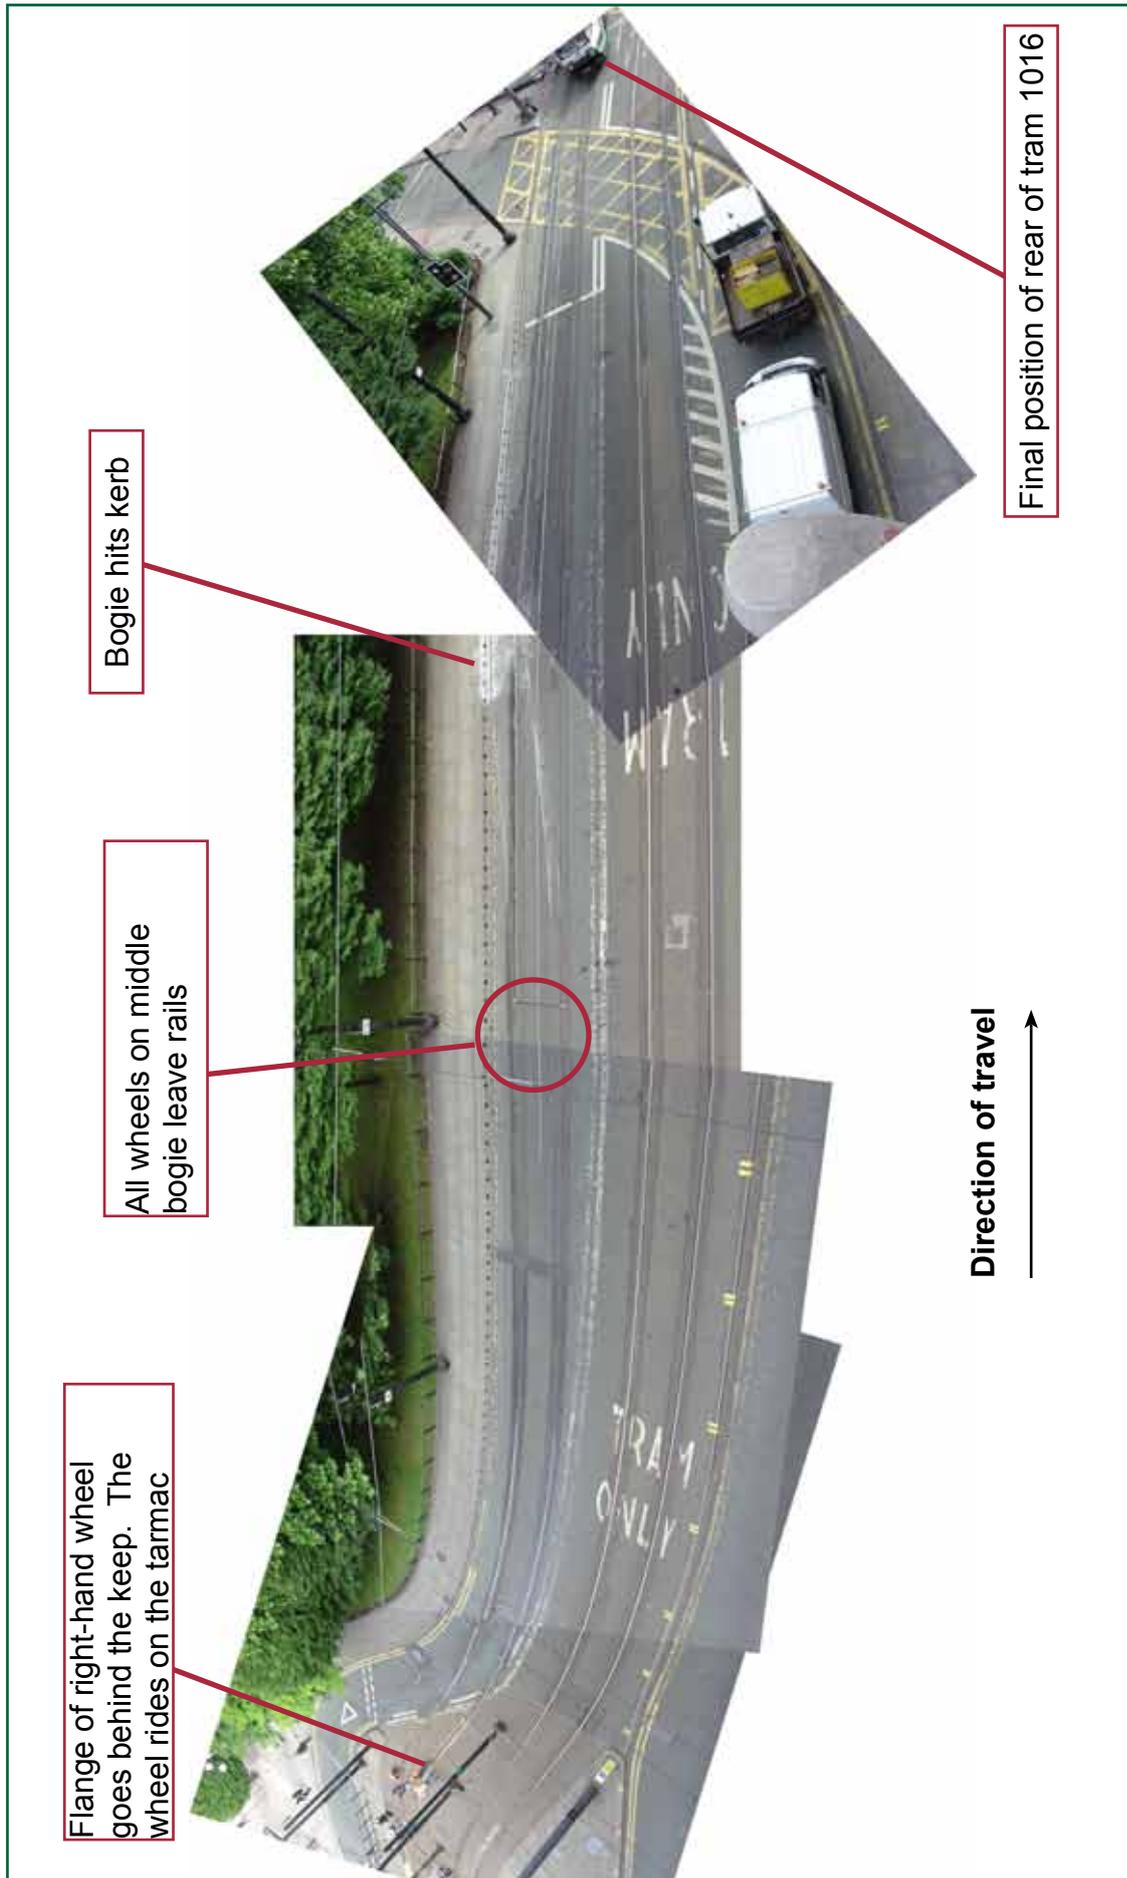
Figure 7: The derailment marks on the road surface

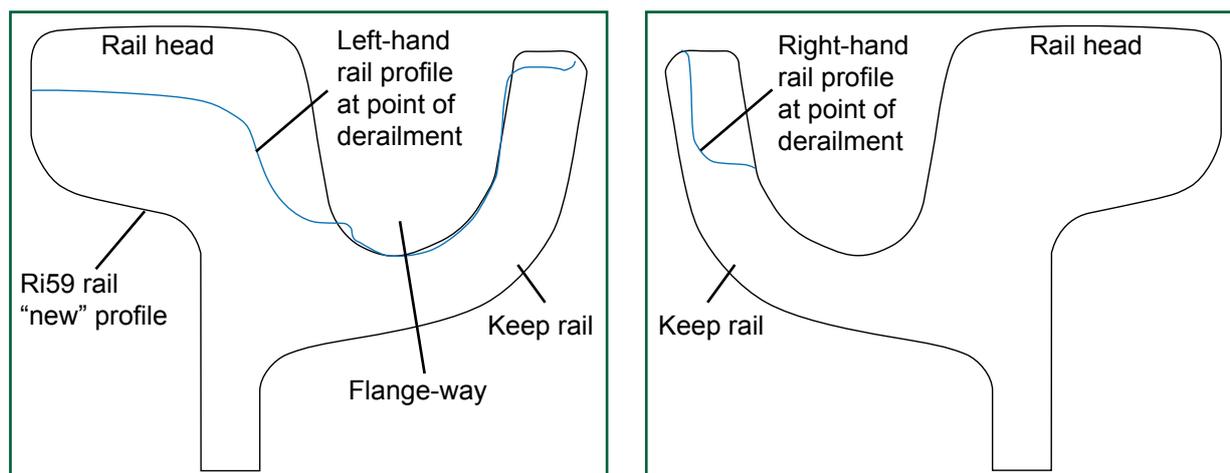
- 44 At the point of derailment the left-hand rail was significantly side worn (Figure 8) by the passage of wheels (Figure 9) and the right-hand rail's keep was worn to a thickness of 2.5 mm, from an original thickness of 15 mm. The right-hand rail's keep had worn because of contact from the backs of passing wheel flanges as a result of wheelsets riding to the left, as allowed by the side worn left-hand rail.

Figure 8: Image showing side wear on left-hand rail and worn keep on right-hand rail (indicative) at the point of derailment

- 105 Following the accident SML undertook a programme in the city centre to restore the gauge by building up the rail head profile by weld deposition, instead of continuing the short-term approach of removal of the keep. Restoring the gauge eliminates flange-back contact with the keep and therefore removes the load on it. SML undertook this because of its lack of confidence in identifying all failing keeps, and its reluctance to remove large sections of keep because of concerns on the effect on preservation of the road/pavement surface and preventing debris entering the flange-way. SML adopted this approach even though much of the track where it invested in weld deposition would be removed for scrap as part of the 'imminent' renewals programme.

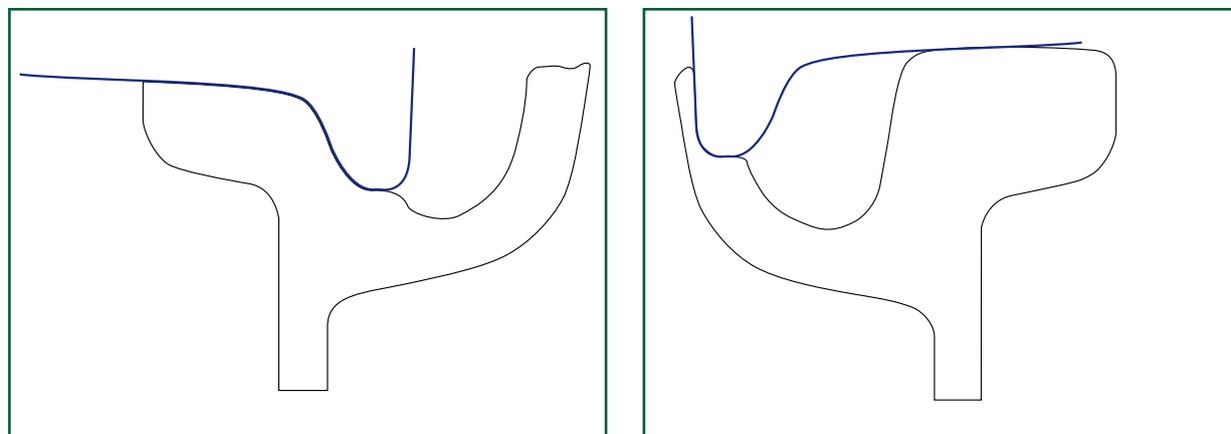
Figure 9: Image showing wheel riding on worn rail and worn keep
