Rail Accident Investigation Branch

Rail Accident Report

Near miss at Llanbadarn Automatic Barrier Crossing (Locally Monitored), near Aberystwyth 21 October 2008

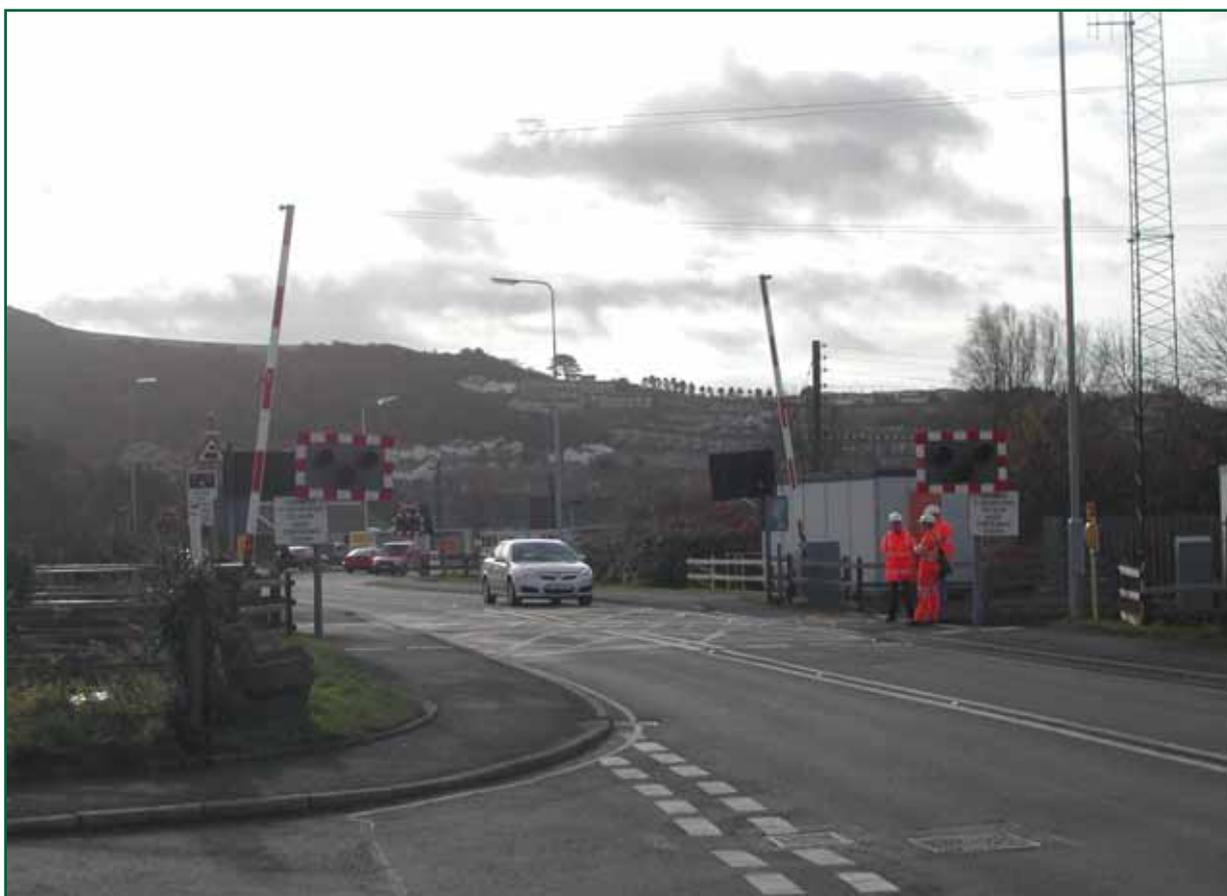
Figure 3: Llanbadarn ABCL looking south along A4120

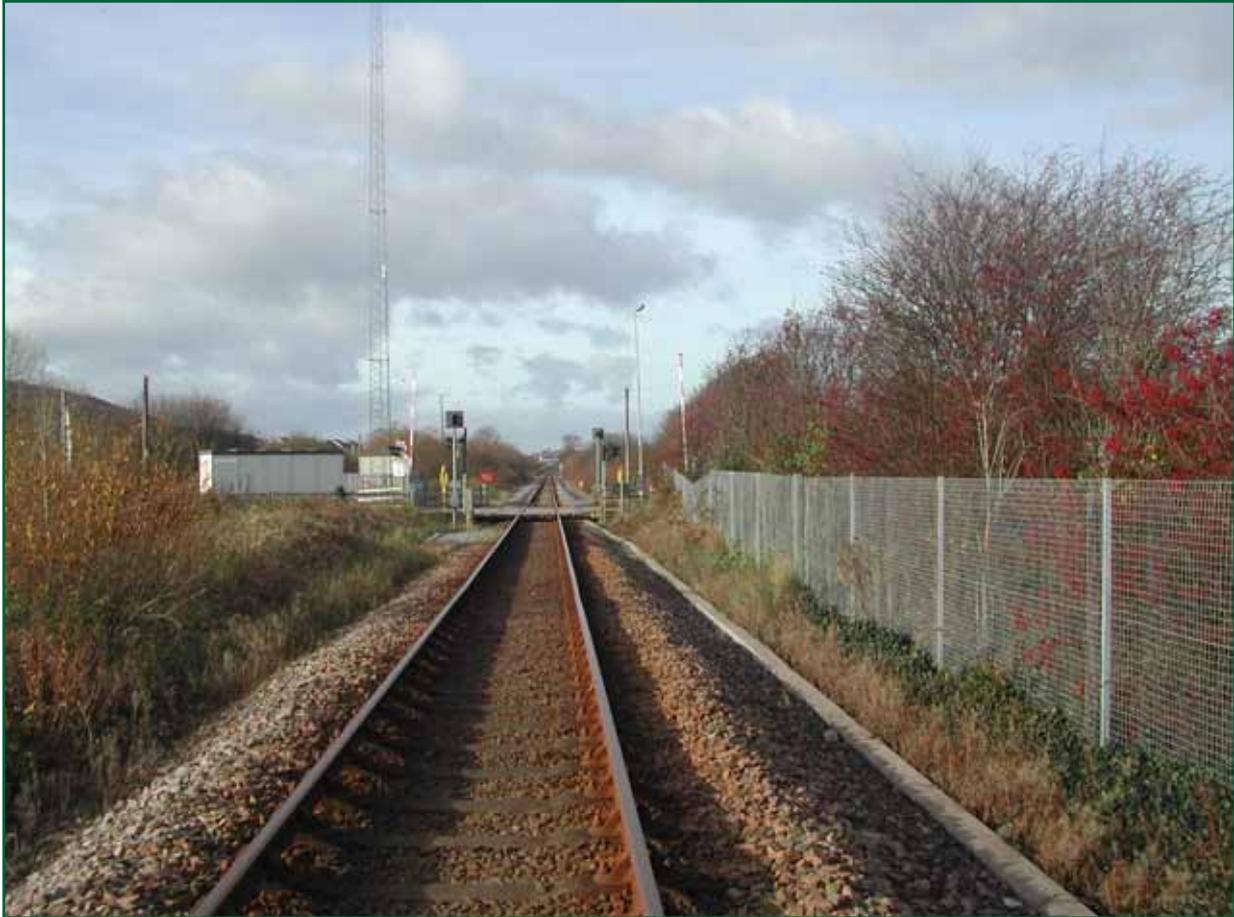
- 21 The Network Rail line is on a falling gradient as it approaches Aberystwyth. This gradient is 1:75 from a summit at approximately 92 $\frac{3}{4}$ miles, flattening to 1:676 around the 94 $\frac{1}{2}$ mile post, approximately 16 chains, or 322 metres, to the east of Llanbadarn crossing (Figure 4).

Figure 4: Llanbadarn ABCL approach in the down direction

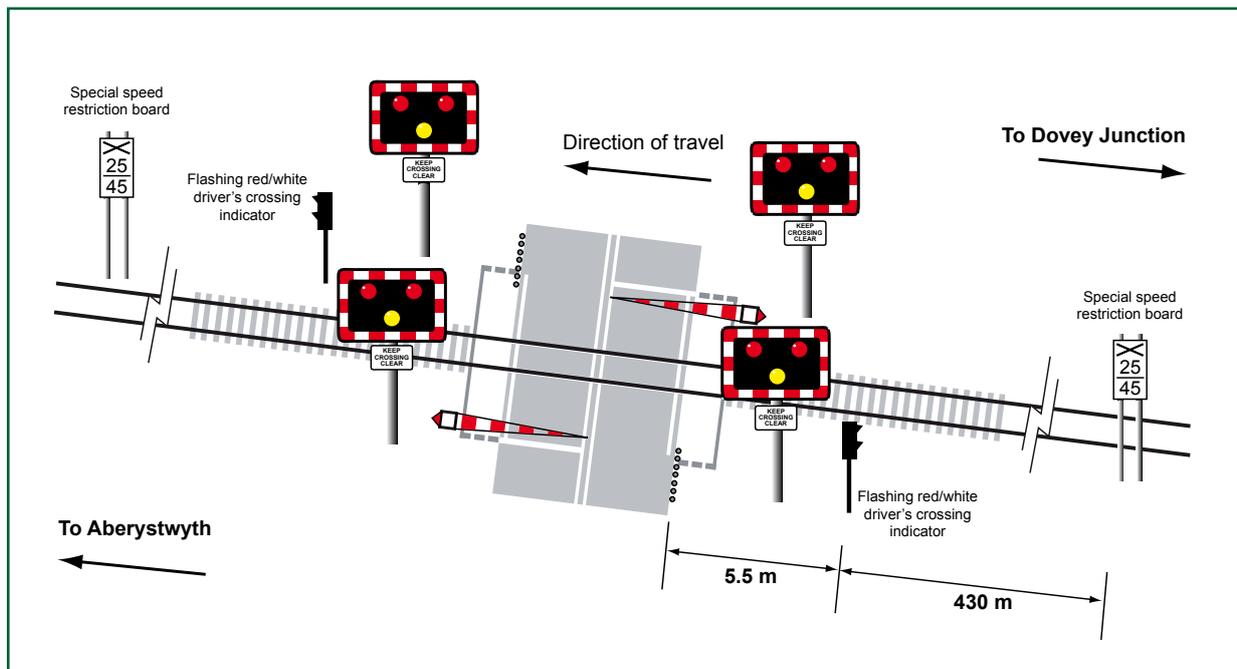
Figure 5: Schematic diagram of Llanbadarn ABCL

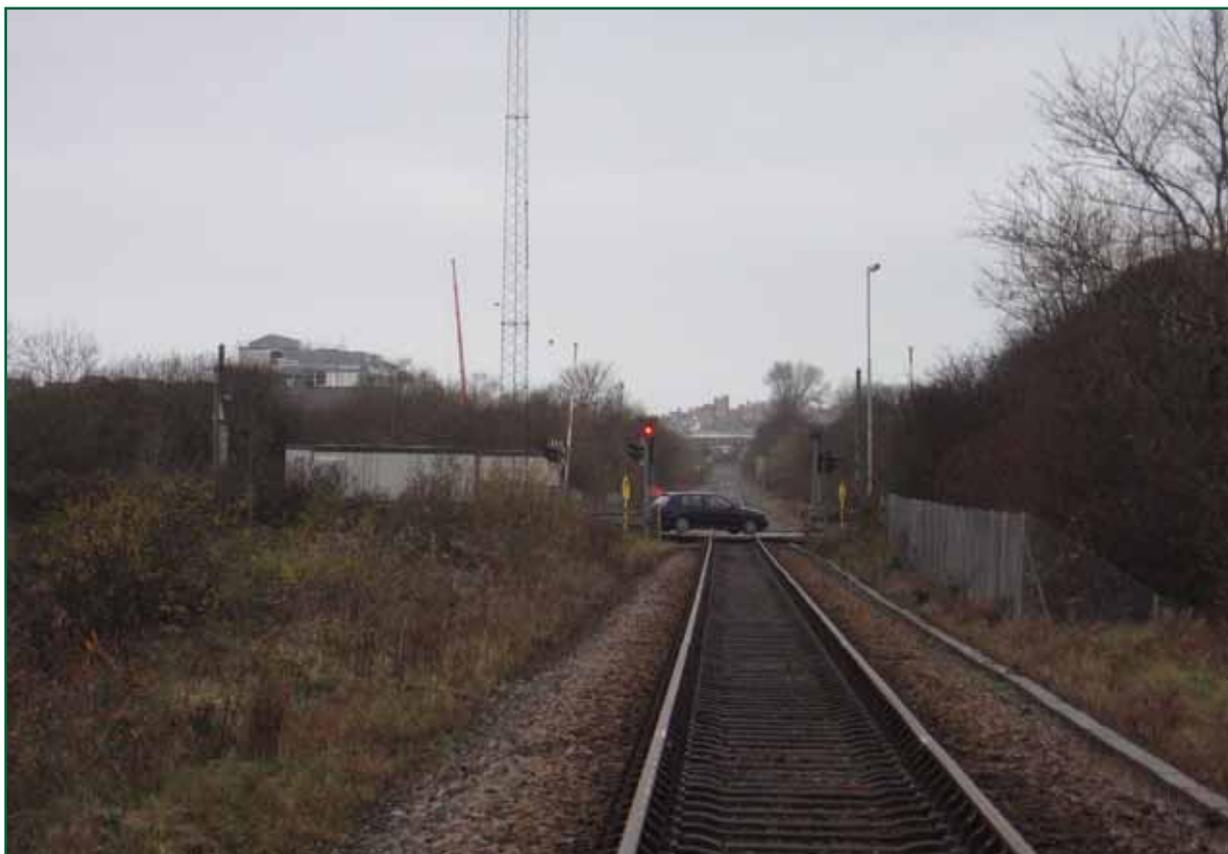
Figure 6: Llanbadarn ABCL showing driver's crossing indicator (flashing red)

- 72 The driver, on first seeing the crossing, observed the driver's crossing indicator showing a flashing red aspect. The driver stated that he had anticipated that the driver's crossing indicator would clear to a flashing white aspect, and hence he did not apply the brakes immediately after he passed the special speed restriction board.
- 73 The driver was tested for drugs and alcohol after the incident, in line with normal industry practice, and found to be clear for both.

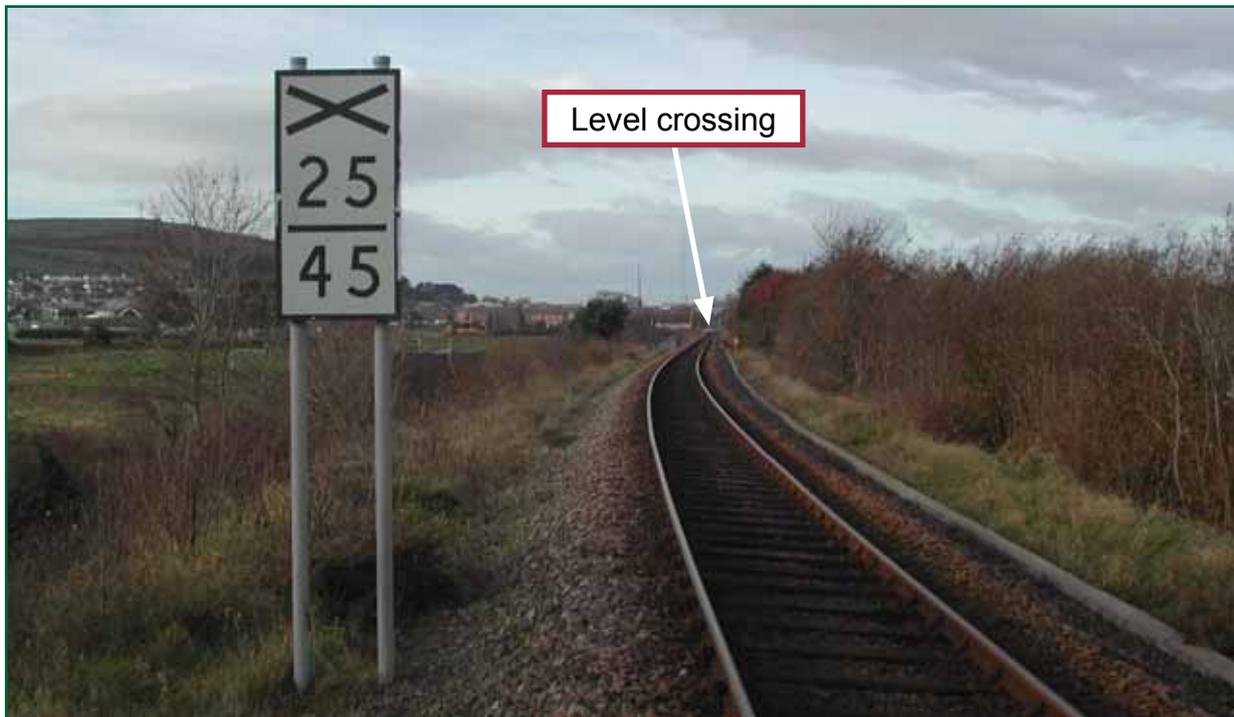
37 The special speed restriction board for down trains at Llanbadarn is located 430 metres before the driver's crossing indicator (Figures 7 and 8), which, in turn, is located 5.5 metres before the crossing. Thus the board is approximately 436 metres before the crossing. The *driver's crossing indicator* can be seen by a driver 480 metres before it is reached, that is 50 metres before the train reaches the board.

Figure 7: The SSRB on the down approach to Llanbadarn ABCL

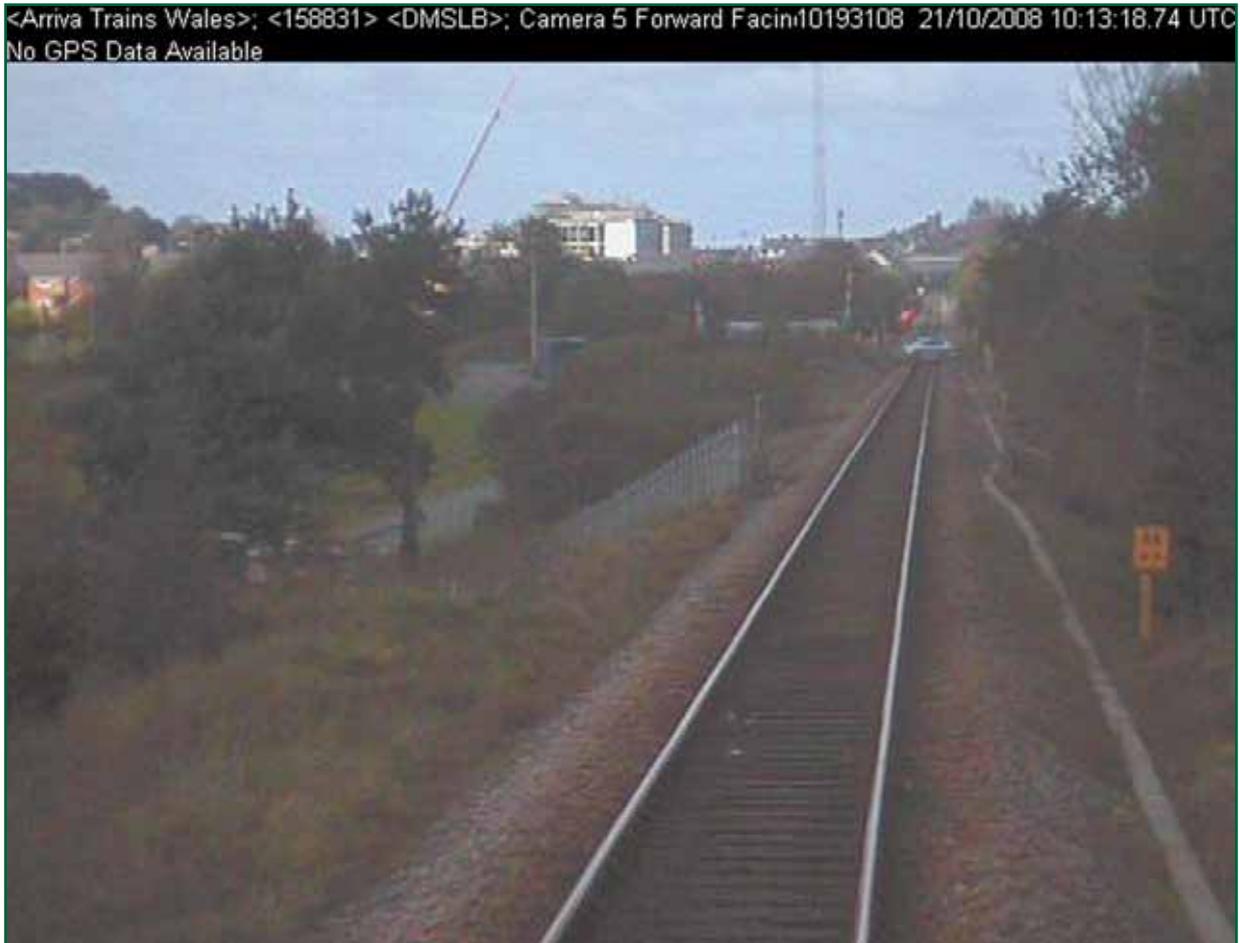
- Five cars crossed over the crossing at 4 (Figure 9), 11, 12, 12.2 and 20 seconds after the train passed the special speed restriction board.

Figure 9: CCTV image showing car crossing four seconds after train passed special speed restriction board

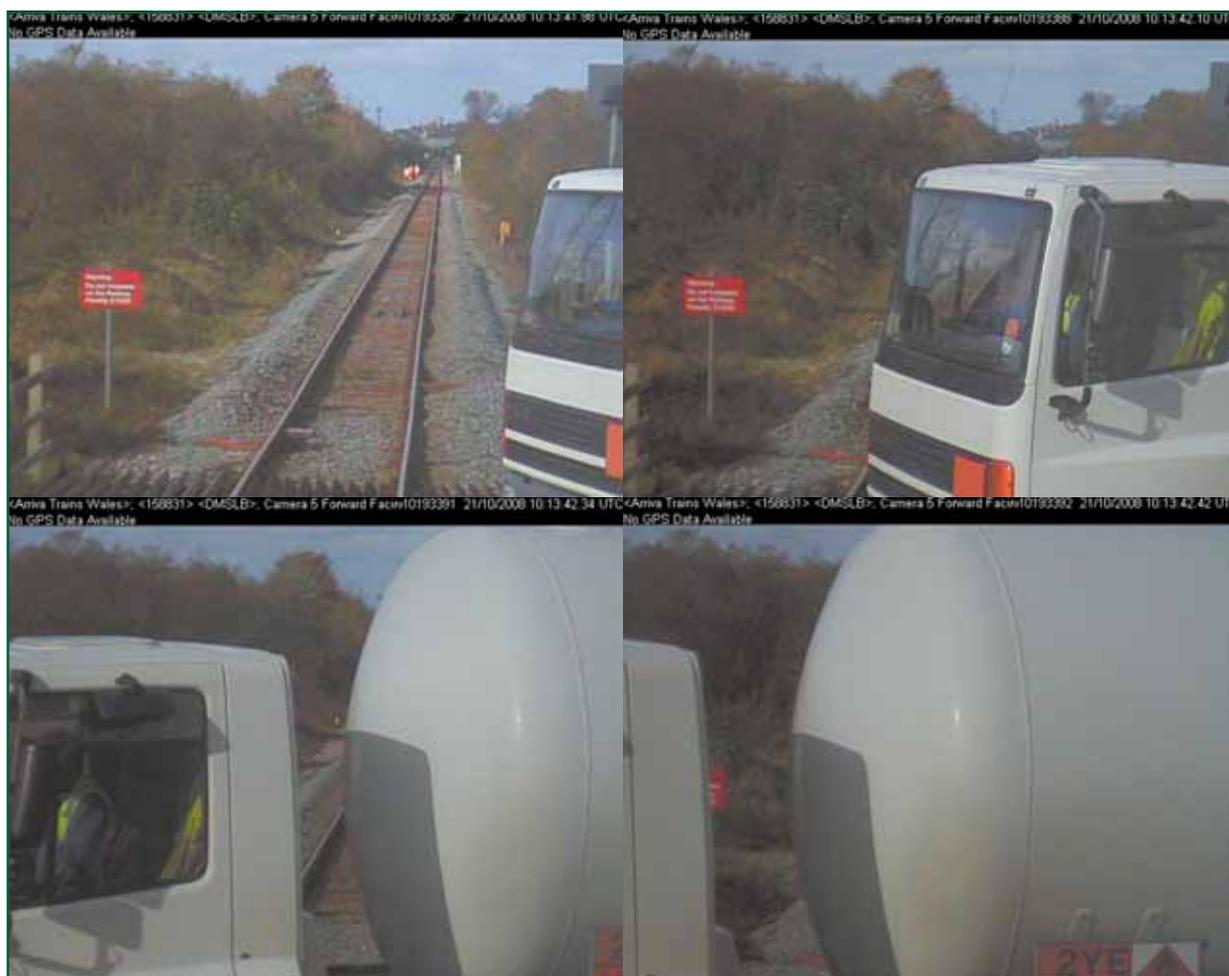
- A lorry carrying a tank containing approximately two tonnes of liquefied petroleum gas was also approaching the crossing. It traversed the crossing immediately in front of the train, and cleared the path of the train 28 seconds after the train had passed the special speed restriction board, that is less than one second before the train reached the crossing (Figure 10). The driver of the lorry had accelerated to clear the crossing when he realised that the train was approaching him, and subsequent calculation indicates that at their closest approach the two vehicles were some two metres apart. The RAIB has calculated the speed of the train at this point as 12.5 mph (20 km/h).

- 50 The train continued to brake, and came to a halt with its leading cab beyond the crossing. The rear of the train remained on the crossing. The RAIB has calculated that the leading cab of the train came to a halt approximately 13 metres beyond the surface of the crossing.

Figure 10: CCTV images showing gas tanker crossing in front of train

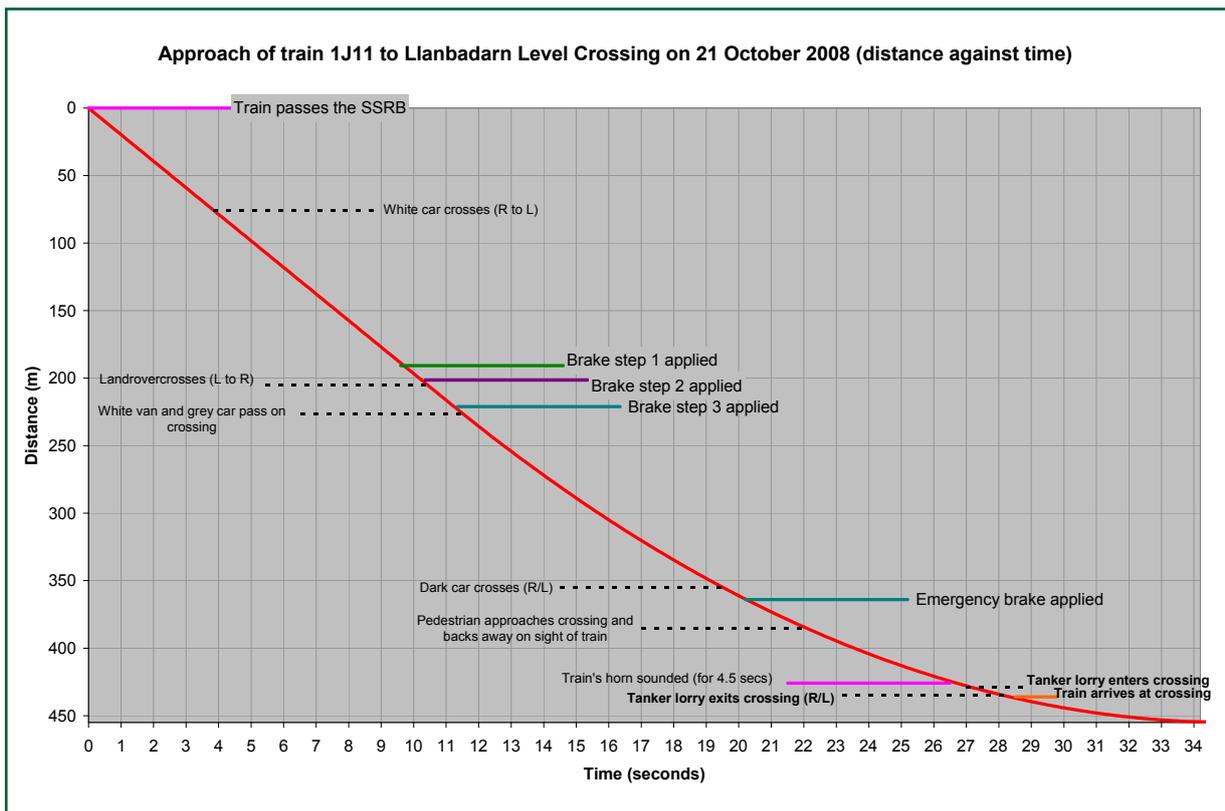
Figure 11: Distance / time plot of the deceleration of the train

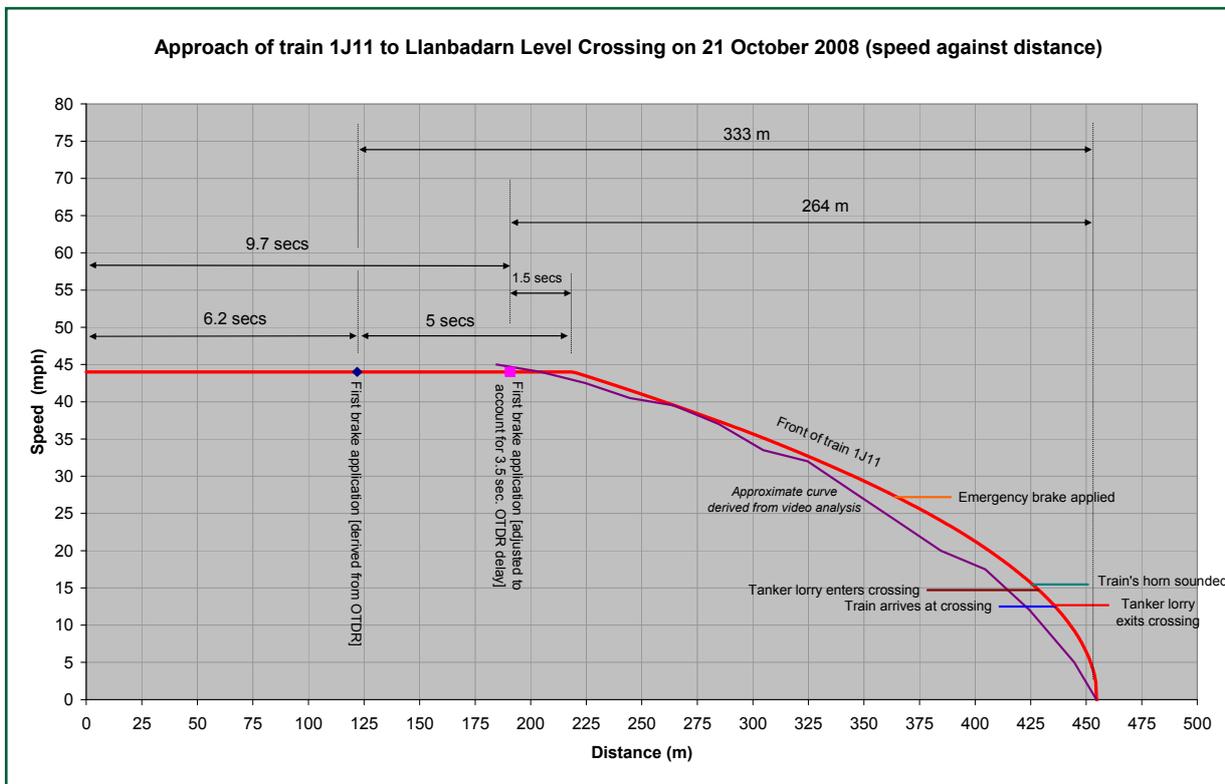
Figure 12: Speed / distance plot of the deceleration of the train
