Rail Accident Investigation Branch

Rail Accident Report

Collision near New Southgate 27 July 2008

Report 17/2009
June 2009

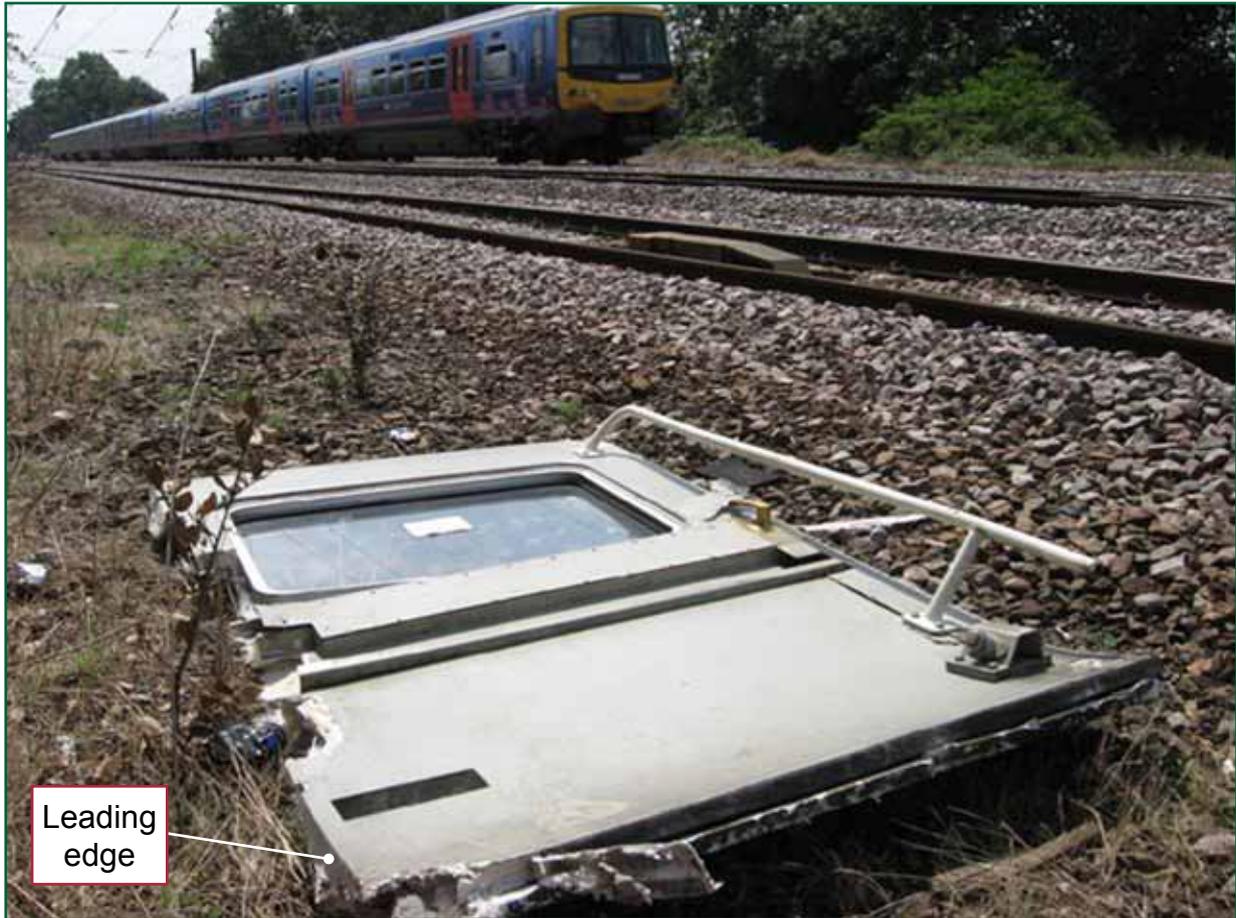
Figure 3: The door involved in the incident as found (the train shown is not related to the incident)

- 44 The door, as found, is shown in Figure 3; the leading edge had been largely destroyed. Of the components mounted on that edge, the main and budget locks were recovered from the trackside, but the centre trolley, roller and pin were not found.

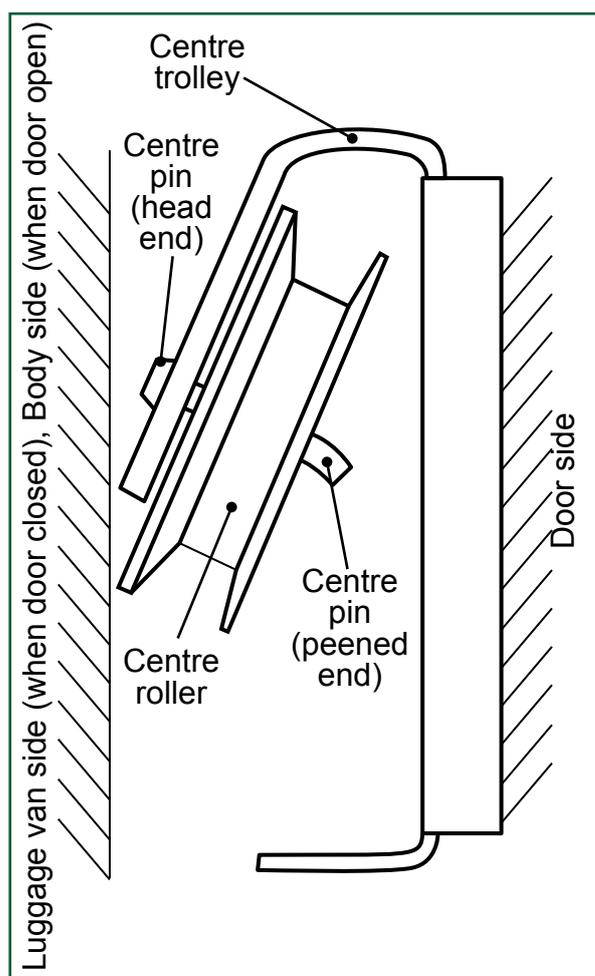
Preface

Figure 6: The centre trolley assembly recalled by staff at Bounds Green (note that the normal condition is shown in Figure 5)

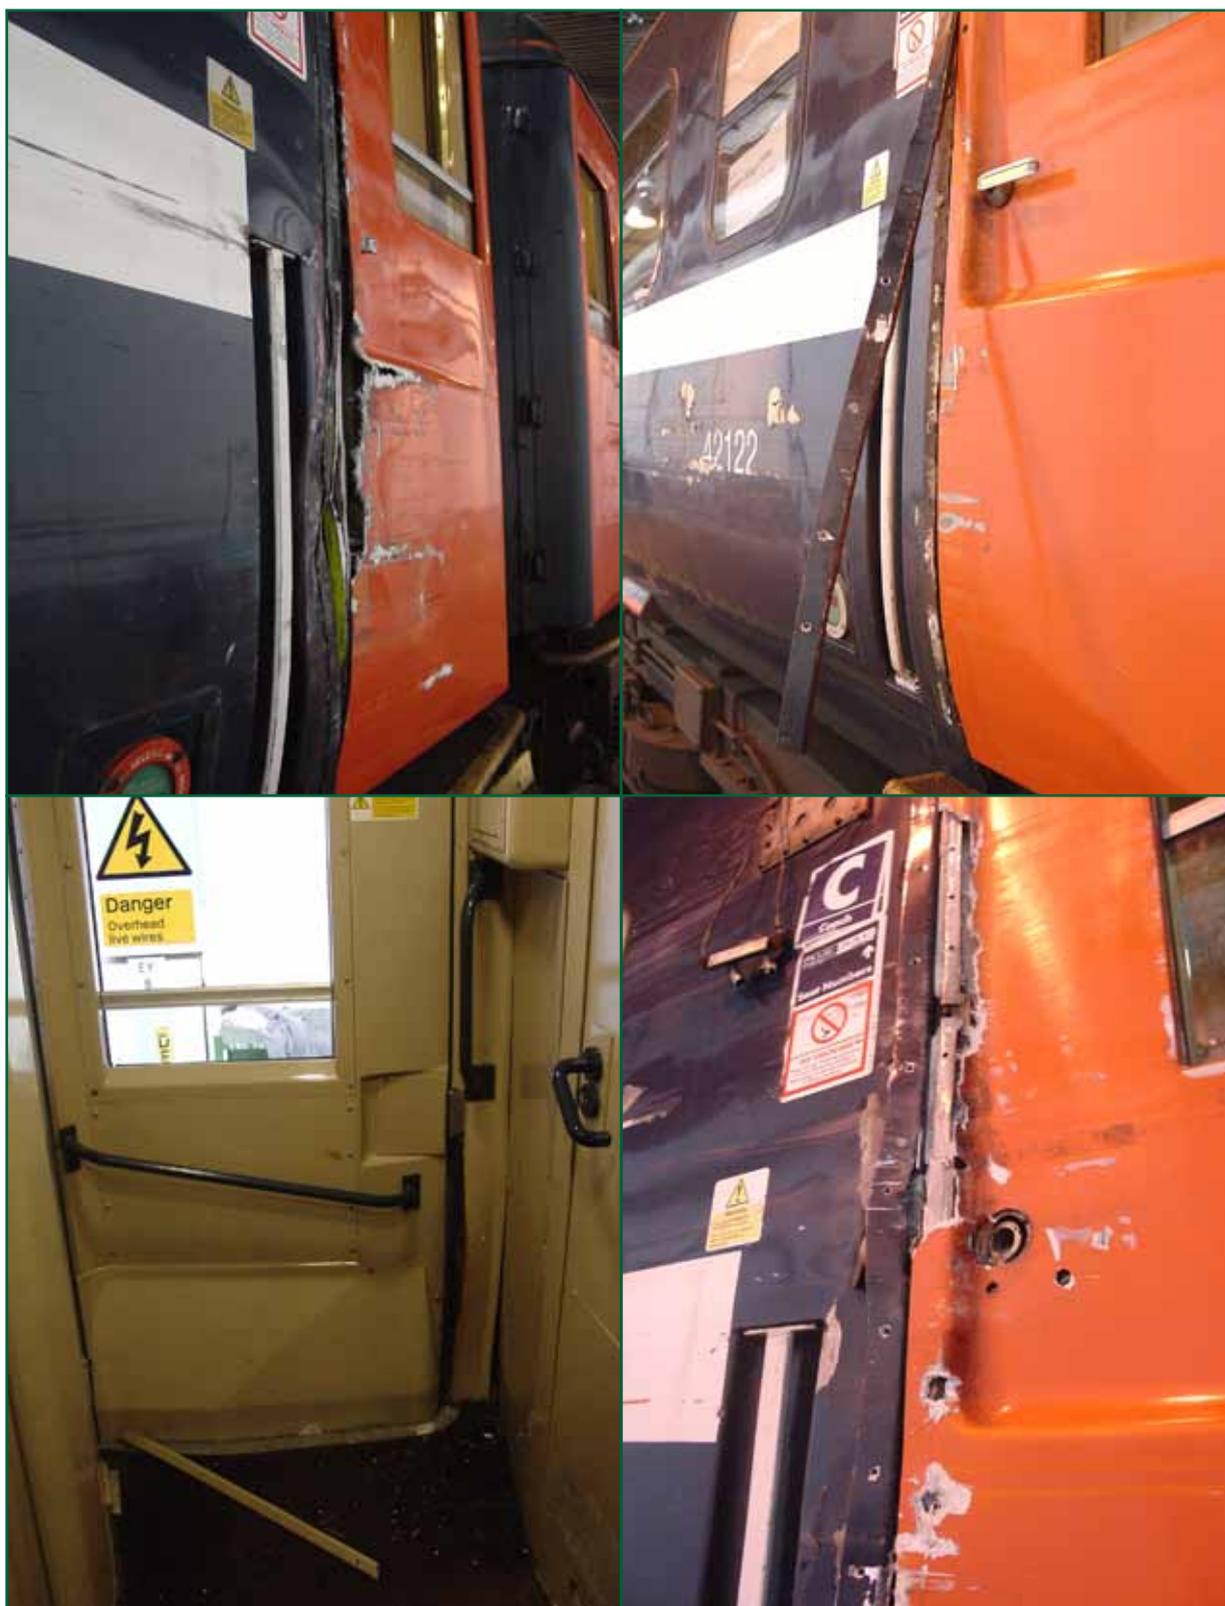
- 27 A number of passengers and crew on train 1A16 were shaken and one passenger reported suffering a minor eye injury as a result of glass-fibre particles entering a vestibule through a part open window. The right-hand side of the train suffered significant damage, although the passenger compartment was not penetrated. All the doors and windows remained intact (Figure 7).

Figure 7: Examples of damage to right-hand side of southbound train 1A16

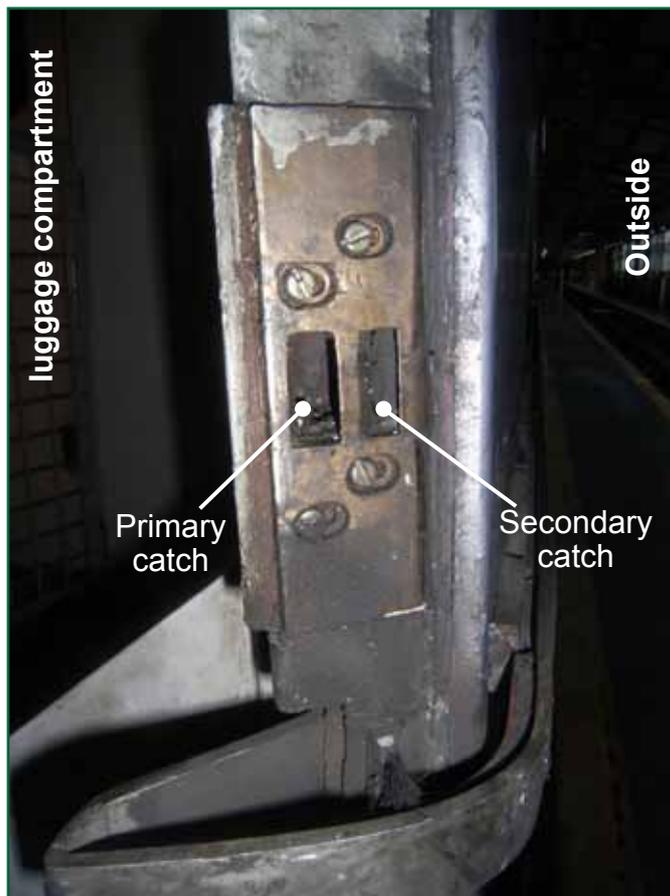
Figure 8: 43306 main lock striker plate after the incident

- 47 The RAIB arranged for specialist metallurgical examinations of the recovered locks by a consultant. These and the RAIB's own examinations showed that:
- the main lock tongue had fractured by ductile bending overload, almost certainly as a consequence of the incident;
 - the main lock was likely to have had only one of its two springs in place prior to the incident, which would have resulted in around half of the normal outward force on the tongue (this was supported by tests on a new lock, as the incident lock was too badly damaged to test);
 - marks on the main lock tongue indicated that, for the majority of its life, there had been at least 8 mm of engagement with a striker plate; and
 - marks on the budget lock tongue indicated a maximum engagement of 7 mm.

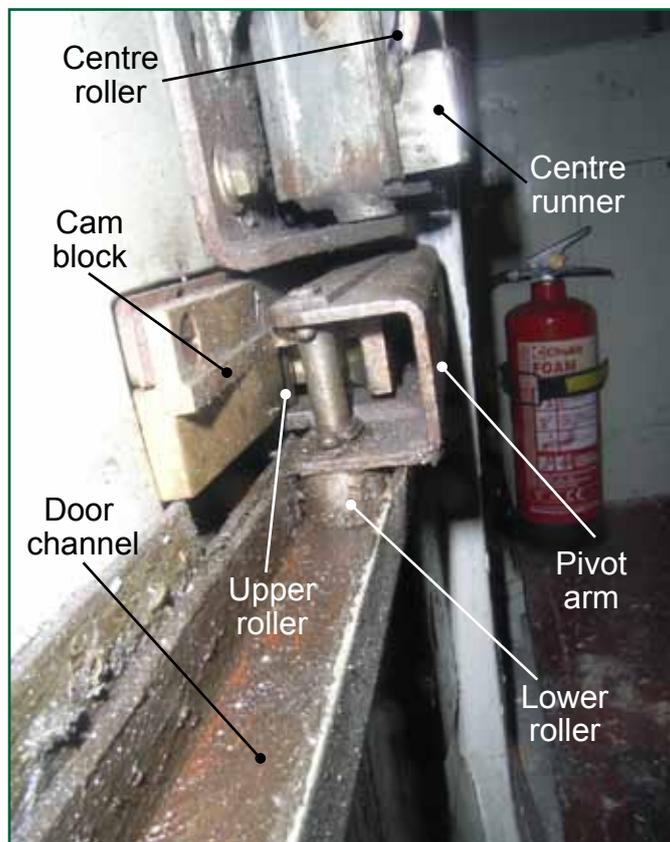
- 37 To help guide the door movement, there is a pivot arm on the vehicle body carrying two rollers (Figure 9). The lower roller runs along the door channel. The upper roller engages in a brass cam block just as the front edge of the door closes into the door opening. This mechanism helps the centre roller steer the leading edge of the door into the door opening correctly. If the cam block is not set up in the correct position, the upper roller will not enter it cleanly when the door is closed and the resulting impact forces will tend to loosen the fixings between the cam block and the door.

Figure 9: A cam block and pivoted arm (note: this is a left-hand door)

72 The cam block is designed to assist the door to close (paragraph 37) and in doing this, reduces the loads on the centre roller as it turns the corner of the centre runner to move the front edge of the door into the closed and locked position. The fact that it came loose on at least two occasions and was not attached when the door came off at Bounds Green would have increased the stresses on the centre trolley assembly making it more likely that the peening would pull through and the trolley become bent. The cam block not being securely fastened to the door on at least two occasions prior to the incident was a contributory factor. It is probable that any continual loosening over time was caused by incorrect set-up of the cam block.

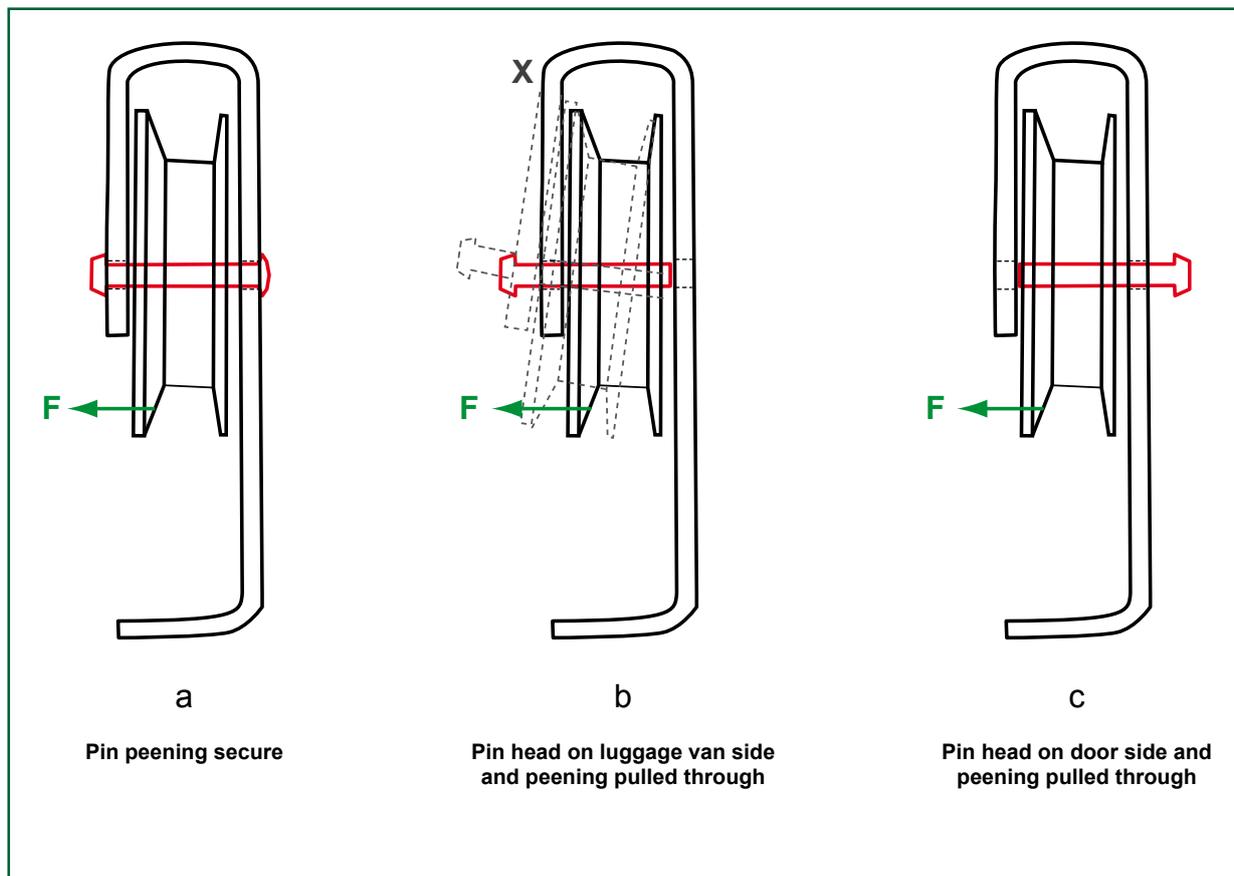
- 50 The RAIB commissioned tests on another centre trolley assembly and used the results as a basis for calculations which showed that for the trolley tested:
- whichever way round the centre pin is fitted, if the peened end is sound and secure in the centre trolley, slamming a sliding door closed cannot cause the trolley to bend (Figure 10a);
 - if the pin head is on the luggage compartment side and the peened end has pulled through the trolley (paragraph 19), a single hard slam of the door can cause the trolley to bend (Figure 10b), as all the door force (F) has to pass through only part of the trolley assembly (X) into the door; and
 - if the pin head is on the door side and the peened end has pulled through the trolley, a single hard slam of the door can not cause the trolley to bend (Figure 10c), because the relatively stiff pin provides an additional load path back to the door.

It should be noted that because the actual trolley assembly was not found, it is not possible to be certain whether it was identical to the tested assembly. However, it is the RAIB's view, based on their calculations, that the first two conditions described above apply to all trolley assemblies. The third condition would only apply to assemblies that have similar pins and rollers to that tested. As there is no evidence to suggest that the incident trolley was dissimilar in this respect, it is probable that the third bullet was applicable to the incident trolley.

Figure 10: Simplified schematic of centre trolley assembly test

- 2 HST owners and operators should consider whether peened centre pins should be replaced by a more reliably fixed pin. If the use of peened pins is continued, consideration should be given to positioning the pins' heads towards the door and the peening towards the luggage van (paragraph 86 6th bullet and 88).

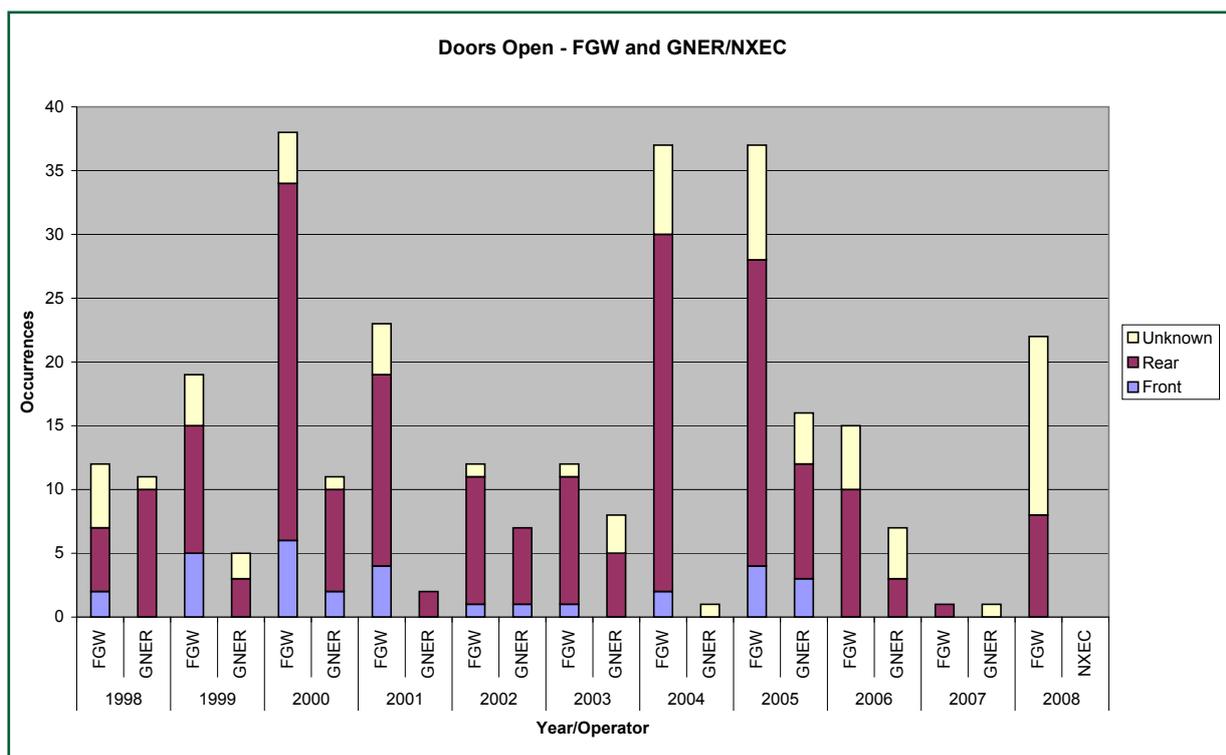
- 65 The figures show that trailing power car doors are much more likely to be found open than those on forward power cars and that the general trend is reducing. The predominance of these events on trailing power cars is explained by the fact that the airflow past them tends to open the sliding doors because the opening edge faces forwards into the airstream; on a front power car the reverse is true and the airflow tends to keep the sliding doors shut.

Figure 11: East Coast and Great Western luggage van door open statistics

- 3 National Express East Coast should put in place procedures mandating the monitoring of the frequency of luggage van doors being found open in traffic and the factors that may be causing this. The procedures should also require that corrective actions should be identified and put in place (paragraph 86 2nd bullet and 87 2nd bullet).
