Rail Accident Report

Derailment of a Docklands Light Railway train, near Deptford Bridge station, London 4 April 2008

Report 16/2009
June 2009

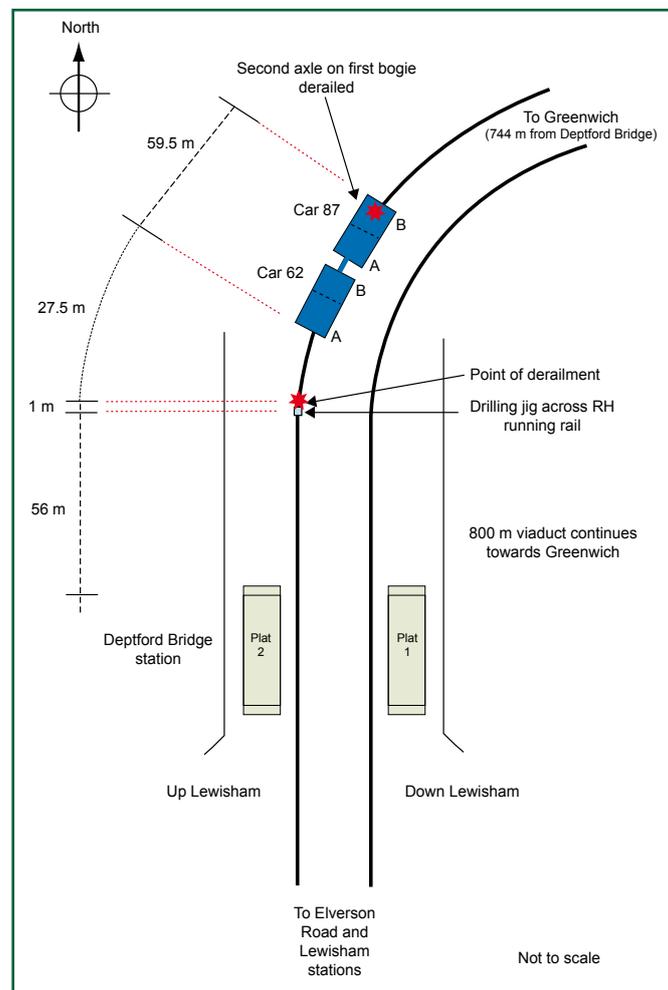
- 13 At 05:22 hrs on 4 April 2008, the 05:19 hrs Docklands Light Railway service from Lewisham had just left Deptford Bridge station, travelling towards Greenwich on the up line (paragraph 5), when it struck an object on the track and became derailed by the second axle of the first bogie. The front of the train came to rest 88 metres after hitting the object (Figure 2).
- 14 The train, which was the first train of the day from Lewisham, was under the control of its on-board computer (automatic mode of operation). The object on the track was found to be a steel drilling jig that had been in use during engineering activities earlier that morning.
- 15 There were no injuries to the 59 persons on board the train and all were evacuated safely back to Deptford Bridge station.

Figure 2: Diagram of the location of the accident north of Deptford Bridge station (A and B refer to the ends of each car [paragraph 3])

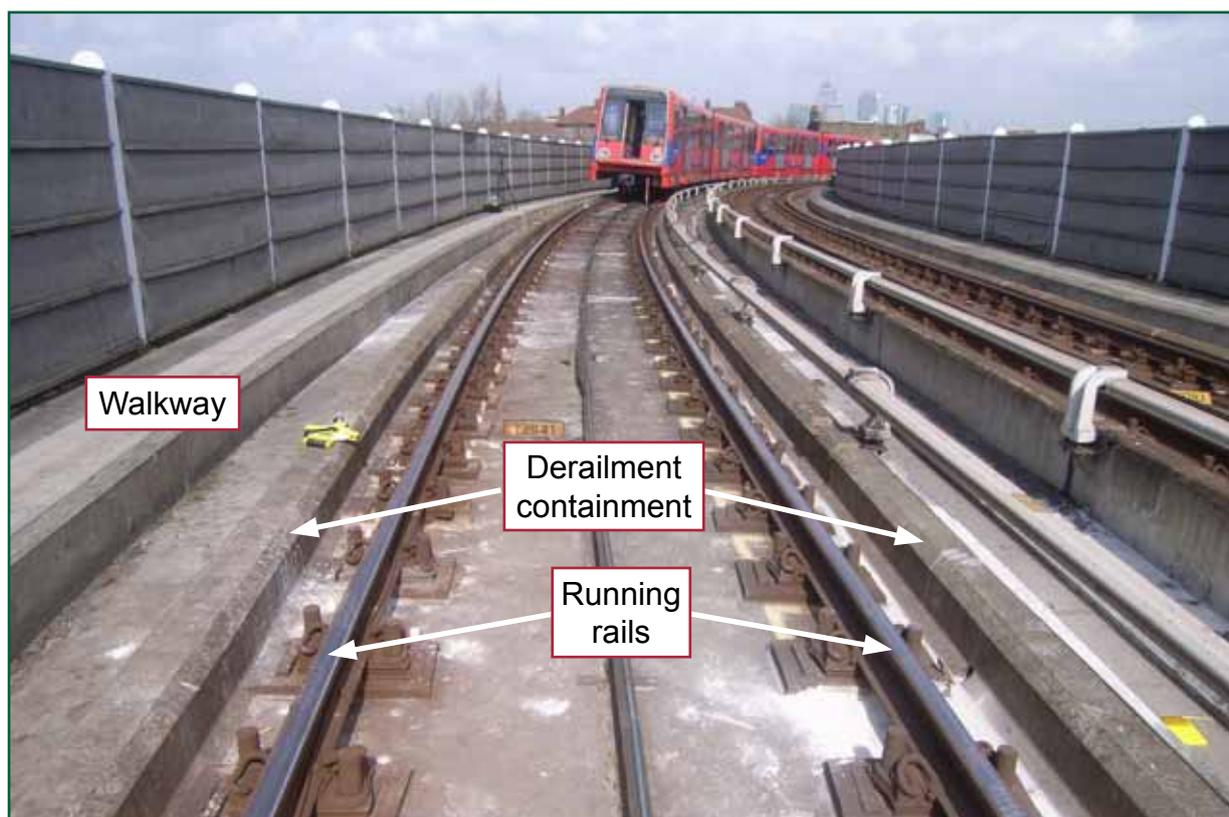
- 55 The train derailed towards the left of the running rail (in the direction of travel). The derailed wheels did not infringe or damage the *derailment containment* shown in Figure 3.

Figure 3: The Lewisham extension showing running rails and concrete derailment containment

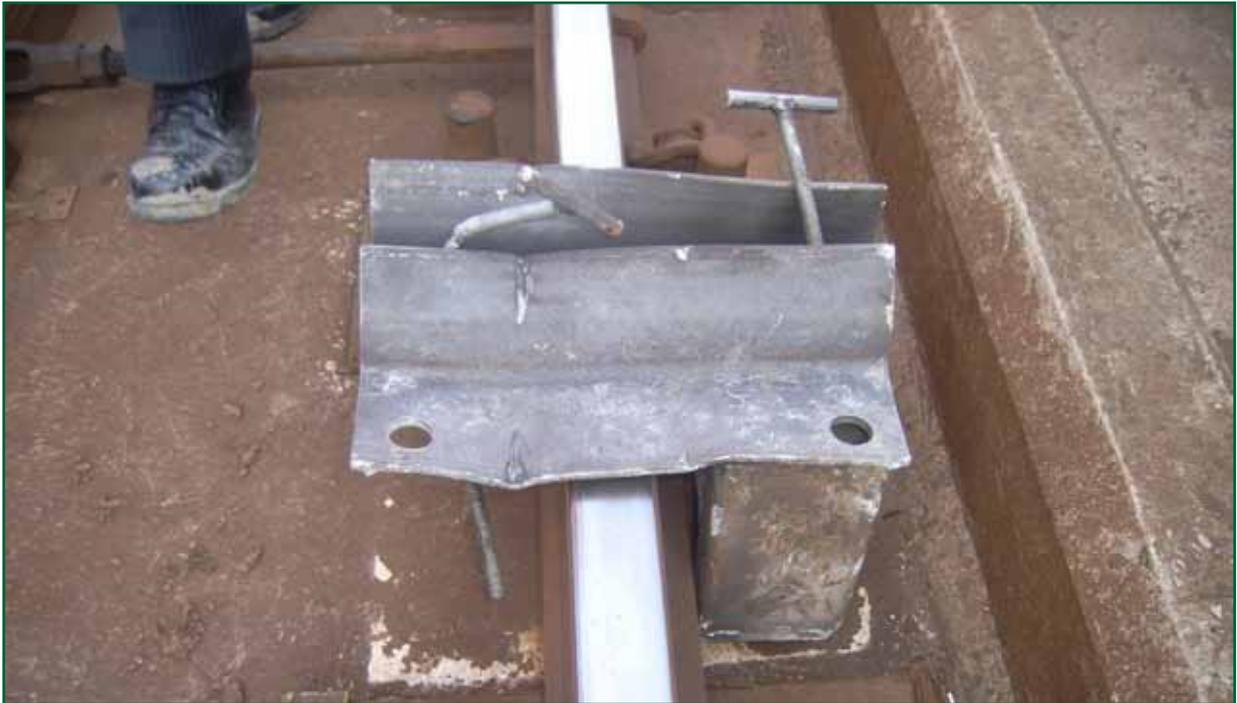
- 62 There was extensive damage to the track fixings that the derailed wheels had run over. The train also received damage to its underside including stopcocks that were displaced, impact damage to the main air reservoir and damage to other wheels that had ridden over the drilling jig.
- 63 The main part of the drilling jig was found lying across the *low running rail* in between cars 87 and 62. The remaining part of the jig came to rest under the B end of car 62, i.e. the third coach of the complete train. The damaged drilling jig can be seen in Figure 4.

Figure 4: Drilling jig (damaged as a result of the derailment) shown in its operating position with two drilling guide holes showing on the front edge

- 64 The drilling jig is a fabricated steel tool which provides location and guidance for drilling one or more holes in precise relationship to a fixed point. A detailed description of why the jig was being used is given in paragraphs 68 to 78.

- 189 Although the drilling jig was a heavy steel tool, it was of a similar colour to the running rail and the concrete trackbed. As a consequence, it was not conspicuous, especially under low lighting conditions, and was missed by the drillers and the PICOW. This lack of conspicuity was a contributory factor.

- 270 Quality Site Testing Ltd have painted the drilling jig with a view to it being seen in poor lighting conditions.
- 271 Quality Site Testing Ltd have developed a daily check list for the equipment and tools taken to site and also identifying the person responsible for each item. This list has to be signed by both the Quality Site Testing Ltd employee and the PICOW when it has been confirmed that all the equipment and tools taken to site have been returned to the platform from which access to the work site was gained.
