RAIB Bulletin 08/2009

Collision between a moving tram and stationary tram

The event took place at Blackpool Starr Gate on 24 June 2009

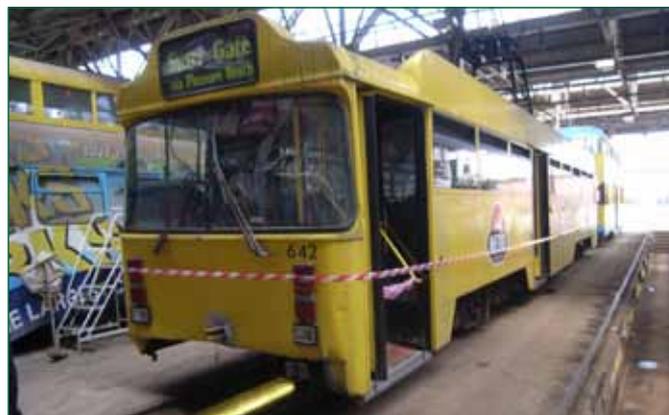
2. The moving tram (Figure 1) was one of a fleet of eight trams constructed between 1984 and 1987. Two other trams of a different fleet type have the same braking system. Three braking systems are fitted:

Figure 1: tram involved in the collision at Starr Gate

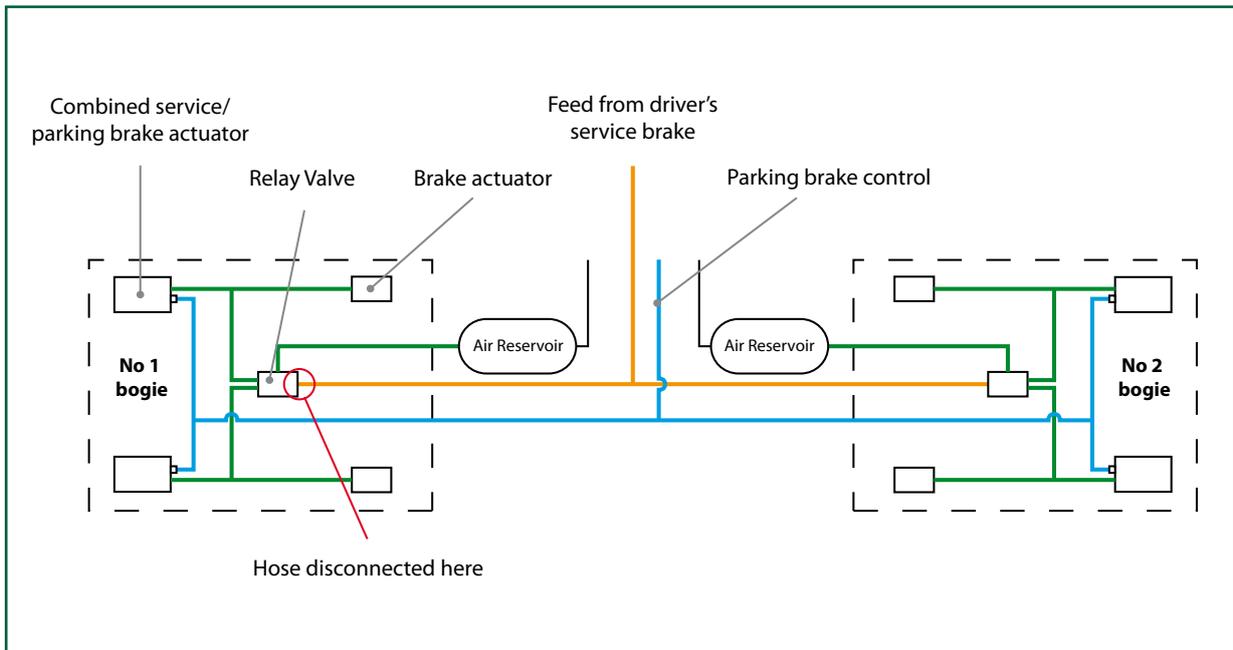
- The service brake when operated admits air pressure to a relay valve on each bogie (Figure 2). These operate to allow air pressure from each of two air reservoirs to the eight brake actuators. The pressure admitted to the actuators is in proportion to the movement of the service brake handle.

Figure 2: diagram of air system

5. Depot tests indicated that with the hose to one of the relay valves disconnected, the service brake was completely ineffective, including to the bogie whose relay valve connections were intact, because there was insufficient air pressure left to operate it. Operation of an emergency brake plunger did provide sufficient air pressure to operate the relay valve whose connections were still intact to apply the brakes on that bogie. The parking brakes on both bogies also applied when an emergency brake plunger was operated.

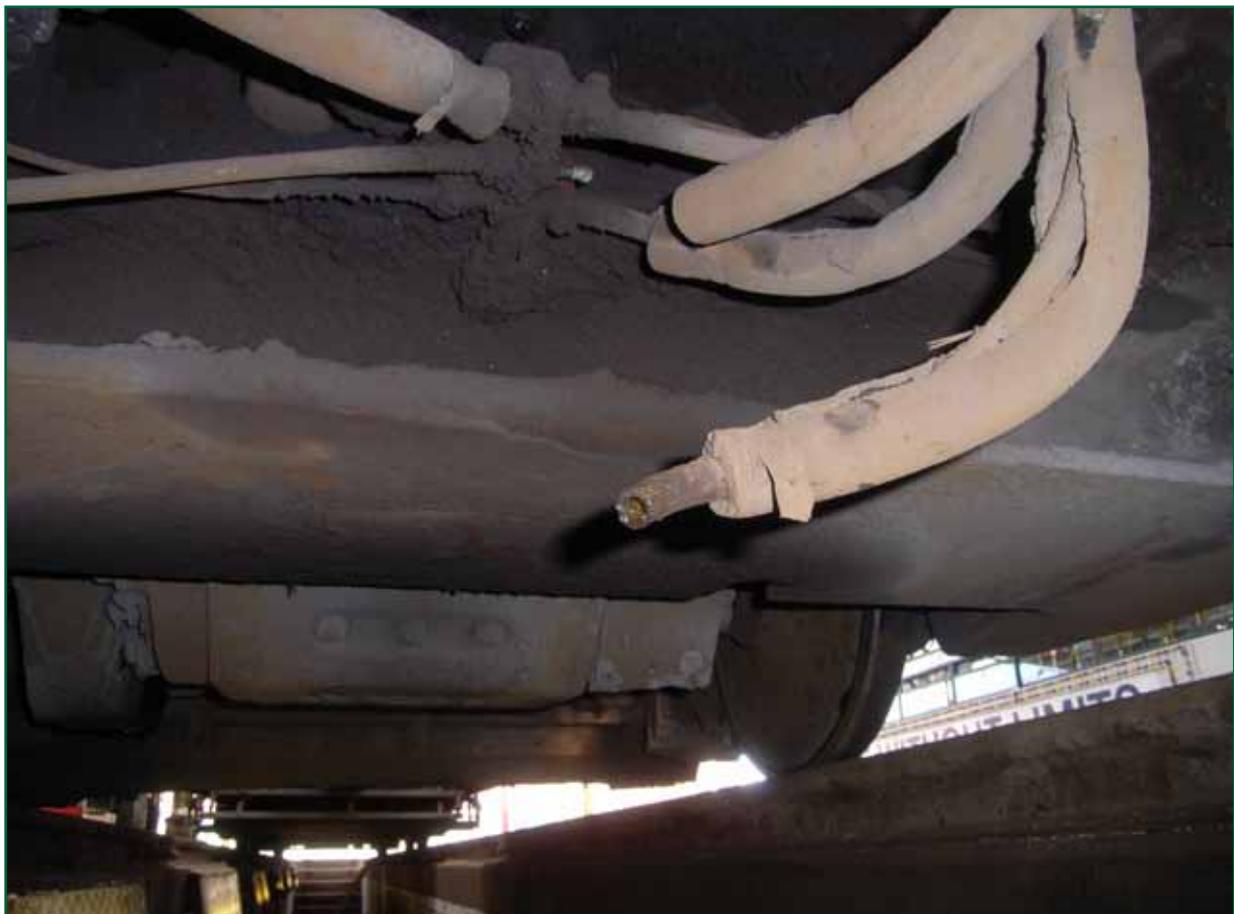
Figure 3: disconnected hose

4. In order to accommodate the rotation of each bogie, the brake system pipework between the underframe and each bogie consists of flexible hoses secured in position by jubilee clips. One of these clips broke and the corresponding flexible hose came apart from its connection to one of the relay valves. The broken clip was found still in situ on the end of the hose. It is likely that the hose became disconnected from its fitting (Figure 3) in the period between the driver's last use of the service brake when it operated normally and his use of it when he attempted to stop just before the collision.

6. Jubilee clips once fitted were not subject to any maintenance requirement or any consideration as to their serviceable life. The subsequent accumulation of dirt and detritus would also have hidden any failure of a clip which may otherwise have been noticed as part of a general inspection of the tram underframe.

9. The duty holder replaced every jubilee clip on all 11 tram cars with the same sort of braking system fitted to the tram involved in the accident. Efforts were also being made to obtain a better quality fastening.
