Rail Accident Investigation Branch

RAIB Bulletin 01/2009

Collision of tram and double decker bus in September 2008

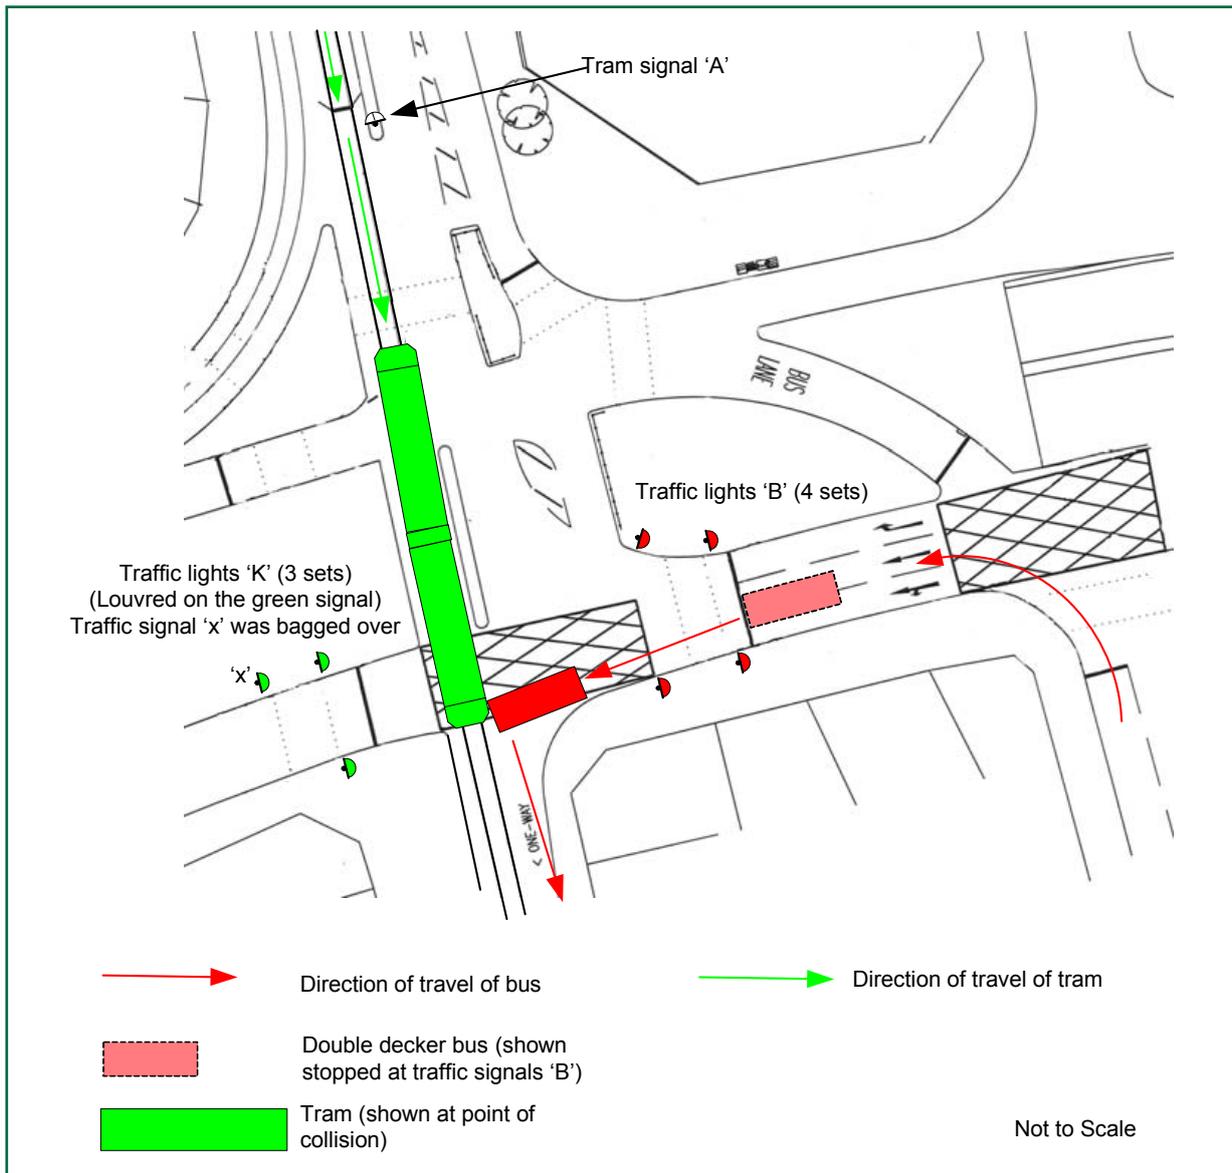
Figure 1: Diagram of road junction showing positions of the tram and bus and the relevant traffic lights

- 1 In September 2008, a tram and a bus collided at a complex road junction (see Figure 1). The tram was derailed by its front bogie and the bus suffered extensive structural damage to its front offside corner and driver's compartment. A member of the public travelling at the front of the upper deck of the bus was thrown out of a side window and received fatal injuries. Six other people, including the bus and tram drivers and passengers on the bus and the tram, were injured.

- 3 Evidence obtained from Closed Circuit Television, including cameras onboard both the bus and the tram, shows the following (see Figure 1):
 - when approaching the stop line, four sets of traffic lights at 'B' were showing red and were visible to the bus driver; and

- whilst the bus was stationary at traffic lights 'B', the traffic lights at 'K' turned to green. One of the green traffic lights at 'K' was visible to the bus driver because the louvres on that signal were damaged.

- 4 The reason for the bus driver passing the red traffic lights at 'B' is still the subject of an on-going police investigation. However, it is possible that the appearance of a green traffic light at 'K', on the other side of the road junction, was a factor.

- 11 Before modification, vehicles following the same route as the bus involved in the accident would always encounter the four sets of traffic lights at 'B' showing red. In these circumstances the lights at 'K' (protecting the pedestrian crossing) would remain at red while tram signal 'A' was showing 'proceed' for a tram to pass through the junction. As soon as the traffic lights at 'B' turned to green, then the lights at 'K' would also turn to green.
- 12 After modification, it was possible for lights 'K' to change to green while the tram signal 'A' showed proceed and lights 'B' remained at red. The louvres fitted to the green signal of lights 'K' were intended to prevent this signal being seen by drivers of road vehicles standing at lights 'B', but prior to the accident these had been damaged and were not effective.

- 14 Following the RAIB's on-site investigation, the lamps in the green signal of the 'K' lights were disconnected by the traffic authority's contractor until repairs had been carried out on the louvres.

- 20 These learning points are:
- the need to carry out regular checking, maintenance and timely repair of road traffic lights and in particular ones fitted with louvres;
